# OTTA SEAL TRIALS IN KWAZULU-NATAL, SOUTH AFRICA

S. Oloo,<sup>\*</sup> D. Thevadasan<sup>\*\*</sup> and H. Bennett<sup>\*\*\*</sup>

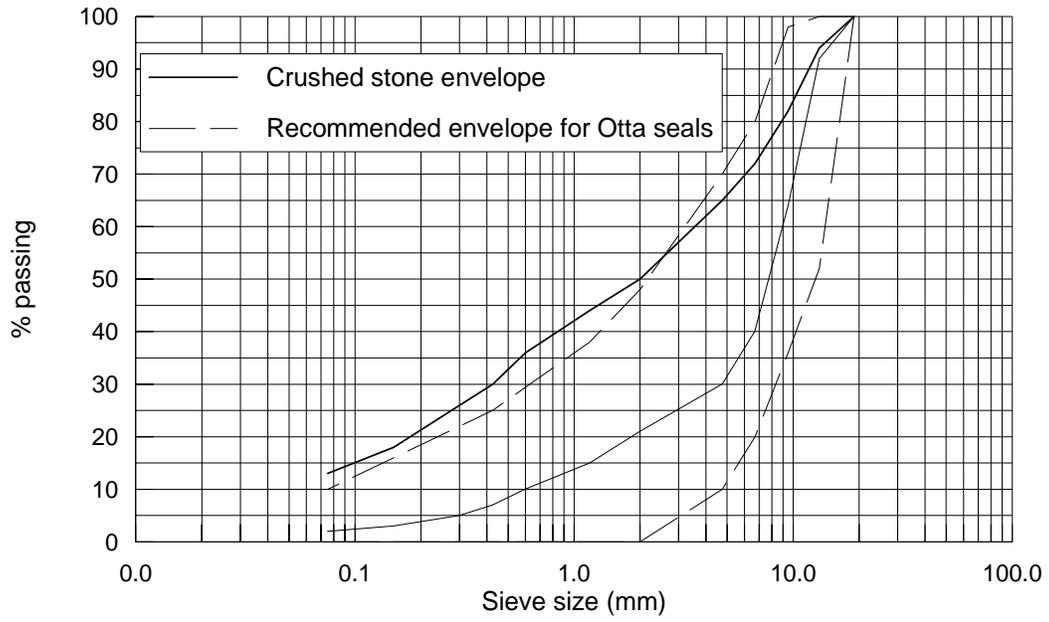
Two types of aggregates were used, a crushed quartzite rock and a decomposed granite. The crushed rock aggregates had good physical properties but, as shown in Figure 3, had grading from marginal to out of specification for Otta seals. The crushed rock was gap graded forming an open texture with a fair proportion of oversized stones on the one end and significant proportions of fines on the other end.

Figure 3: Grading envelope for crushed rock aggregates.

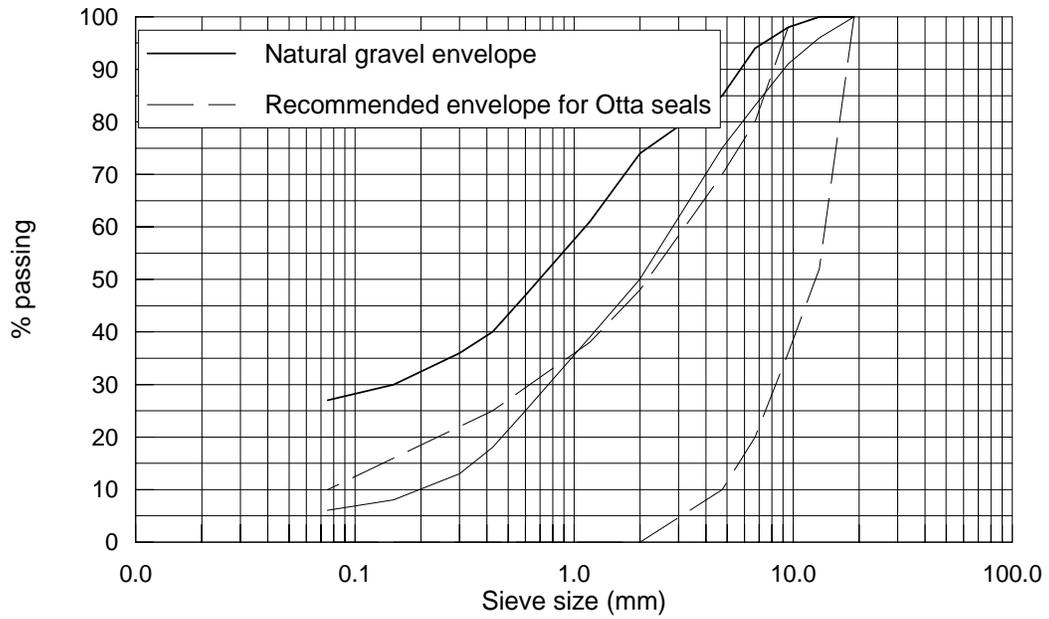
The decomposed granite aggregates had lower crushing strength and grading that was also marginal to out of specification (Figure 4).

Figure 4: Grading envelope for natural gravel.

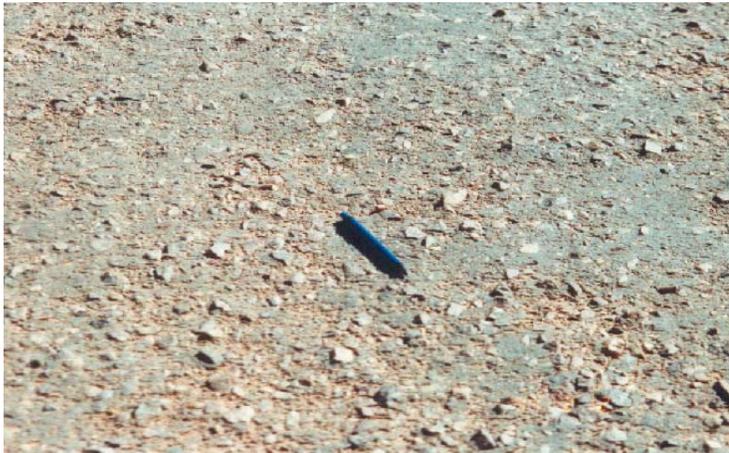
The interaction between aggregate and binder in Otta seals is a gradual process. As a result, one week after construction there was still a large quantity of loose aggregate on the pavement and shoulders (Figure 5). Telltale signs of the kneading affect between the binder and aggregate could be seen along the crown and wheel paths. At this stage the only distinguishing feature separating the various trial sections was the difference in colour and texture of the aggregates used. The gap graded bluish grey crushed rock sections were clearly distinguishable from the denser, yellowish-brown decomposed granite sections.

Figure 5: Appearance of a crushed rock section one week after construction.

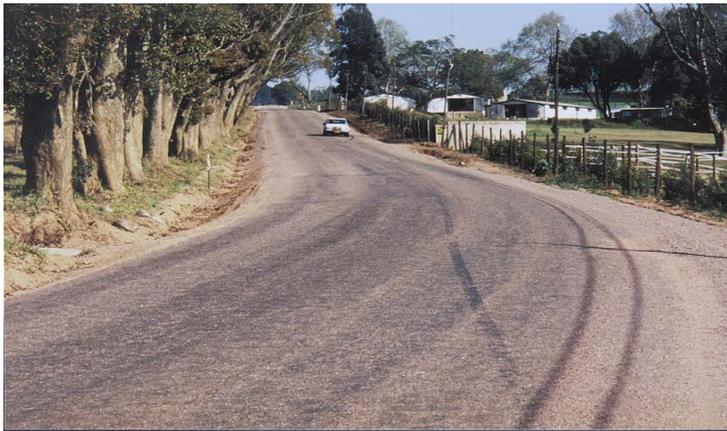
The binder had worked its way completely through the aggregate particle interstices displaying typical Otta seal characteristics (Figure 6). Trial sections consisting of the natural gravel where the higher binder application rate was used exhibited signs of bleeding. This was particularly true of Sections 7 and 8.

Figure 6: Characteristic premix look of Otta seal two months after construction.

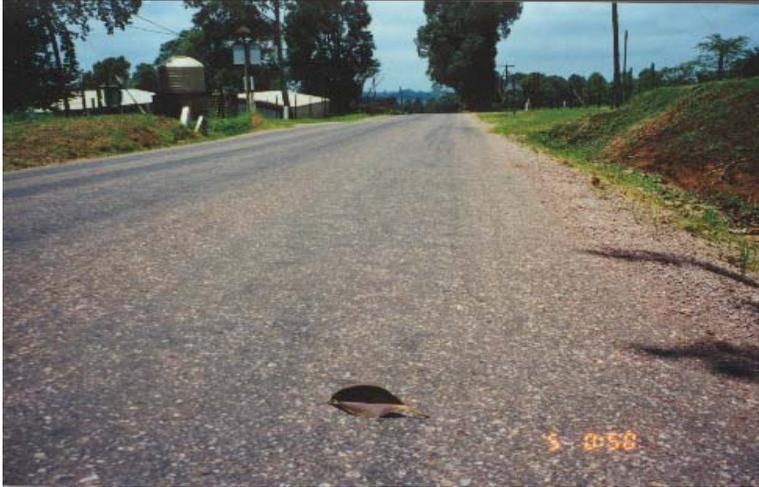
Six months after construction the Otta seal had completely cured in all the test sections. The whole road had a uniform dark premix-like appearance with variable bleeding along the wheel paths (Figure 7). Natural gravel sections tended to bleed more than the crushed stone sections.

Figure 7: Bleeding along the wheel paths after 6 months.

- Binder application rates and amount of cutback appear to influence the performance of the Otta seal as evidenced by the excessive bleeding of the natural granite sections in which the amount of cutback was increased from 8 to 11 percent.
