# *Instrumentation of Bridge #MEG-124-6.78*

**Draft Final Report to the Sponsor:**

**Ohio Department of Transportation  
October 1999**

**University of Cincinnati  
Department of Civil and Environmental Engineering  
P. O. Box 210071  
Cincinnati, OH 45221-0071**

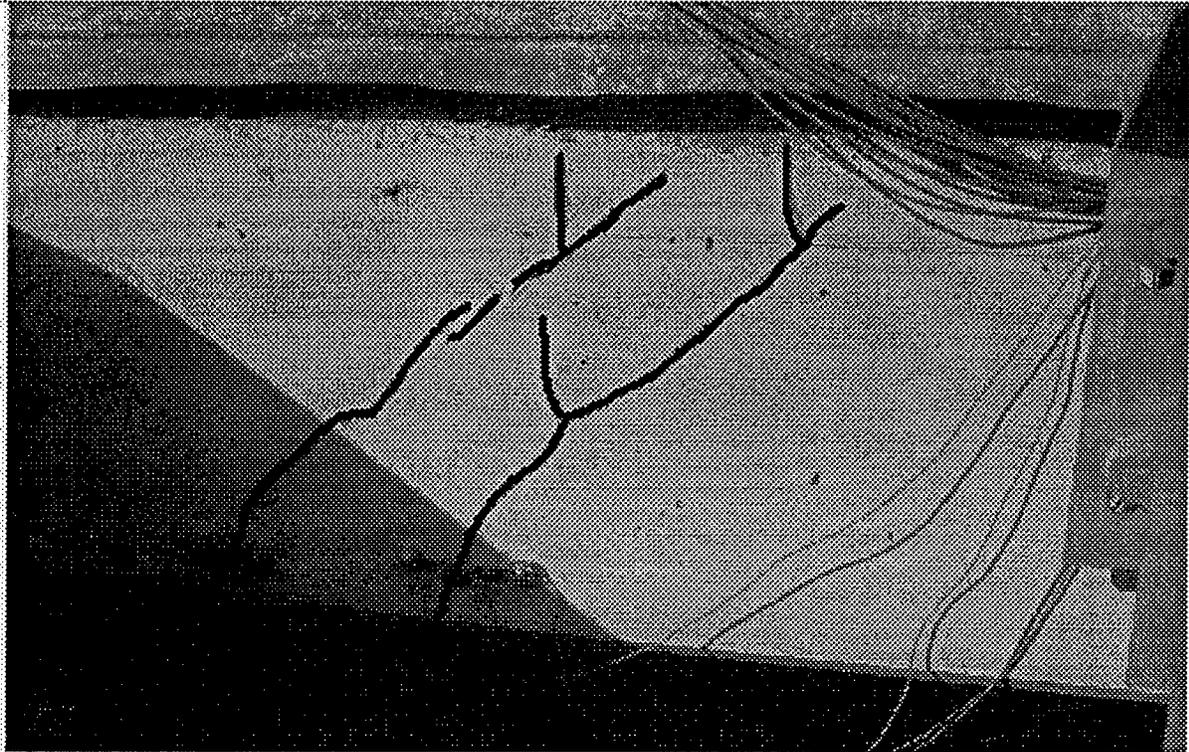
- 1) The beam on the southwest edge (numbered 9 in Figure 1.1 and shown in Figure 1.3) had diagonal cracks and straight cracks in the exposed side of the beam. These cracks continued to the bottom of the box where they became transverse (perpendicular to the span). Whether the cracks continued up the other side of the beam was not clear as the other side of the beam (being up against the adjacent beam) was not visible. The worst cracking occurred at the northwest corner where the cracks appeared to be diagonal shear cracks. Less severe cracking, which appeared to a vertical flexural crack, occurred at the other end of the beam as well. In both cases, the cracks formed about 4 ft. from the obtuse corner.

Figure 1.3a - Diagonal Cracks in Beam #9 (cracks highlighted to show detail)

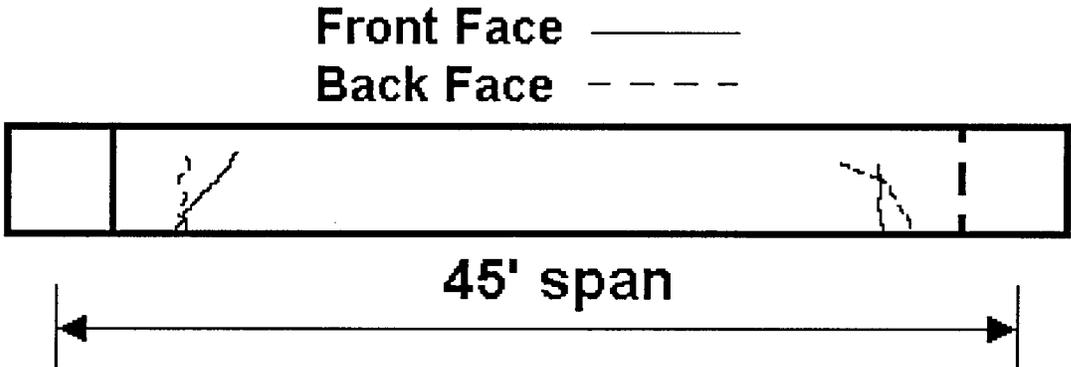
- 2) Each of the adjacent beams (numbered 7 and 8 in Figure 1.1) had transverse cracks along the bottom. The sides of the beam were not visible so it could not be ascertained if the diagonal cracks existed along the sides of the beam. Again, cracking occurred at both ends of the beams approximately 4 ft. from the obtuse corner.

Figure 1.3b - Typical Crack Patterns - Beams # 7, 8, 9.

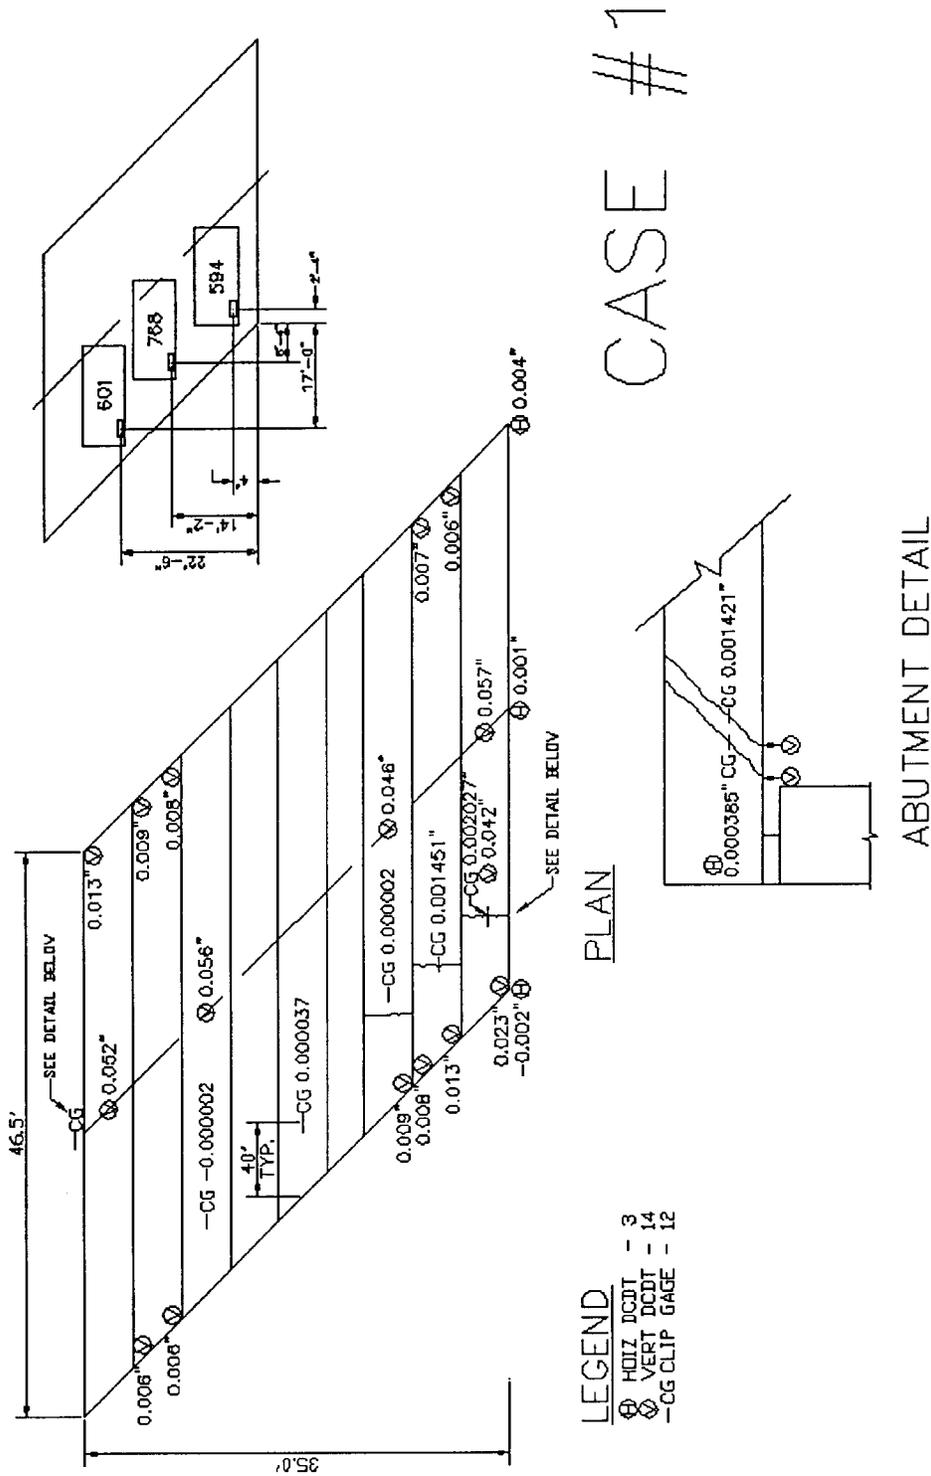
Figure 2.3 - Load Case #1

- 2) It is clear that some of the beams are twisting. This twist appears to be caused by two factors: loose bearing pads and the skew of the bridge. A loose bearing pad was found under beam #8. This can be seen in Figure 2.3 where there is a measured twist in the NW end (left side as viewed in Figure 2.3) of beam #8. This end shows a differential deflection of 0.005" (0.013" - 0.008") between the sides of the beam. The other end shows no appreciable twist as the 0.001" difference is within the accuracy of the instrument. Twist is found in beam #8 in Load Cases 1, 2, 3, 8, 9, 10. In all of these cases the trucks were positioned to load beam #8. In the remaining cases, the trucks do not directly load beam #8 and no twist is found.

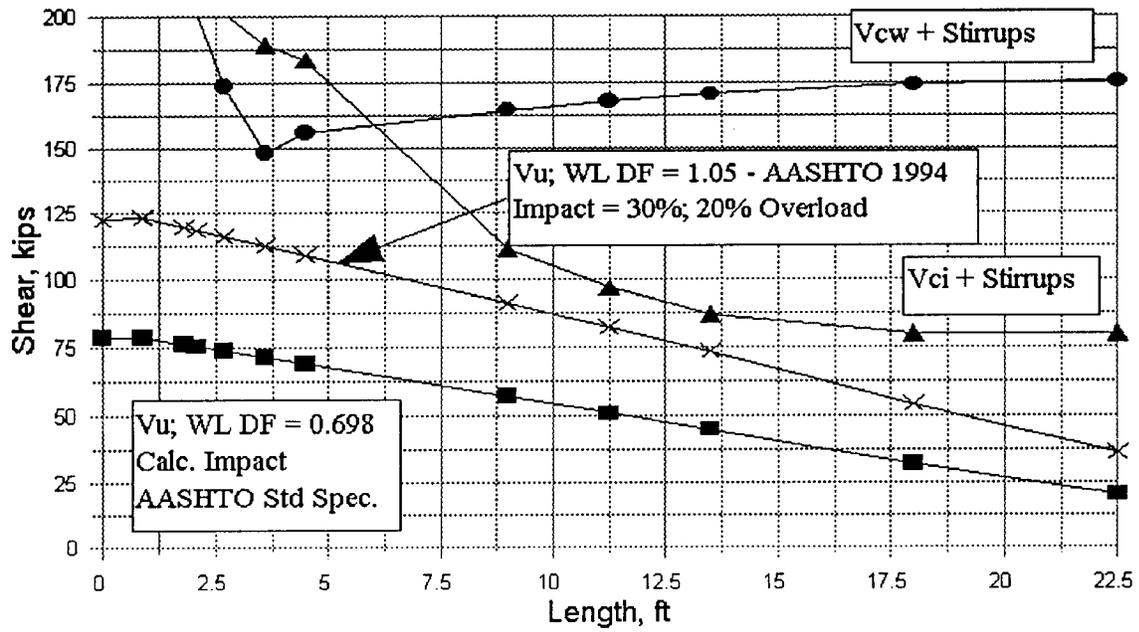
Figure 2.13 - Design Shear Forces

- 4) The bridge had a large skew, which the standard specifications do not account for. Also, the bridge is on a coal route where trucks may be overloaded. However, even when accounting for the increased load effect of skew (using the *AASHTO 1994 Guide Specifications*) and allowing for overload by using an impact factor of 50%, the beams still would have had sufficient shear capacity. Therefore, the effect of skew did not cause failure.
