# Acoustic Emission Monitoring of Fatigue Cracks in Steel Bridge Girders

1. Report No. MN/RC - 1999-36		2.		3. Recipients Accession No.	
4. Title and Subtitle ACOUSTIC EMISSION MONITORING OF FATIGUE CRACKS IN STEEL BRIDGE GIRDERS				5. Report Date September 1999

# **ACOUSTIC EMISSION MONITORING OF FATIGUE CRACKS IN STEEL BRIDGE GIRDERS**

## **Final Report**

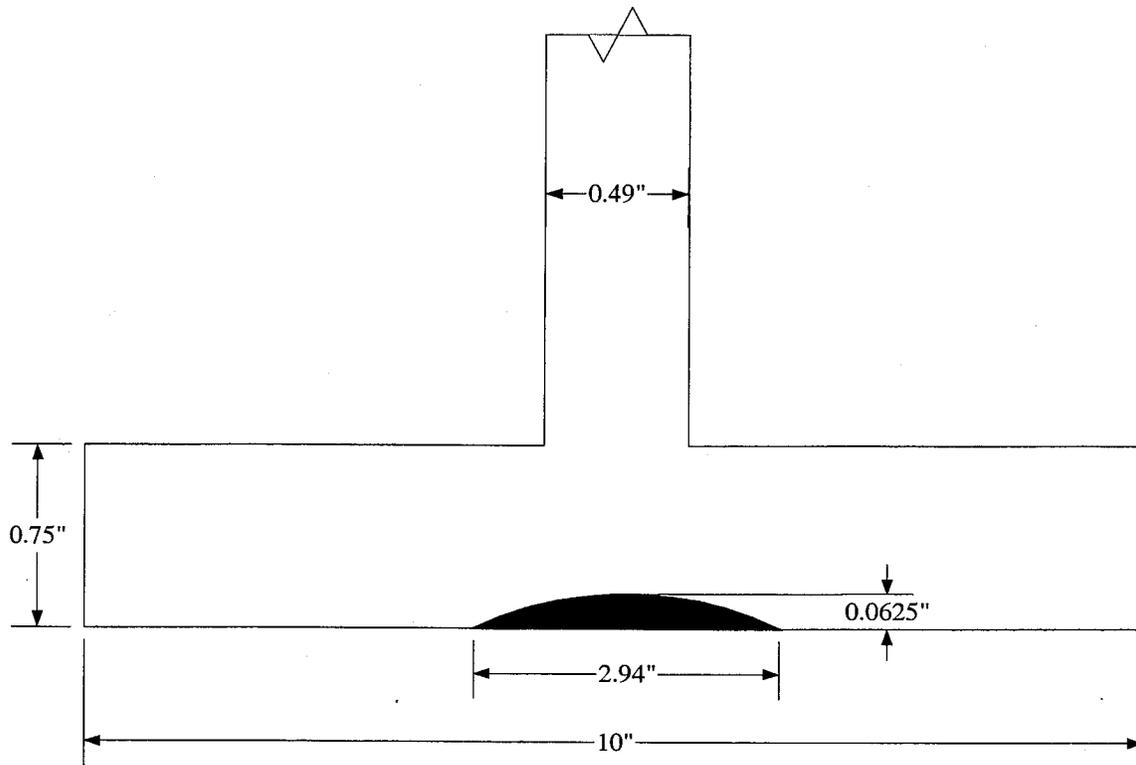
Figure 3.3: Bottom Flange Section Loss at 1,773,000 cycles

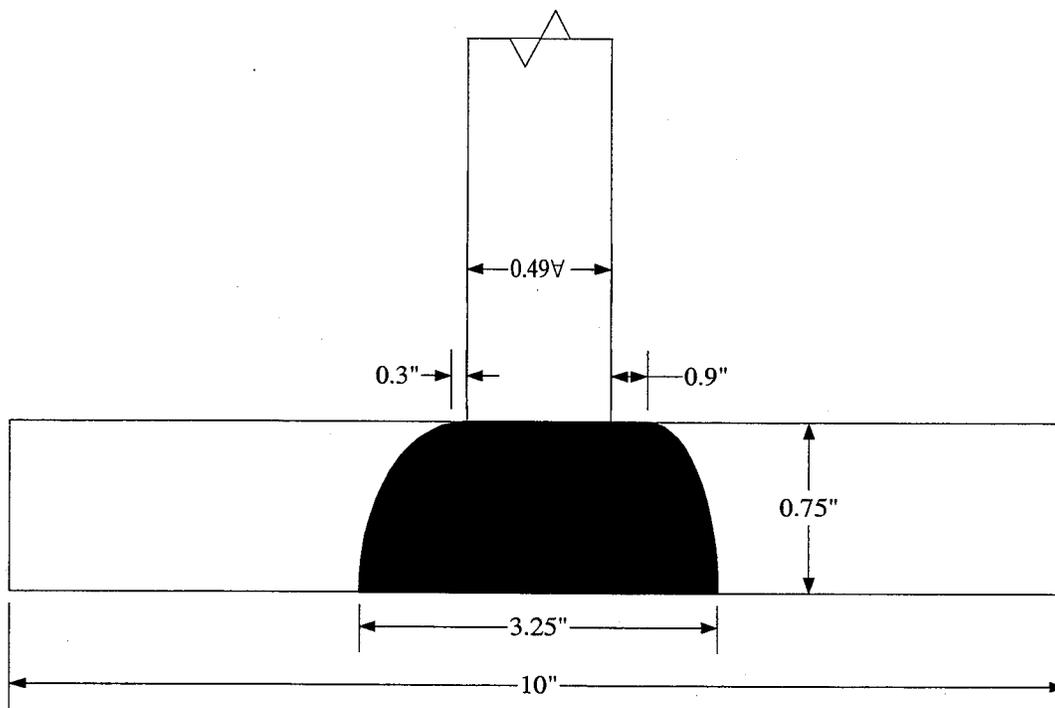
Figure 3.4: Bottom Flange Section Loss at 1,983,000 cycles

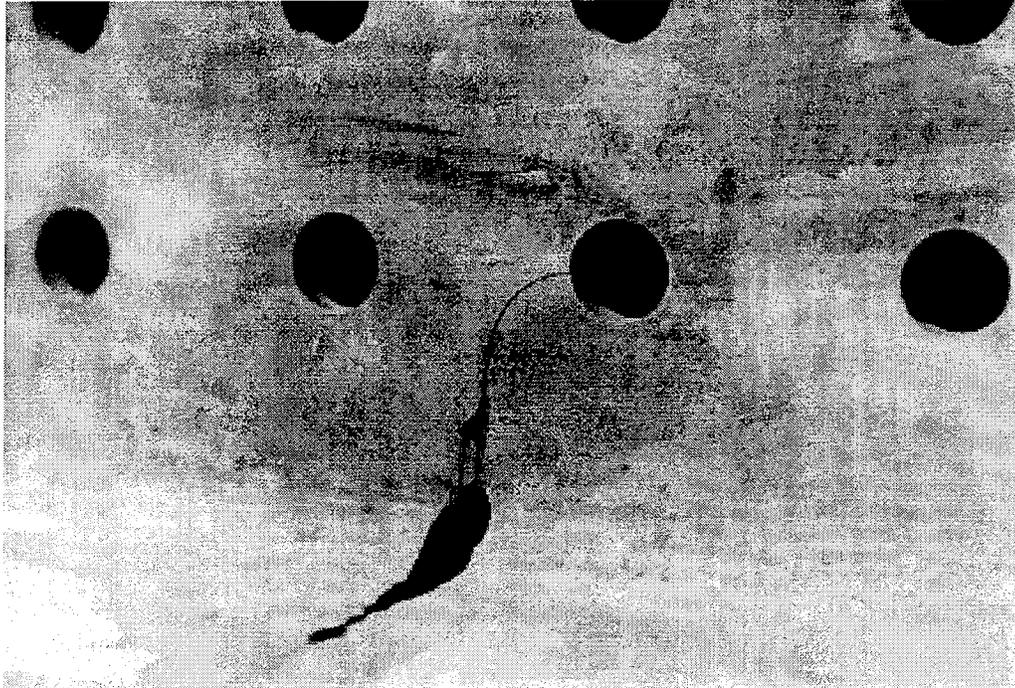
Figure 4.6: Final Web Crack of Laboratory Specimen
