Investigation of Cracks in Cylindrical Spun-Cast Concrete Piles in a Marine Environment

by
R. Richard Avent
David J. Mukai

LTRC Project No. 98-1SS
State Project No. 736-99-0502

Louisiana Department of Transportation and Development
Louisiana Transportation Research Center

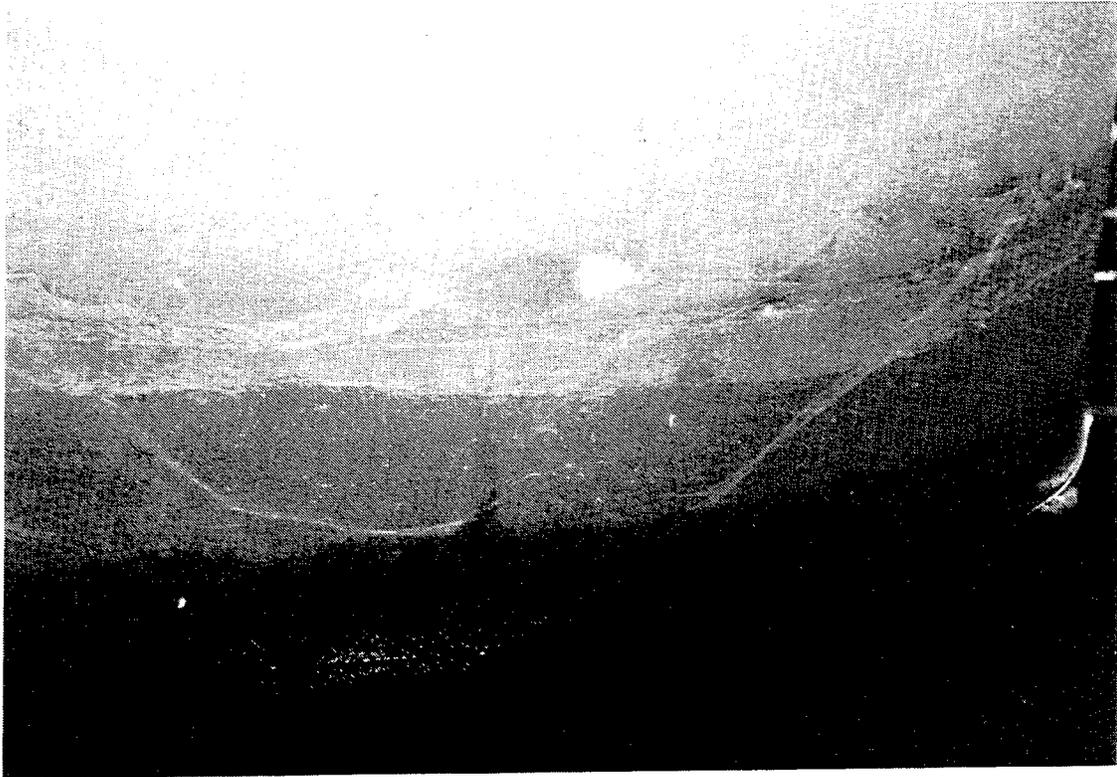
The level I above water inspections revealed that hairline cracking was confined to relatively few piles and in a few isolated instances to cracks approaching 1/8 inches at the surface that necked down to hairline cracks not far from the surface. These cracks were limited to I-10 over the Reserve Relief canal and I-10 between Ramah and Whiskey Bay. A database of piles with cracks was developed and a printout can be found in appendix A. Typical hairline cracks are shown in figures 11 to 14. These cracks are so small they do not show well in photographs except when highlighted by efflorescence. Cracks that appear at the junction with the pile cap girder are typically from piles supporting I-10 between Ramah and Whiskey Bay. Cracks found near the waterline are typically from I-10 over the Reserve Relief Canal.

Figure 12
Typical hairline crack near waterline

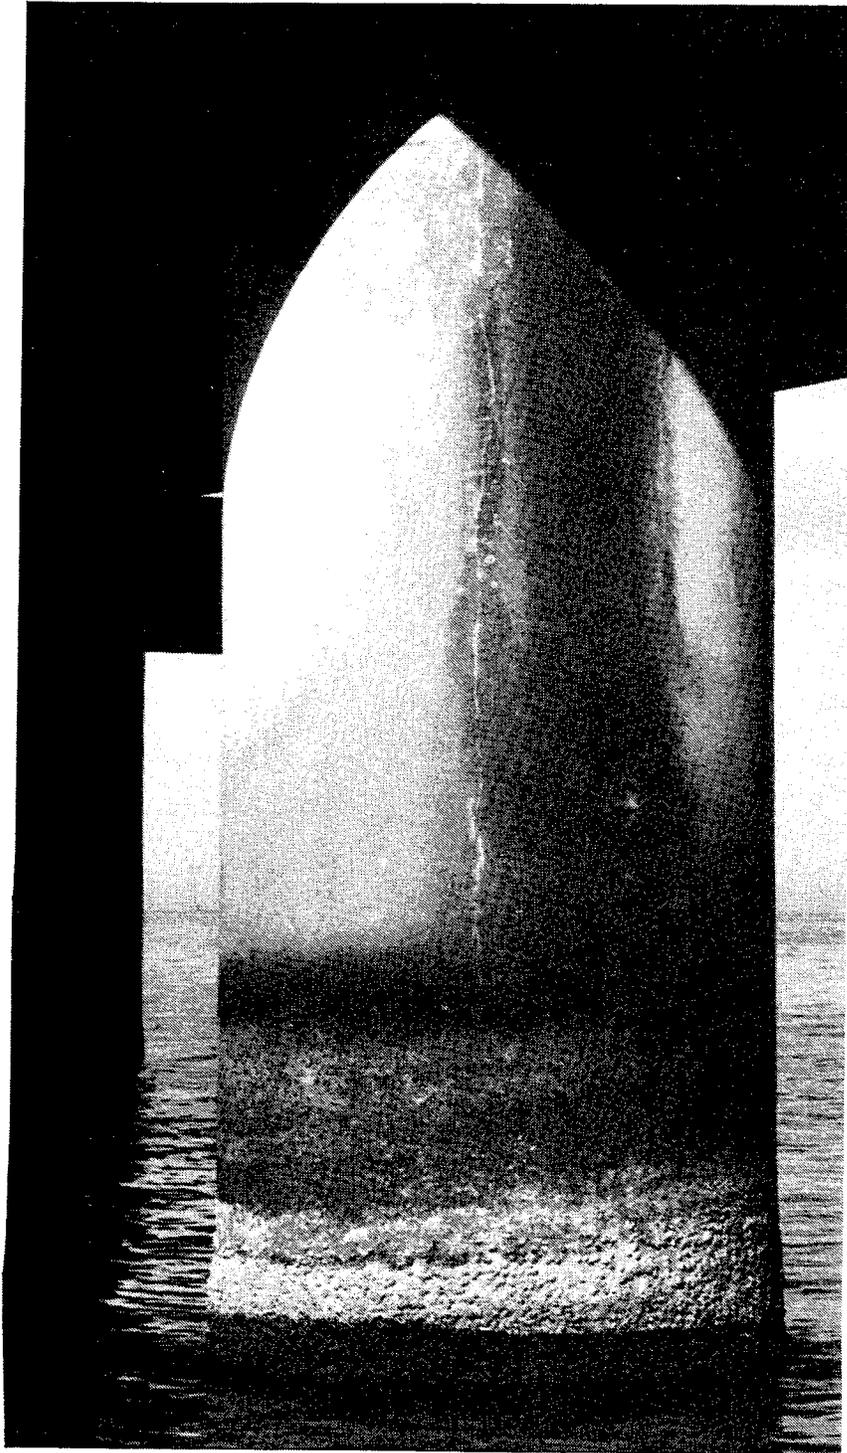
Figure 13
Typical hairline crack near pile cap

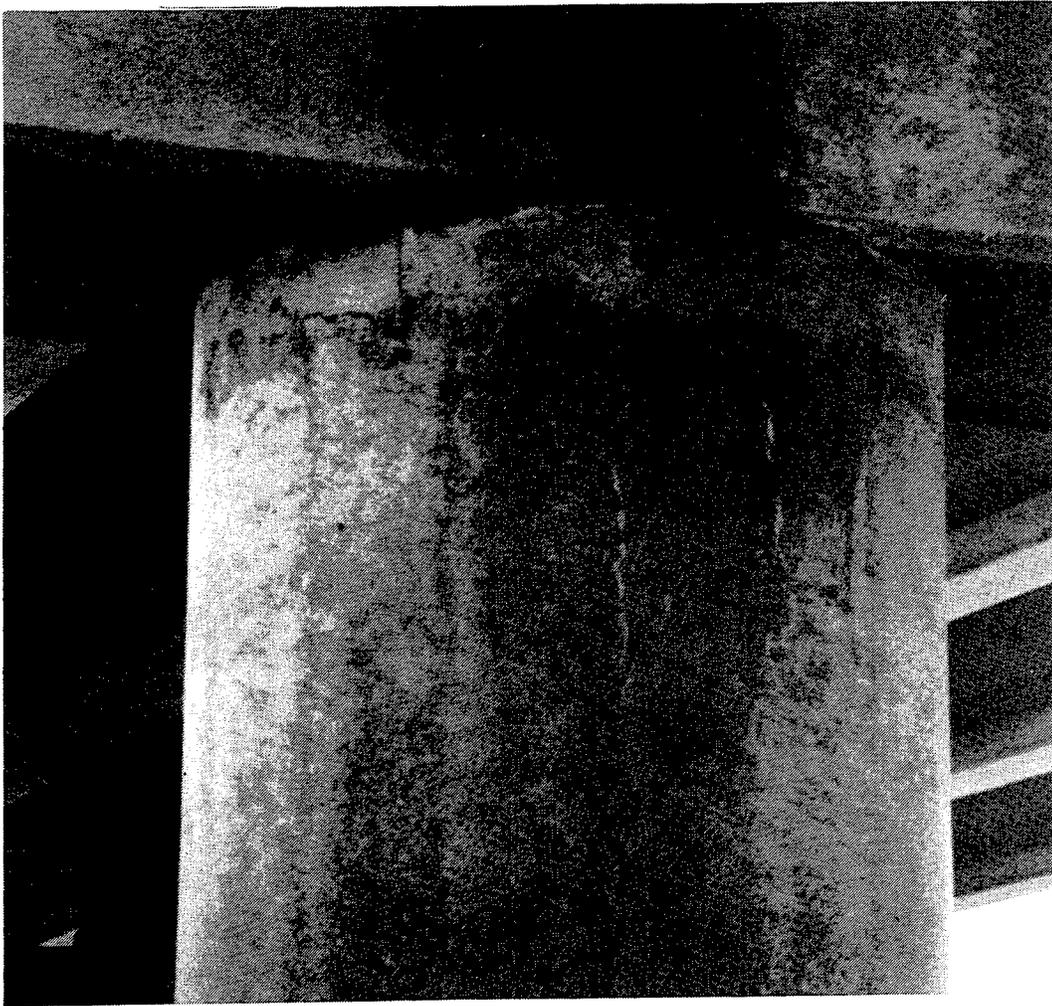
Figure 14
Typical hairline crack near pile cap

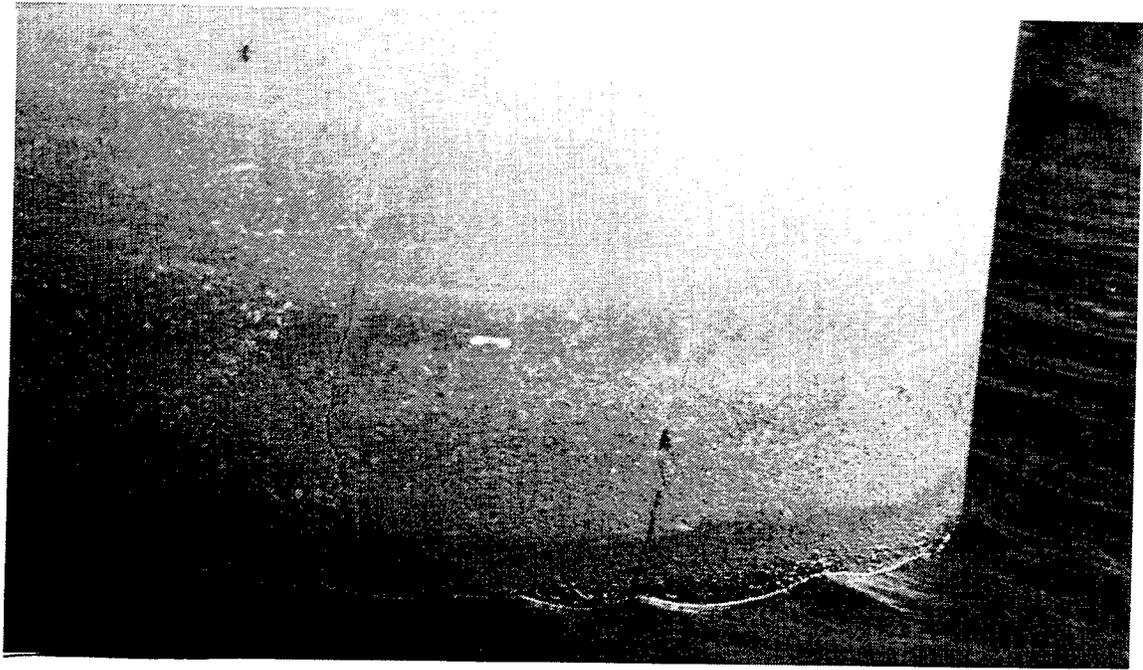
Pictures of the most severe cracks are shown in figures 15 to 19. These cracks were found on piles supporting I-10 over the Reserve Relief Canal near the waterline. These cracks were concentrated over a consecutive series of bents, centered on Bent 101. The complete information on this bent is:

Reserve Relief Canal
I-10 Copser
62484501305151
Bent 101

Figure 15
Crack near waterline on Reserve Relief Canal

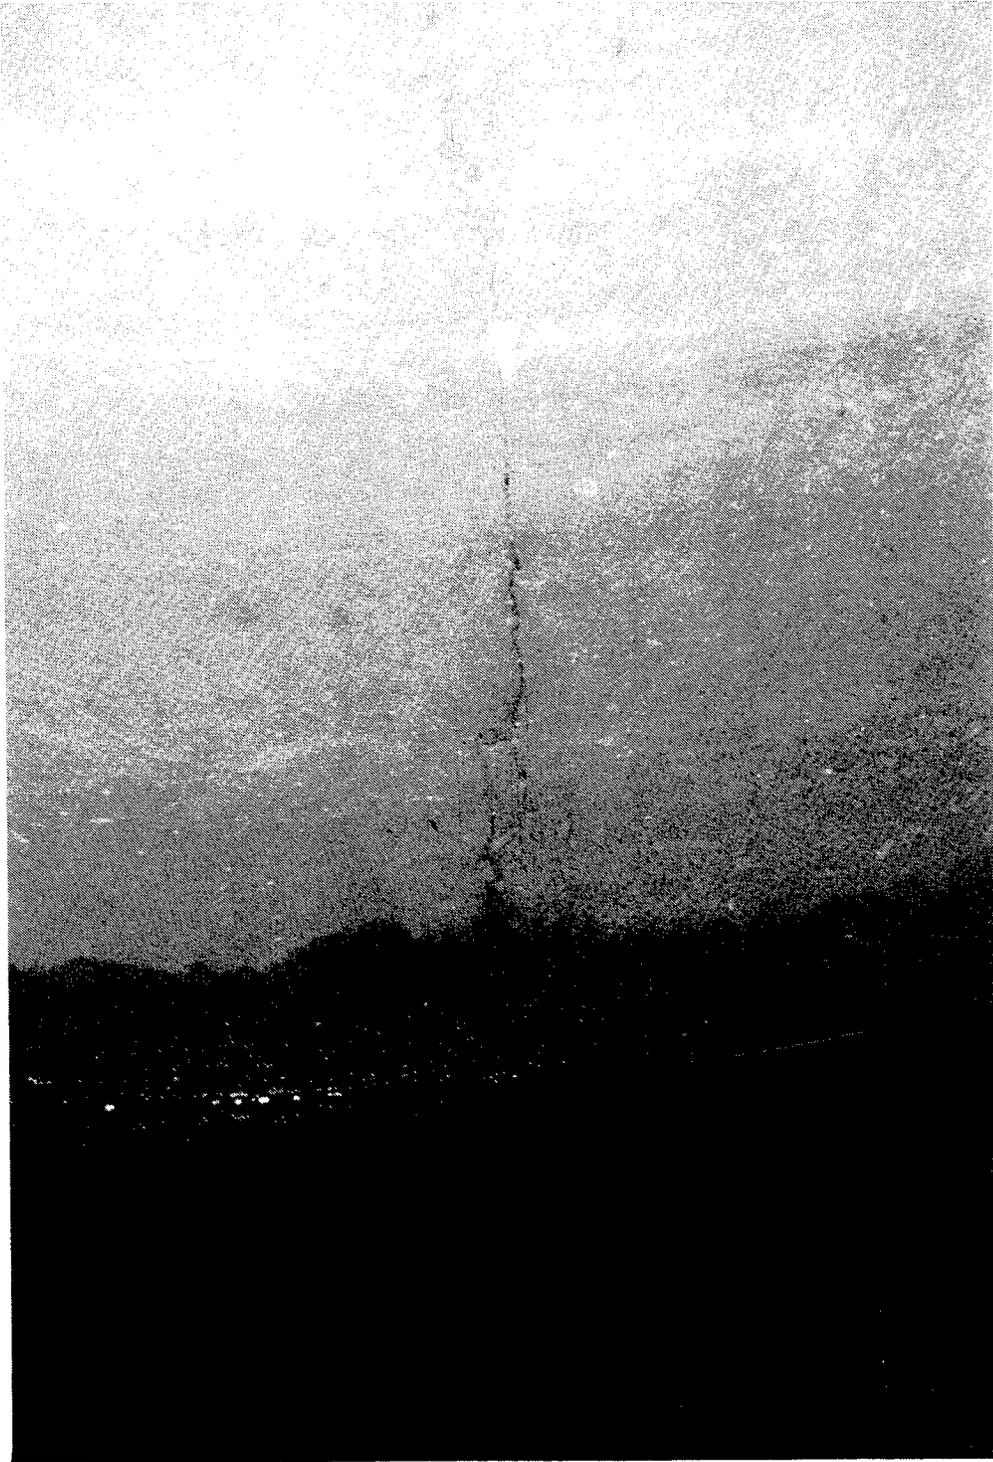
Figure 16
Crack near waterline on Reserve Relief Canal

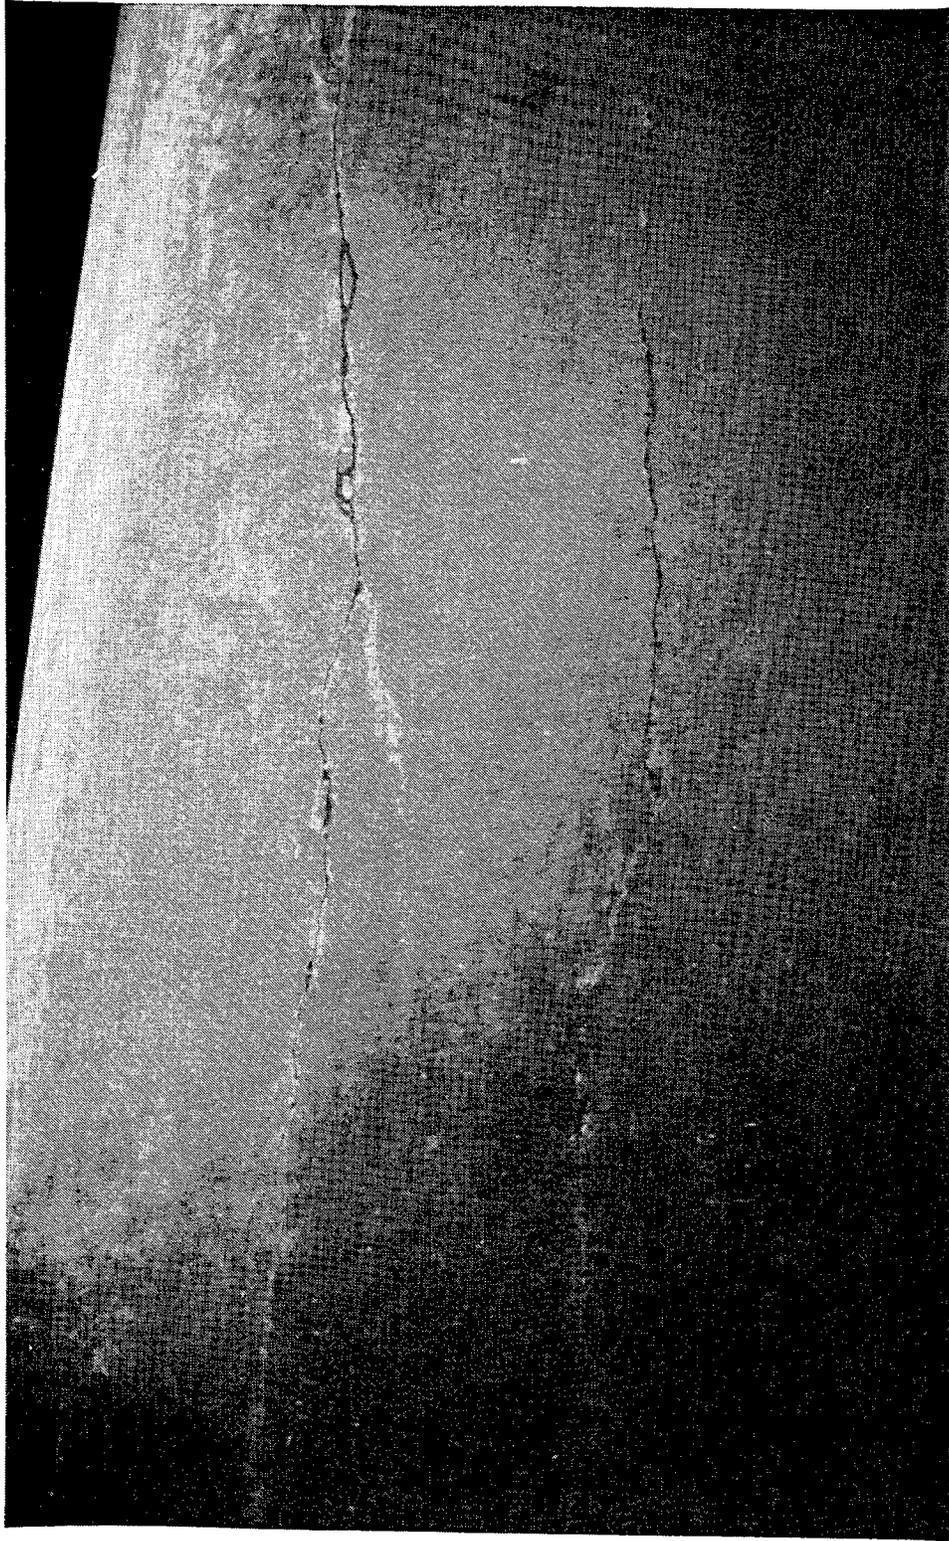
Figure 17
Crack near waterline on Reserve Relief Canal

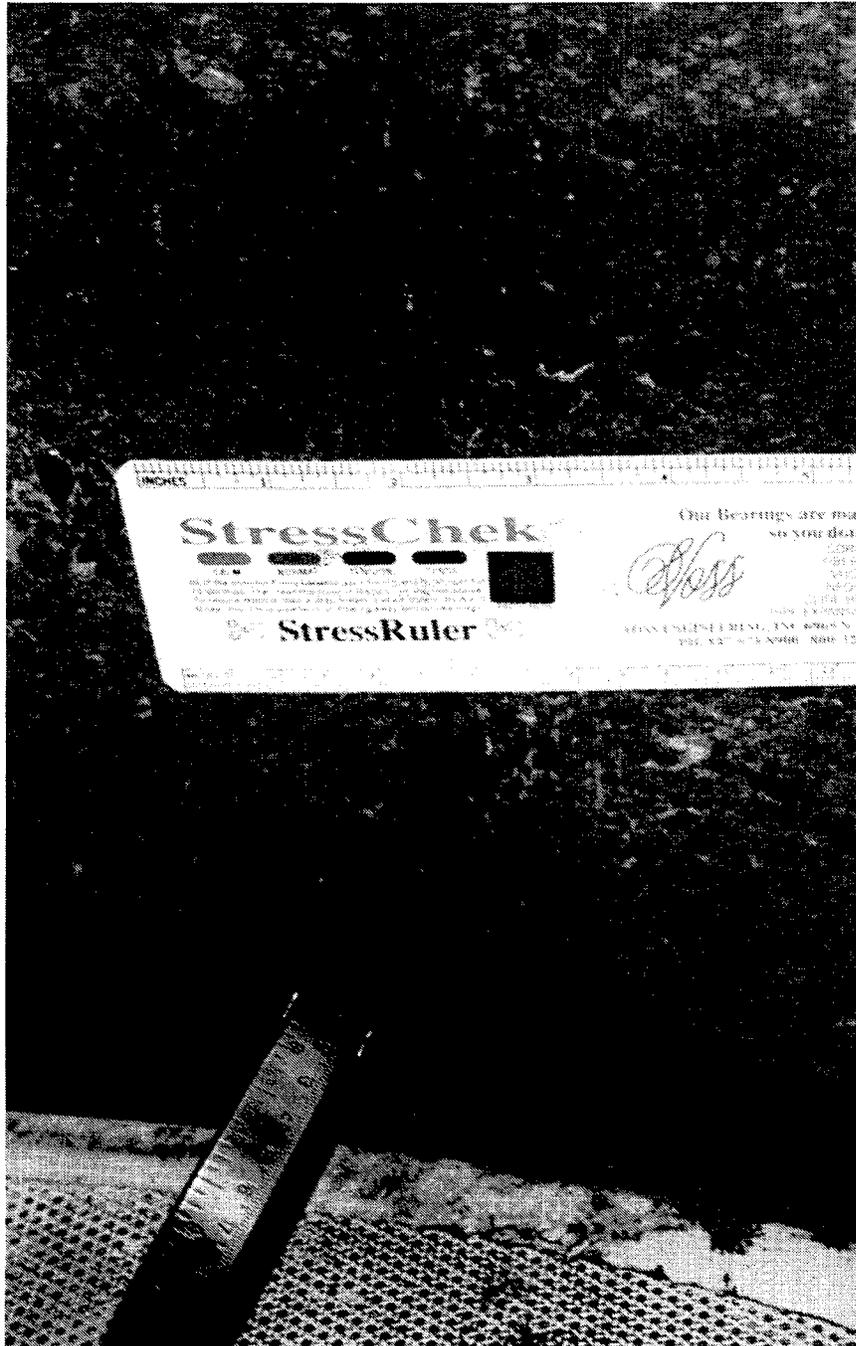
Figure 18
Crack near waterline on Reserve Relief Canal

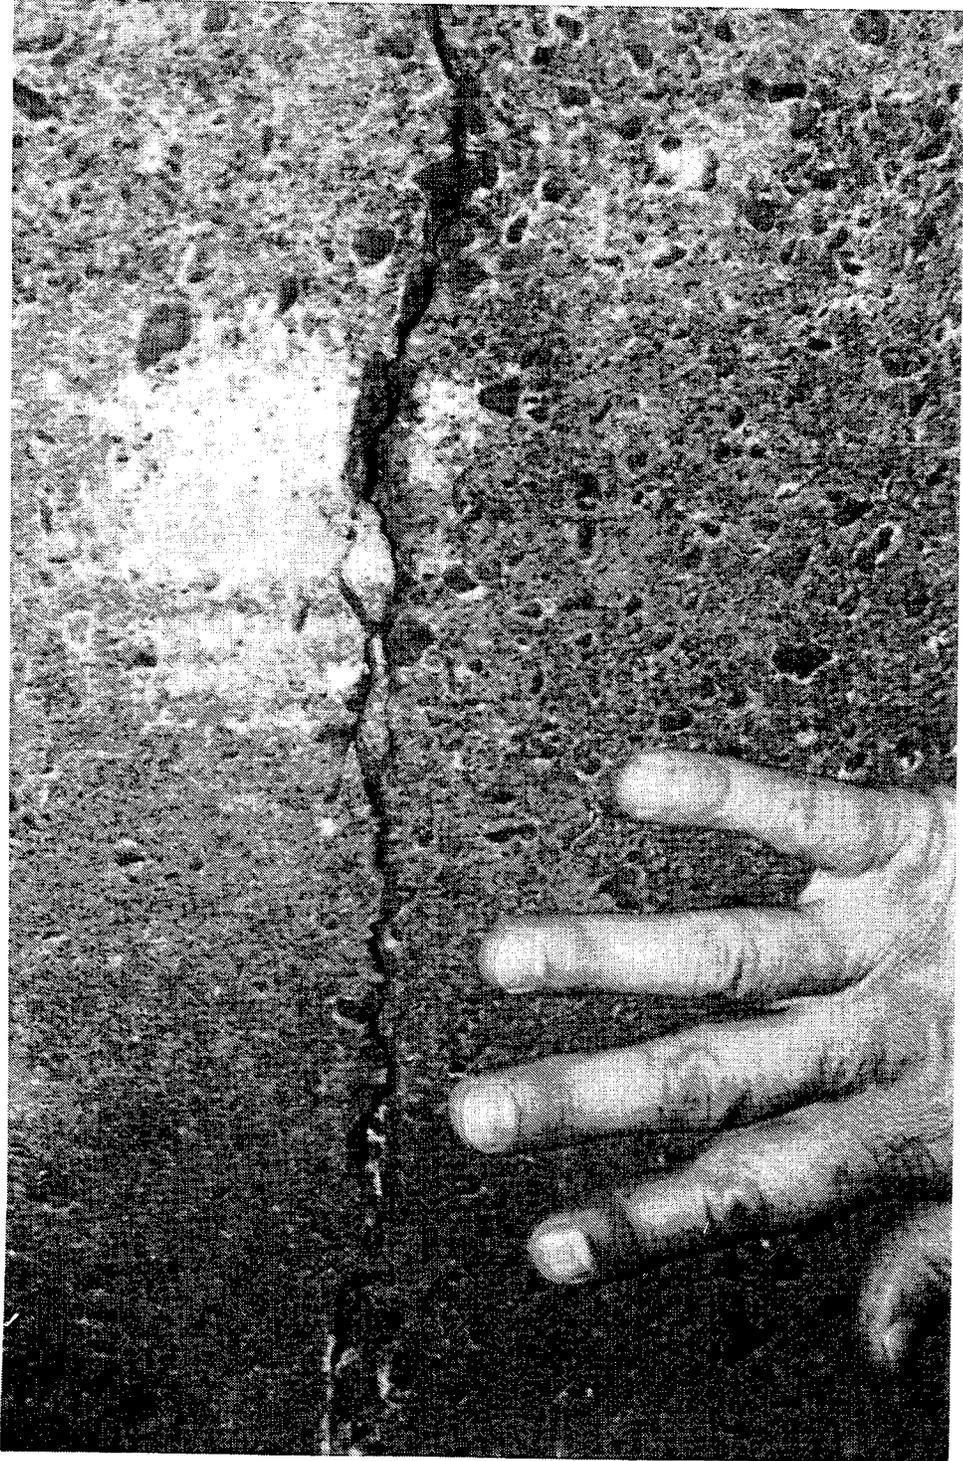
Figure 19
Crack near waterline on Reserve Relief Canal

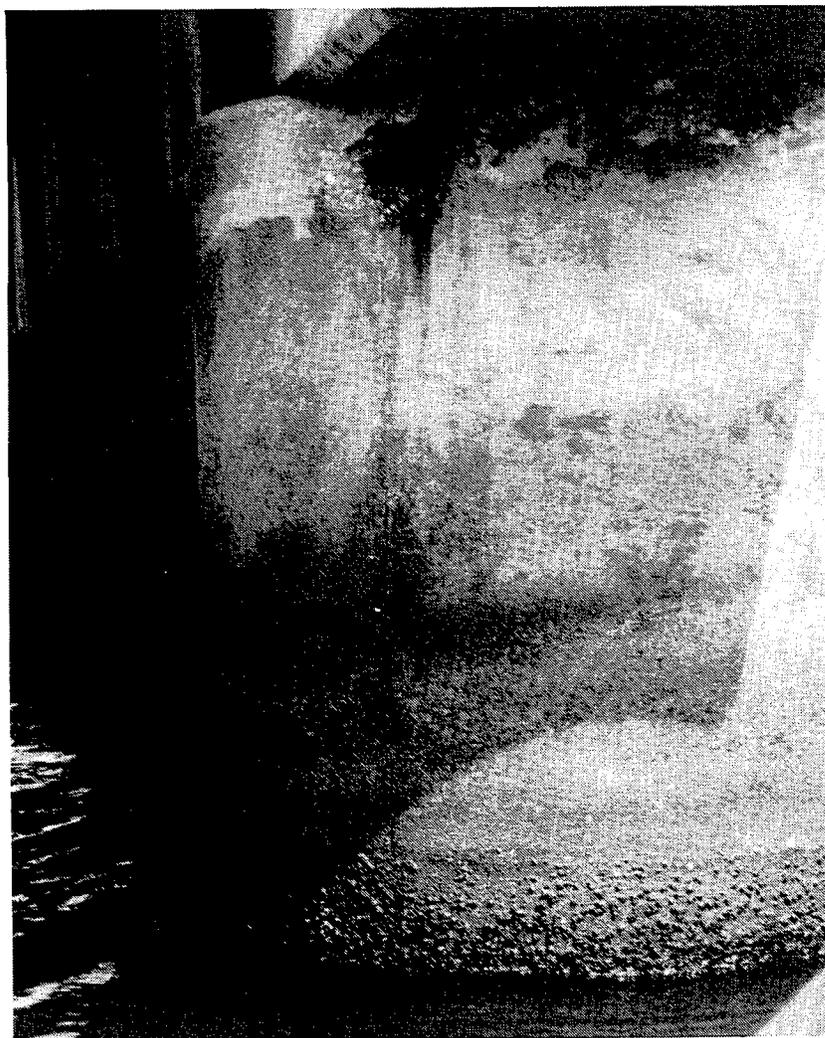
Apparent cracks on the Twin-Spans between New Orleans and Slidell turned out to be depressions made from the forms used in the rolling process. These seams, which did not penetrate into the concrete, are shown in figures 20 to 22.

Figure 20
Seam in pile that looks like a crack

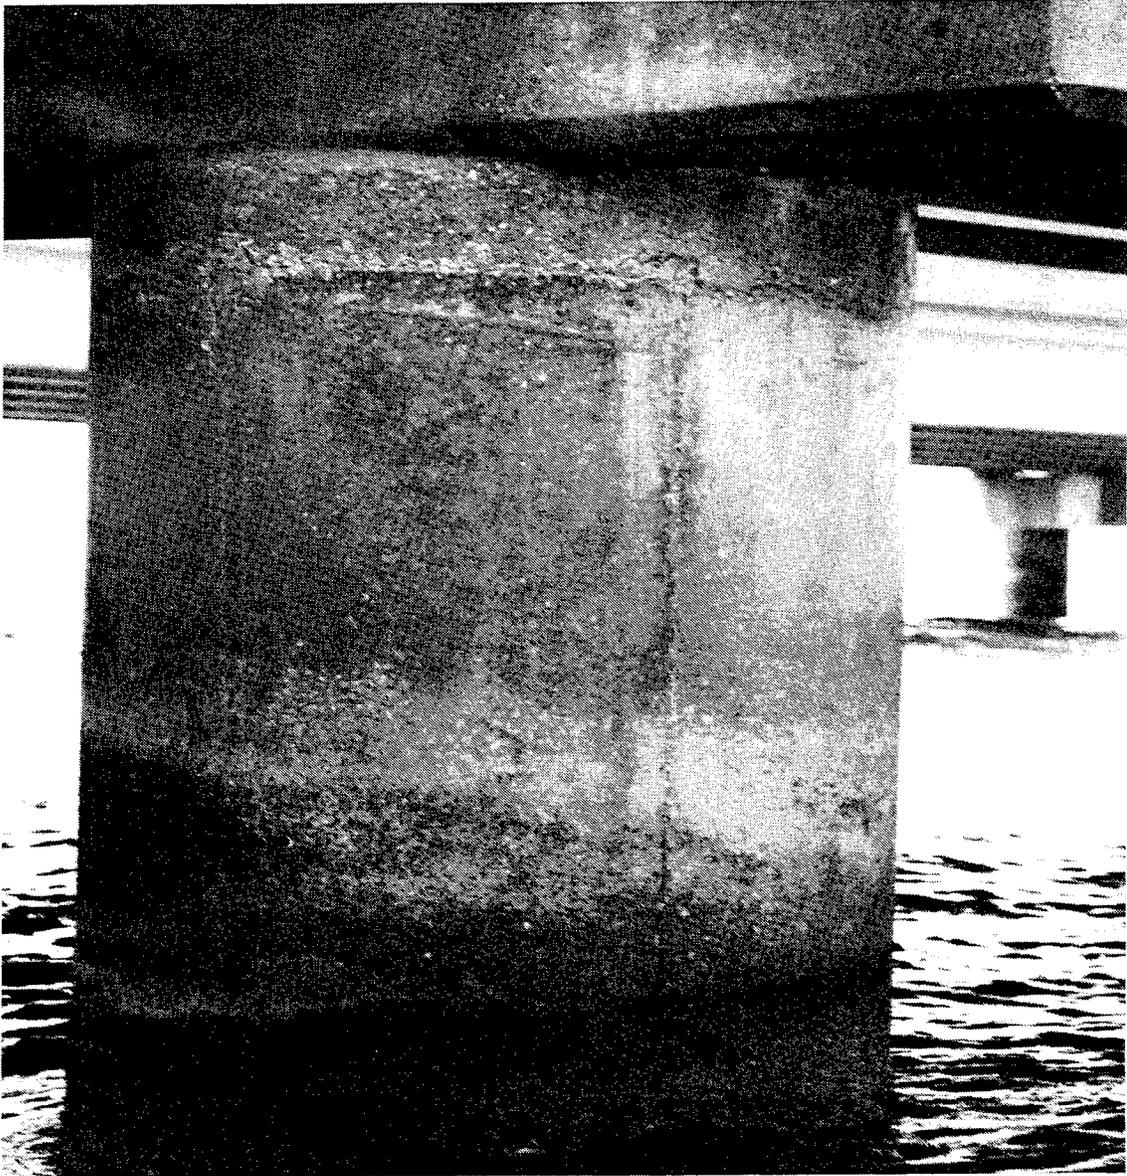
Figure 21
Seam in pile that looks like a crack

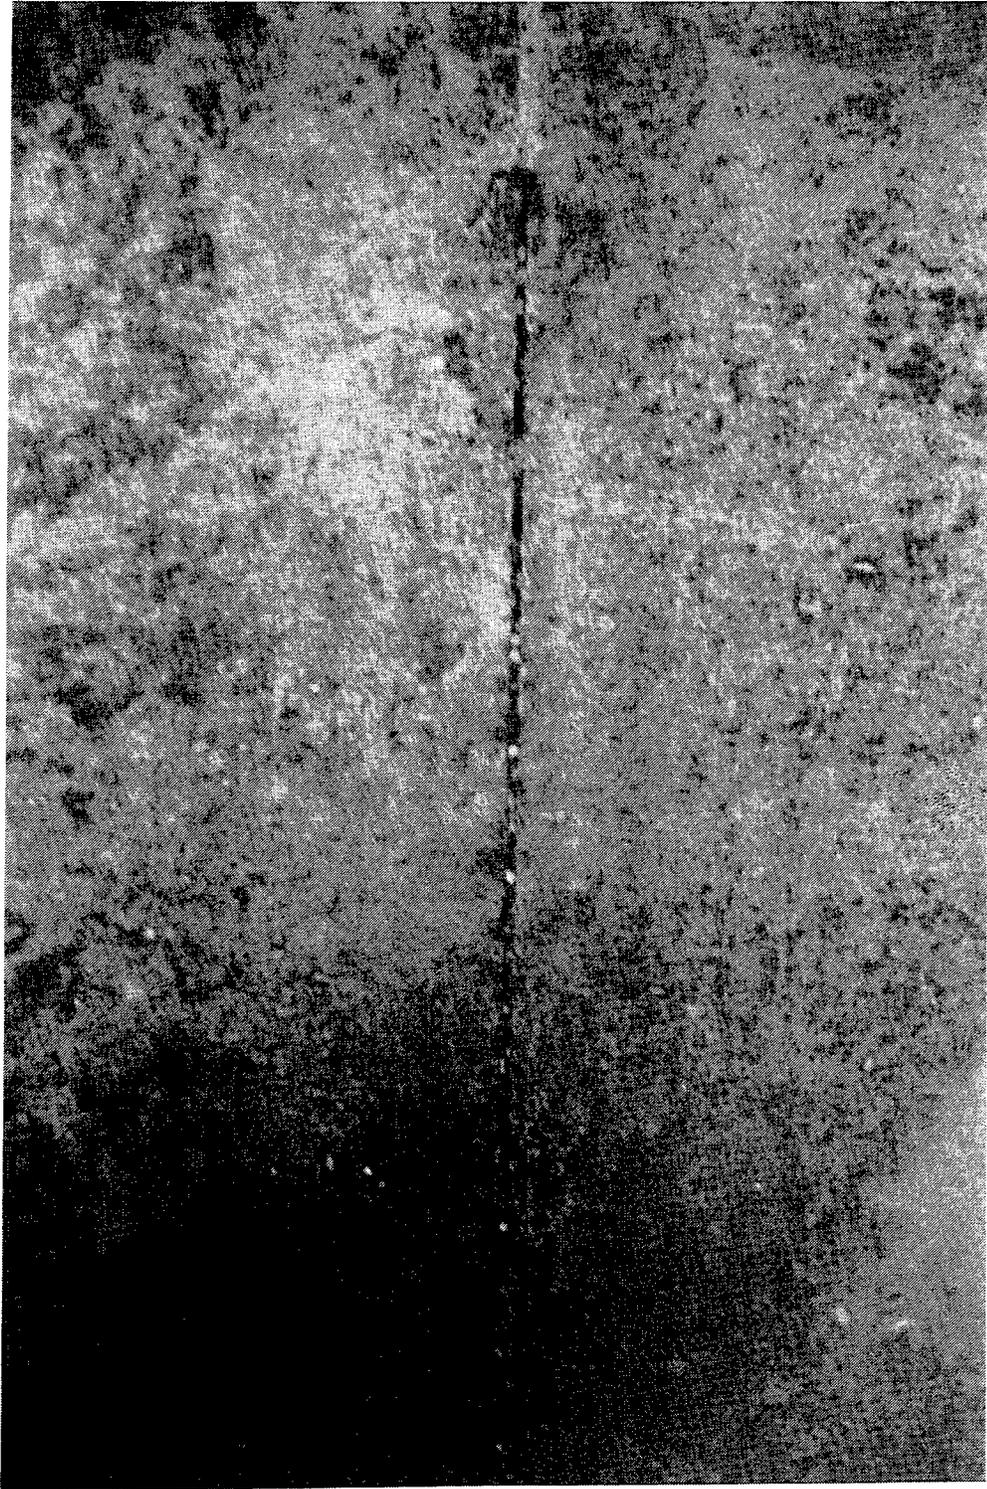
Figure 22
Close-up of seam in pile that looks like a crack

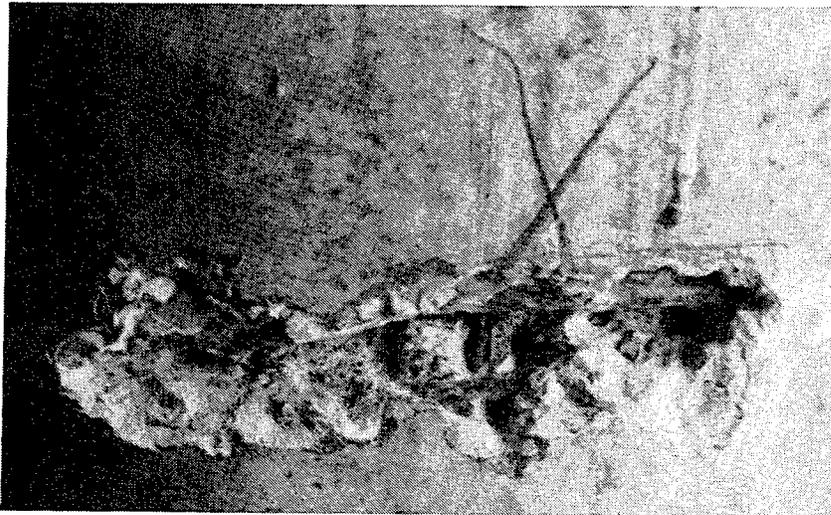
confined near the outer surface of the pile and quickly necked down with depth into the pile. In addition to conducting an underwater inspection, half-cell potential readings were taken at two locations. The process is illustrated in figures 26 to 28.

Figure 26
Concrete chipped away to attach half-cell potential probe

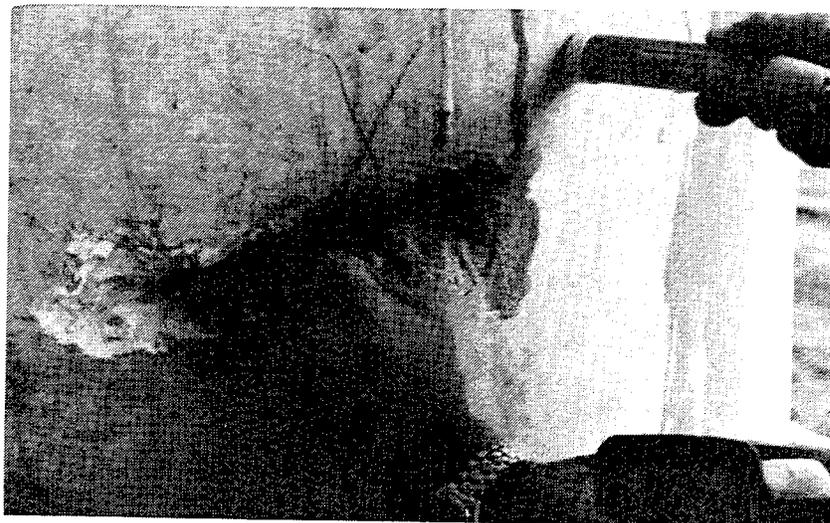
Figure 27
Half-cell potential test being conducted above water

The results of the test shown in the figure were 3.2 above water and 5.5 under water. Both these results are on the borderline of corrosion beginning to occur.

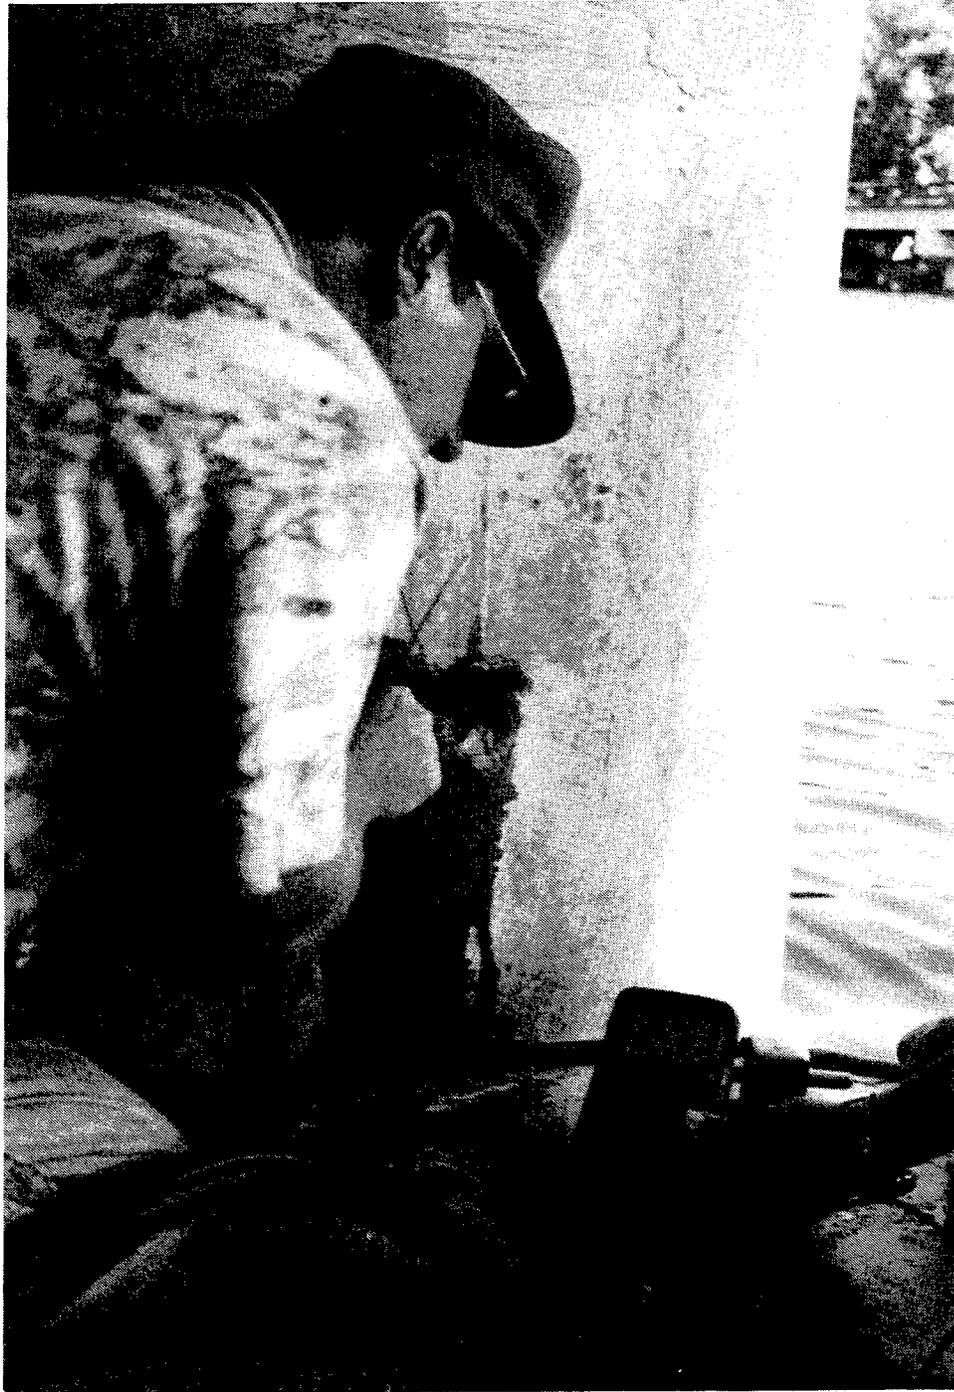
Figure 28
Half-cell potential test being conducted below the water
