Research Report
KTC-90-2

FIELD INSPECTIONS OF
HIGH-PERFORMANCE BRIDGE PAINTS

March 1990

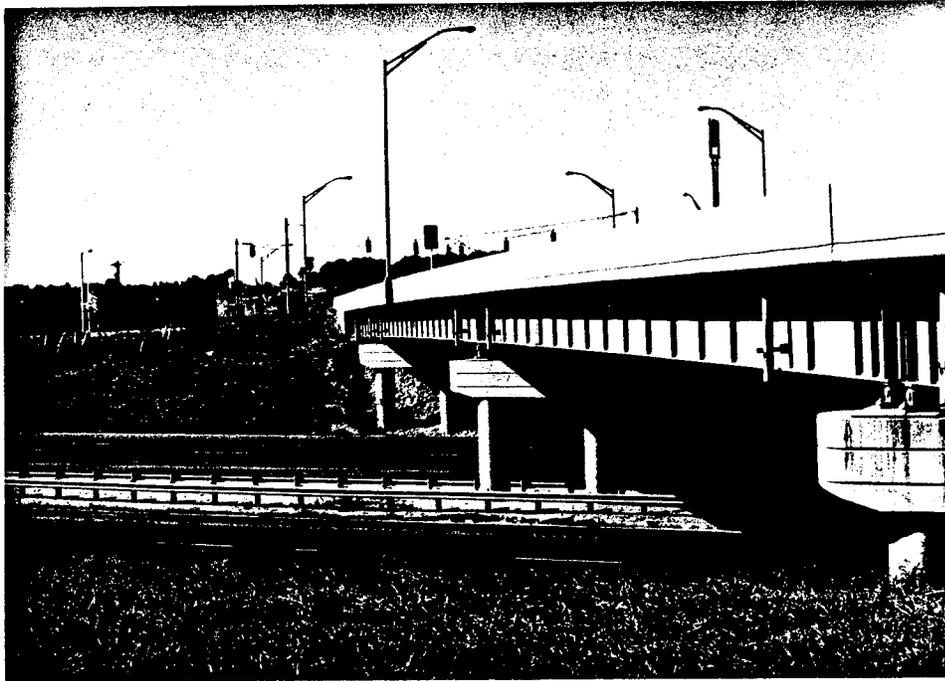
Four construction painted bridges were inspected. The paint coatings ranged from two to five years in age when inspected. The paint condition on all of those bridges was excellent (Figure 1). The paint on each bridge appeared to have been very well applied. The only problem noted was variance in surface sheen which appeared to be the result of overspray settling on wet paint. That imparted a slightly mottled surface appearance.

Figure 1. New Painted Girder Bridge, US 62 over I 65 in Hardin County (August 1987).

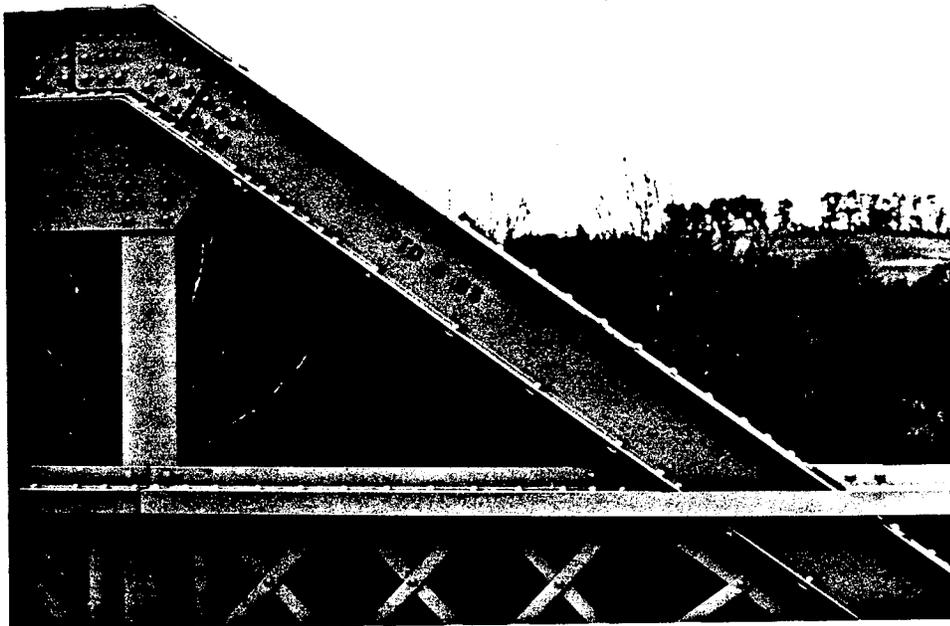
Most of the paint systems on the 13 repainted bridges inspected by Kentucky Transportation Center personnel were performing well (Figure 2). There were no instances of massive coating failure. However, some of the bridges had localized corrosion. Also, paint was peeling on several bridges.

Figure 2. Guardrail and End Post of Truss Bridge, KY 32 over L & N RR (October 1987).

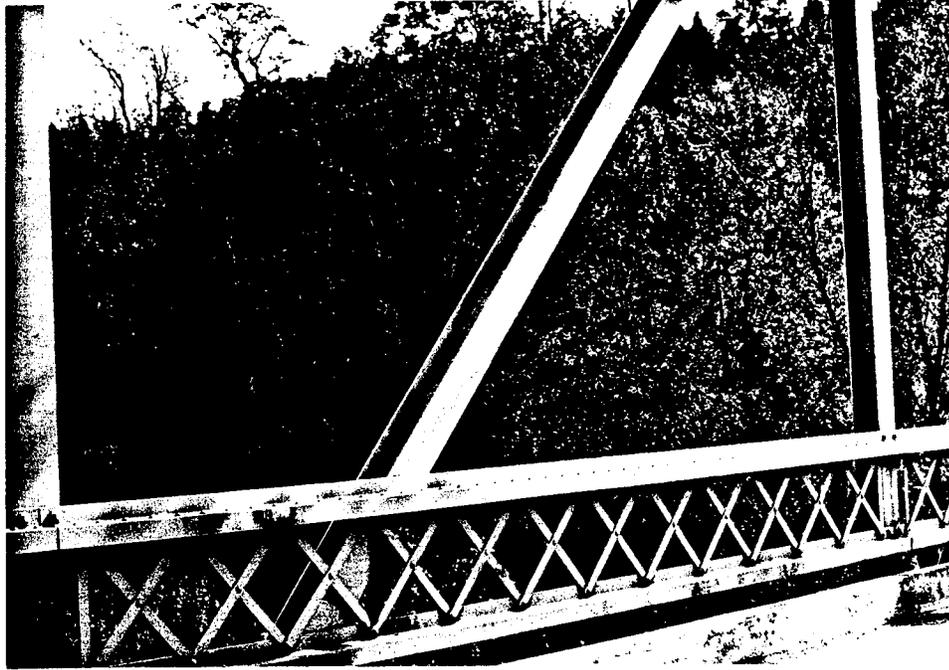
Most corrosion was detected at locations near deck level where chlorides are normally present (Figure 3). The most commonly corroded locations were between the end posts and lower chords and along the lower chords. Another corrosion-prone location was along walkway and guardrails. The floor systems of several bridges had some rust at the ends of spans. Those were the only locations where rust was observed on girder and stringer spans.

Figure 3. Diagonal and Guardrail on KY 89 over Red River (August 1987).

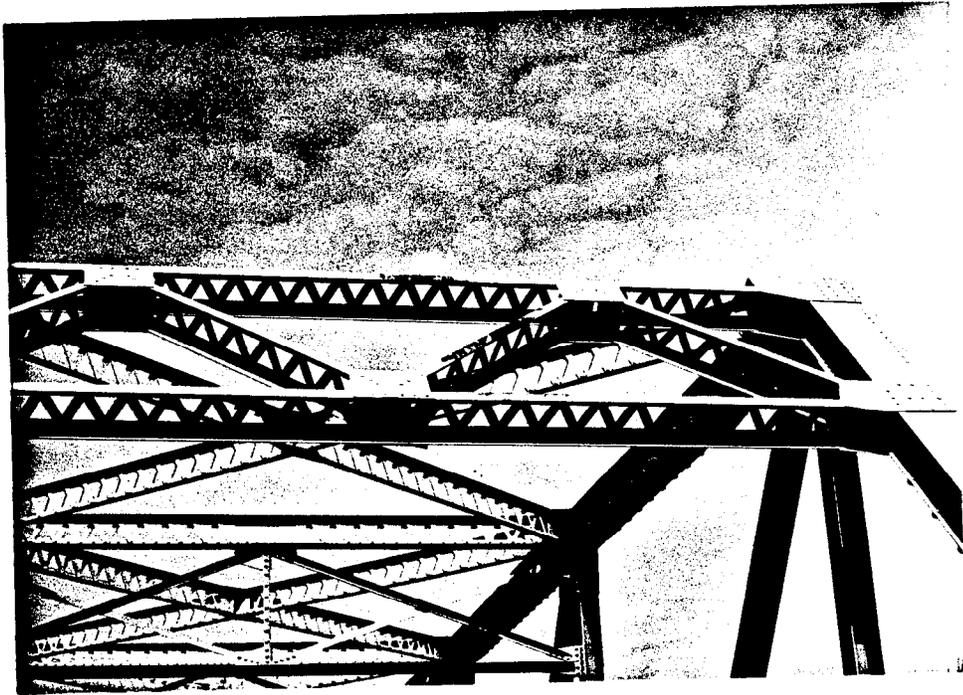
On several truss bridges, rust was present at elevated locations (Figure 5). Typical locations were the vertical posts (on the interior faces of the flanges and on the webs), upper chords, and lateral bracing. Several bridges had only minor cleaning on the interior of the upper chord box members. In some cases, an aluminized epoxy mastic was applied on those surfaces. Sometimes, rust was present at those locations.

Figure 5. Rust Visible on Portal of Truss Bridge, KY 7 over Little Sandy River (November 1987).

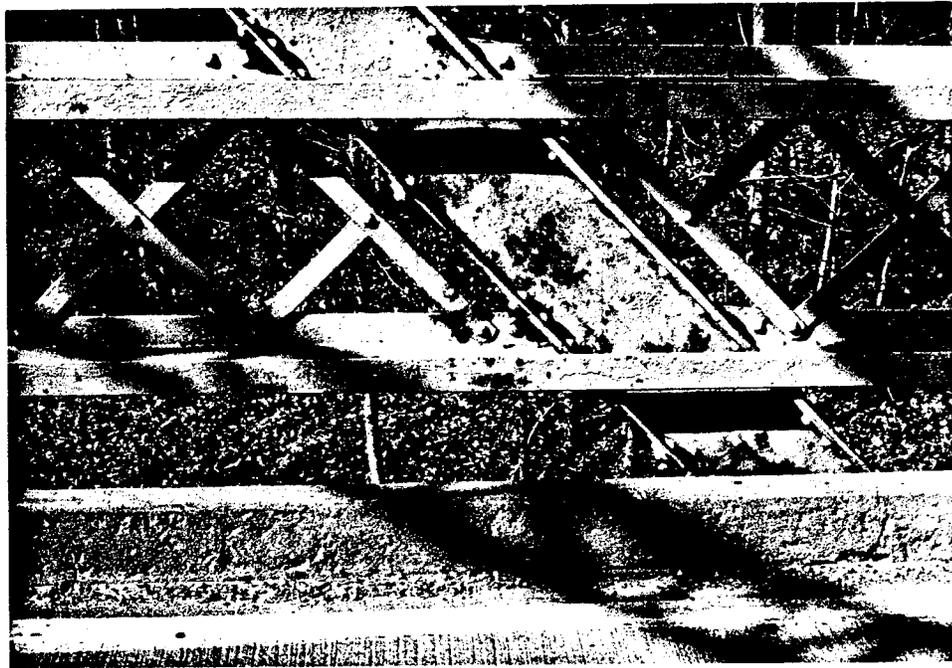
Figure 6. Peeling Paint and Rust on End Post of a Truss Bridge, KY 7 over Little Sandy River (November 1987).
