Research Report
KTC-90-5

INVESTIGATION OF PREMATURE
CRACKING ON THE
NATIONAL TURNPIKE, JEFFERSON COUNTY

March 1990

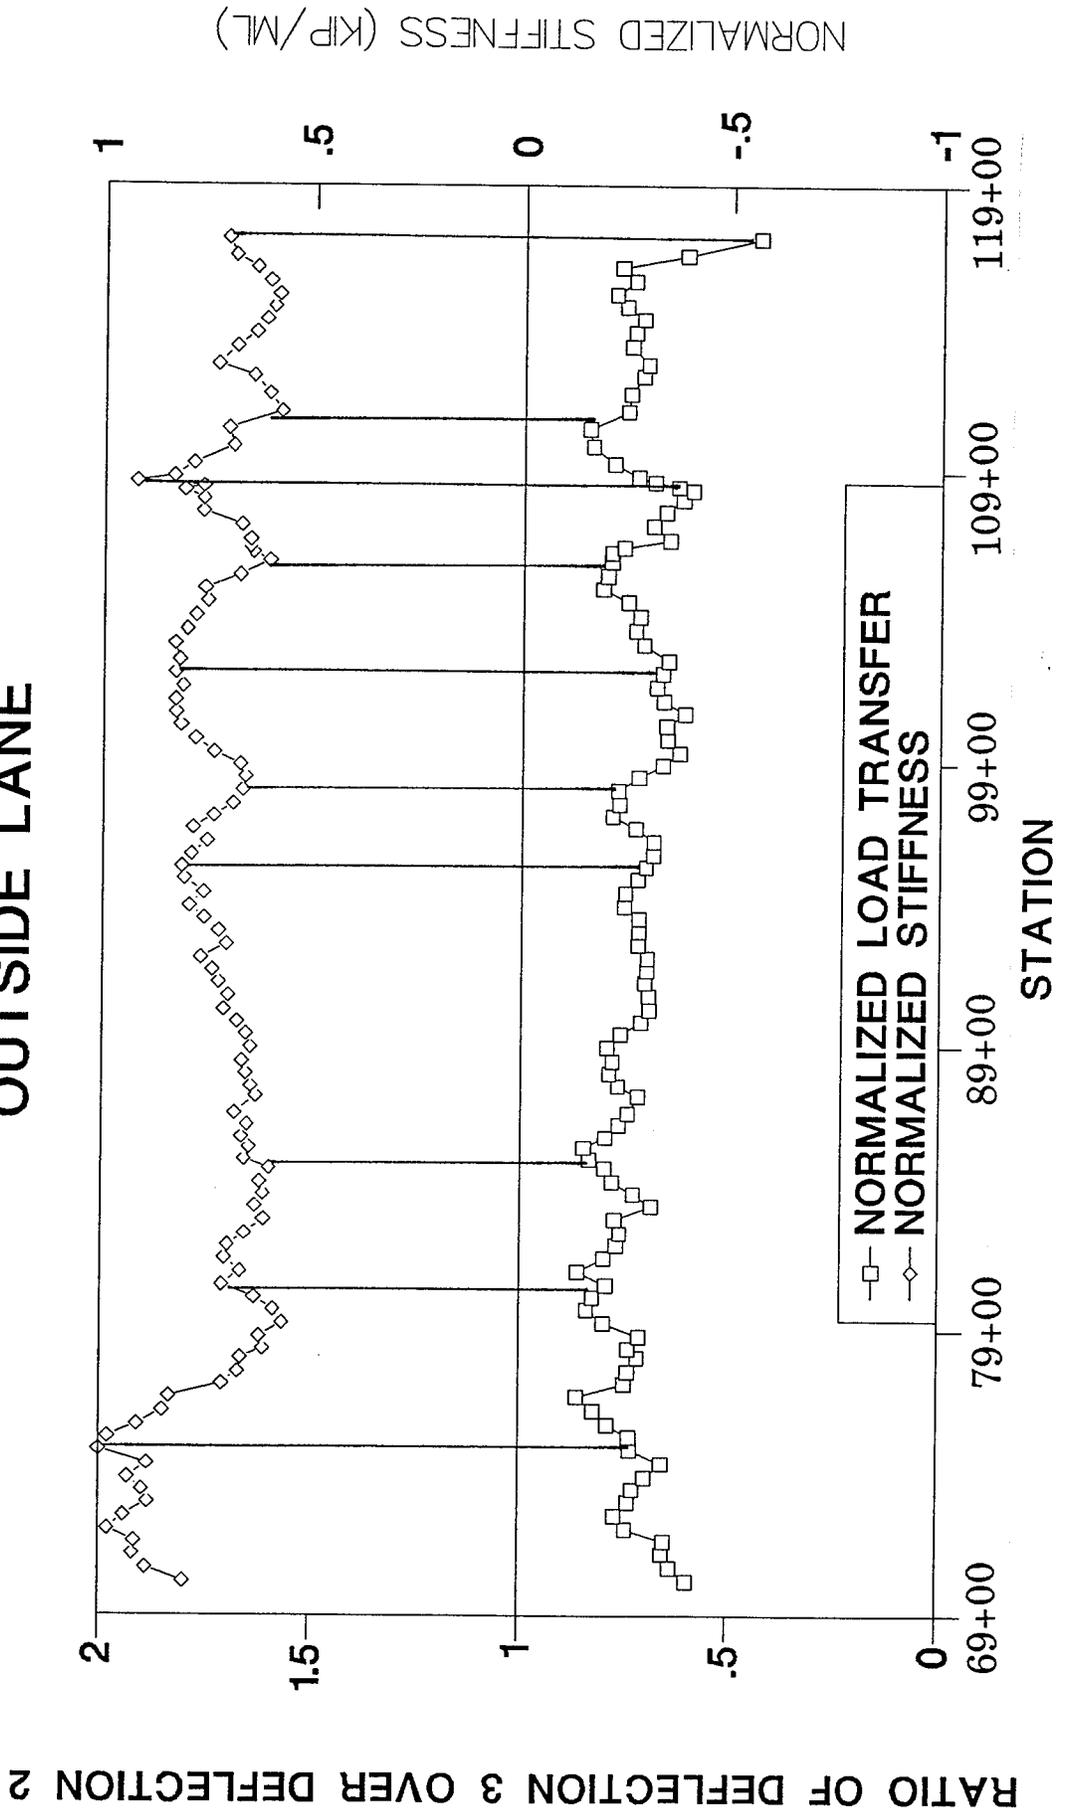
**FIGURE 1. NATIONAL TURNPIKE SOUTHBOUND
5 PT FLOATING AVERAGE
OUTSIDE LANE**

Figures 1 through 4 show the stiffness of the pavement structure was greater in the southbound lanes than in the northbound lanes. As mentioned previously, the southbound lanes were constructed largely on the old roadbed. This may indicate the subgrade under the old structure had consolidated and was probably stiffer, and consequently, provided better support to the new structure.

Although not true in every case, in many instances, at locations where the stiffness curves in Figures 1 through 4 showed small peaks, there was a corresponding "valley" in the load transfer curves. The thin vertical lines in those figures illustrate that relationship. This may suggest that a stiffer base and subgrade do not permit the slab to deflect as much as a weaker base and subgrade. Therefore the slab that is under load cannot transfer as much deflection to the adjacent slab. These locations appeared to be distributed throughout the project with a noticeable number of these occurring at the south end of the project in the northbound lanes. However, it does not appear that a definitive statement can be made concerning the location of particularly weak areas when using this relationship.

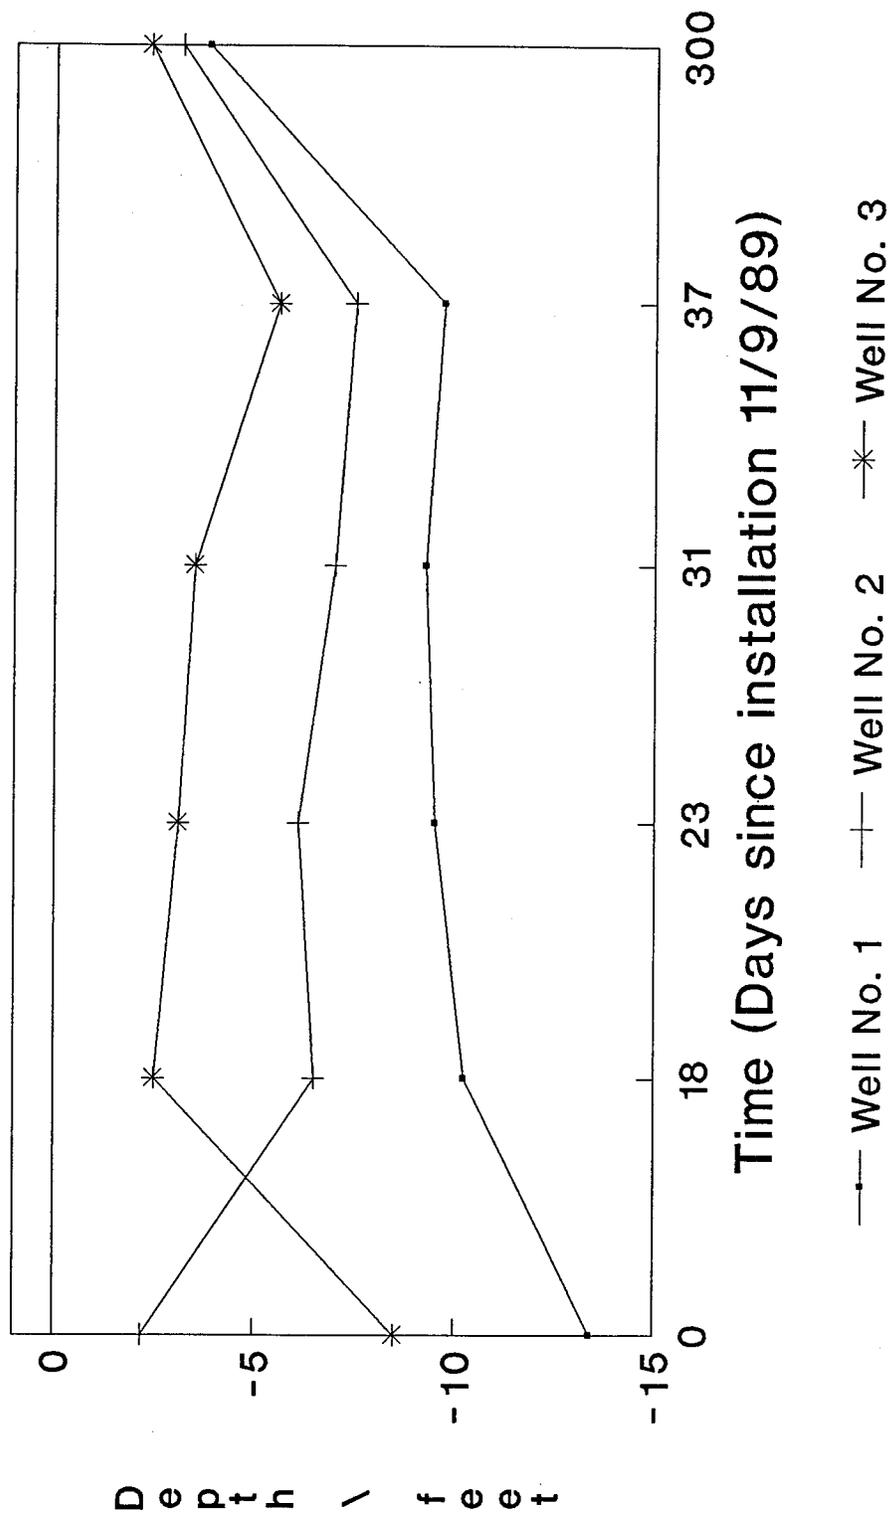
Figure No. 5. National Turnpike
Water Monitoring Wells

Two wells were placed in the vicinity of Sinclair Street, in the center turning lane of the National Turnpike. The first well was installed to a depth of 13.6 feet (Well 2). At Well No. 2, the subgrade appeared to be saturated. Water was observed rising in the well immediately after installation. The water stabilized at a depth of 2.2 feet below the surface. An additional hole (Well No. 3) was drilled approximately five feet north of Well 2. A thin-walled tube sample was collected from a depth of 31 inches to 73 inches. Well No. 3 was further augered to a depth of 8.5 feet. No free water was encountered. Figure No. 5 shows the well readings since installation. Information gathered from the monitoring wells indicates that the water table reaches the base of the stabilized stone layer. During periods of heavy rain, it is probable the water table is penetrating the stabilized stone layer.

The last reading on the water wells installed during this study indicated the water table was as close as 30 inches to the surface (Figure 5) and this was in a relatively dry period. Also, during the spring of 1990, the entire pavement was flooded for a short period. These facts indicate the subgrade is probably in a state of near saturation for a large portion of the year.

Longitudinal edge drains placed at the back of the curbs would help to intercept any surface water that infiltrated through the joints of the pavement and would otherwise become trapped at the interface between the DGA and the base of the slab. The edge drains would probably help to reduce pumping of the slab and the consequent loss of DGA fines. These edge drains are recommended. However, in all likelihood, this would alleviate only part of the problem. Edge drains would not significantly help the weak subgrade because the drains could not be placed sufficiently deep to effectively drain the subgrade.

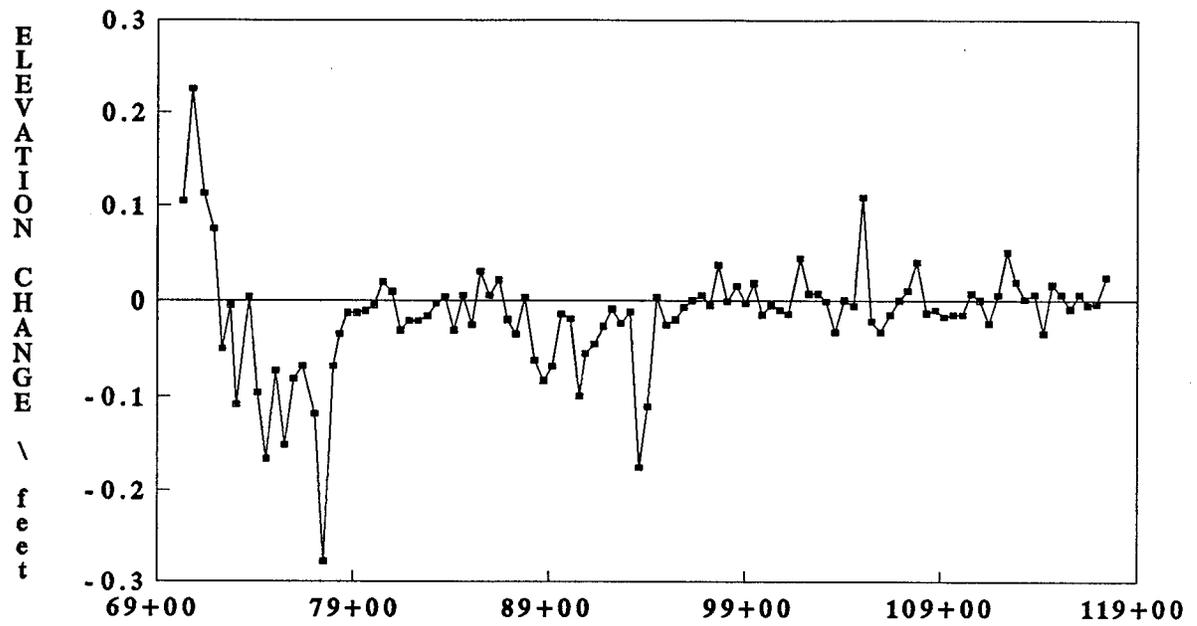
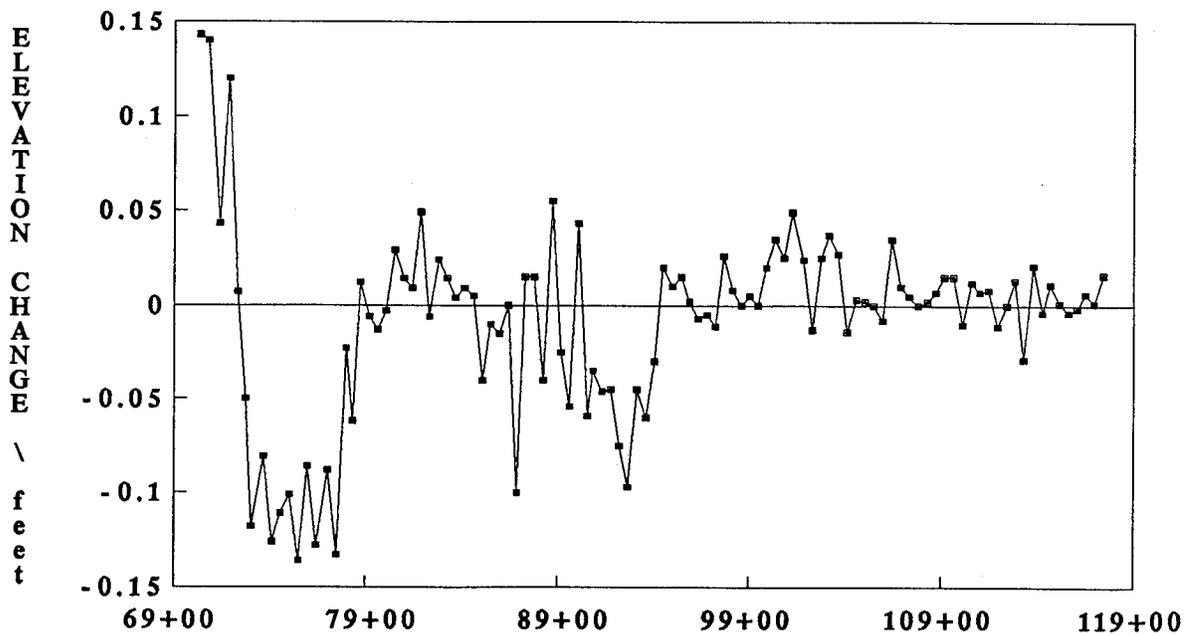
**FIGURE 6. CHANGE IN ELEVATION (1989-1990)
NORTHBOUND**

Figures 11 and 12 show the locations of the 12-inch layer and the 24-inch layers of No. 3 stone. There appears to be little or no difference in behavior between the 12-inch sections and the 24-inch sections. However, Figure 6 indicates from Station 72+00 to 78+00 considerable

settlement occurred in one year (from 1989 to 1990). This area of the project had no stone layer. It appears that the addition of at least 12 inches of stone was beneficial.

Figure 6 shows that settlement and some shifting of the slabs occurred from 1989 to 1990. In general, the northbound lanes settled more than the southbound lanes. Most settlement occurred from Station 72+00 to Station 78+00. This is the area that has no stone layer. A

second area where considerable settlement has occurred is from Station 85+00 to Station 95+00. This is in the area of Sinclair Street. It is expected that settlement from consolidation of the subgrade resulting from traffic loading will continue. It would be difficult to predict the amount of settlement because of the complexity of factors involved.

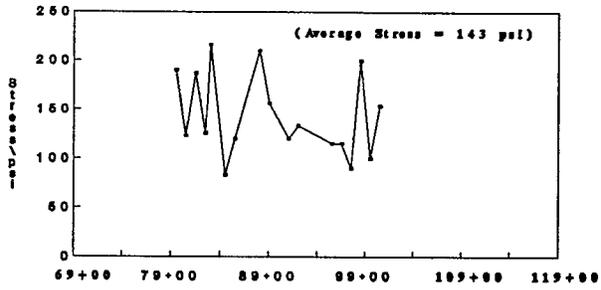
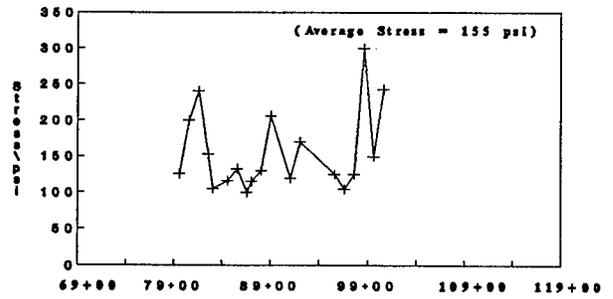
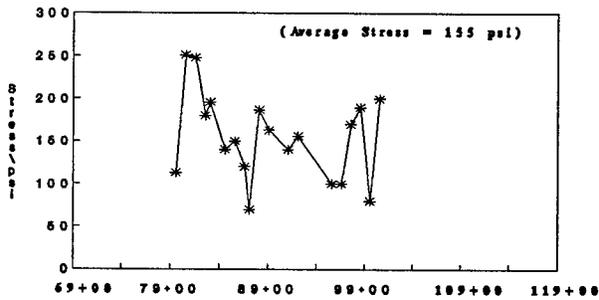
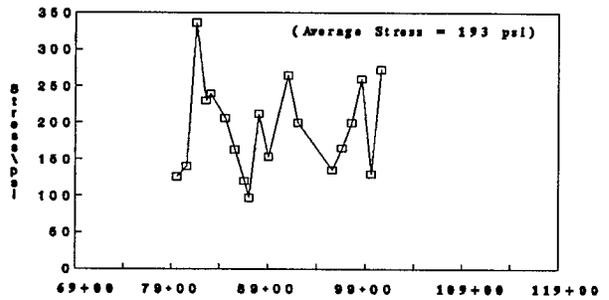
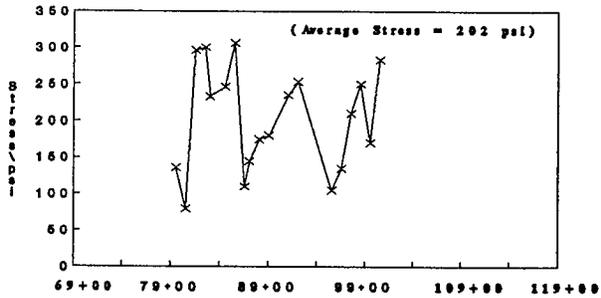
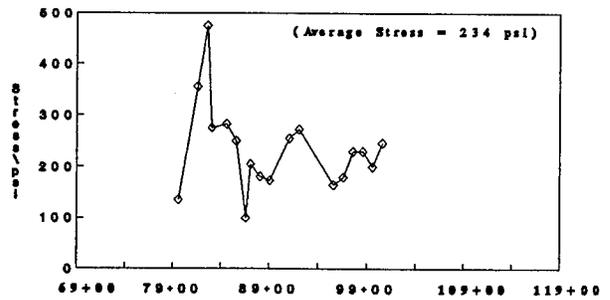
Figure 7. Cone Penetrometer Data

Cone penetrometer readings obtained by Cabinet personnel indicate there are three areas of weak subgrade at Station 86+47, Station 95+47 and Station 99+97 (Figure 7). The cone penetrometer data are scattered but the values indicate soft to very soft subgrade soils are present.

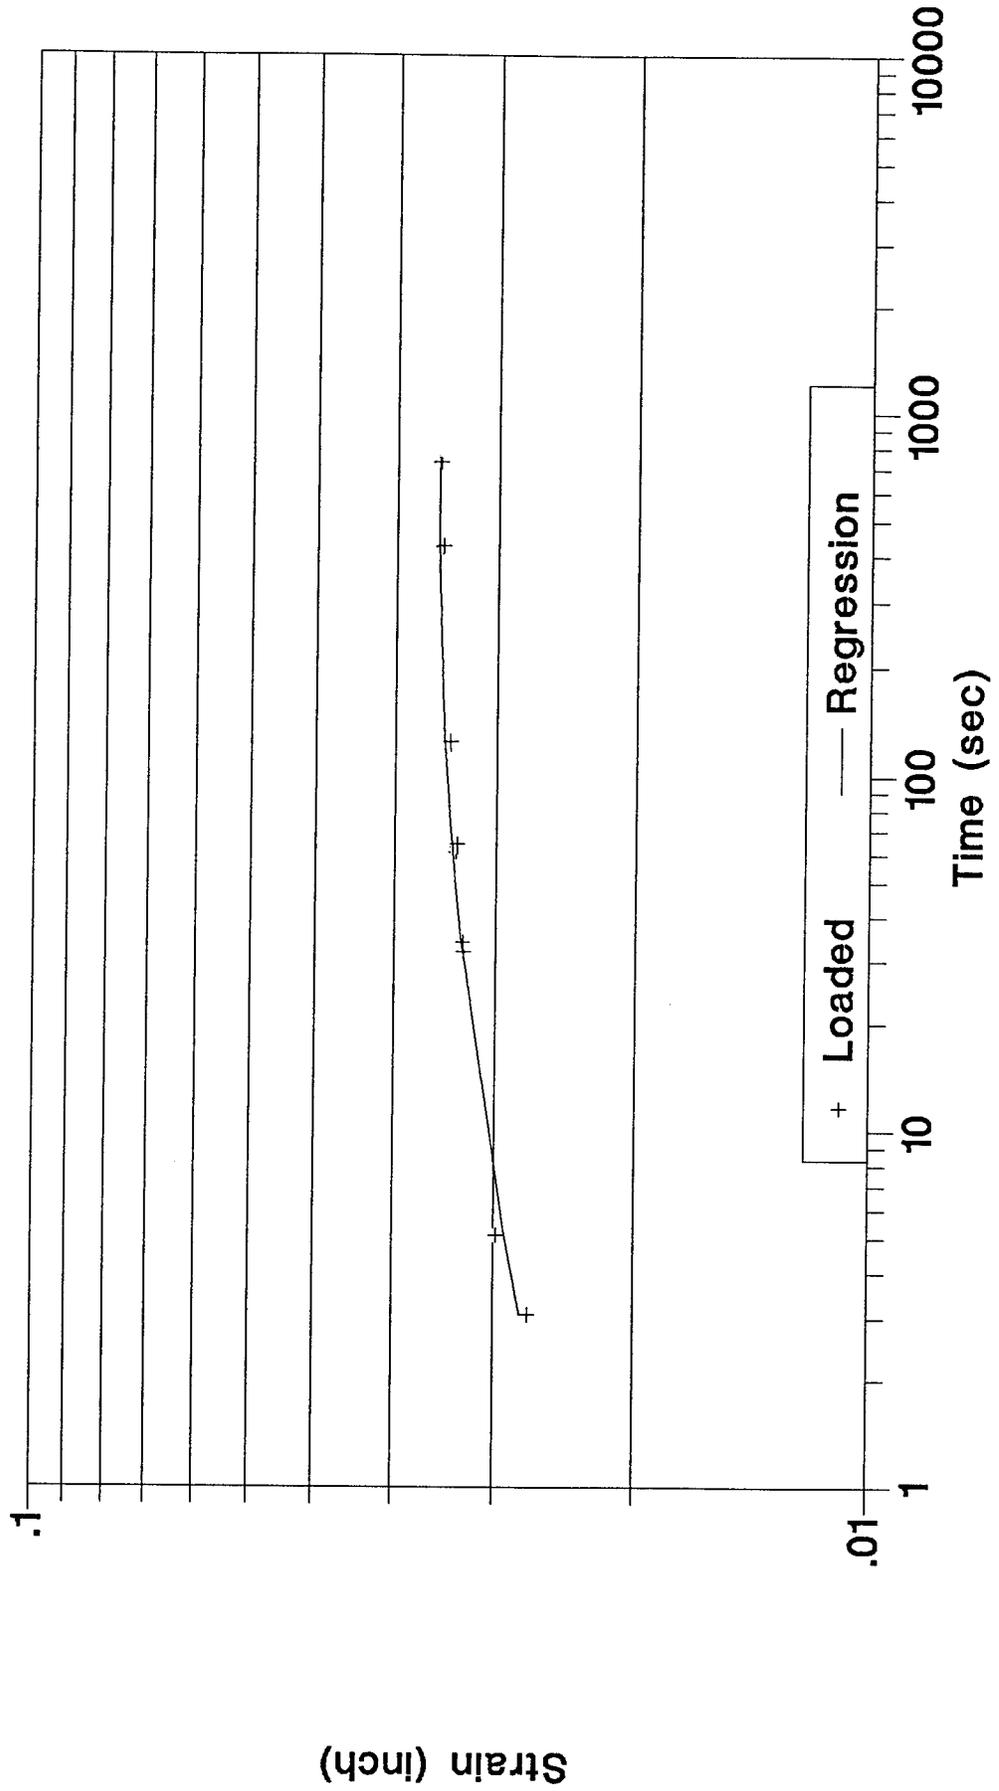
FIGURE 8. REPEATED LOAD TEST
Hole No. 182 (34.5"-40.5")
(Sample was tested saturated)

A saturated, unconfined, repeated load compression test was performed on an undisturbed subgrade specimen. The specimen was loaded for one second and allowed to relax for one second at a deviator stress level of 2.0 pounds per square inch for 1,000 cycles. Results of the test are shown in Figure 8. Assuming 10,000 vehicles per day (2-way), and assuming five

percent trucks (total weight equal to 80,000 pounds), results of Figure 8 indicate as much as 0.30 of permanent deformation could occur in the upper portion of the subgrade in one year. This confirms the fine-grained and somewhat plastic nature of the subgrade, as determined from the soil classification tests. This further indicates that slab settlement and movement may continue indefinitely.

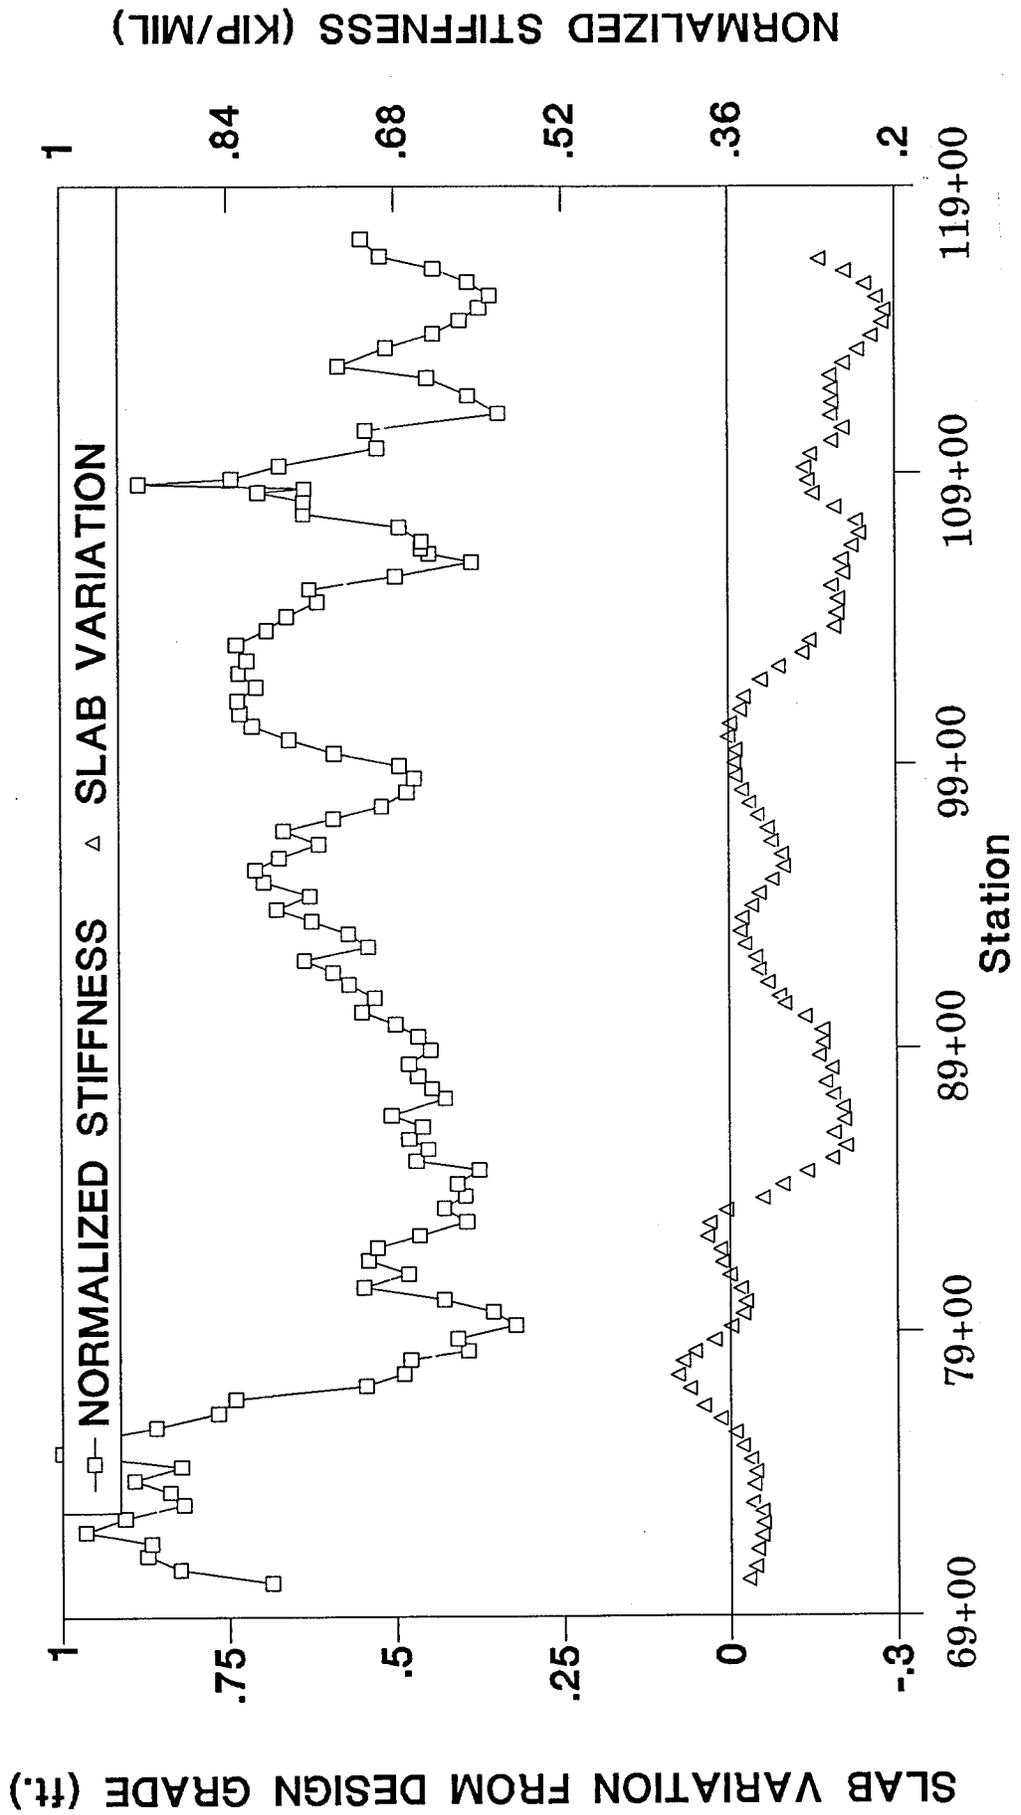
**Figure 9. National Turnpike, Stiffness/Slab Variation
Southbound Outside Lane**

A comparison of the variation of the slab from the design grade with stiffness (Figures 9 and 10) does not reveal a good correlation. However, there are dips in the slab elevation in the area near Sinclair Street and near the south end of the project. Again, these are the areas where most distress was noted.

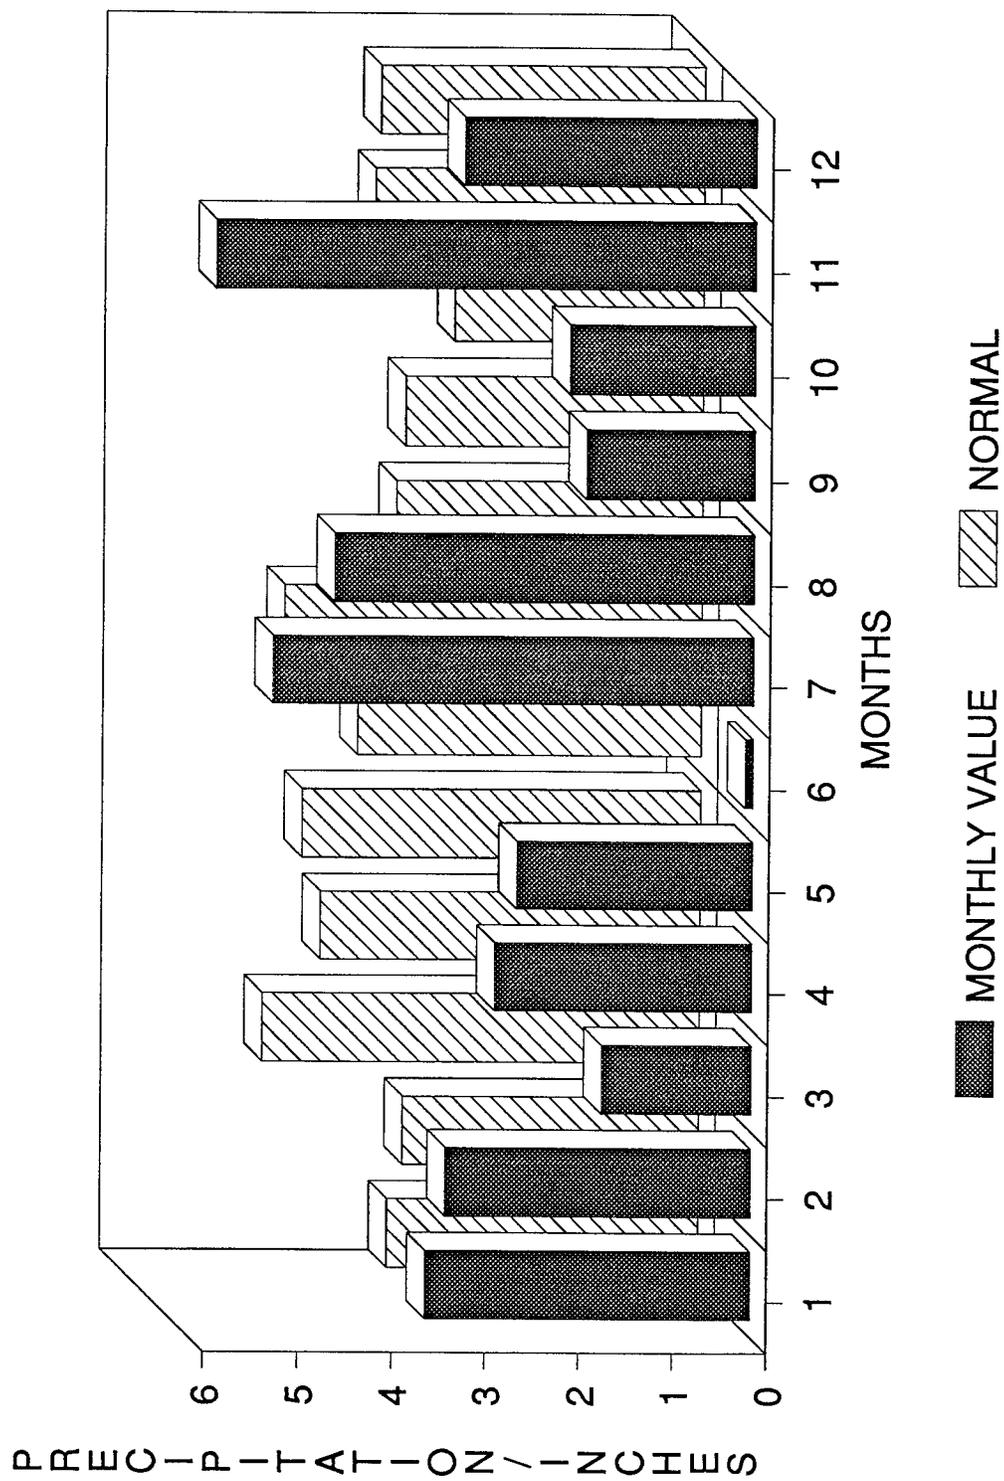
FIGURE 13. MONTHLY PRECIPITATION AND DEPARTURES FROM NORMAL (1988)

The northbound lanes were opened to traffic on July 8, 1988. Figure 13 indicates the months of July and August of that year received abnormally high amounts of rainfall. The southbound lanes were opened to traffic on December 14, 1988. The previous month (November 1988) received well above the normal rainfall. It is suspected this excess moisture may have saturated and weakened the subgrade of the new pavement.
