# TRUCK ROUTE ACCESS EVALUATION

Kenmor Stone and Ruth Brothers Quarry  
Olive Hill  
Site # 2620

Report No. KTC-98-27

September 1998

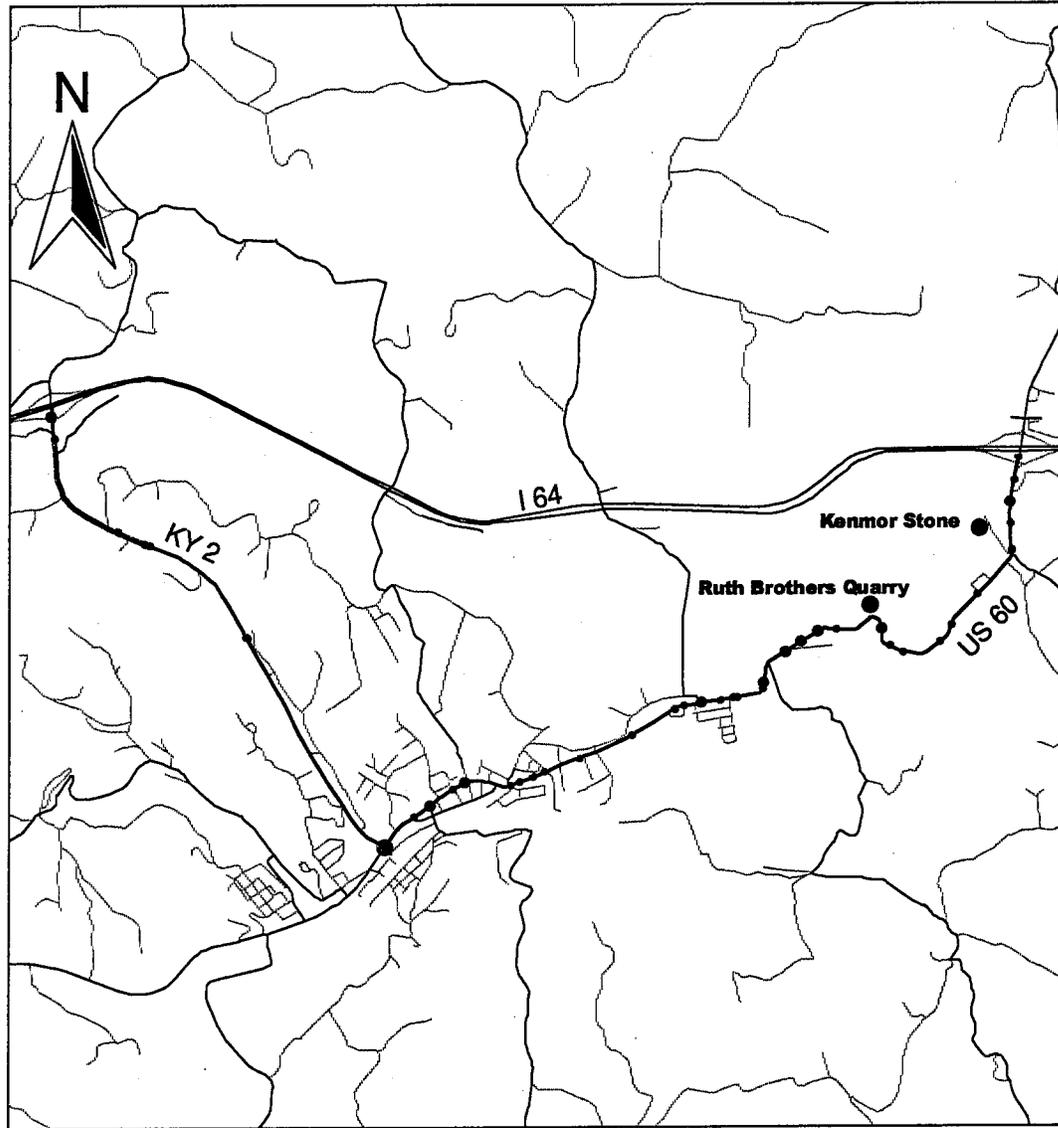
**Figure 2: Accident Locations (1994-1996)**

The section of KY 2 near I-64 (between milepoints 2.0 and 2.8) had a critical rate factor (the ratio of the actual accident rate to the critical accident rate) of 1.0 indicating that the truck accident rate is equal to the critical rate for that particular highway type. The section with a critical accident rate is shown in green in Figure 2.

Figure 2 also shows the locations of all accidents during the years 1994, 1995 and 1996. The figure shows that a majority of the accidents were on US 60, with a significant number occurring at intersections. This indicates that there are safety concerns along US 60. Most accidents on KY 2 were at the I-64 interchange or the intersection with US 60.

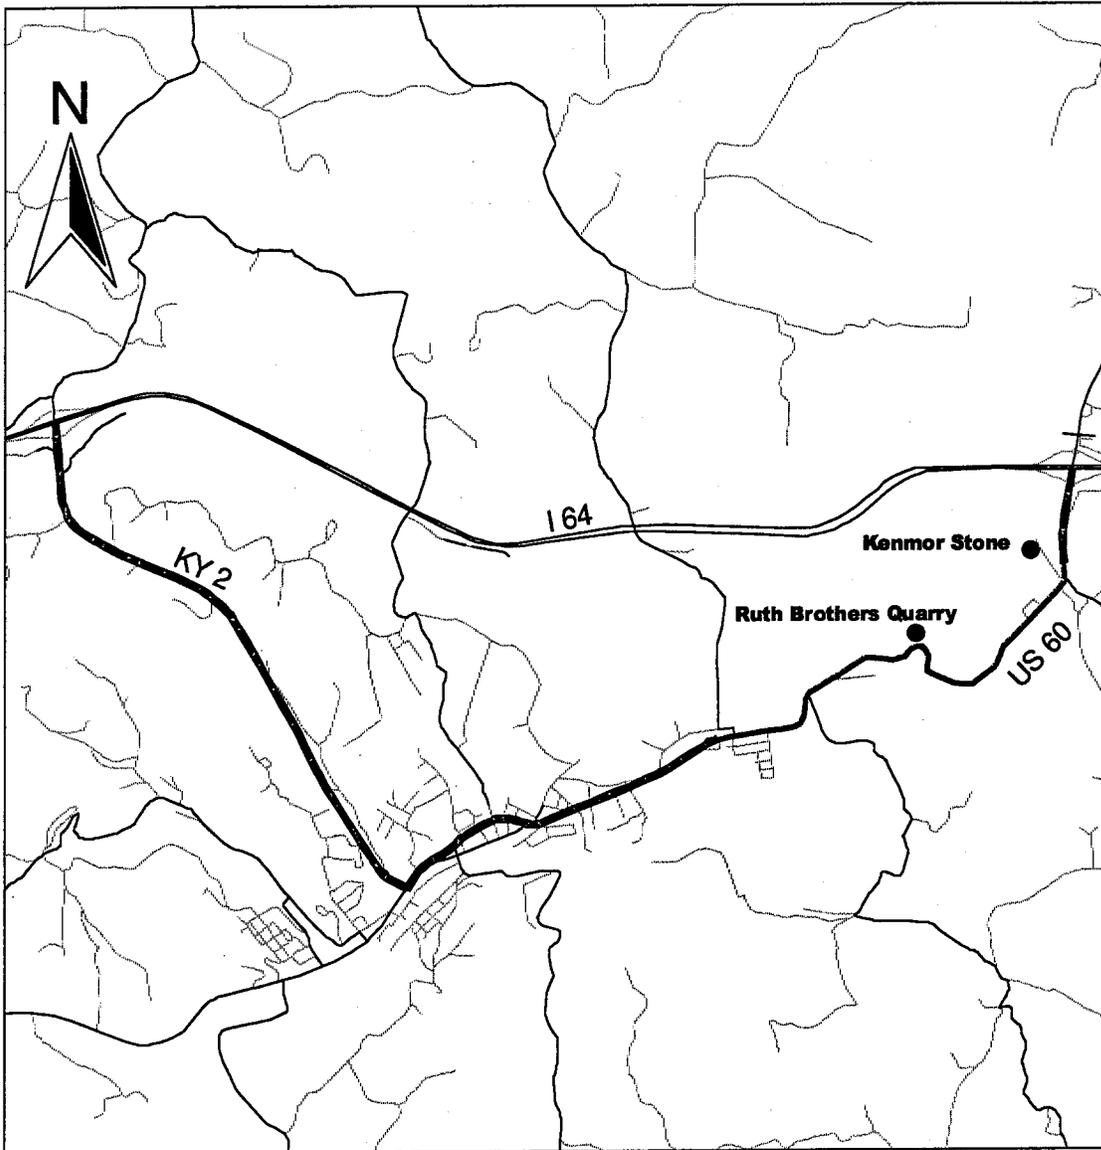
**Figure 3: Lane Widths**

Figures 3 and 4 illustrate the sections of the routes having different widths of lanes and shoulders. A 2.3 mile section of US 60 which includes the Ruth Brothers entrance has “adequate” 11 foot lanes. All other sections of both routes have “preferred” 12 foot lane widths. The eastern route includes 0.4 miles of US 60 with “adequate” 10 foot gravel shoulders. The remaining 1.5 miles have “less than adequate” 3 foot shoulders. The western route includes 0.8 miles of “less than adequate” 3 foot shoulders and 0.9 miles with no shoulder on US 60. The remaining 0.9 miles of US 60 and all of KY 2 have “adequate” 10 foot gravel shoulders. Sections of US 60 on both routes had inadequate clear zone with the most common problems being trees and drainage ditches. There were no significant clear zone problems found on KY 2. The pavement on both routes was generally good.

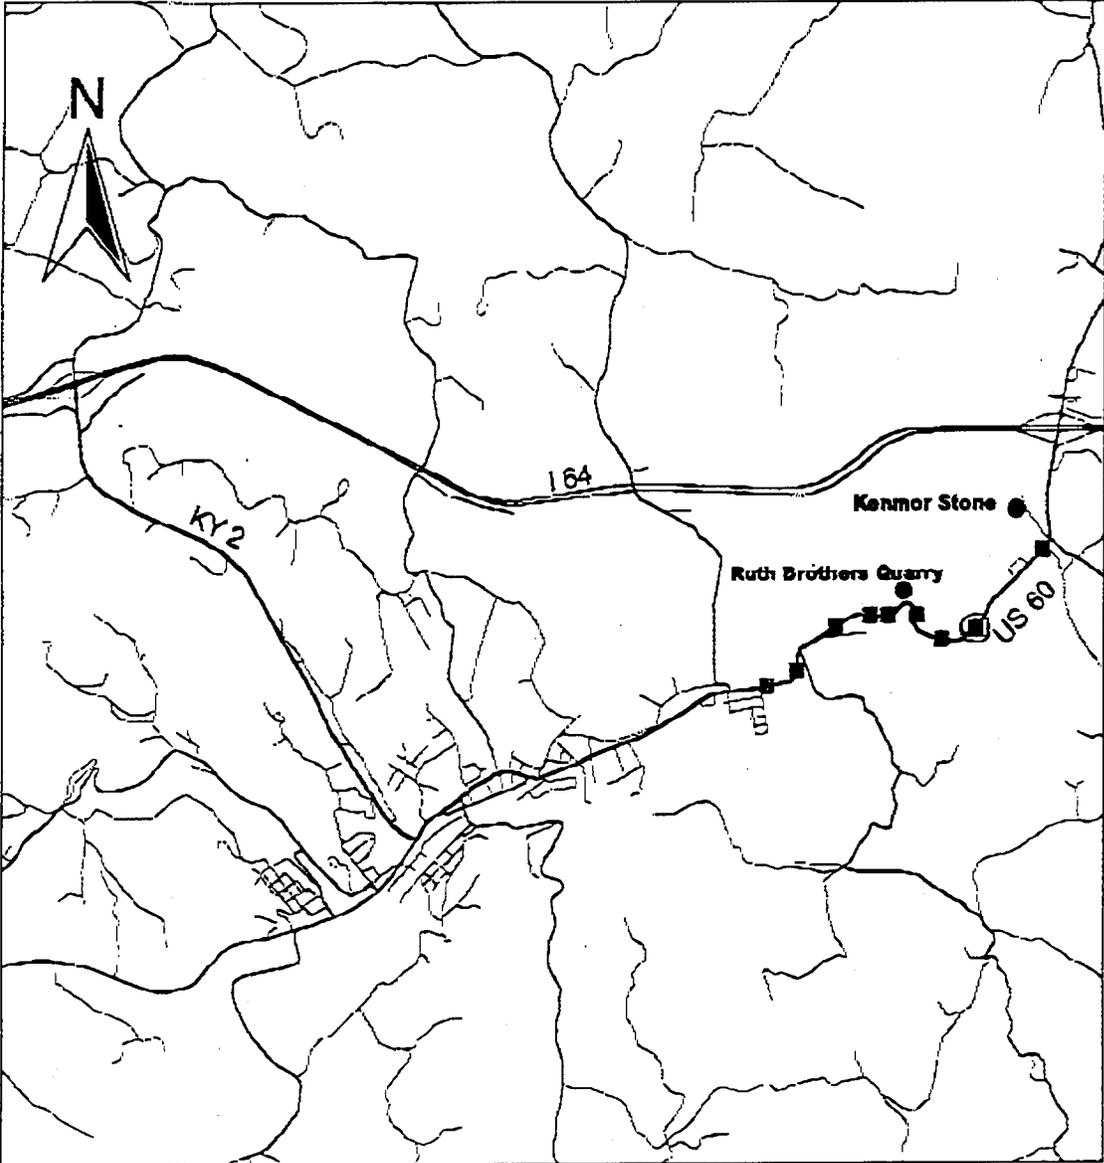
**Figure 6: Curves Where Offtracking Could Occur**

Offtracking is considered a problem where a truck cannot stay in its lane through a curve. Figure 6 shows the location of several curves on US 60 where offtracking could be a problem as calculated from lane width and degree of curvature. The eastern route has five curves that received a rating of “less than adequate” and one curve with an “adequate” rating. The western route includes three curves that received a “less than adequate” rating due to offtracking.

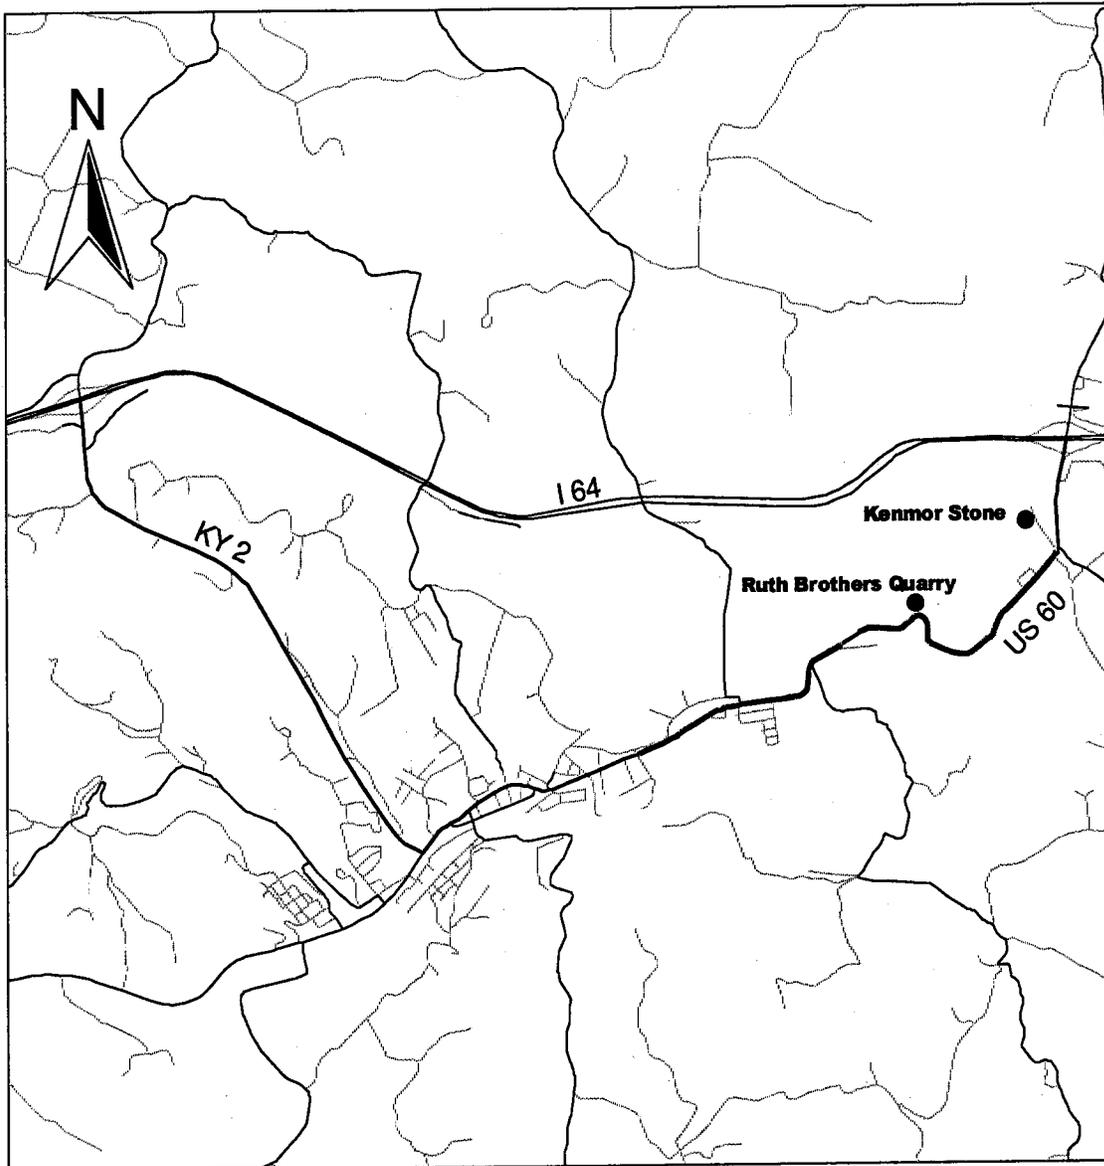
**Figure 5: Problematic Grades**

Grades are considered problematic if they cause trucks to slow down excessively. The locations of problematic grades (evaluated using AASHTO speed reduction tables) are shown in Figure 5. The eastern route includes three “less than adequate” grades. The western route also has three “less than adequate” grades on US 60 and one that was rated “adequate.” The most significant grade on US 60 (near Olive Hill) is not considered a problem because a climbing lane is provided. There is also a rather long hill on KY 2, north of Olive Hill that is not a problem because a climbing lane is provided for most of the hill.

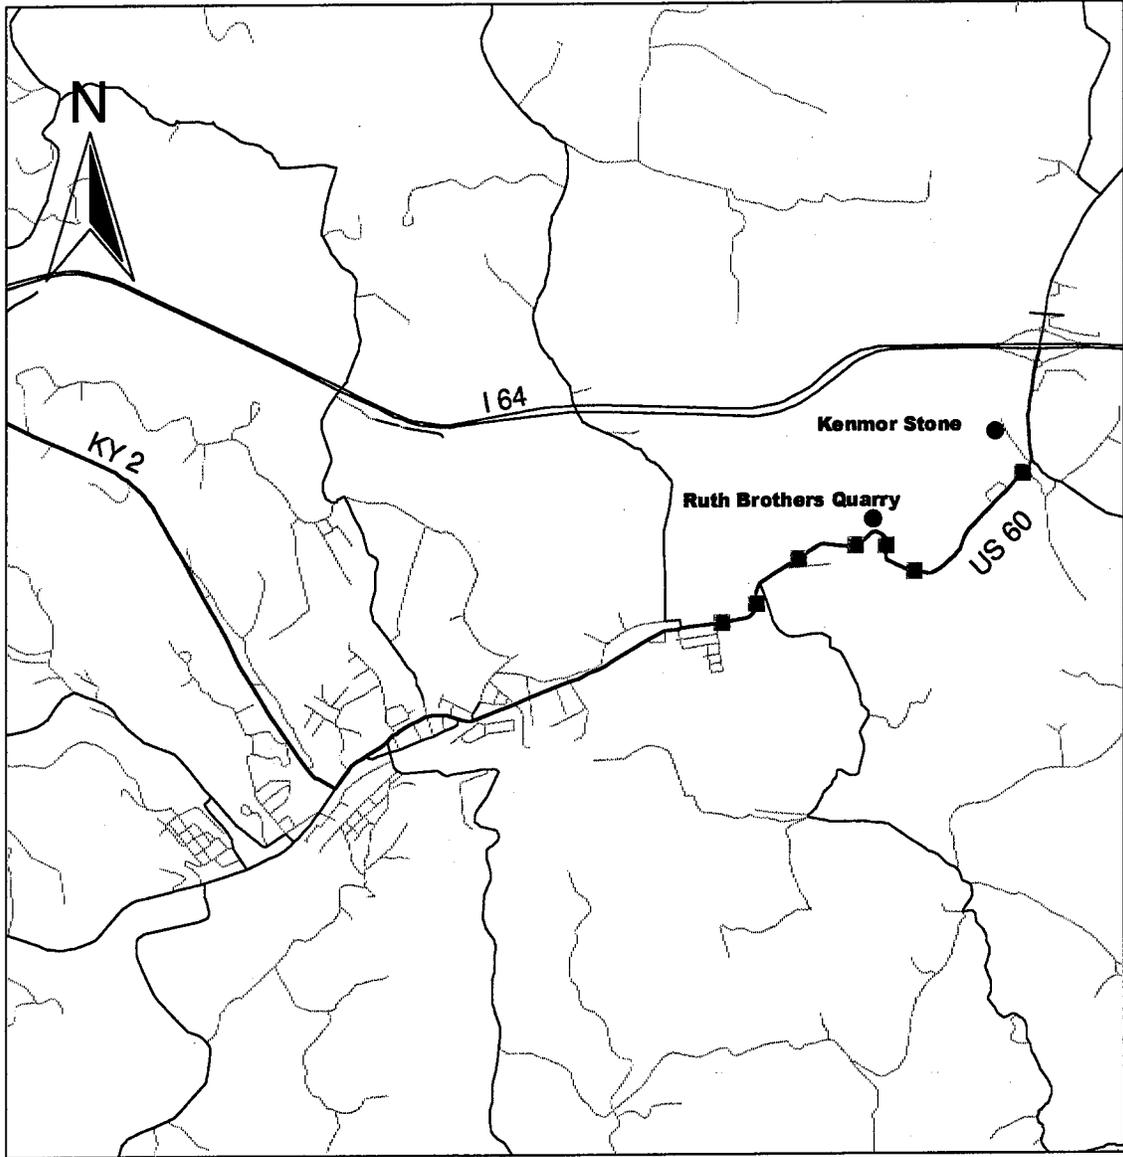
**Figure 7: Curves Where Safe Speed May be a Problem**

There are also some sections of US 60 where safe speed on a curve can be a problem as measured using a ball bank indicator. These curves are shown in Figure 7. The eastern route has two curves rated “adequate” and one rated “less than adequate.” A fourth curve has an advisory speed sign in one direction for an “adequate” rating, but does not have a similar sign for the other direction which gives it a “less than adequate” rating. The western route includes one curve receiving an “adequate” rating and two curves with a “less than adequate” rating.

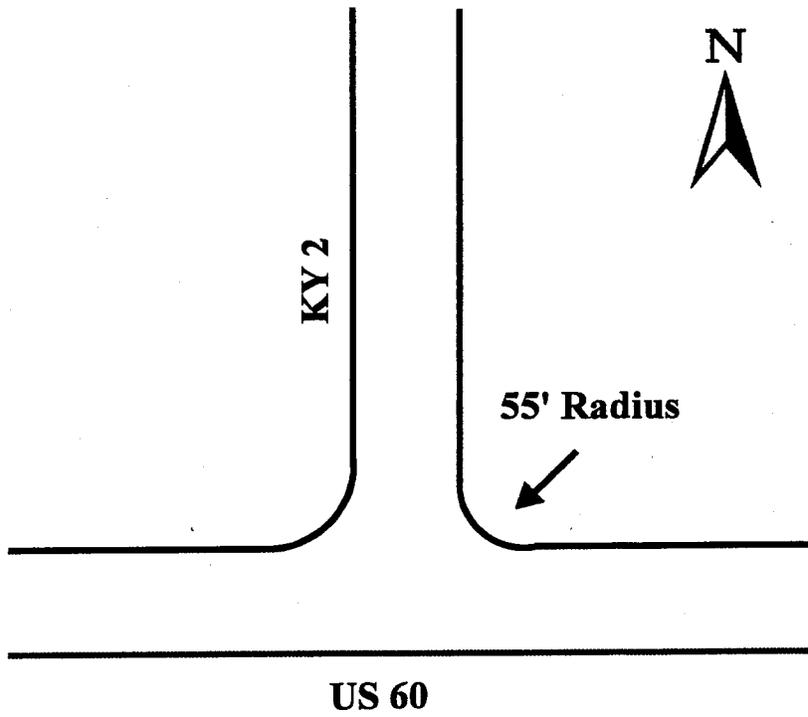
**Figure 8: Approximate Turning Radius at US 60 and KY 2**

The turning radius from US 60 onto KY 2 was approximated in the field. This location is shown in Figure 8. The turn (55 foot radius) was rated “less than adequate” because trucks are not able to complete the turn without encroaching on opposing traffic or starting the turn in the westbound through lane rather than the turn lane.

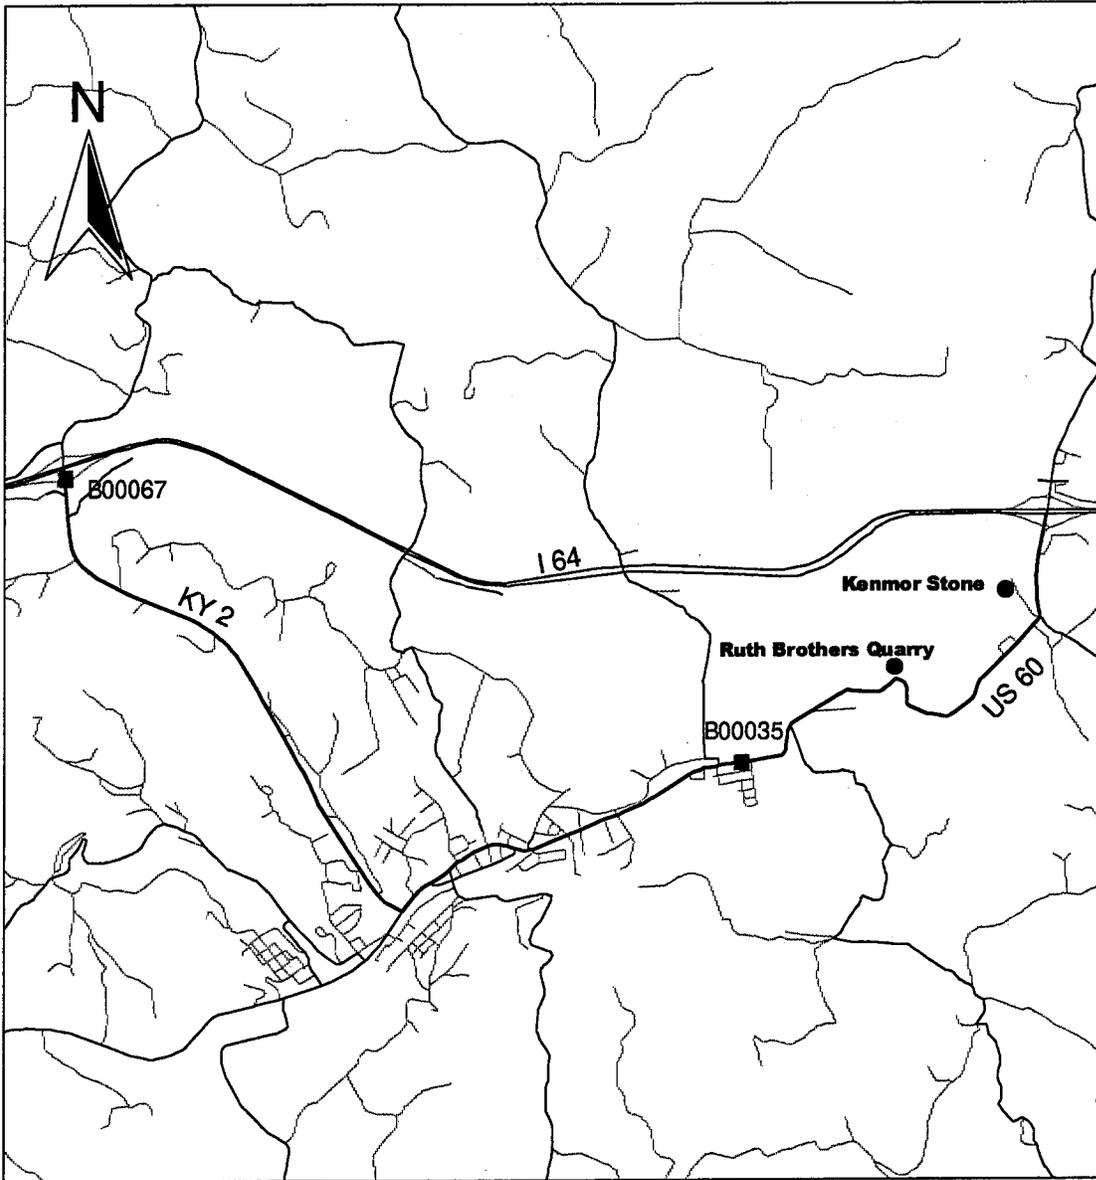
**Figure 9: Bridge Locations**

The location of the bridge on US 60 near milepost 11 is shown on Figure 9. The bridge has a sufficiency rating (provided by the Division of Operations at the KYTC) of 60.7 (out of a possible 100) which is considered “adequate.” The bridge is relatively narrow and obstructs the clear zone. The only other bridge along these routes is on KY 2 at the interchange with I-64. This bridge has a sufficiency rating of 81.6 which is “preferred.”

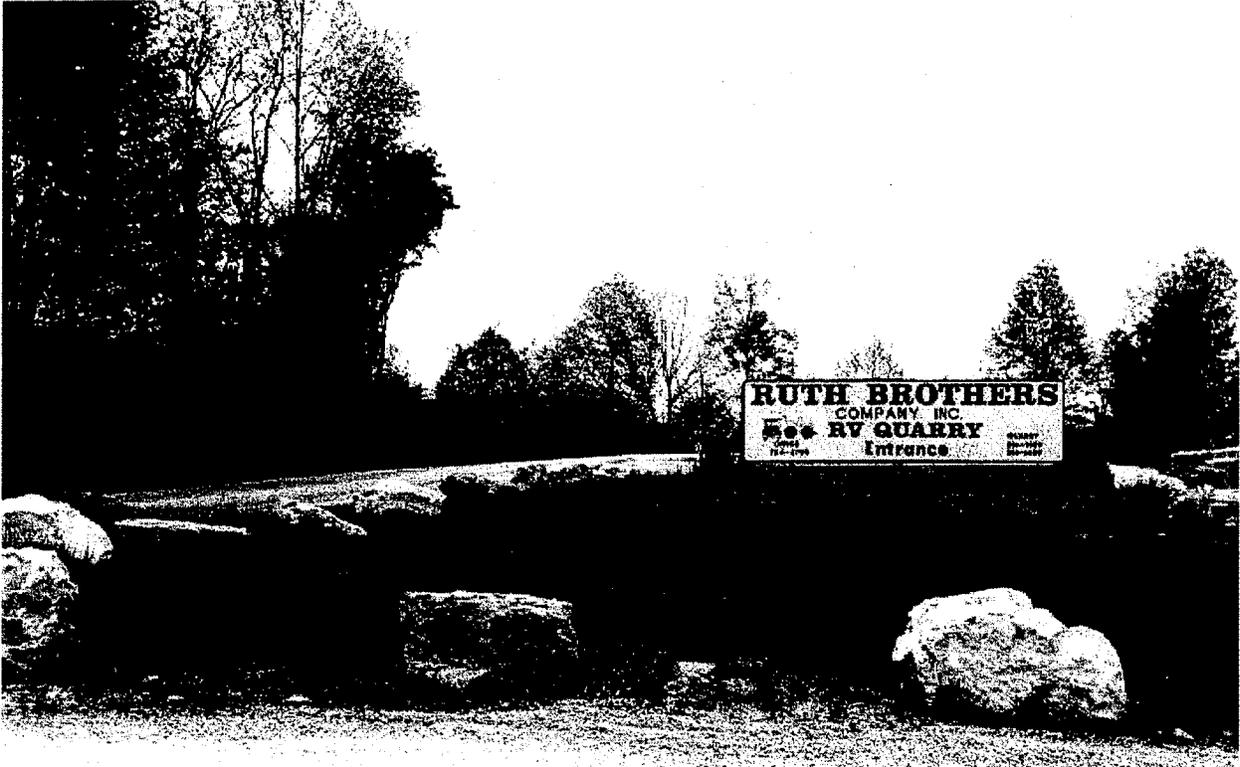
**Figure 10: Sight Distance at Quarry Entrance**

The sight distance was measured at the entrance of the Ruth Brothers Quarry where a sharp curve (shown in the background of Figure 10) limits the sight distance for truck turning left to travel east on US 60. The 300 foot distance is considered “adequate” because there are warning signs on US 60 indicating a truck entrance.
