Crash Test Between a 6-KG/M

U-Channel Sign Support and a 1997

Geo Metro: FOIL Test Number 99F010

PUBLICATION NO. FHWA-RD-01-046

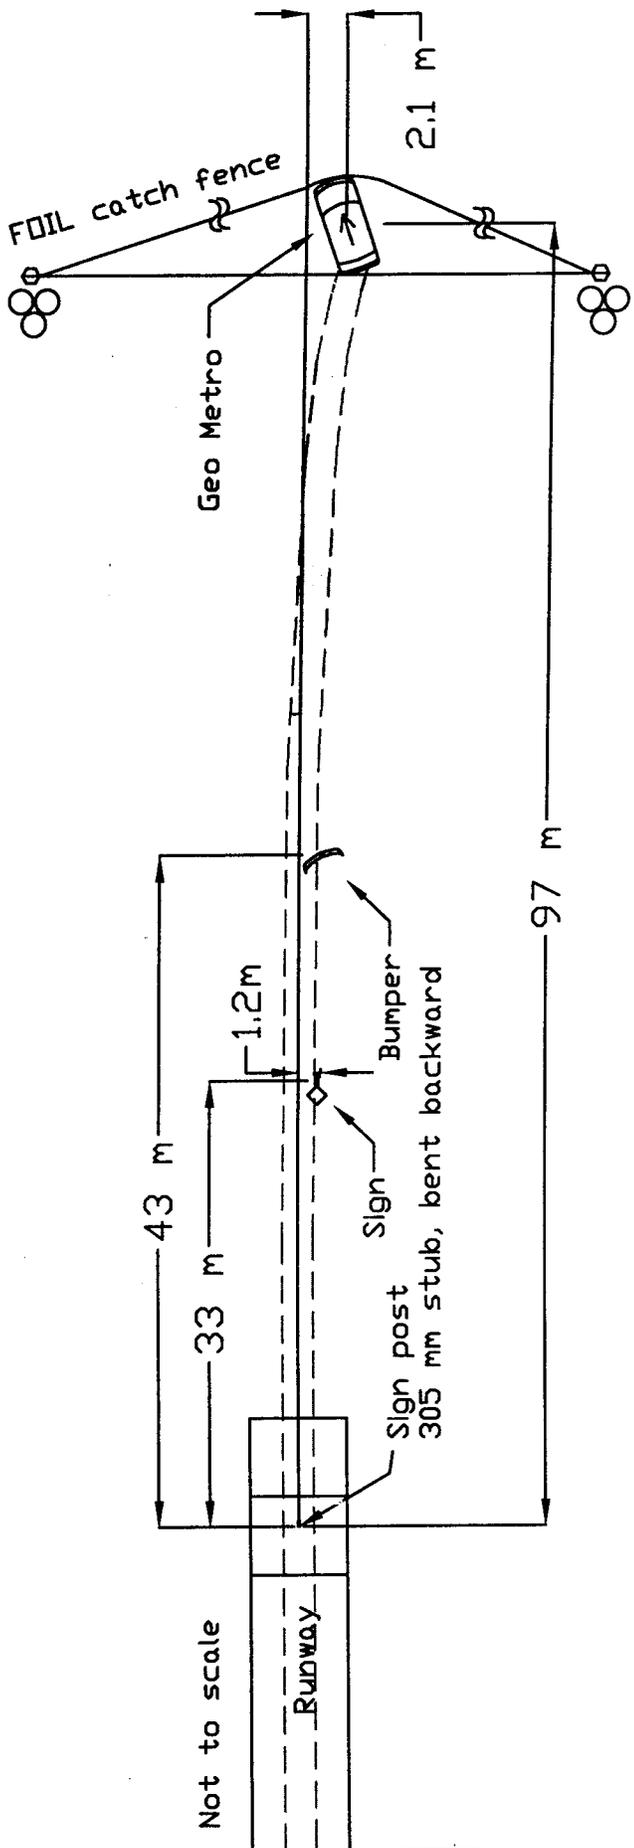
Figure 4. Summary of results, test 99F010.

The results summarized in figure 4 indicate that the 6-kg/m small sign support embedded in strong soil did not meet the safety performance criteria outlined in *NCHRP Report 350* (test designation 3-61). The sign support did fracture as anticipated and the longitudinal OIV (1.7 m/s) was below the allowable limit (5 m/s). However, the sign post contact with the vehicle caused a significant amount of denting to the roof and shattered the windshield, diminishing a driver's visibility. Table 6 summarizes the safety performance of the small sign support.

Vehicle Damage:
 Traffic Accident Data (TAD).....12-FC-4
 Vehicle Damage Index (VDI).....12FCEN3
 Static crush.....305 mm
 Post fracture.....305 mm above ground
