AEROSPACE REPORT NO.
ATR-2002(7596)-1

INFRARED INSPECTION OF COMPOSITE-REINFORCED CONCRETE STRUCTURES

OHIO DEPARTMENT OF TRANSPORTATION
Columbus, OH 43223

FHWA Report No. FHWA/OH-2001/11

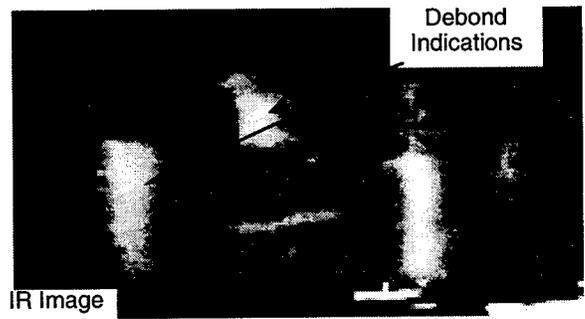
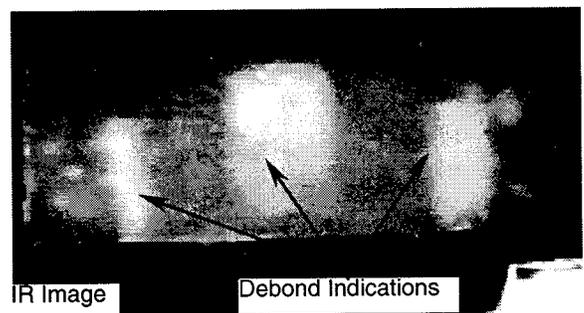
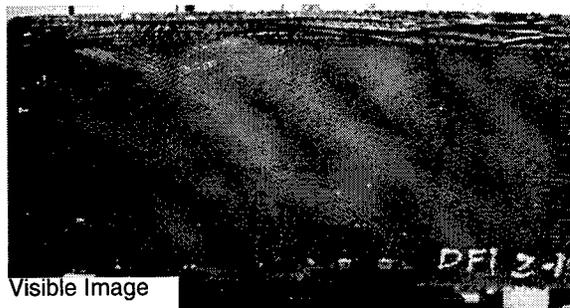
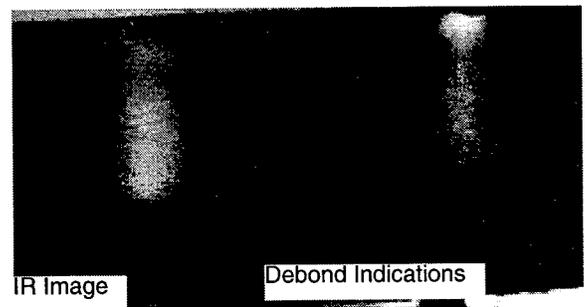
Initial trials were performed at Aerospace to determine the feasibility of using the thermographic inspection technique to evaluate the composite retrofit systems supplied by two manufacturers, DFI and Mitsubishi. Steve Morton, project engineer at ODoT, provided samples of these materials bonded to concrete blocks. Each sample contained several debonds created using a spacer forced under the composite during the bonding process. The spacer was removed prior to composite curing, creating a void between the composite and the cement block. The samples were inspected using IR thermography with a quartz-halogen heating source. The resulting images were recorded, and in each case the voids were easily detected. The visible and IR images from the defect samples are shown in Figure 3.1.

Figure 3.1. Proof-of-concept images for the IR thermographic inspection of the composite retrofitting materials selected for the ODoT study. The lighter areas in the IR images are typical of debond /delamination indications.

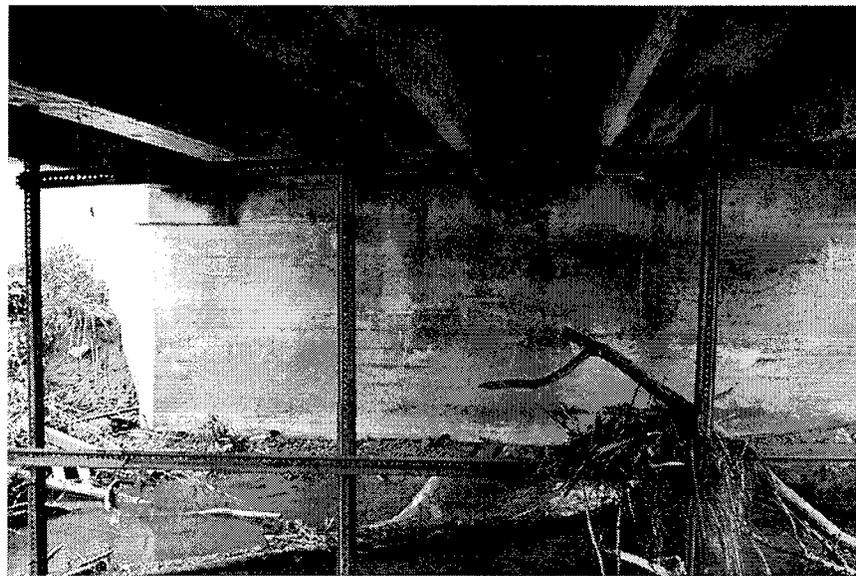
Figure 3.3. Debris and standing water found under the Wakatomika Creek Bridge.

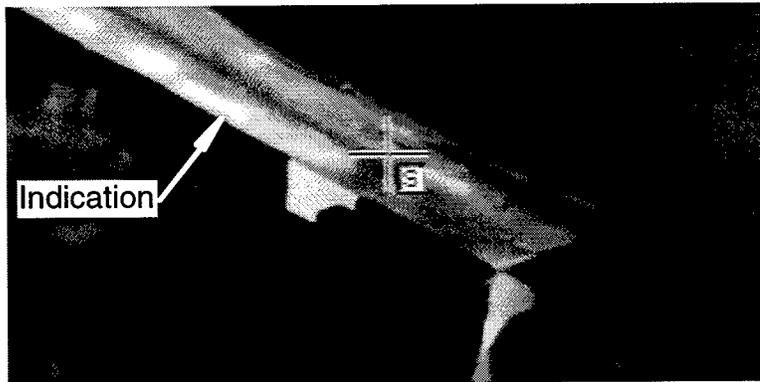
The initial inspection of the two bridges was completed in August of 1998. Numerous indications were noted at that time. A typical example is shown in Figure 3.5.

These indications were confirmed using a resonance “tap test” technique. Tap testing requires an inspector to strike the composite material with a hammer while listening for changes in the pitch that might indicate voids.^{1,2} The IR inspection for each year was recorded on videotape for playback in the laboratory. The evaluation process consisted of reviewing the data tapes for thermal indications of voids. Reviewing the data acquired during the first inspection identified a number of limitations in the inspection procedure to be addressed in follow-on testing. These issues included required modifications to the heating fixture, allowing for better handling of the heating elements in spite of the mud and debris in the inspection area, and changes in how the data was collected. There were two issues

Figure 3.5. Typical IR indication in the composite retrofit material.

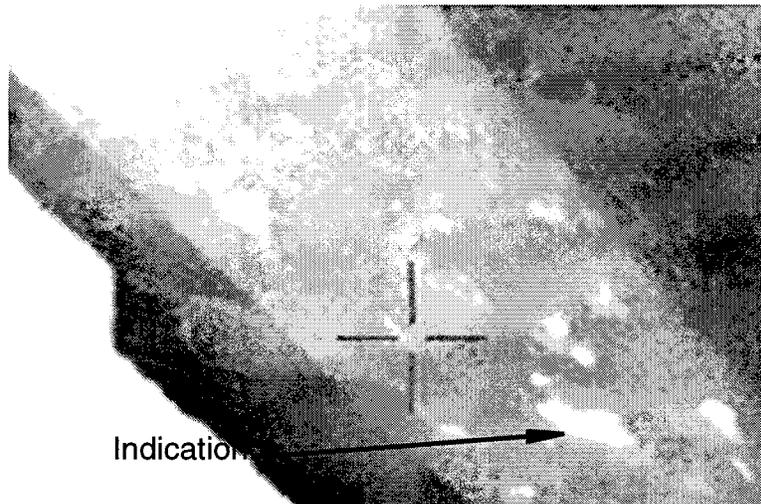
The second IR inspection was completed in June of 1999. The same heat source was used in both 1998 and 1999; however, an upgraded version of the FLIR 570 camera was used for the 1999 inspection. The inspection was carried out in much the same manner, with the data being recorded to videotape. Several changes in procedure were made for the 1999 inspection. Specifically, additional care was taken to make the inspection dwell time and the field of view consistent. Again, the data was evaluated at Aerospace, and several indications were noted. A typical example of the 1999 data is shown in Figure 3.7.

Figure 3.7. Typical IR indication found in the Mitsubishi material.

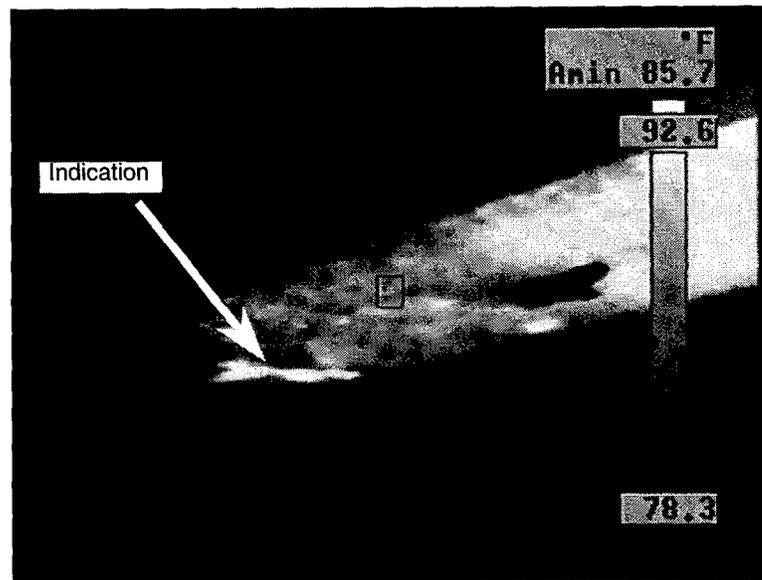
Figure 3.8. IR image of the Mitsubishi retrofit material showing a well-defined indication.

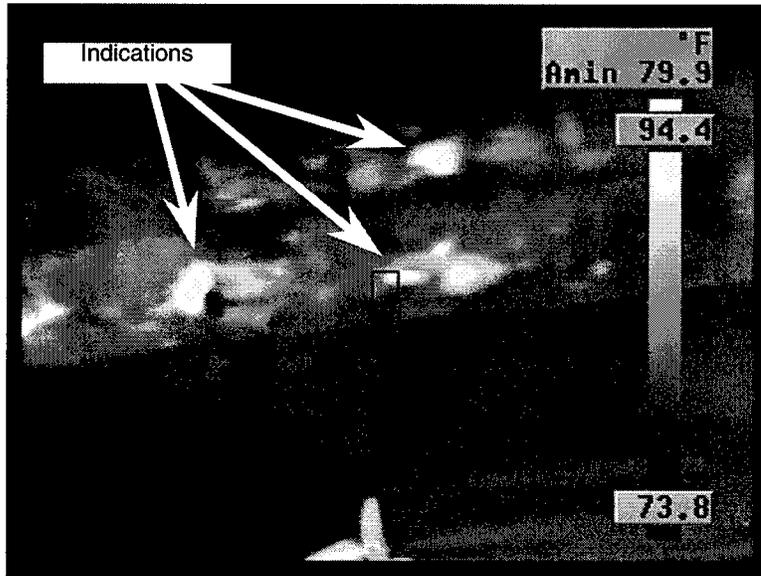
Figure 3.9. IR image of DFI material showing 3 well-defined indications.
