**COMPLIANCE CRASH TESTING OF THE TYPE 60K CONCRETE
BARRIER USED IN SEMI-PERMANENT INSTALLATIONS**
FINAL REPORT # FHWA/CA/TL-2001/08

August, 2001

CALTRANS STUDY # 680841

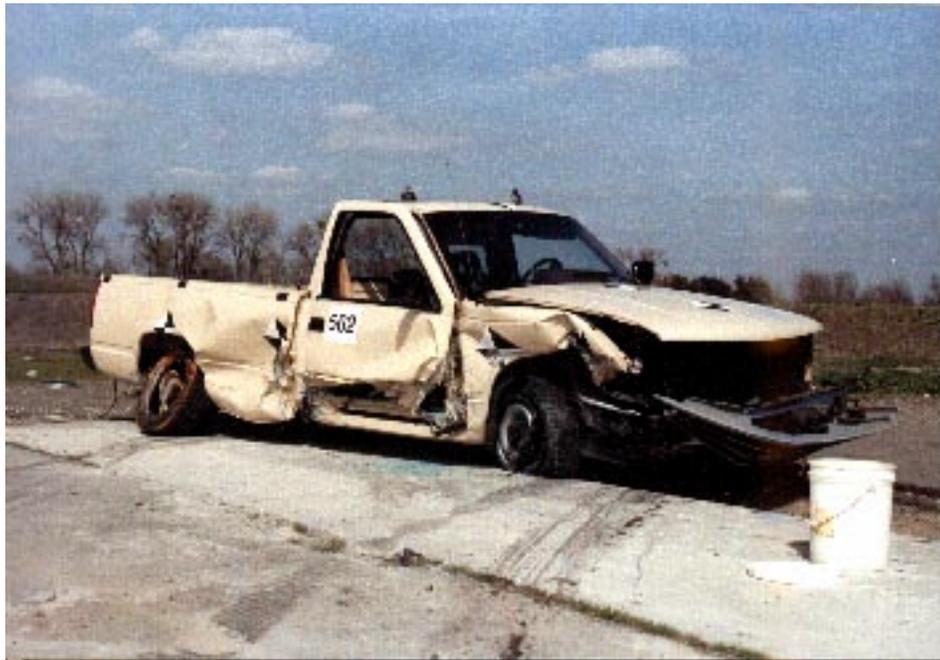
Figure 2-1 – Test 562. Overall damage to the vehicle

Most of the damage to the vehicle was on the front half of the right side (Figure 2-1). The right third of the bumper was pushed back into the front right wheel well. The front tire was

The back half of the vehicle also received some damage. The portion of the bed separating the rear tire and the cab was crushed and rippled. The rear right tire was blown and the rim was bent. The wheel did not sustain any permanent longitudinal displacement.

The floor deformation at the center of the front passenger side of the vehicle was about 115 mm. At the firewall, the maximum floor deformation was 135 mm.

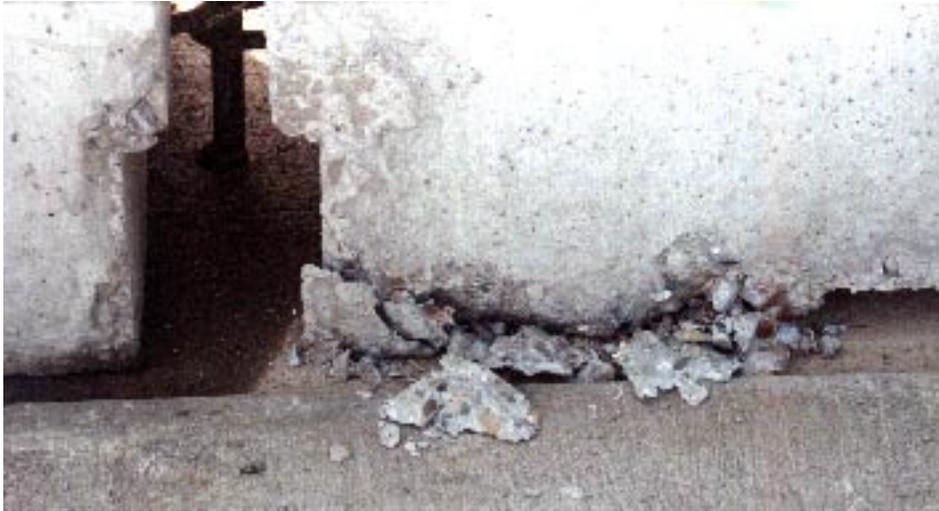
Figure 2-3 – Test 562. Segment 8 at Joint 7-8

The barrier did not have any significant permanent deflection and appeared, at first glance, to be in good condition after the impact. After closer examination, however, it was noted that the backside of each of the segments that shifted was spalled along the bottom edge. The steel angle that lined the sides of the trough was littered with concrete that had been cut by the angle. The leading edges of two of the segments sustained minor spalling. Two of the connecting pins were bent enough that they had to be cut before the barrier could be disassembled.

Figure 2-3 shows the spalled concrete at the base of segment 8, one joint upstream of impact. The steel angle lining the sides of the trough acted to cut the barrier along the backside of the segments that were laterally deflected.

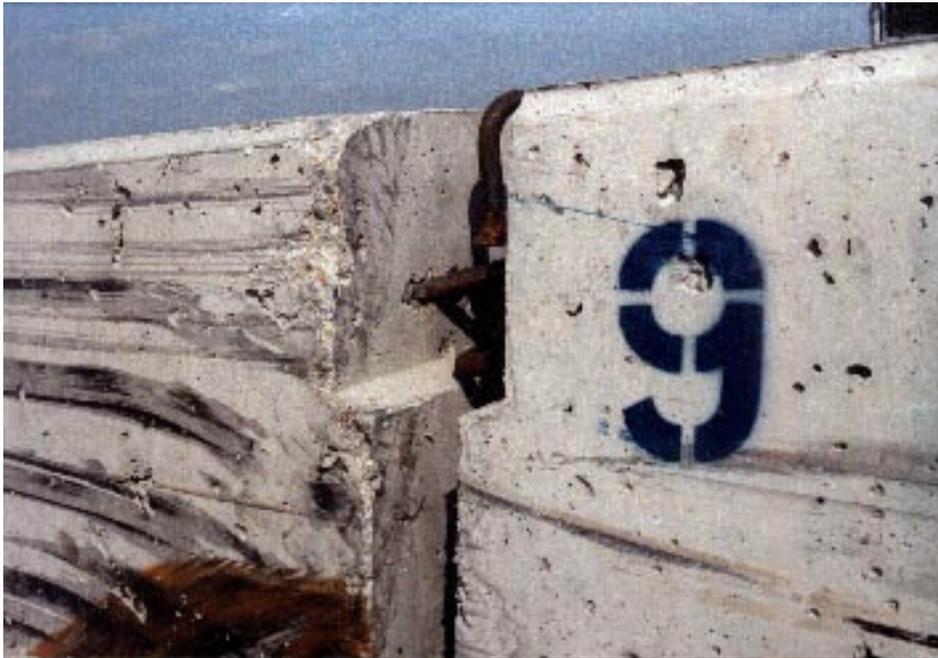
Figure 2-4 - Test 562. Segments 9 and 10

Illustrating the snagging potential of the Type 60K-v1, Figure 2-4 shows the scuff marks on the end face of segment 10 where the vehicle penetrated the barrier face.

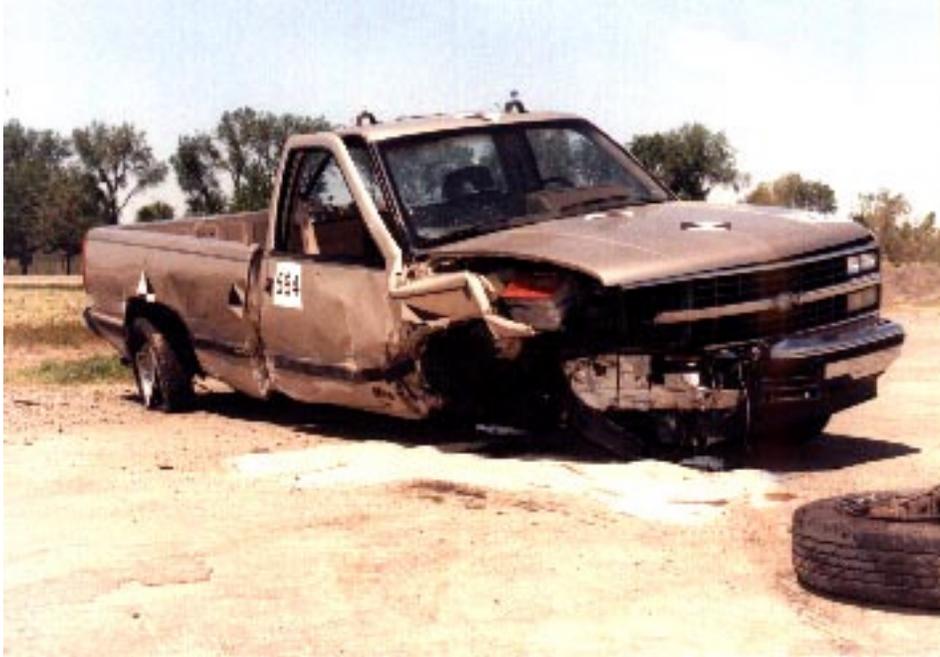
Figure 2-6 – Test 564. Damage to the front of the vehicle

Vehicle damage was extensive. The right front wheel, hub and spindle assemblies were sheared from the suspension. The right A-arm was bent back and twisted. The right side of the front bumper was pushed back approximately 510 mm (see Figure 2-6). The right front fender and inner fender were pushed in and back against the engine. The right frame rail was bent into the engine and the engine was tilted up on the right side. The radiator, transmission cooler, battery box and battery received extensive damage.

Transmission oil, coolant and battery acid leaked out of the vehicle. The right side of the hood received minor damage and the windshield was fractured on the right side. The right door was pushed back into its frame. The right door buckled outward approximately 140 mm, jamming the door closed and breaking the door glass.

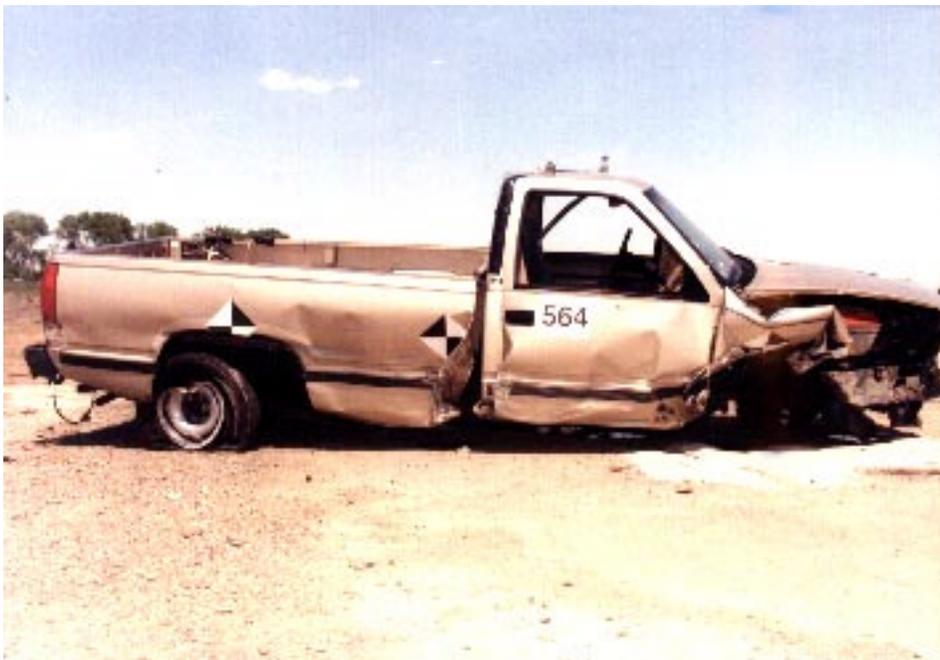
Figure 2-7 – Test 564. Damage to the side of the vehicle

The right rear of the vehicle also received extensive damage (see Figure 2-7). The right side of the bed was dented the full length and the whole bed was shifted to the left on the frame. The rear axle broke loose from the suspension, and was pushed back approximately 600 mm. The axle housing bent and the differential housing broke. Both of the right side tires were flat and ruptured with extensive damage to both wheels.

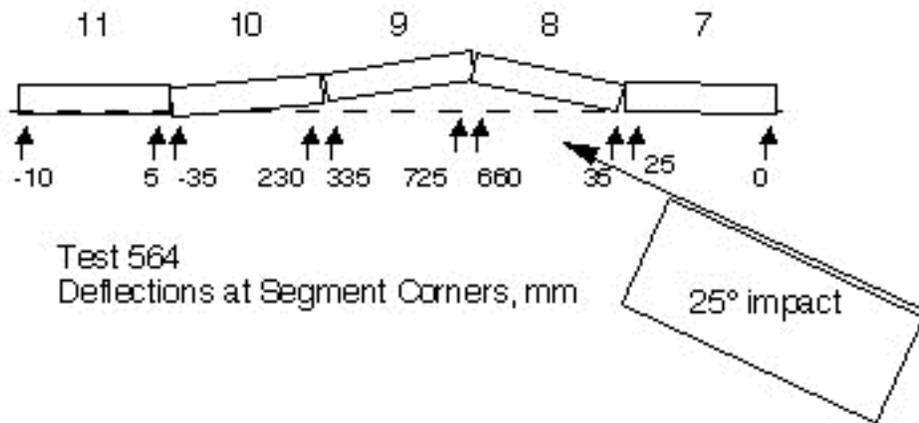
Figure 2-8 – Test 564. Barrier deflections

Damage to the barrier was limited to barrier deflection, two of the connection pins being pulled out of the pavement, and some minor concrete spalling. The maximum, permanent barrier deflection was 725 mm at the joint between segments 8 and 9 (see Figure 2-8). The barrier deflections led to the pins at joints 8-9 and 9-10 being pulled out of the pavement. Concrete spalling was limited to the leading edges of segments 8 and 10 where the vehicle snagged the barrier. All of the barrier segments were reusable.

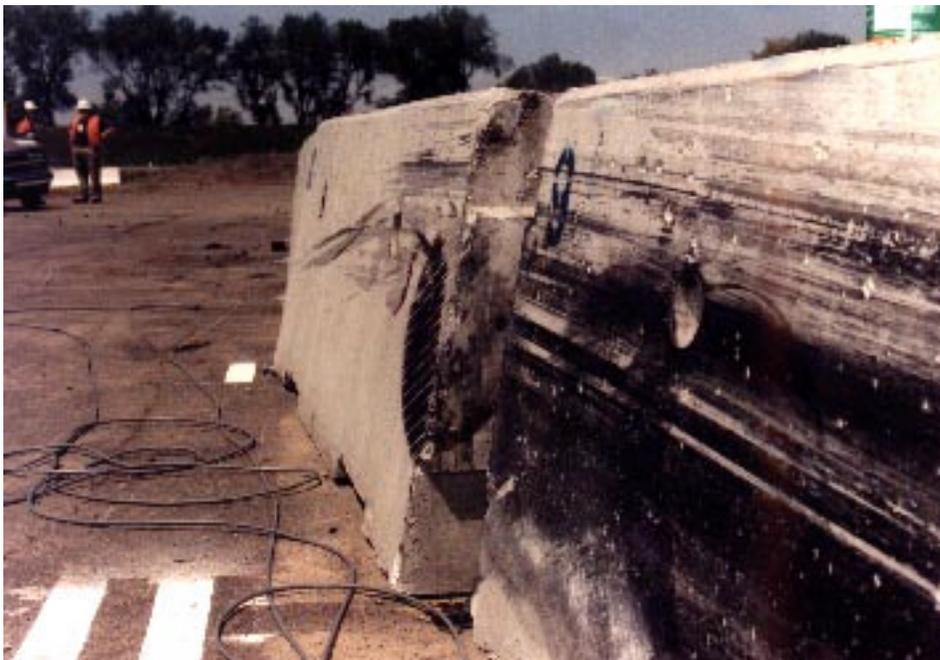
Figure 2-10 – Test 564. Snag at joint 9-10

60K-v2: The structural adequacy of the 60K-v2 was also unacceptable. Test 564 showed that the differential rotation of the barrier segments and consequential vehicle snagging at the barrier joints was even more pronounced than in the test of 60K-v1. During the time of contact between the test vehicles and the barriers there were minor amounts of scraping and spalling.

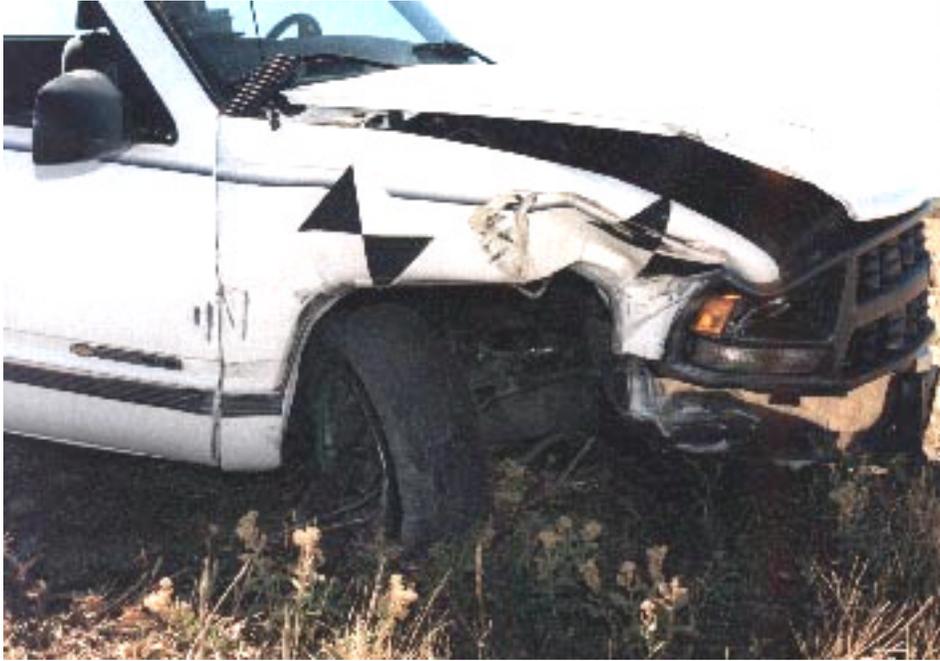
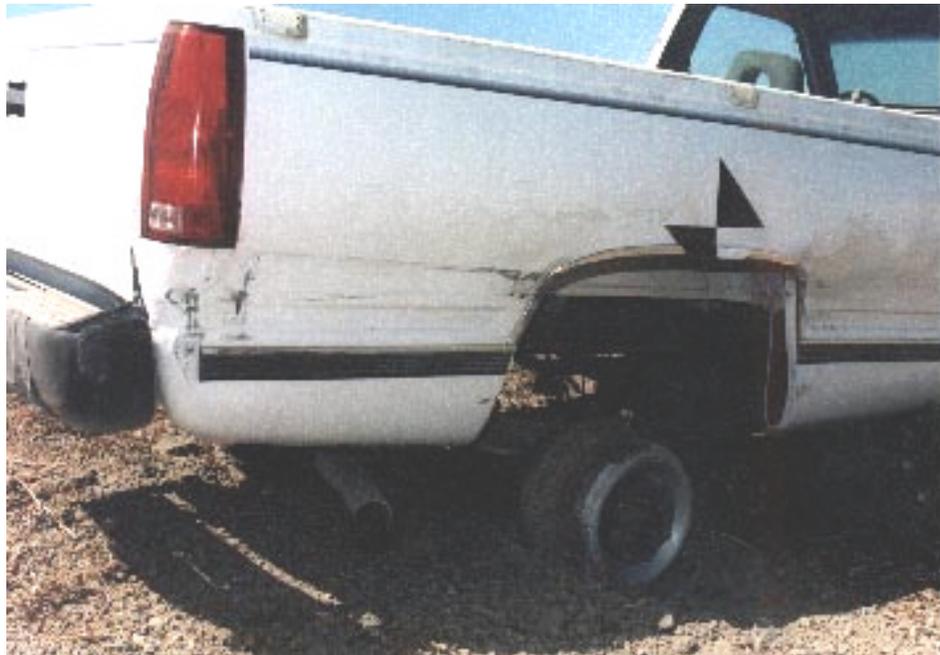
Most of the damage to the vehicle was confined to the front right corner, with additional damage along the impacting side of the vehicle (see Figure 2-12 and Figure 2-13). The front right tire was torn, but still on the vehicle. The corner panel and the far right side of the bumper were crushed. The tie-rod was severely bent. The hood was partly raised, but still latched. There were scuff-marks along the rear right side of the vehicle. The right rear wheel separated at the seam, allowing the tire and rim to detach from the vehicle. The engine was still functional.

The occupant compartment sustained some minor crumpling on the right side floorboard measuring 25 mm at the center of the passenger side and 110 mm at the firewall. The right door was jammed closed. The windshield was not cracked.

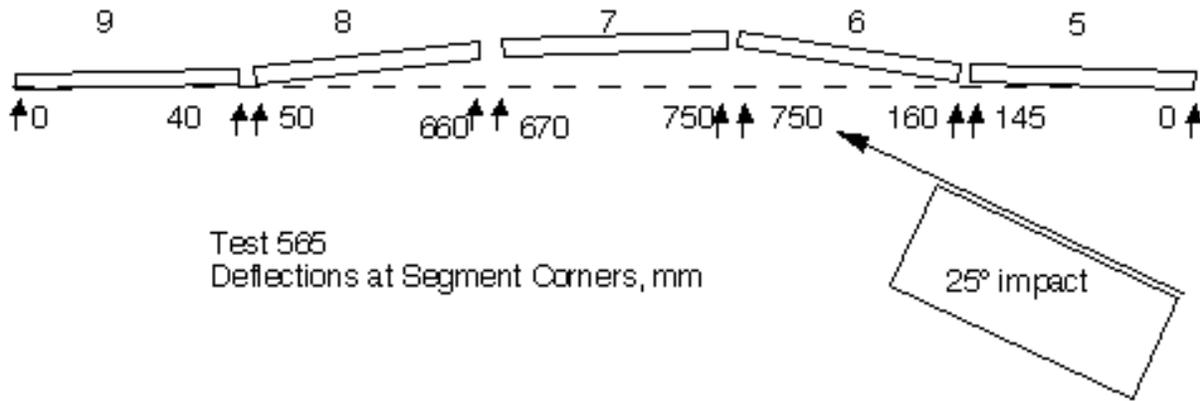
Figure 2-14 – Test 565. Barrier deflections

The barrier shifted a maximum of 750 mm at the impacted joint during impact.

Damage to the barrier was limited to shifted segments, minor concrete spalling, bent connecting pins, and scuffing of the concrete face. Out of the 12 segments making up this barrier, only segments 1, 2, and 12 did not move. Segments 5, 6, 7, 8, and 9 had measurable lateral deflections. The spalling concrete occurred at joint 6-7 where the concrete is the thinnest. The connecting pins nearest the impact were bent, six of which had to be cut. All of the barrier segments were reusable.

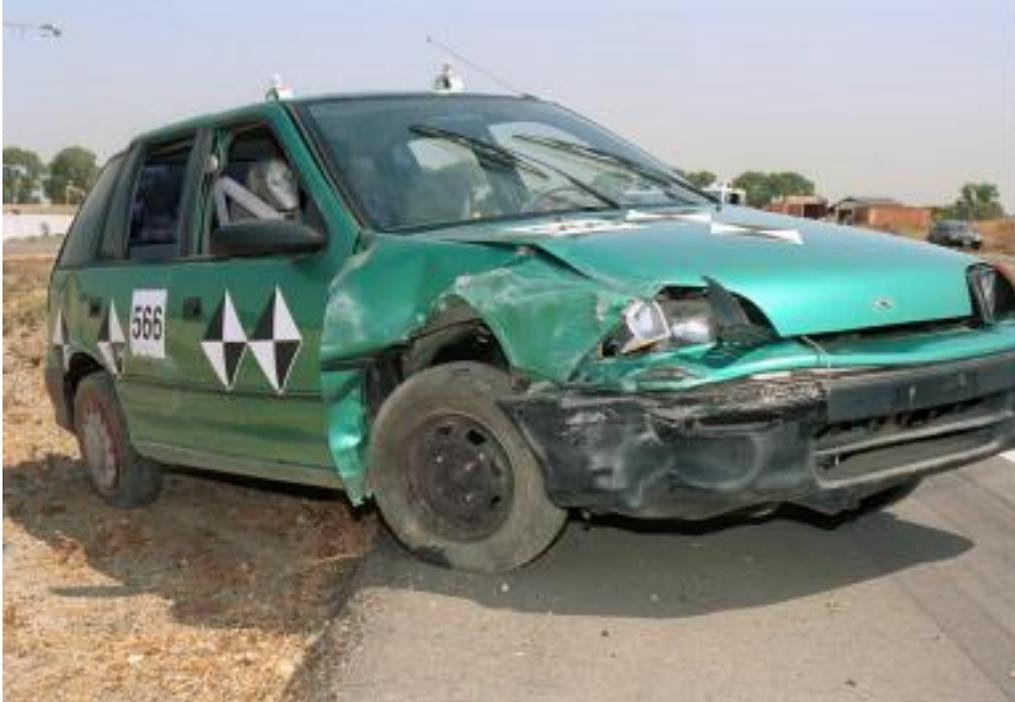
Figure 2-18 – Test 566. Vehicle damage to the impacted corner

Most of the vehicle damage was limited to the front right corner of the vehicle. The corner panel was crushed and the hood had been buckled. The front right wheel was turned inward. The steering mechanism was damaged but the steering wheel could still turn the wheels. The tire was still inflated. The hubcap was missing from the front right wheel.

The rear right fender panel also received some minor damage. The flare on the rear wheel well was flattened and hubcap was scraped. The bumper also received some minor scraping. There was no visible structural damage to the rear of the vehicle.

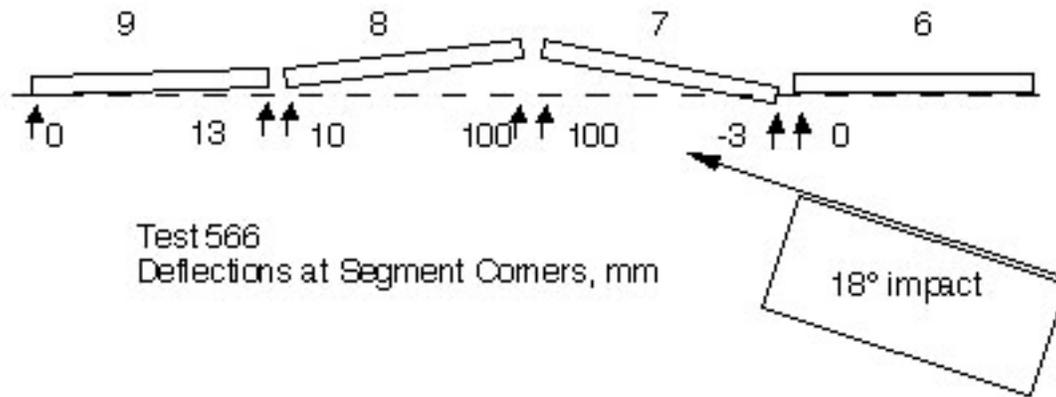
Figure 2-19 – Test 566. Barrier deflections

The barrier shifted a maximum of 100 mm during impact.

Impact occurred on segment 8, 535 mm downstream from joint 7-8. Damage was limited to scuffing on the face of segment 8 only. Although the connecting pins were slightly snug, they could be pulled out using a pry bar.

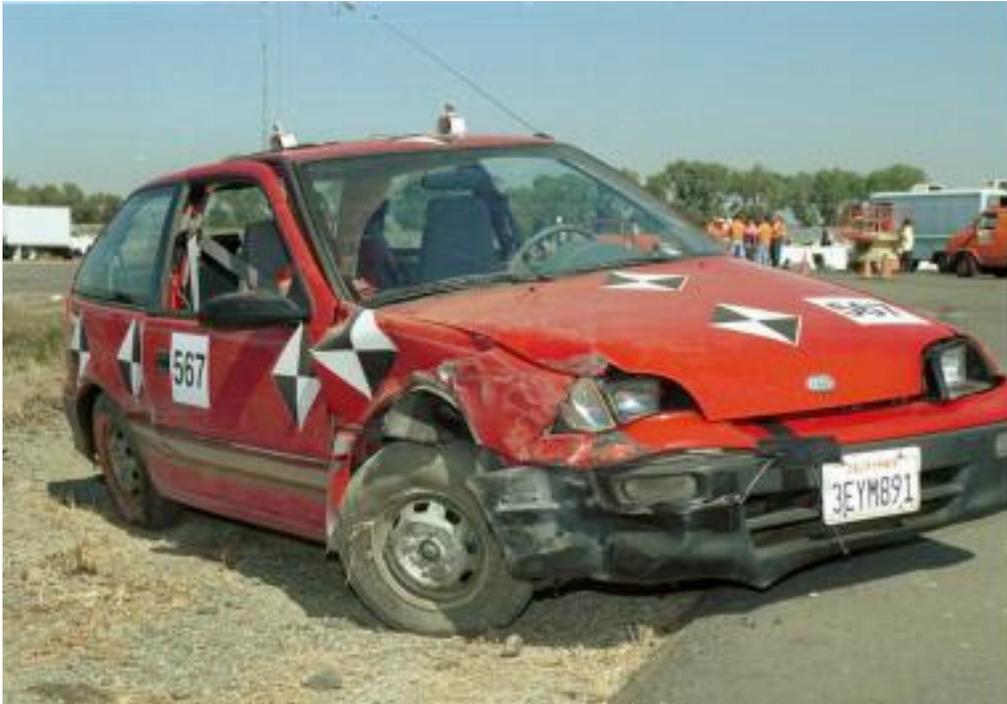
Figure 2-21 - Test 567. Damage to the impacted corner of the vehicle

The damage to the test vehicle was similar to the vehicle damage in test 566. Most of the damage was limited to the front right corner of the vehicle. The corner panel was crushed and the hood had a small dent. The right 300 mm of the front bumper was pushed back 150 mm into the wheel well. The front right wheel was turned inward more severely than in test 566 and the hubcap was lost. The steering mechanism was damaged but the steering wheel could still turn the wheels. The tire was still inflated.

The rear right fender panel also received some minor damage. The flare on the rear wheel well was flattened and hub cap was lost. The bumper also received some minor scraping. There was no visible structural damage to the rear of the vehicle.

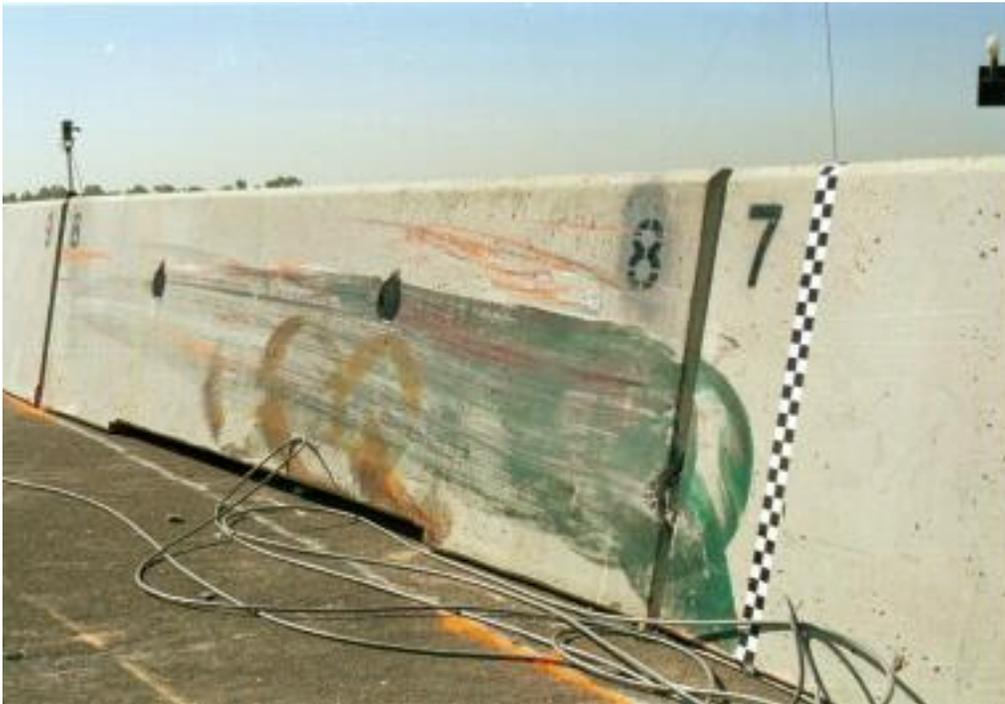
Figure 2-23 – Test 567. Scuffing and lateral deflection of barrier

Impact occurred on segment 7, 100 mm upstream from joint 7-8. Segments 7 and 8 received some scuffing during contact with the test vehicle. Segment 8 received some minor spalling at

its leading edge. As in Test 566, the connecting pins were slightly snug, but could be pulled out using a pry bar.
