ULTRA-THIN PORTLAND CEMENT CONCRETE OVERLAY

RESEARCH PROJECT
FINAL REPORT

Commonwealth of Pennsylvania
Department of Transportation
Prepared by: Bureau of Maintenance and Operation

6. AUTHOR(S) Paul E. King, P.E.		8. PERFORMING ORGANIZATION REPORT NUMBER FHWA-PA-96-002F	
7. PERFORMING ORGANIZATION NAME(S) AND ADDRESS(ES) Pennsylvania Department of Transportation Bureau of Maintenance and Operations Roadway Management Division 555 Walnut Street, 7th Floor, Forum Place Harrisburg, PA 17101-1900		9. SPONSORING / MONITORING AGENCY NAME(S) AND ADDRESS(ES) U.S. Department of Transportation FHWA Washington D.C. 20590

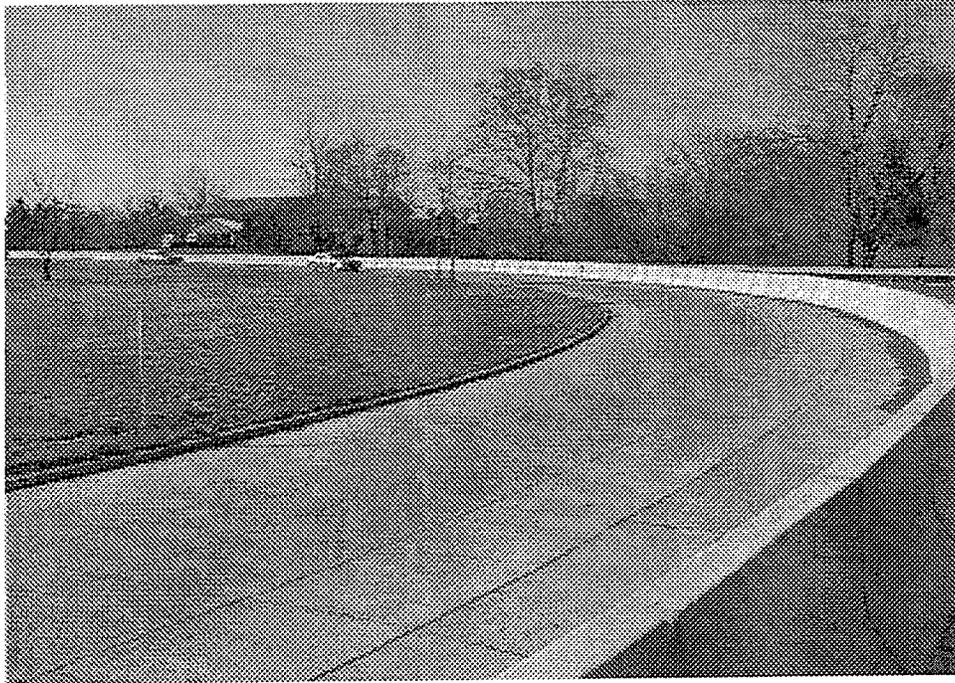
The whitetopping overlay has now experienced two winters. As described in the construction report, there were transverse cracks that appeared prior to opening to traffic. The crack that formed at inlet #2 is showing some signs of minor spalling. However, the remainder of the whitetopping overlay is performing quite well. The construction report also described the transition that was made from a bonded concrete overlay into the whitetopping of the bituminous material. At the beginning of the transition area there is one square that has cracked, however, at this point all of the pieces are remaining intact. All visual observation and comments from others are very favorable. It does appear at this point that the whitetopping, based on performance thus far, will be a viable alternative to milling and overlaying with Hot Mix Asphalt (HMA).

Figure 4. View of ramp after experiencing two winters.

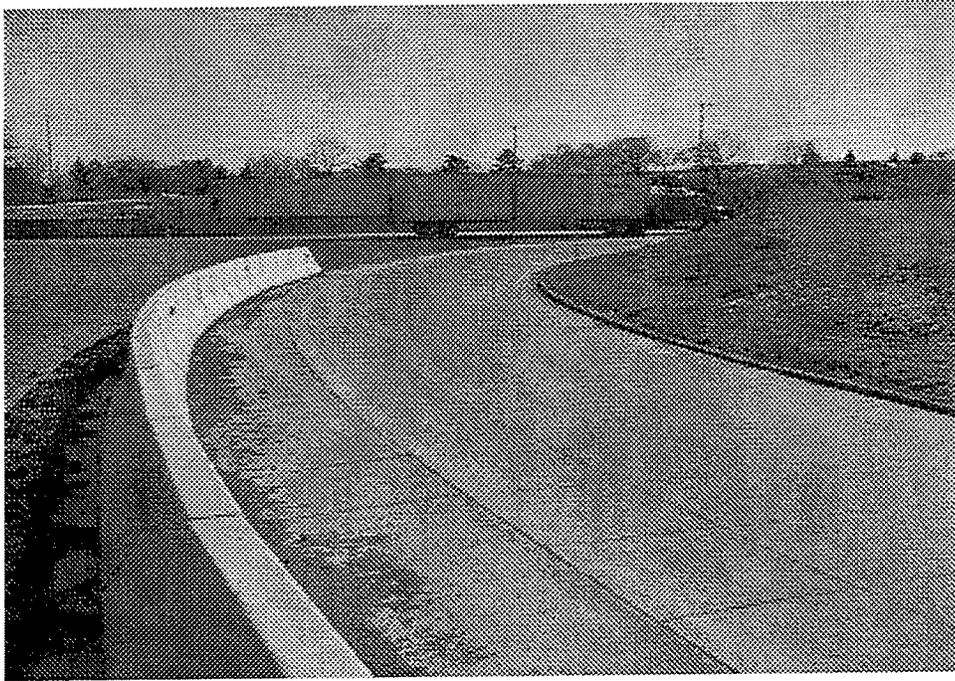
Figure 5. View looking at end of ramp toward I-83.

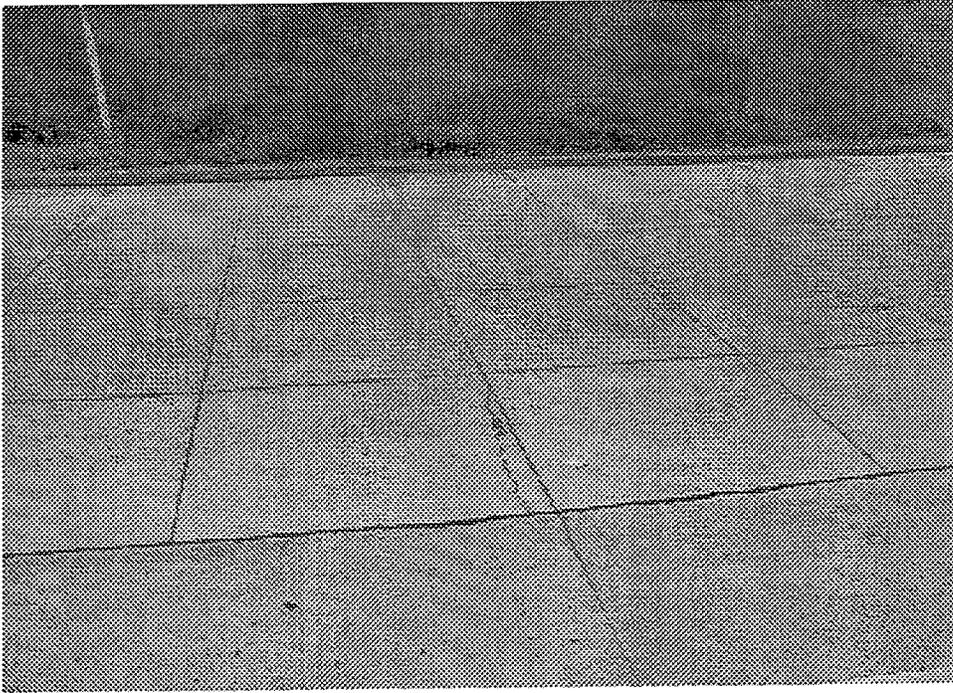
Due to cooler temperatures on the day of the second pour (40° - 45° F) and experience from the first pour, a decision was made to wait until early the next morning to saw the joints so that the concrete had enough time to set. However, one transverse crack formed at inlet #2 and two days later another crack had formed adjacent to a sawed transverse joint.

placing the concrete, sunny with temperatures in the upper 50's, the concrete did not set enough on the first pour to allow completion of sawing in one day. This also contributed to the decision made to wait until the following day to saw joints on the second pour, which resulted in transverse cracking.

Figure 6. Crack that occurred before opening to traffic as it appears at this time.

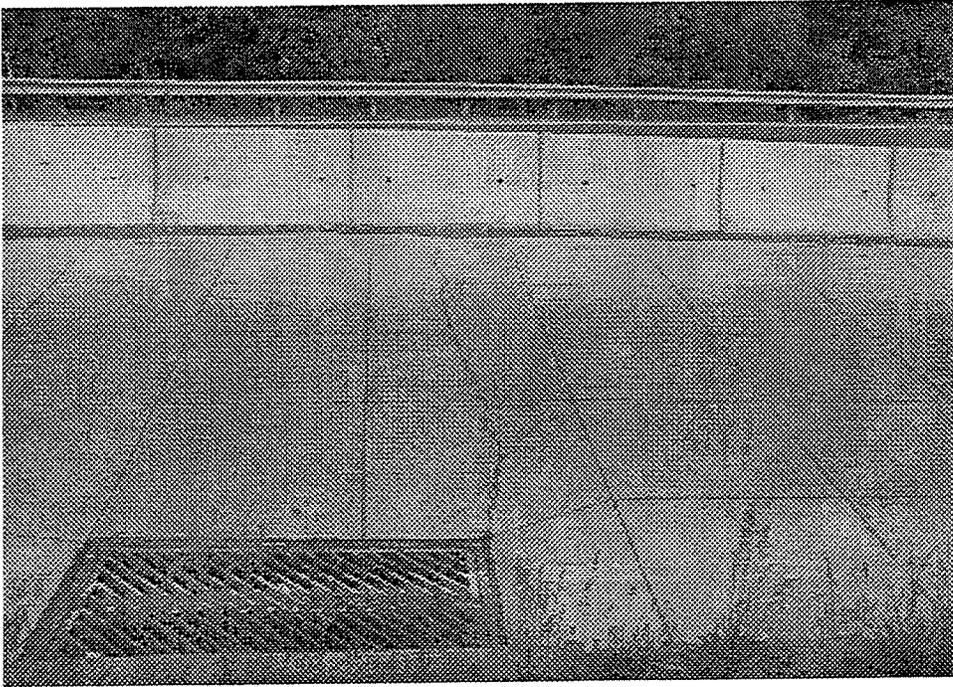
Figure 7. Transverse crack at inlet #2 after two winters.

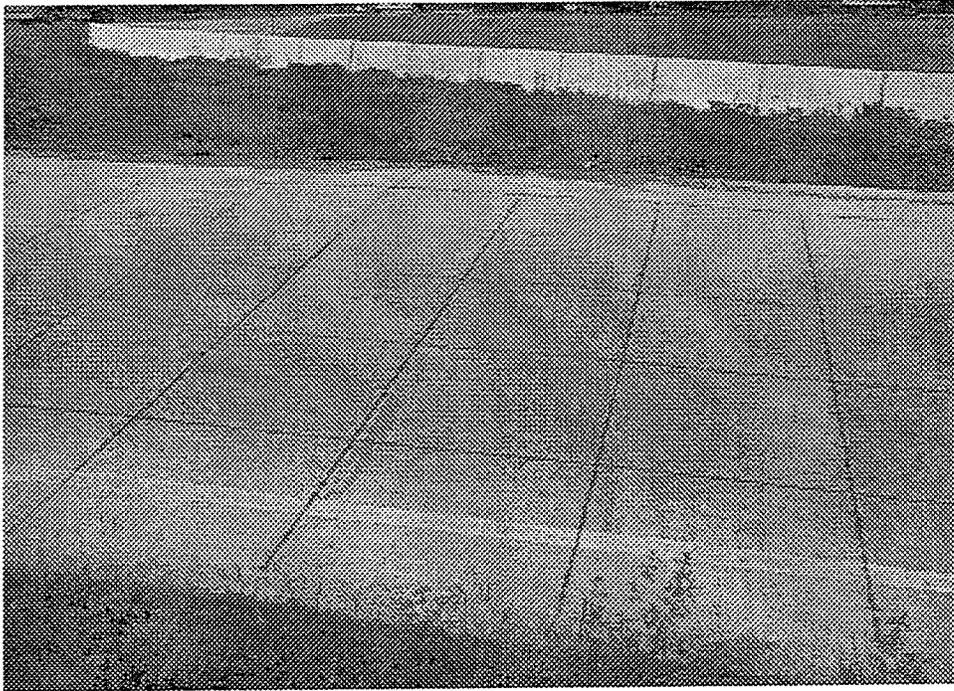
As mentioned, on the initial pour date some joints were sawed while the concrete was too green. These damaged joints showed progressive deterioration by spalling within one month of placement. However, there appears to be no further deterioration to this point in time.

Figure 8. Joints that were sawed while the concrete was too green have not deteriorated significantly since being opened to traffic.

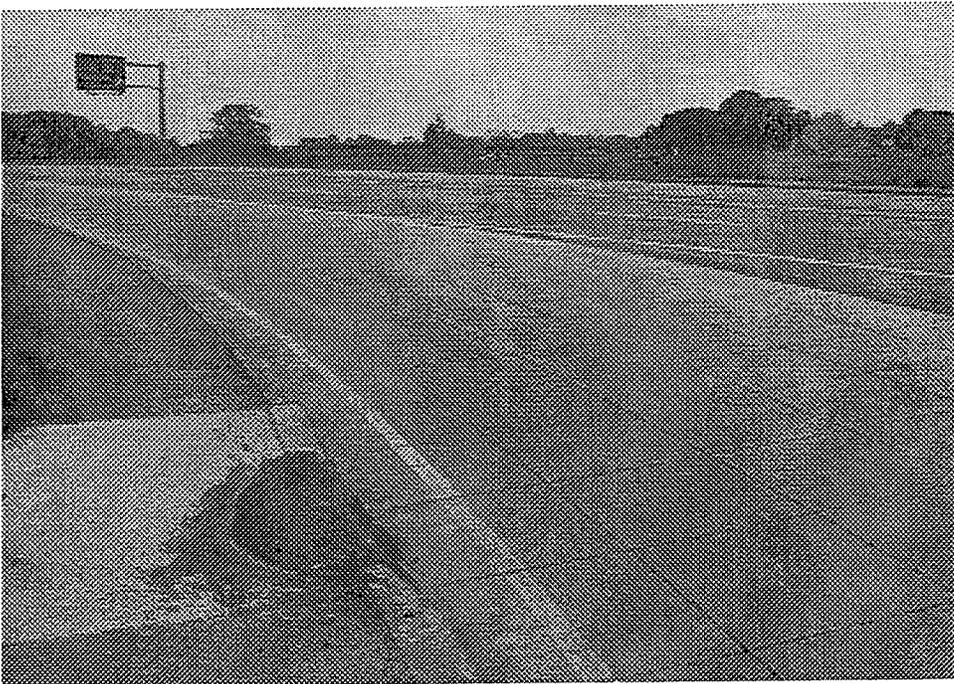
Figure 9. View of transition from bonded overlay to whitetopping overlay showing one cracked panel.
