Report No. CDOT-DTD-R-98-1

I-76 Truck Study

David A. Price
Colorado Department of Transportation
4201 East Arkansas Avenue
Denver, Colorado 80222

Final Report
February 1998

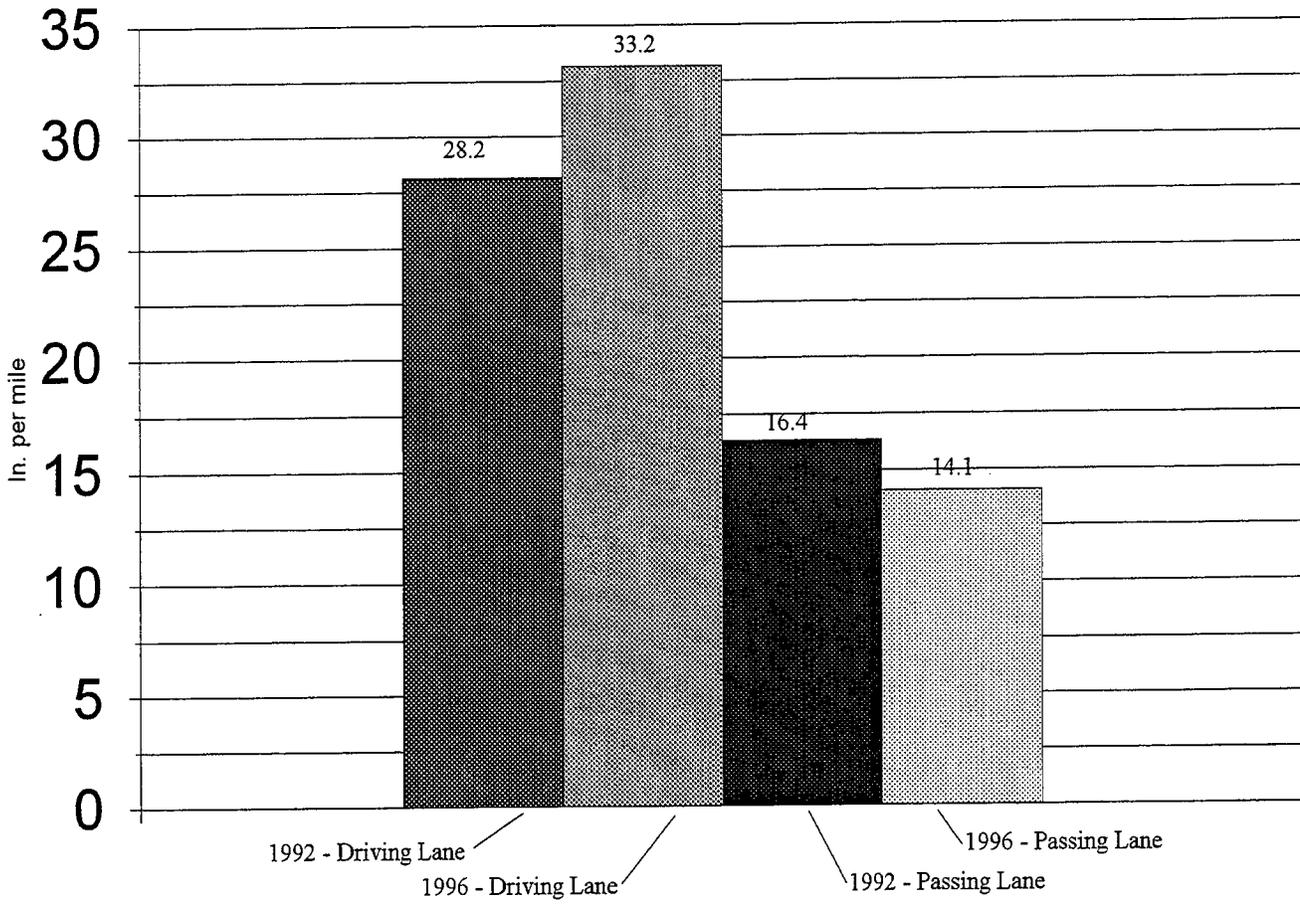
Figure 1

Table 1 shows the testing results for the test and control section over the four-year period. The control section data is shown graphically in figure 1. From this graph it can be seen that the driving lane experienced an increase in roughness of five inches per mile over the four-year period. At the same time it can be seen that the passing lane had a decrease in roughness of 2.3 inches per mile. This was the section of roadway where the truckers were not asked to drive within the passing lane (standard section of roadway). The test section shown in Figure

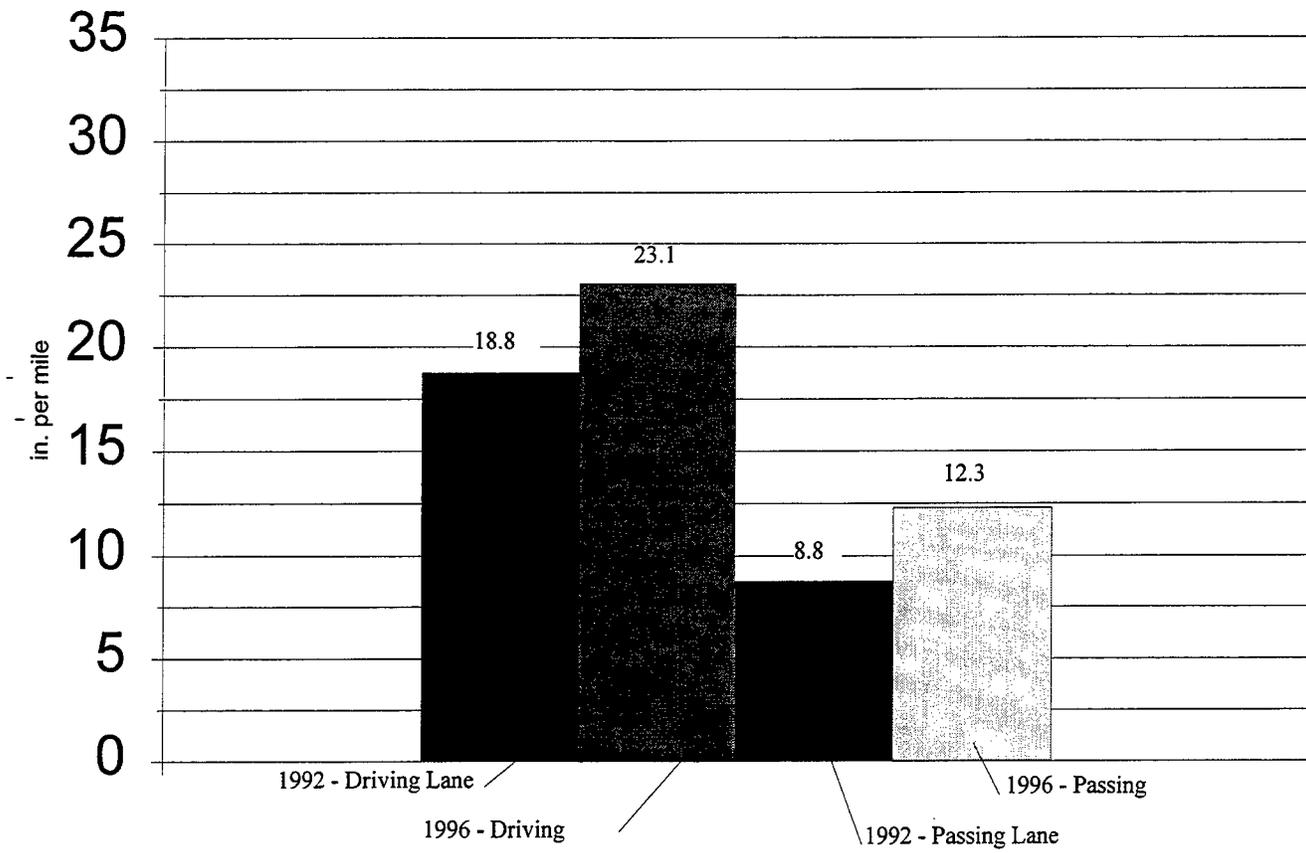
Figure 2

2 demonstrates an increase in roughness in both lanes. Driving lane roughness increased by 4.3 inches per mile and the passing lane also increased in roughness by 3.5 inches per mile. These results show that the driving lane and passing lane in the test section are deteriorating at a much more even rate than the control section. This is possibly due to the heavy trucks being placed into the passing lane and evening out the truck distress between the two lanes.

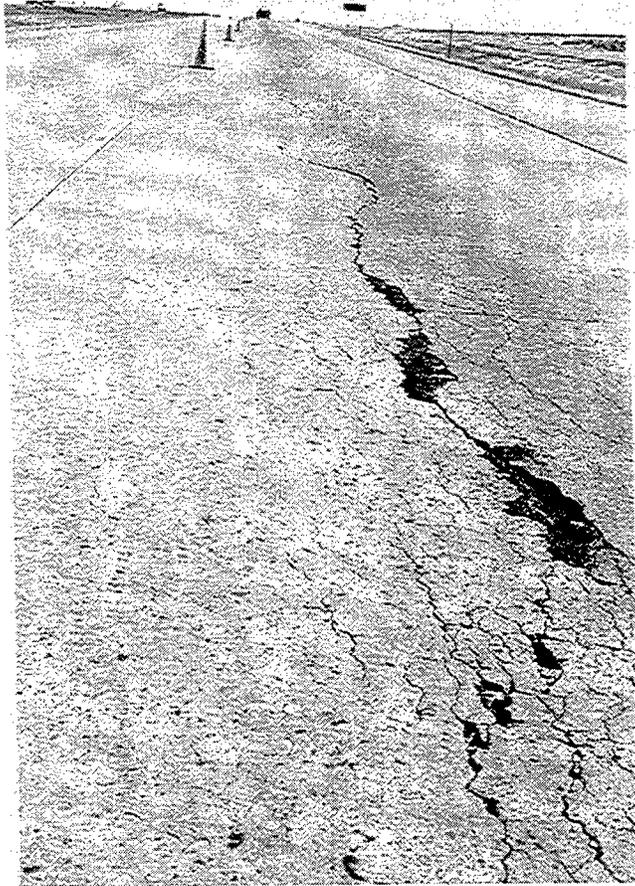
Photo 4 – Control section driving lane with longitudinal cracking and reactive aggregate. Typical in both the control section and the test section.

Using the above criteria the driving lane within both sections showed a medium severity in longitudinal cracking throughout the site. The passing lane in both sections showed little if any longitudinal cracking. Typical longitudinal cracking can be seen in photo 4. These cracks showed minor increases in length and width over the four-year period. Photo 4 also shows reactive aggregate distress with the driving lane being the most severe in crack widths.

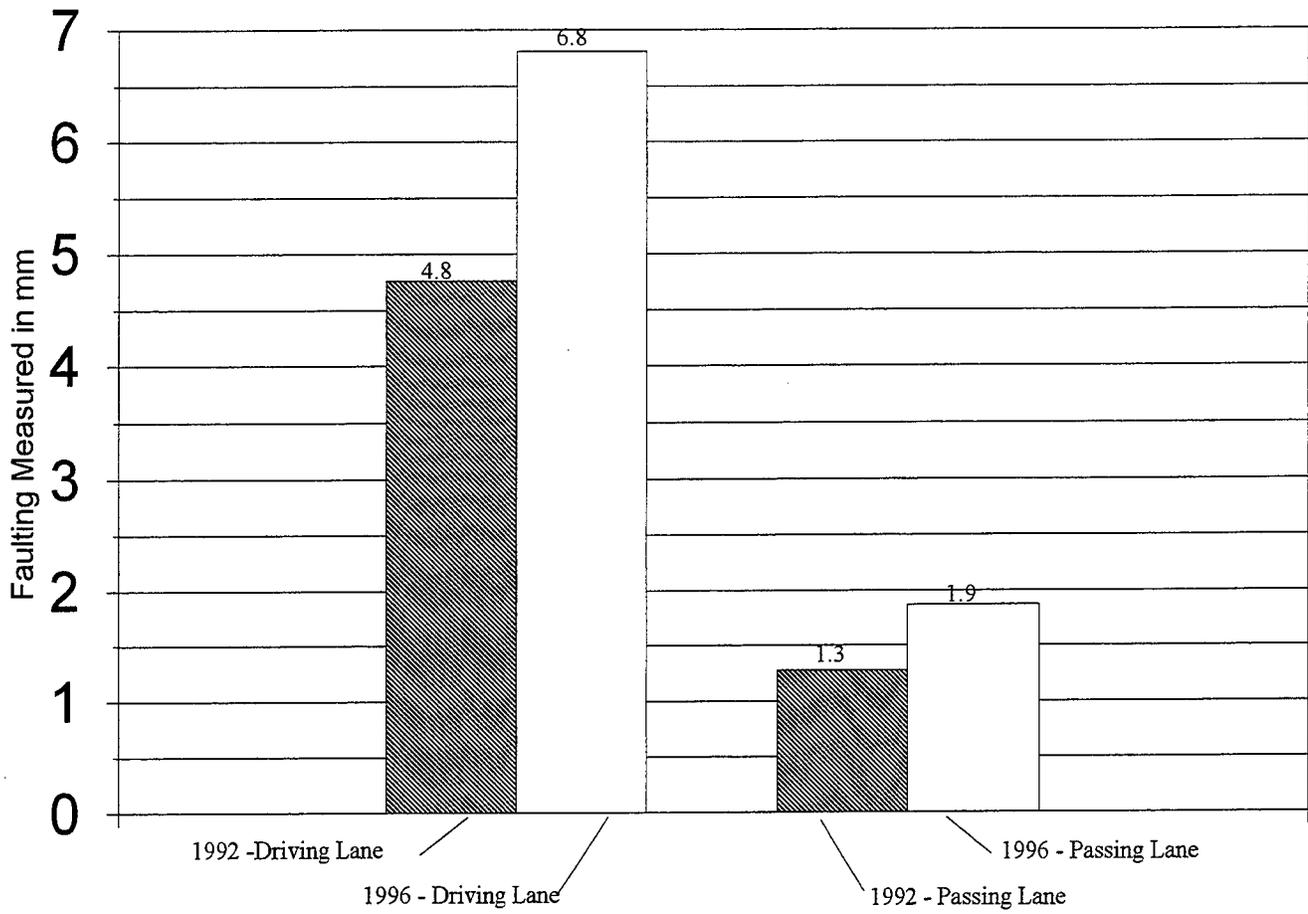
nearest tenth of a millimeter. Photo 3 shows the Georgia fault meter prepared to take a measurement across a joint. Figure 3 shows graphically the fault measurements taken from the test section where there was a small increase in the driving lane as well as a small increase in faulting within the passing lane. The test section shows a small increase in both lanes demonstrating that placing truck traffic in the passing lane may help even out the faulting distress between the two lanes. Using the "Highway Pavement Distress Identification Manual" criteria listed above, the faulting with both the test and control section in 1990 would be placed within a medium severity for faulting. The faulting continued to rise within the test section over the four-year period not showing a reduction compared to the control section.

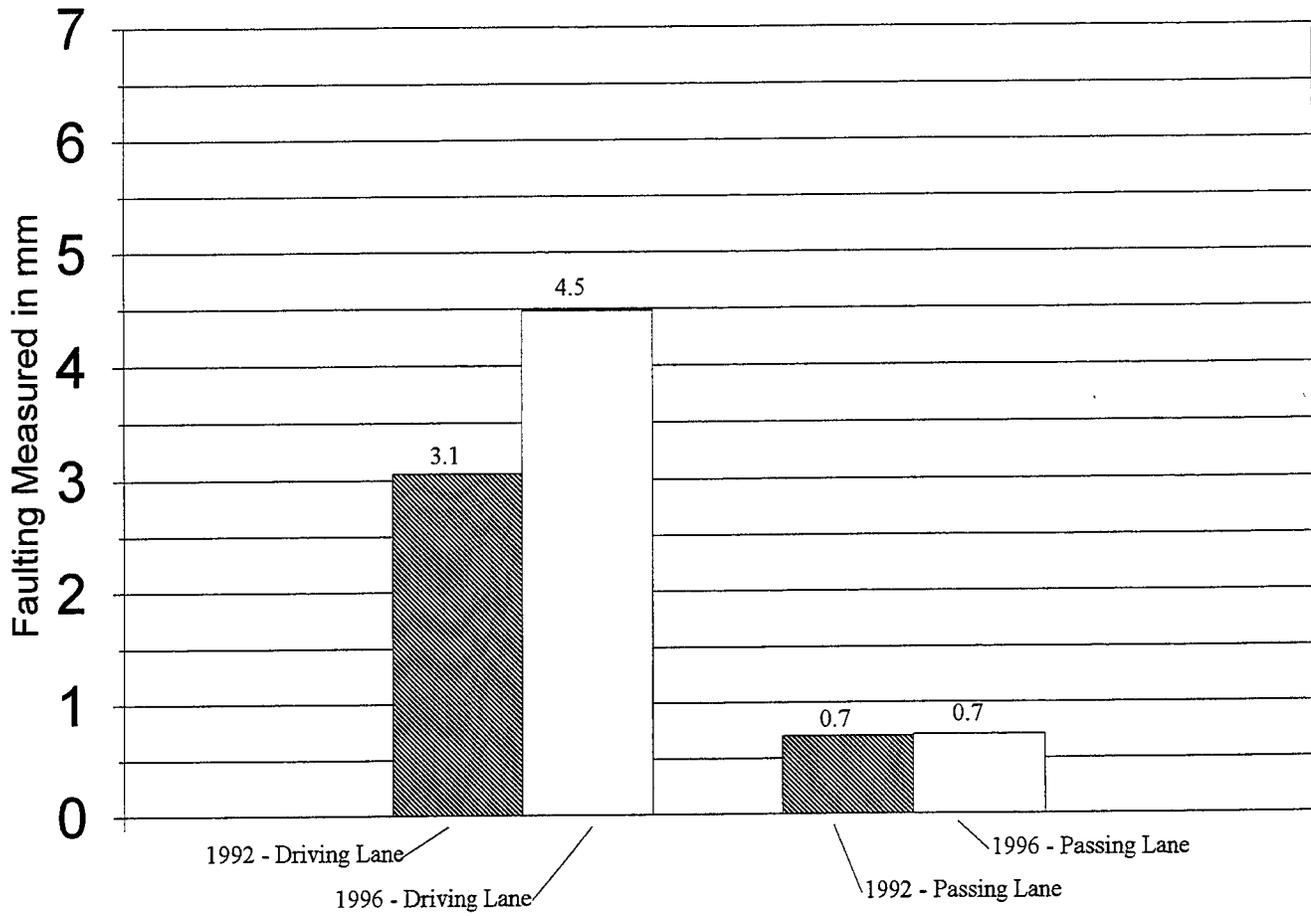
Figure 4 shows the control section (m.p.35 eastbound lanes) faulting in 1992 compared with four years later in 1996. The control section shows an increase in faulting within the driving lane of 46.5%. During the same time period there was no faulting increase within the passing lane. This section (control) did not ask truck drivers to use the passing lane.

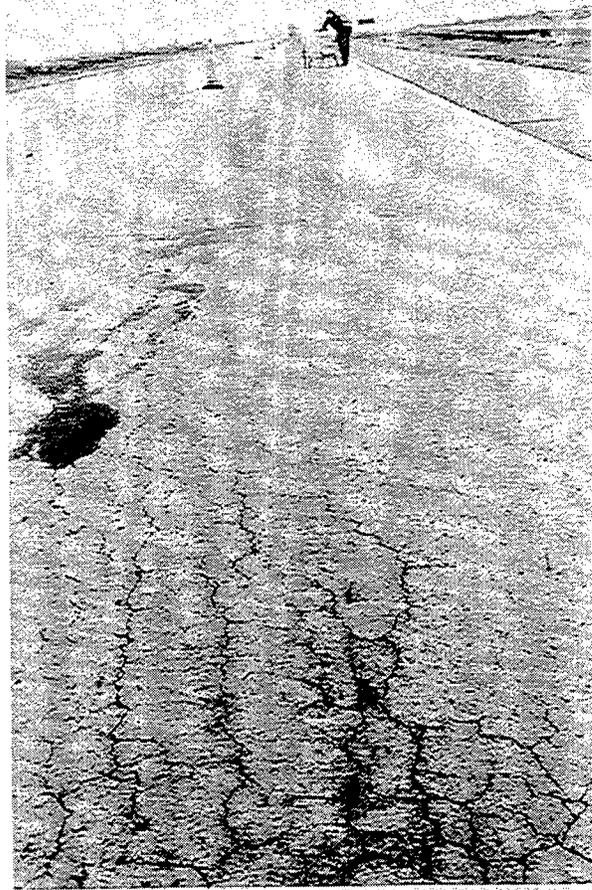
Photo 5 – Reactive aggregate distress can be seen in both lanes however, the driving lane is the most severe.

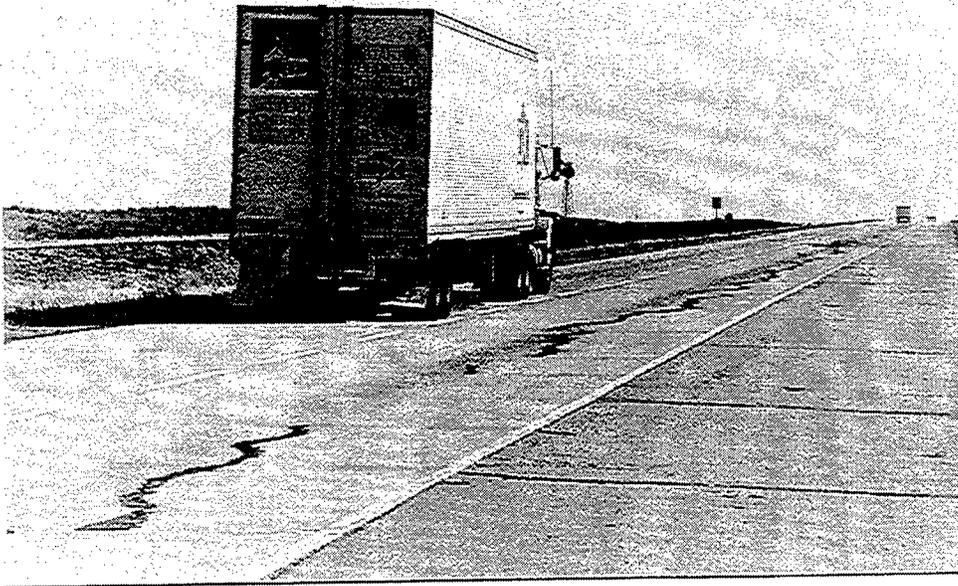
Photo 7 – This photo demonstrates the severity of the longitudinal cracking in the driving lane.

Looking at traffic data and distress data it is recommended that the truck traffic continues to use the inside passing lane as a primary driving lane to help prolong the life of the driving lane until reconstruction of I-76 can be completed.
