CONCEPT DEVELOPMENT OF A BULLNOSE GUARDRAIL SYSTEM FOR MEDIAN APPLICATIONS

MIDWEST ROADSIDE SAFETY FACILITY

MwRSF Research Report No. TRP-03-73-98

May 22, 1998

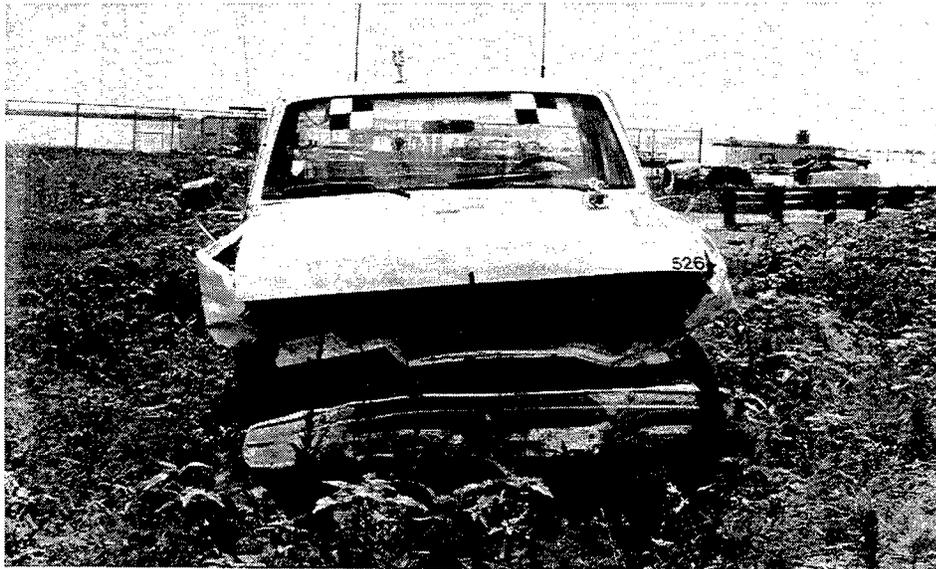
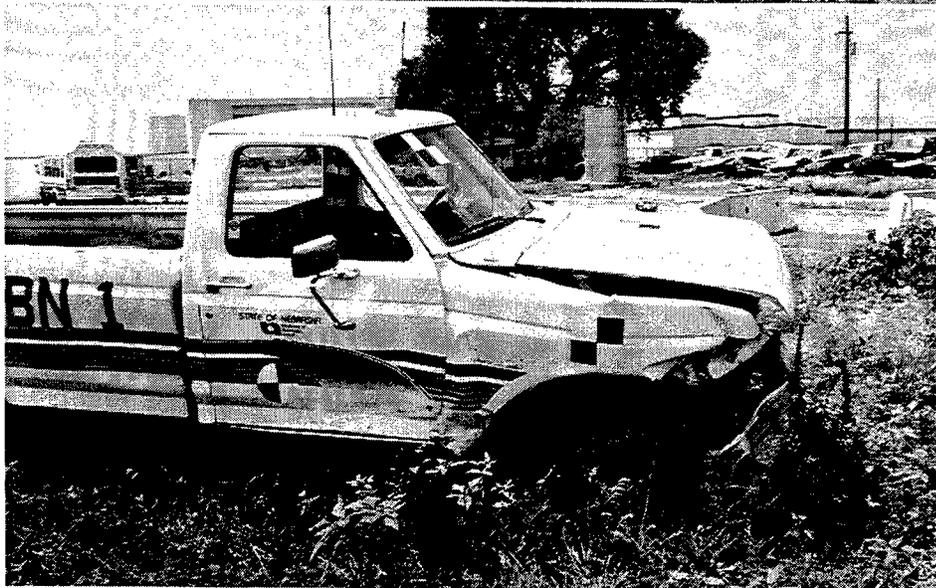
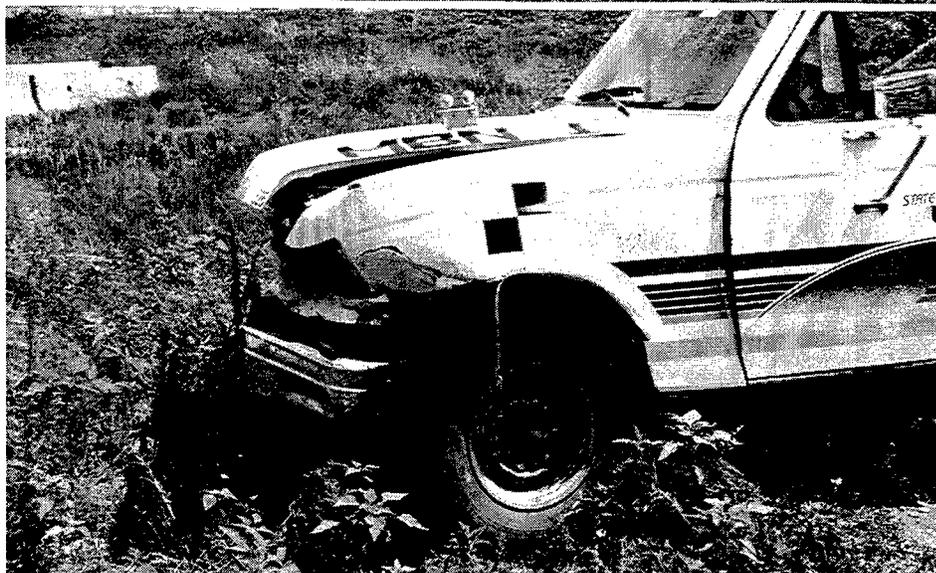
Figure 25. Vehicle Damage, Test MBN-1

Vehicle damage was moderate, as shown in Figure 25. The front bumper and front end of the truck were crushed inward. The right-front fender of the pickup truck was crushed outward due to the barrier impact. The lower section of the right door was slightly crushed inward. The left-front

fender of the truck showed some damage but there was no damage to the left-side door. There was no crushing of the pickup truck's occupant compartment. The front tire on the right side was detached from the rim during impact. Finally, the bolt mounts on the transmission were sheared off.

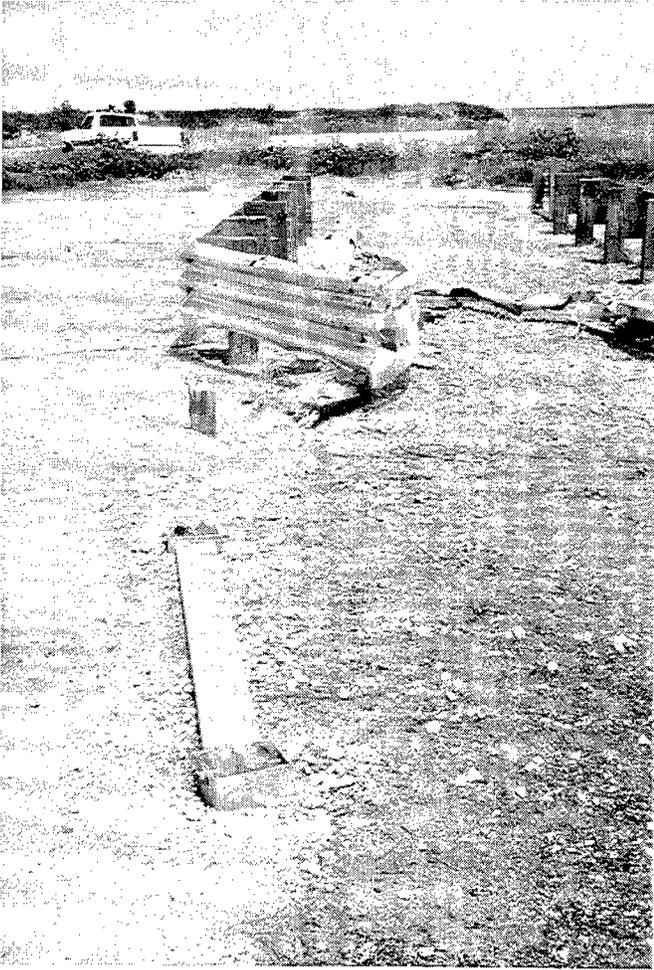
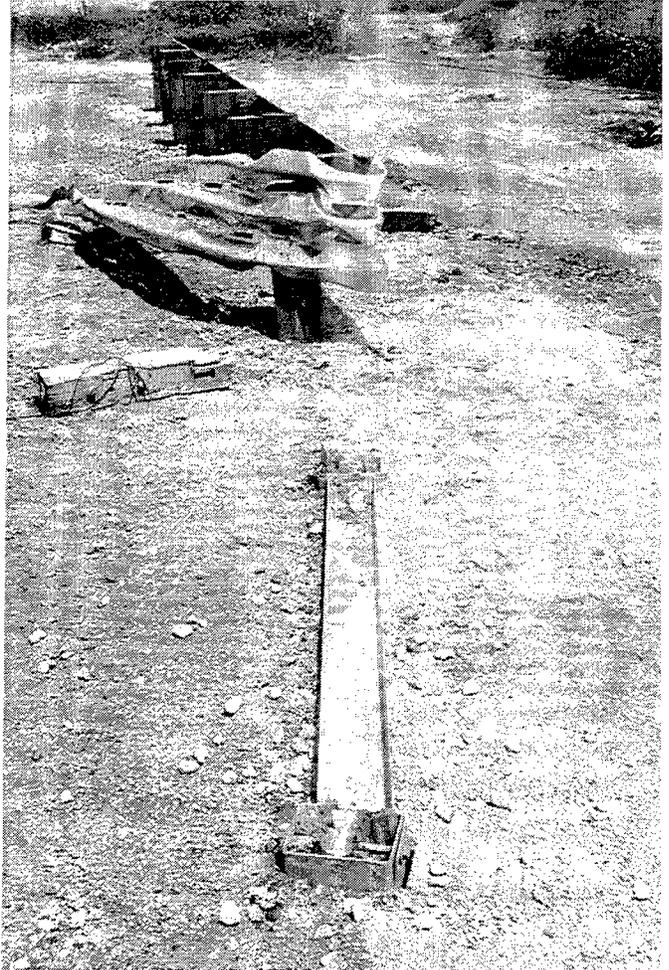
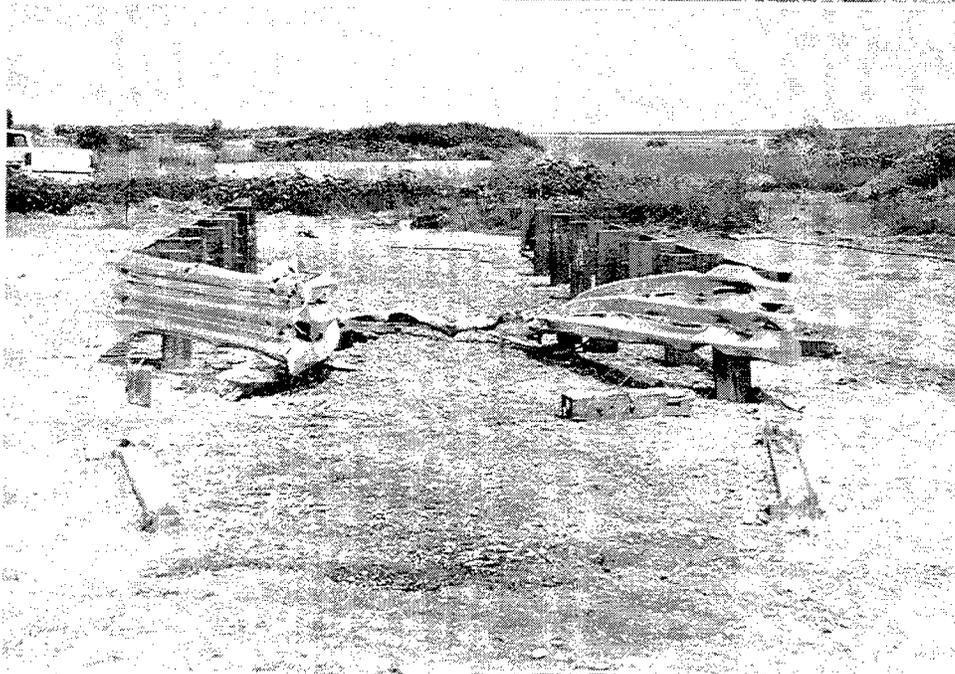
Figure 26. Barrier Damage, Test MBN-1

Barrier damage was extensive, as is shown in Figures 26 through 27. All four of the BCT posts used in the barrier fractured at the hole near the base of the post. Post no. 3 on both sides of the barrier was also broken. Post no. 11 on the left side of the barrier was contacted and broken as the truck exited through the middle of the barrier. The thrie beam buckled and bent at post no. 3 on both sides of the barrier. The thrie beam also buckled at post no. 4 on the left side of the barrier.

The failure of the system to meet all of the safety performance criteria was directly attributed to the fracture of the thrie beam. The causes of the thrie beam fracture were investigated for correction in future designs. The thrie beam fracture occurred when the rail wrapped around post no. 3 on the right side of the barrier. When the post did not fracture, the thrie beam was pulled tight while bending, thus creating large stresses in the thrie beam at high strain rates ultimately causing the thrie beam to fracture. The use of weaker posts at post nos. 3 and 4 would allow the beam to continue to deform without snagging on the posts, preventing the large stresses and ensuing beam failure that occurred in test MBN-1.

the slotted thrie beam rail prevented the pickup truck from overriding the nose section of the system. Therefore, the researchers believed that the system could be significantly improved by weakening the buckling and bending strength of the thrie beam rail after post no. 3 as well as replacing post nos. 3 and 4 with posts that would fracture more easily. Following the failure of test MBN-1, modifications were made to the guardrail system. These modifications to the bullnose guardrail system consisted of changing of post nos. 3 and 4 to breakaway posts and incorporating slots in another section of the thrie beam rail. A schematic of the modified design is shown in Figure 28, and photographs are provided in Figures 29 through 30.

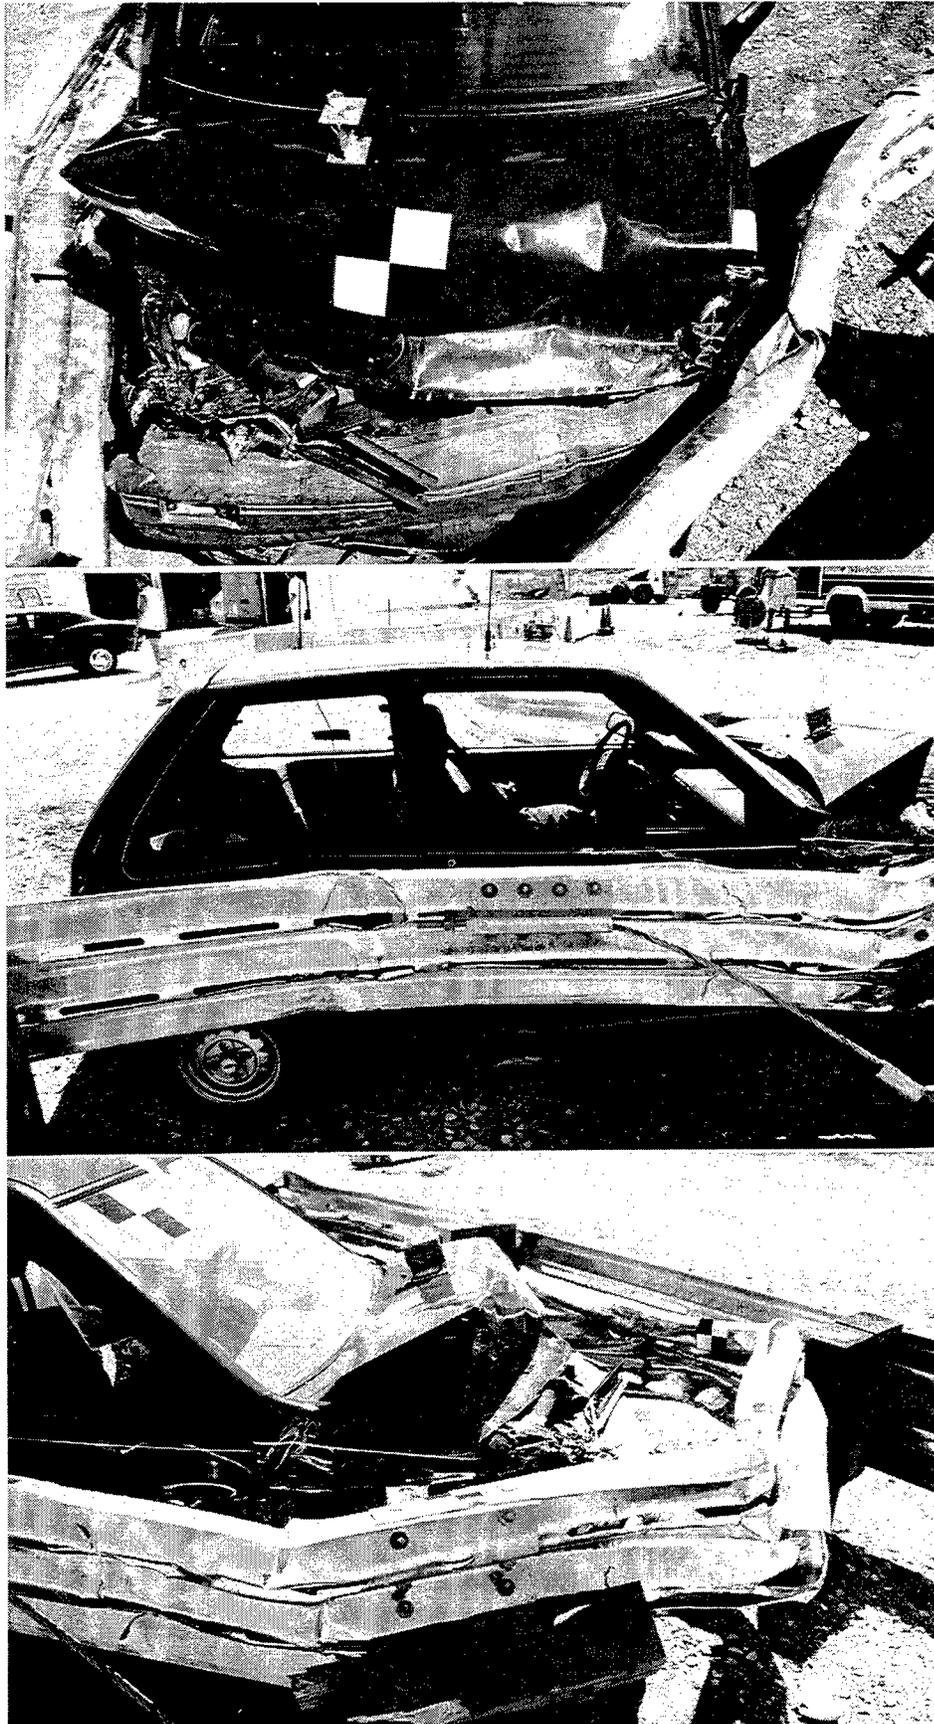
Figure 40. Vehicle Damage, Test MBN-2

Vehicle damage was extensive, as shown in Figure 40. The front end of the small car was crushed, including the bumper, engine compartment, hood, and front quarter panels. The front windshield was also fractured during the impact. The right-side sheet metal behind the door was

deformed inward approximately 12.7 cm due to "knees" forming in the thrie beam rail and impacting the side of the vehicle. The right-side door was damaged along its entire length, and the right-side window glass was shattered. The left-side door was deformed and wedged shut at the front hinge. Only minor floorboard deformation was found in the occupant compartment.

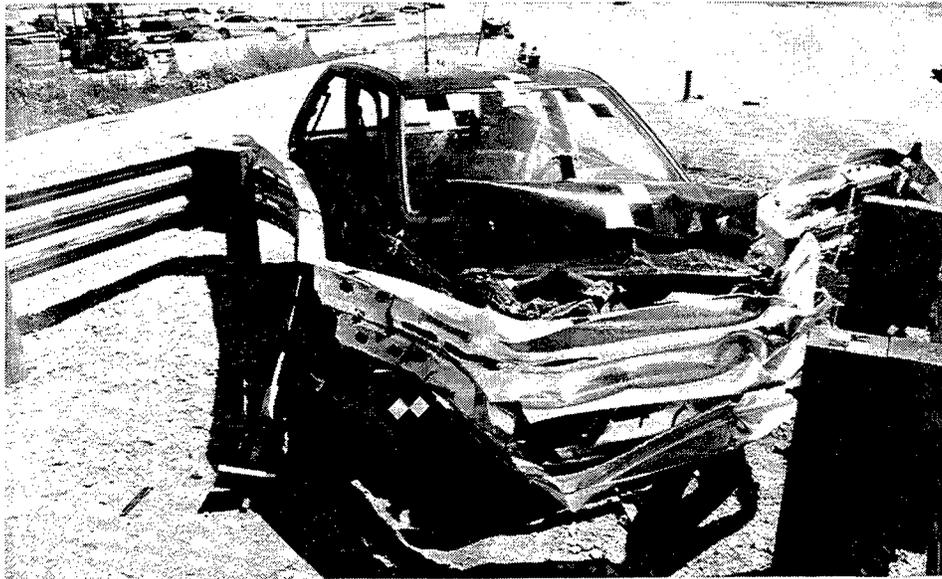
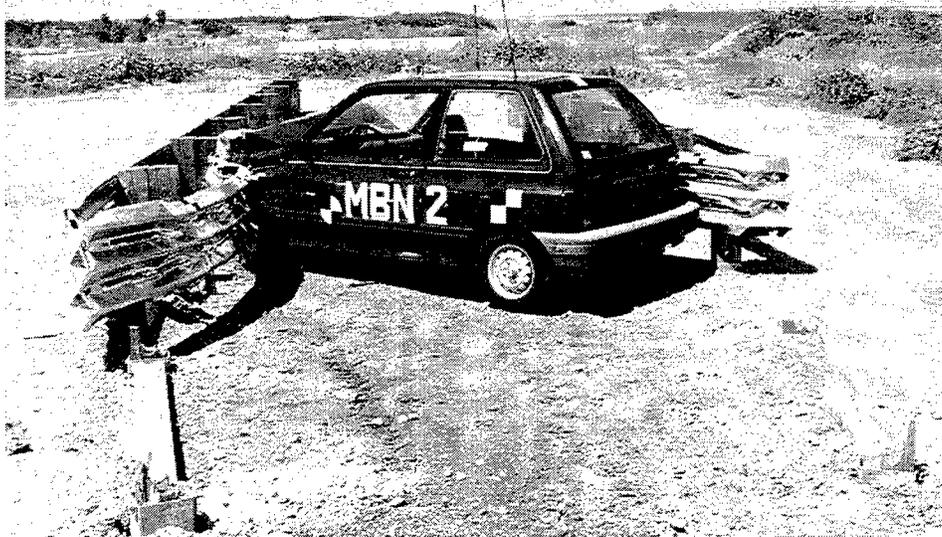
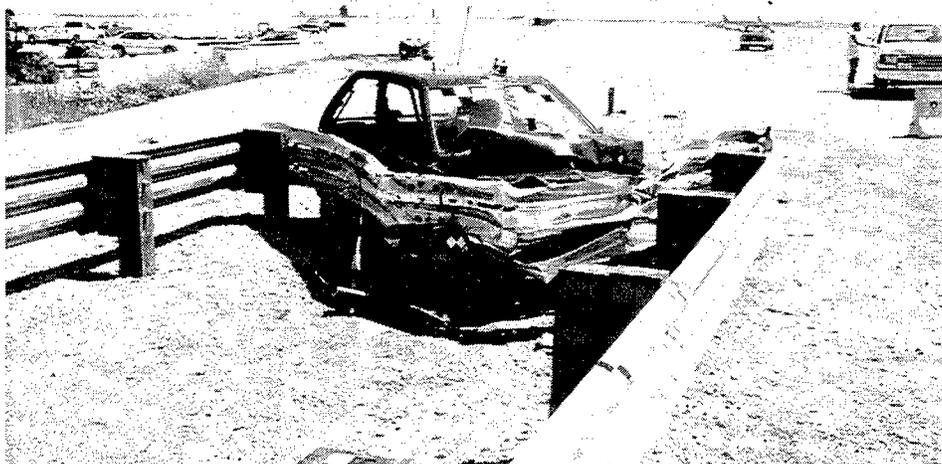
Figure 41. Barrier Damage, Test MBN-2

Barrier damage was extensive, as shown in Figure 41 through Figure 42. Post nos. 1 and 2 on each side of the system were completely fractured. The rail buckled during impact at post no. 2 on the left side of the system and slightly upstream of post no. 3 on the right side of the system. Significant tearing of the thrie beam occurred where the rail wrapped around the front end of the small car. Tearing of the horizontal slots in the thrie beam occurred at several posts and where the rail buckled near the posts nos. 2 and 3. In addition, tearing of the slots occurred at some midspan locations. Deformations to the thrie beam occurred to the nose piece as well as rail section no. 2 on both sides of the system. The deformed shape and deflection of the barrier is shown in Figure 43. The maximum permanent rail deflection was 7.11 m.
