Report No. CDOT-DTD-R-98-5

Evaluation of the Iowa Vacuum Tester

William (Skip) Outcalt
Colorado Department of Transportation
4201 East Arkansas Avenue
Denver, Colorado 80222

Final Report
April, 1998

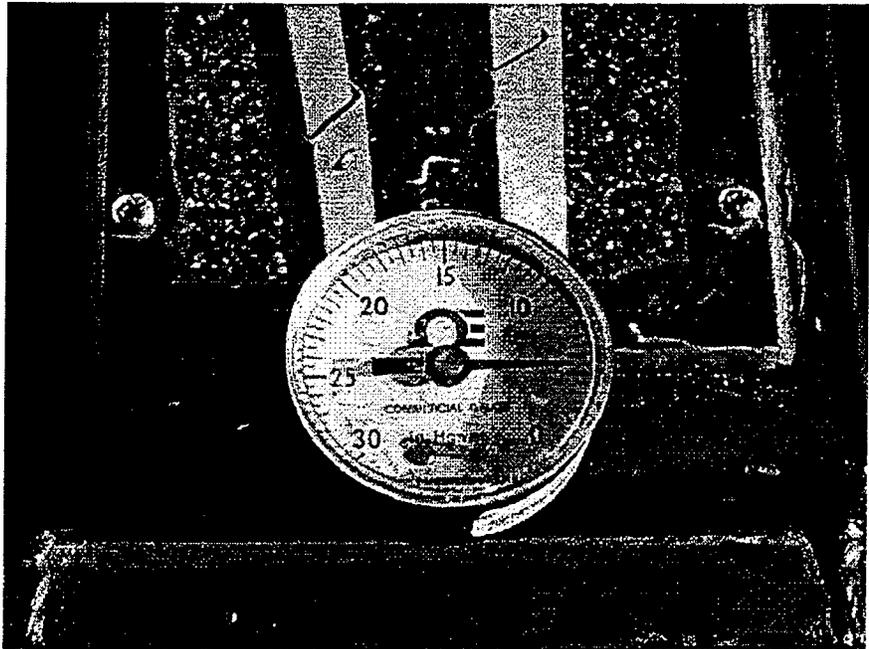
NOTE: The vacuum gauge on the test chamber used for this study reads 5 in. Hg with no vacuum applied to the chamber (Figure 7). It is important to be sure that the change from static position on the chamber gauge does not exceed 125 mm Hg during testing. Higher vacuum can damage the chamber seal by causing it to roll and tear away from the base of the chamber.

Figure 7 The vacuum gage on the test chamber reads 5 in. Hg when the system is disconnected. If possible, it should be re-calibrated. If it is used in this condition the vacuum level in the chamber must be read as the change in the gage reading when vacuum is applied.
