# Relationship Between Timber Bridge Characteristics and Asphalt Pavement Wear Surface Performance

## **Summary Report**

Wood & Paper Science Department  
University of Minnesota

**June 1997**

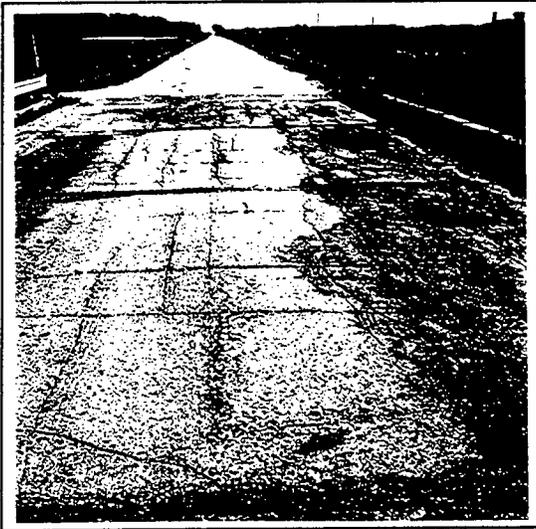
**Figure 4 - Longitudinal and Transverse Pavement Cracking on a Field Laminated LNL Deck**

Both asphalt cracking and fatigue can occur as a result of differential lamination movement and loss of transverse load transfer capability. For example, severe longitudinal pavement cracking can be seen in the pavement overlay covering a Minnesota LNL bridge due to both of these factors (Figure 4).

Transverse pavement cracks over the pier-caps and abutment-caps are about the most common form of pavement cracking observed in timber bridge wear surfaces (Figure 4). Both bridge deflection and differential movement between laminations over the abutment caps and pier caps will focus stress in the asphalt overlay producing a well defined transverse pavement crack.

A simple maintenance procedure, developed in Sibley County for restoring transverse load transfer in LNL bridges, has effectively demonstrated the reduction in cracking parallel to deck laminations. The procedure involves two simple steps:

- 1) Tightening of all bolts connecting the TSB to the bridge deck, and adding lock nuts.
- 2) Hammering wood shims into the remaining gaps between deck laminations and the TSB (Figure 6). The shims should be made from a species at least as dense

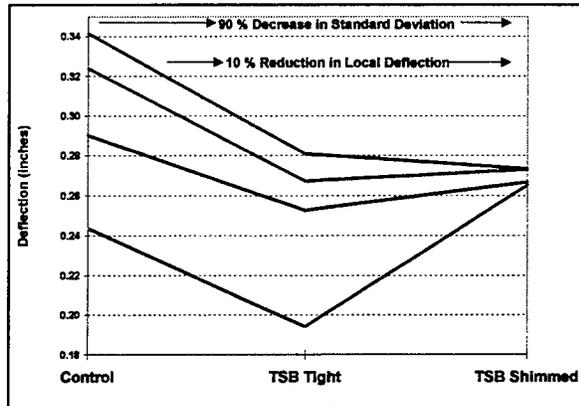
Figure 7 - Decrease of Inter-Lamination Deflection After Tightening and Shimming the TSB

This procedure was recently implemented and analyzed on several LNL timber bridges in Freeborn County. The experiment involved recording inter-lamination deflection on four consecutive lamination before and after tightening and shimming the TSB. The standard deviation of inter-lamination deflection decreased by 90%, and the mean local deflection was reduced by 10% (Figure 7). These results help to explain the improved performance of asphalt wear surfaces on timber bridges in Sibley County where all LNL bridges have had TSBs tightened and shimmed.
