**DESERT VARNISH
ROCKY POINT VIADUCT**

FINAL REPORT

Experimental Features #94-02B

Oregon Department of Transportation

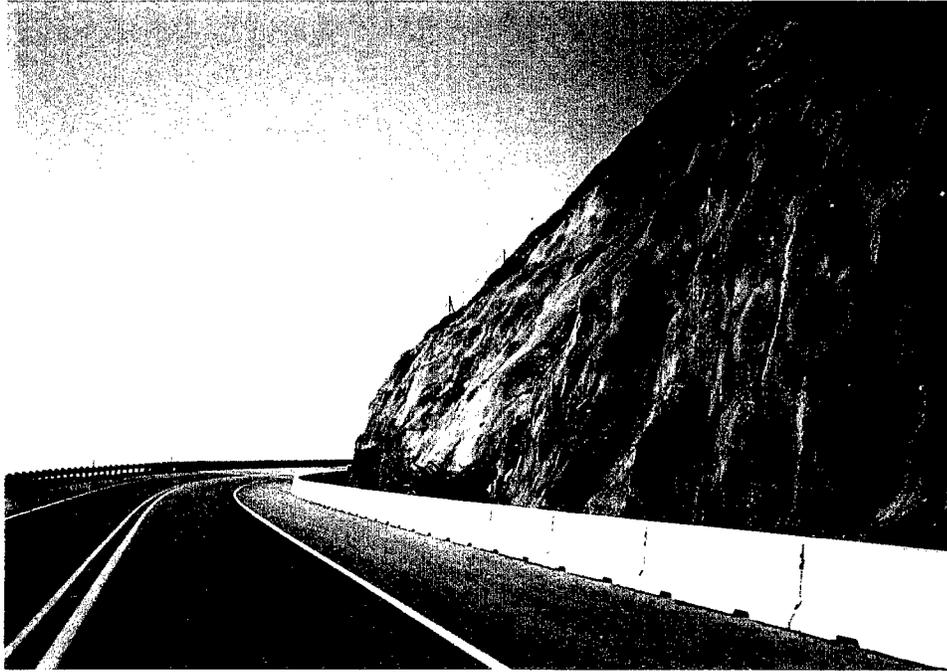
Figure 2.2: Motorist View of the Desert Varnish Cliff.

The project is located on US 101 at milepost 304, just south of Port Orford on the Oregon coast. Figure 2.1 is the location map and Figure 2.2 shows the high visibility of this project to the motoring public.

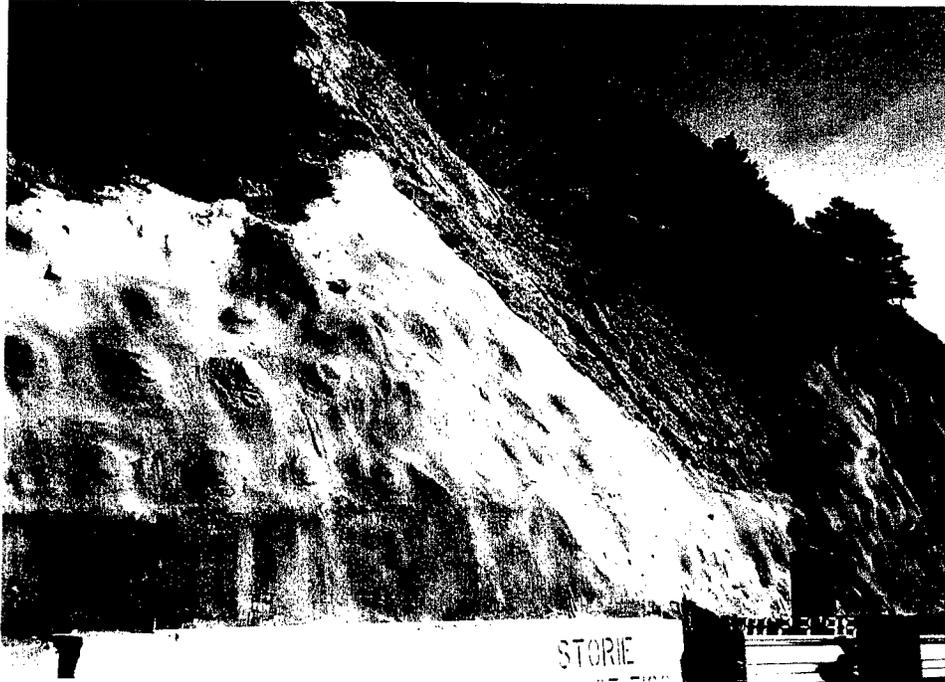
Figure 3.1: Before Desert Varnish Treatment.

One month after the desert varnish was applied, a post construction inspection revealed that the varnish was performing well. There was a dramatic difference in the appearance of the shotcrete stabilization on the rock slope before and after the application of desert varnish as shown in Figures 3.1 and 3.2. From a distance, it was difficult to tell that the desert varnished slope was covered in shotcrete.

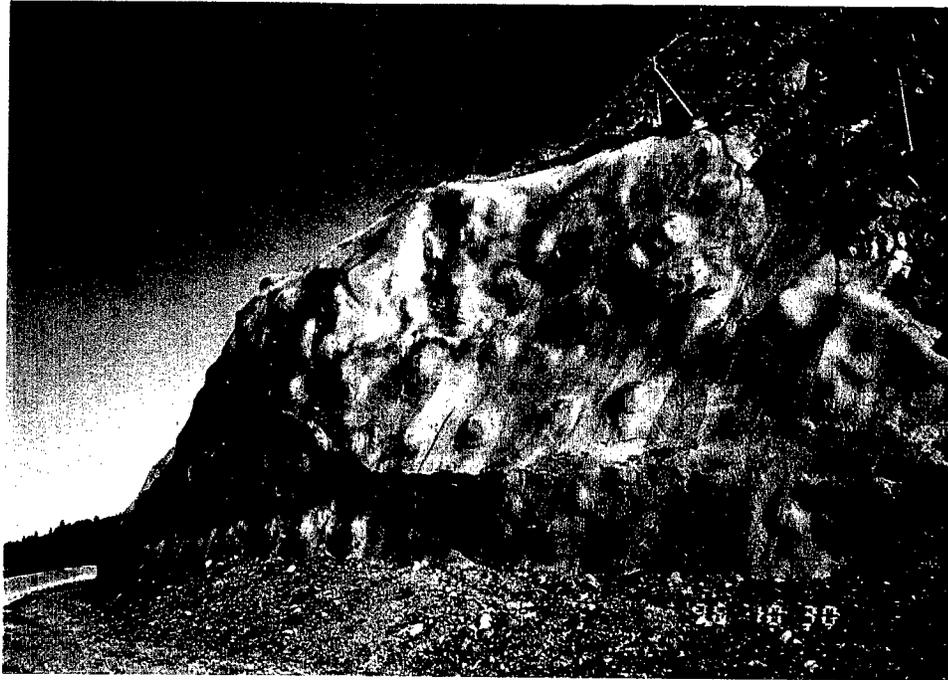
Figure 3.3: One Year after Treatment.

One year after application, October 30, 1996, the dark brown shade of the desert varnish remained on most of the shotcrete. However, minor flaws began to appear. White streaks (caused from water run-off from the hill above) were seen in a few sections. Also, some of the shotcrete was flaking off in two small areas. About thirty percent of the varnished area had been covered by a rock-fall cable system, masking the cliff's natural appearance (See Figure 3.3).

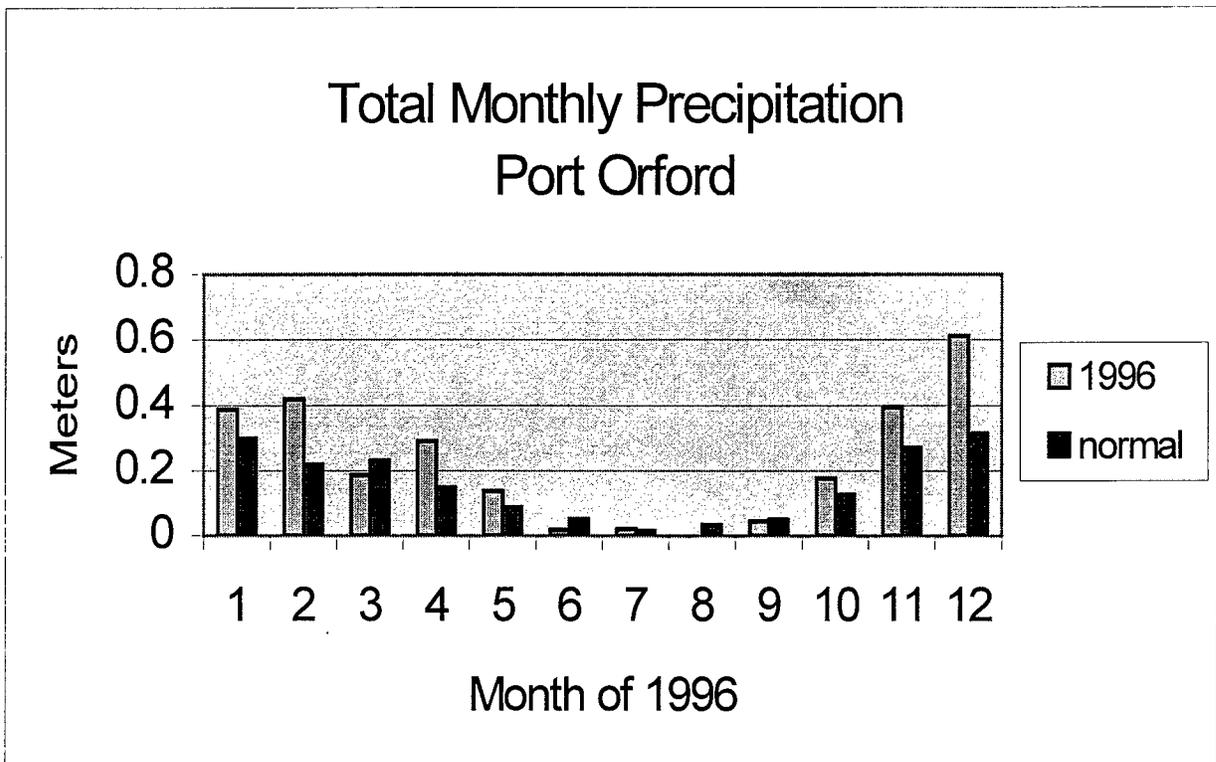
Figure 3.4: 1996 Rainfall in the Port Orford Area.

In 1996, the Port Orford area had a record amount of rainfall of 2.69 m. The mean annual rainfall for this area is about 1.85 m. As indicated on the graph in Figure 3.4, January and February of 1996 had above normal rainfall, as did November to December 1996 and January of 1997. It was some time during this period that the shotcrete slabs broke at the base. Other slide problems occurred in this section of 101 during this record rainfall winter. The resulting cut slope after repair is shown in Figure 3.5. Note the resemblance of the brown slope to the colored shotcrete.

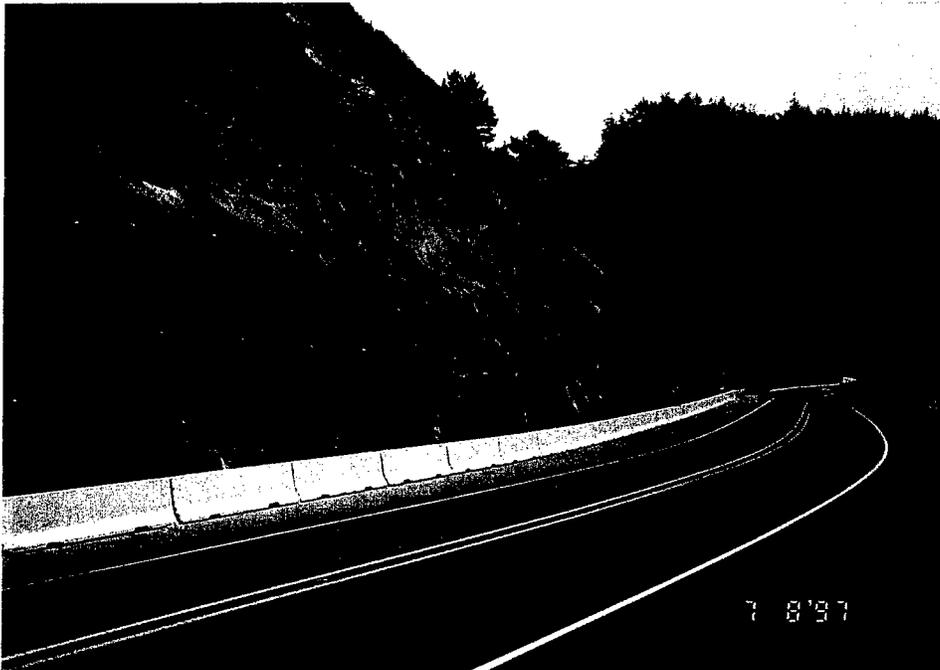
Figure 3.6: Twenty Months after Treatment.

The section was inspected again on July 8, 1997, 20 months after application. The shotcrete in a section about 30 m long, near the south end of the test area, had been damaged. Three rectangular blocks about 1.6 m high and 1.6 to 4 m wide had separated from the main body of the shotcrete. (See Figure 3.6). These blocks were near the bottom of the shotcrete and appeared to have broken at a point where the slope changed to a vertical drop. Not only were they loose from the main section, but were also separated by 0.6 m and tilted slightly toward the roadway. A pine tree about 8 m long and 250 mm at the base, had slid down from the top of the cliff. It was just few meters to the north of the damaged area.

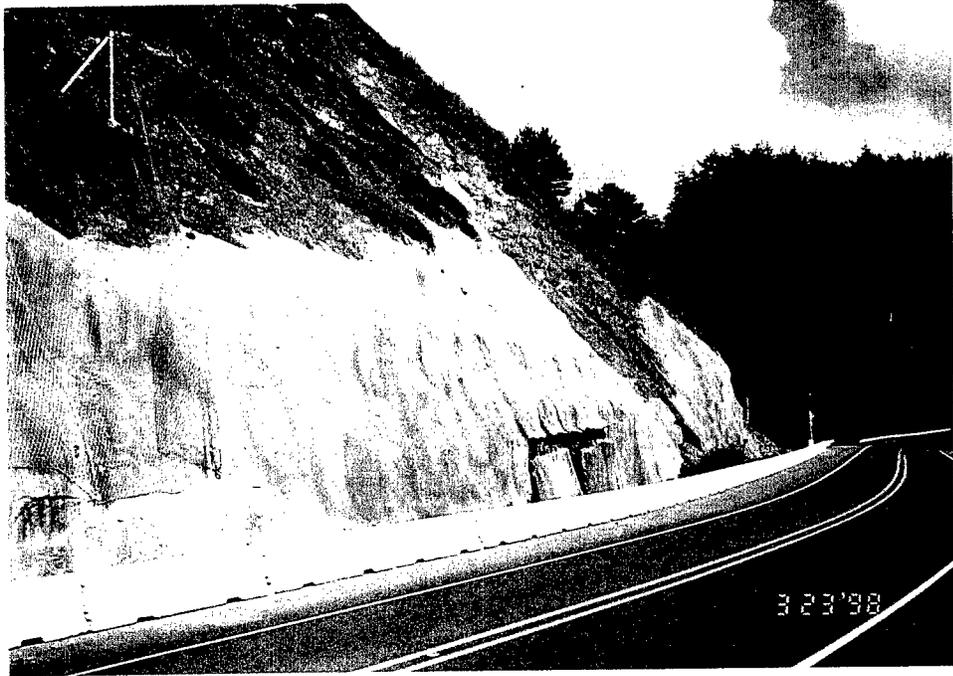
Figure 3.7: Two Years after Construction.

On March 23, 1998 another inspection found that overall, the shotcrete had a natural weathered appearance. Water stains and mud from the cliff above the shotcrete had caused white and brown streaking which would occur on a natural cliff. The sun and wind had also caused the dark brown desert varnish to fade. Erosion also caused the mounds at the tie-rod holes to round out and look more natural (see Figure 3.7).

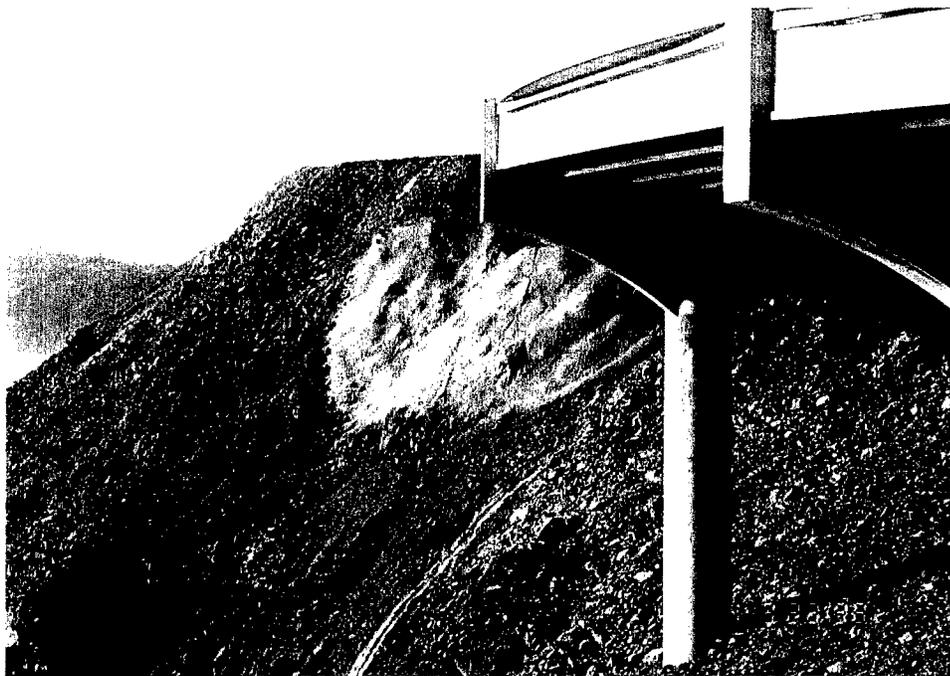
Figure 3.8: Untreated Control Section at North End of the Bridge in 1998.

Pictures of the untreated control section were taken. It still had a solid gray concrete fabricated appearance (see Figure 3.8). Comparing the one-month-after photo to the 1998 photograph, note that the shotcrete has faded a great deal. The treated section, however, is still more natural looking than the 1998 photograph of the control section.

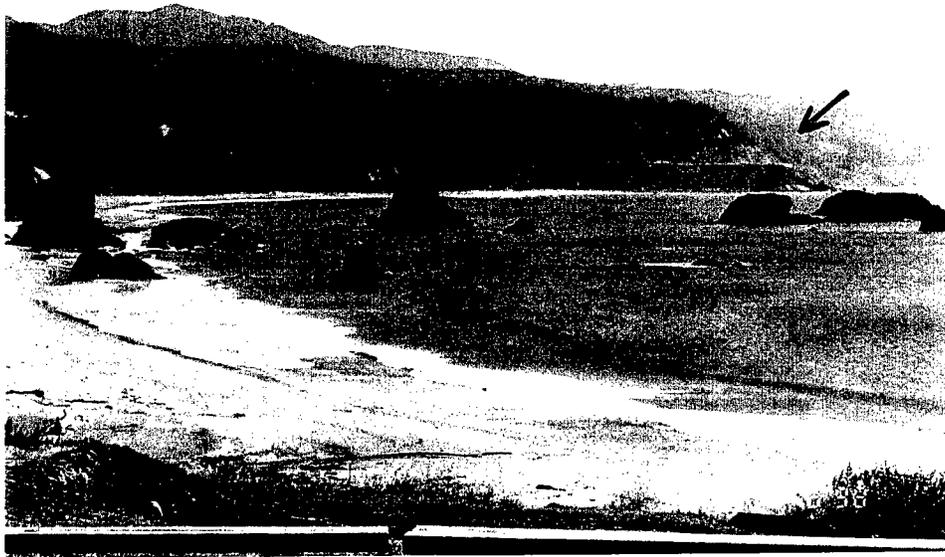
Figure 3.9: Rocky Point from Port Orford.

A final inspection of the desert varnish at Rocky Point was made on October 15, 1998. From the wayfinding point at Port Orford, the shotcrete completely blends into the natural view (see Figure 3.9) As a comparison, you can see the wall and viaduct quite clearly. The north end of the shotcrete, when viewed at close range, shows a variation in the appearance of the desert varnish application. One side looks washed out, while the other remains very dark. The application of the desert varnish on the south end seems more evenly mottled.

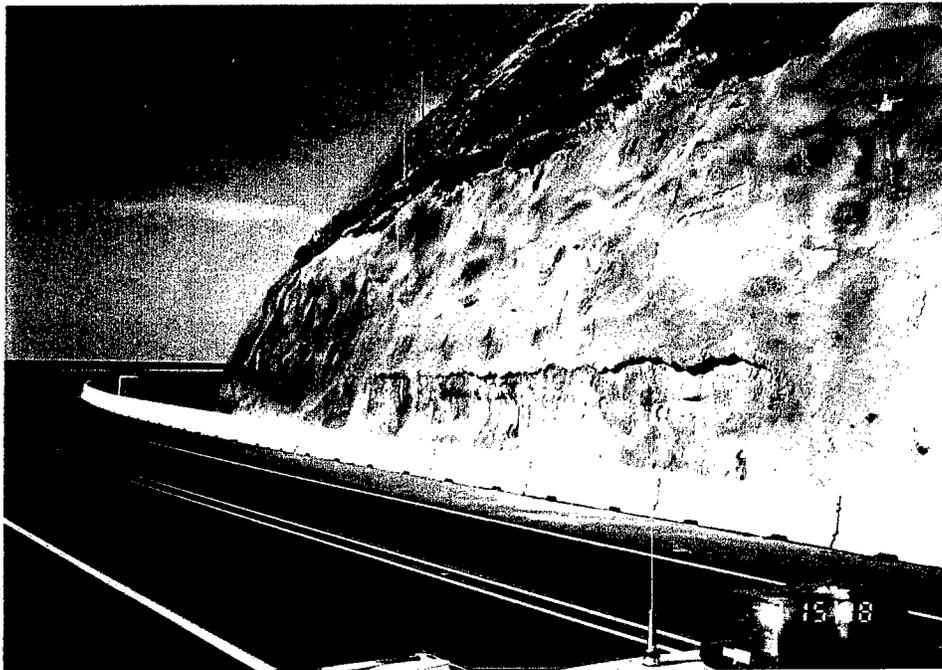
Figure 3.10: Three Years: Includes Repaired Area without Desert Varnish.

The south end of the shotcrete includes a section which is not treated with desert varnish. O.D.O.T.'s Maintenance District 7 repaired an area of broken and cracked shotcrete in May 1998. The shotcrete was not re-sprayed with desert varnish. Note the color contrast in Figure 3.10. The area without the desert varnish is quite distinctly gray and a lip left on the slope is very noticeable.
