TESTING OF FULL SCALE PRESTRESSED BEAMS TO EVALUATE SHEAR KEY PERFORMANCE

Report # FHWA/OH - 98/019
State Job # 14578(0)

by R.A. Miller, G.M. Hlavacs, and T.W. Long

December, 1998

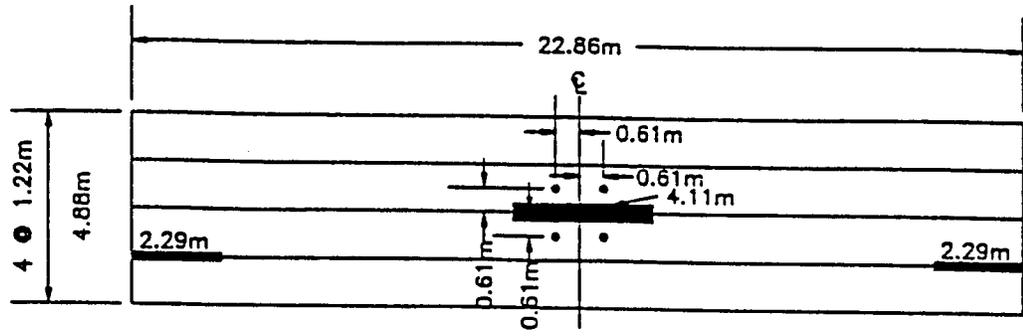
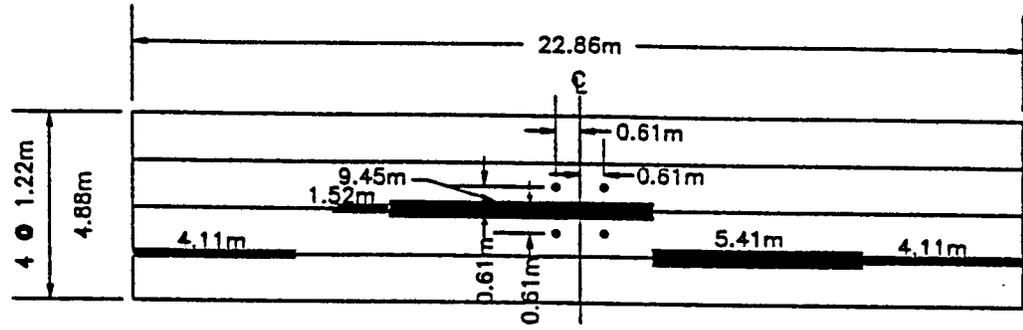
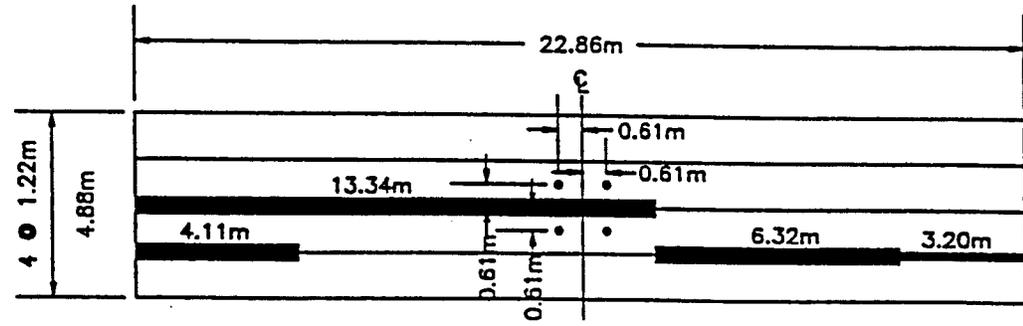
Figure 5.3 Crack propagation for Test #1.

In the first test, the shear keys were grouted in late autumn and cracked soon after casting, before any simulated vehicle loading had been applied. Data from instruments embedded in the beams and shear keys showed large changes in strain due to freezing temperatures. The beams were subjected to 41,000 cycles of loading simulating an HS20-44 truck wheel. No new cracking occurred due to loading, but cracks caused by temperature propagated.

- SEVERE CRACKING - CRACKED COMPLETELY THROUGH AS INDICATED BY PULSE VELOCITY
- MODERATE CRACKING - PARTIALLY CRACKED AS INDICATED BY PULSE VELOCITY
- NO CRACK OR SUPERFICIAL CRACKING
- LOAD POINT

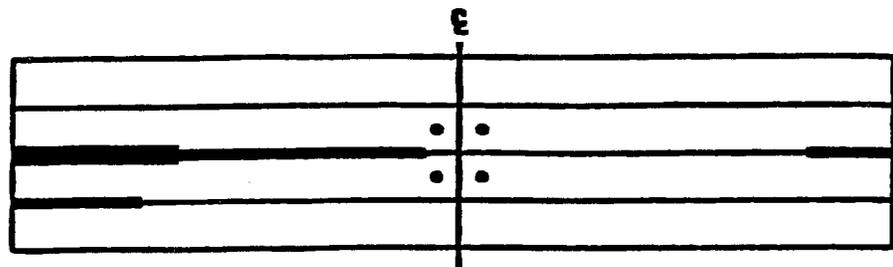
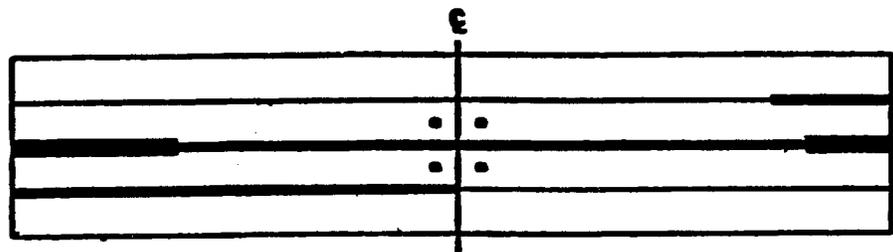
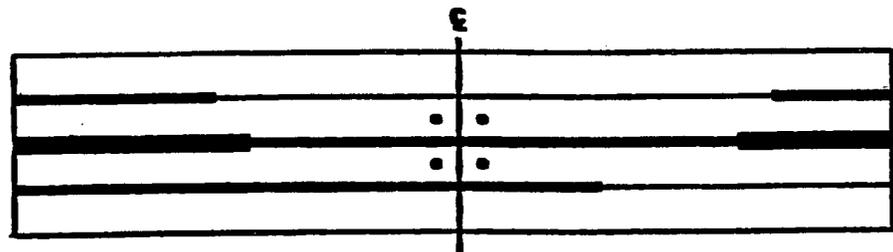
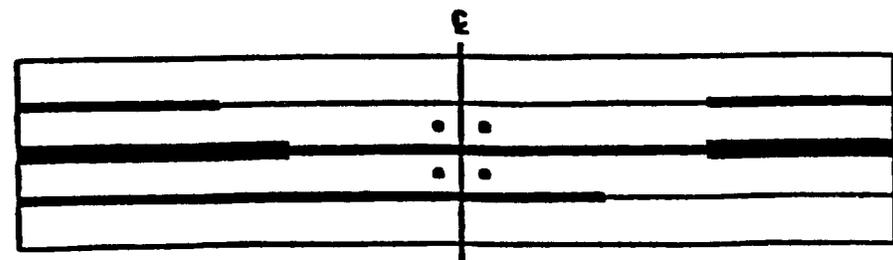
Figure 5.4 Crack propagation for test #2.

In the second test, the keys were grouted in the summer. However, temperature changes caused by the sun heating the top of the girders again caused large thermal strains, which cracked the shear keys at the abutments. Measurements of beam and shear key deformations and strains under temperature induced loading showed that temperature changes cause large transverse strains in the keyways. These strains are of sufficient magnitude to crack the grout. The keyways were subjected to 1,000,000 cycles of load. As before, the load did not cause new cracks but the existing cracks propagated.

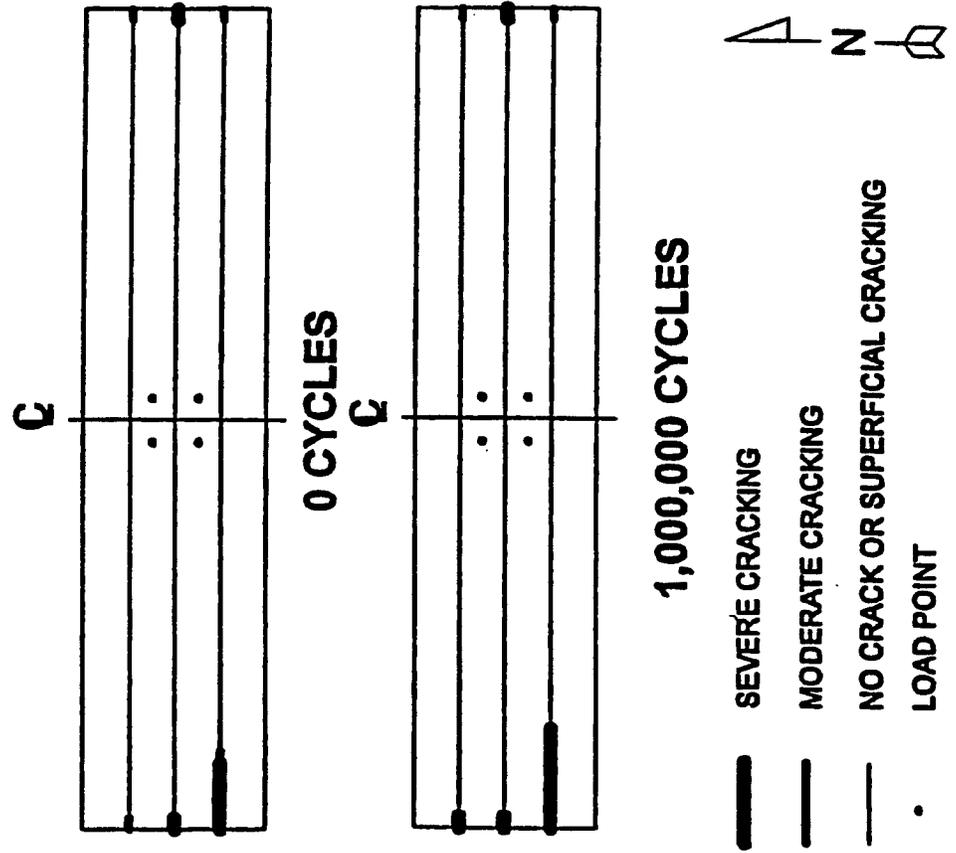
Figure 5.5 Crack propagation for test #3.

In the third test, keyways located at the neutral axis were grouted in late summer. Thermal stresses caused minimal cracking at the abutments. These keys were subjected to 1,000,000 cycles of load only minimal propagation was observed.

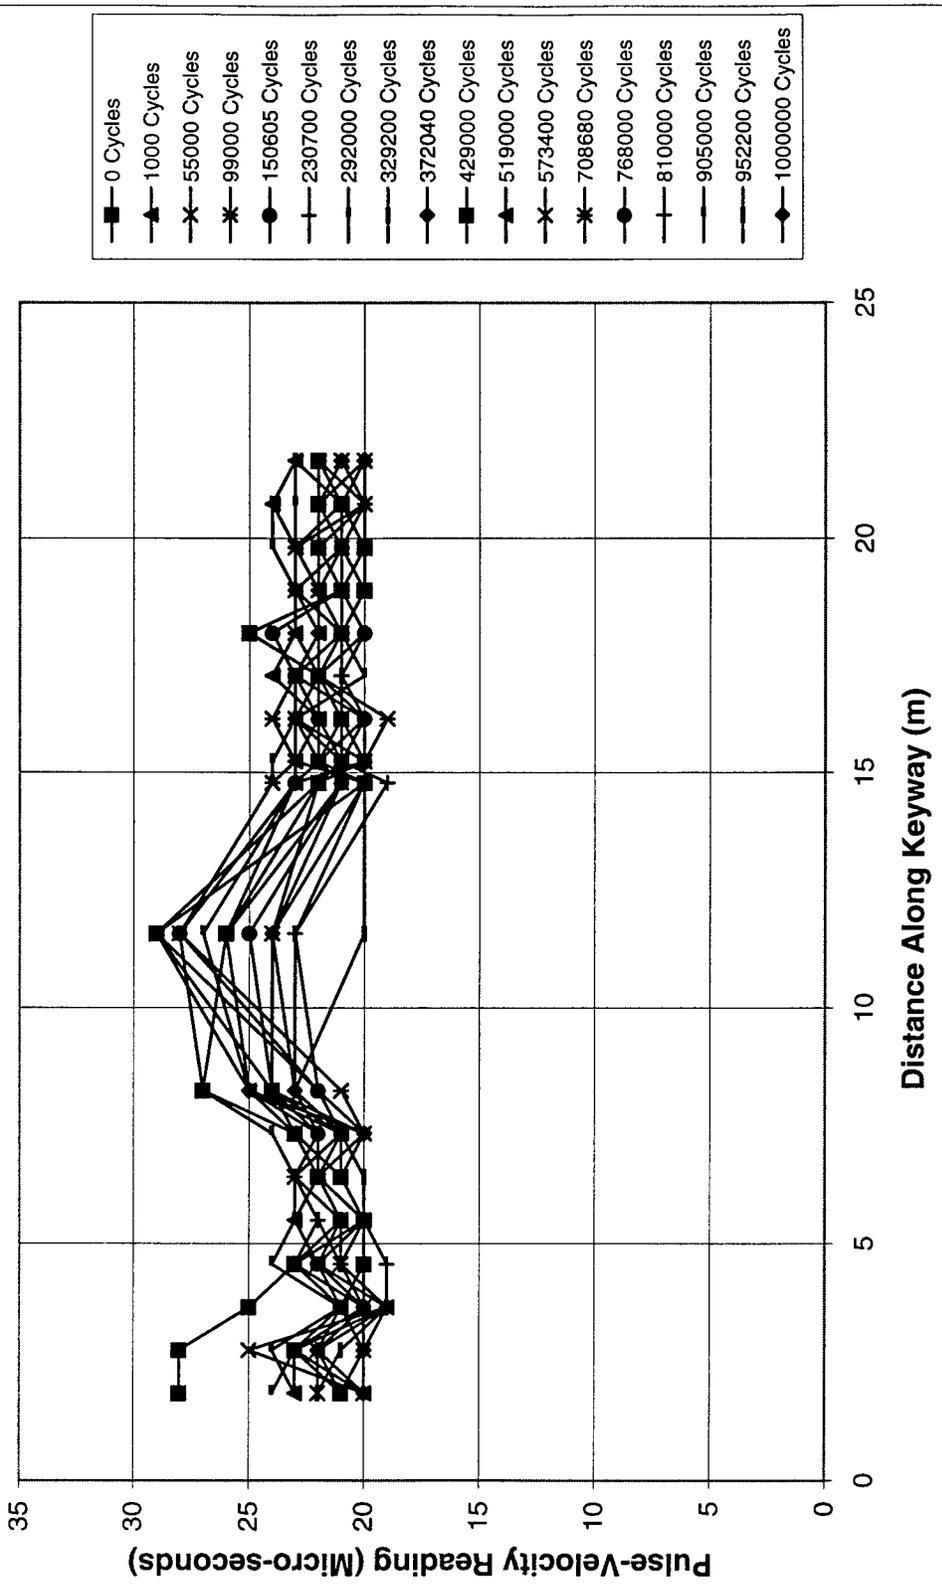
Figure 5.7 Pulse-Velocity readings for test #4

In the fourth test, the standard keyways were grouted in early spring using an epoxy grout. No cracking occurred in any of the keyways during the grouting process nor during cyclic or environmental testing.

The Pulse - Velocity method was again employed in test #4 to determine if there were any cracks. At various intervals during the 1,000,000 cycles the bridge was tested using this method. Figure 5.7 shows that there were only minor deviations of transmission time, well within acceptable error, in any of the keyways during the entire course of this test. At no time were any cracks detected visually nor did the Pulse - Velocity data indicate any cracking. At the conclusion of the test none of the girders could be removed without saw-cutting the keyways along the entire length.

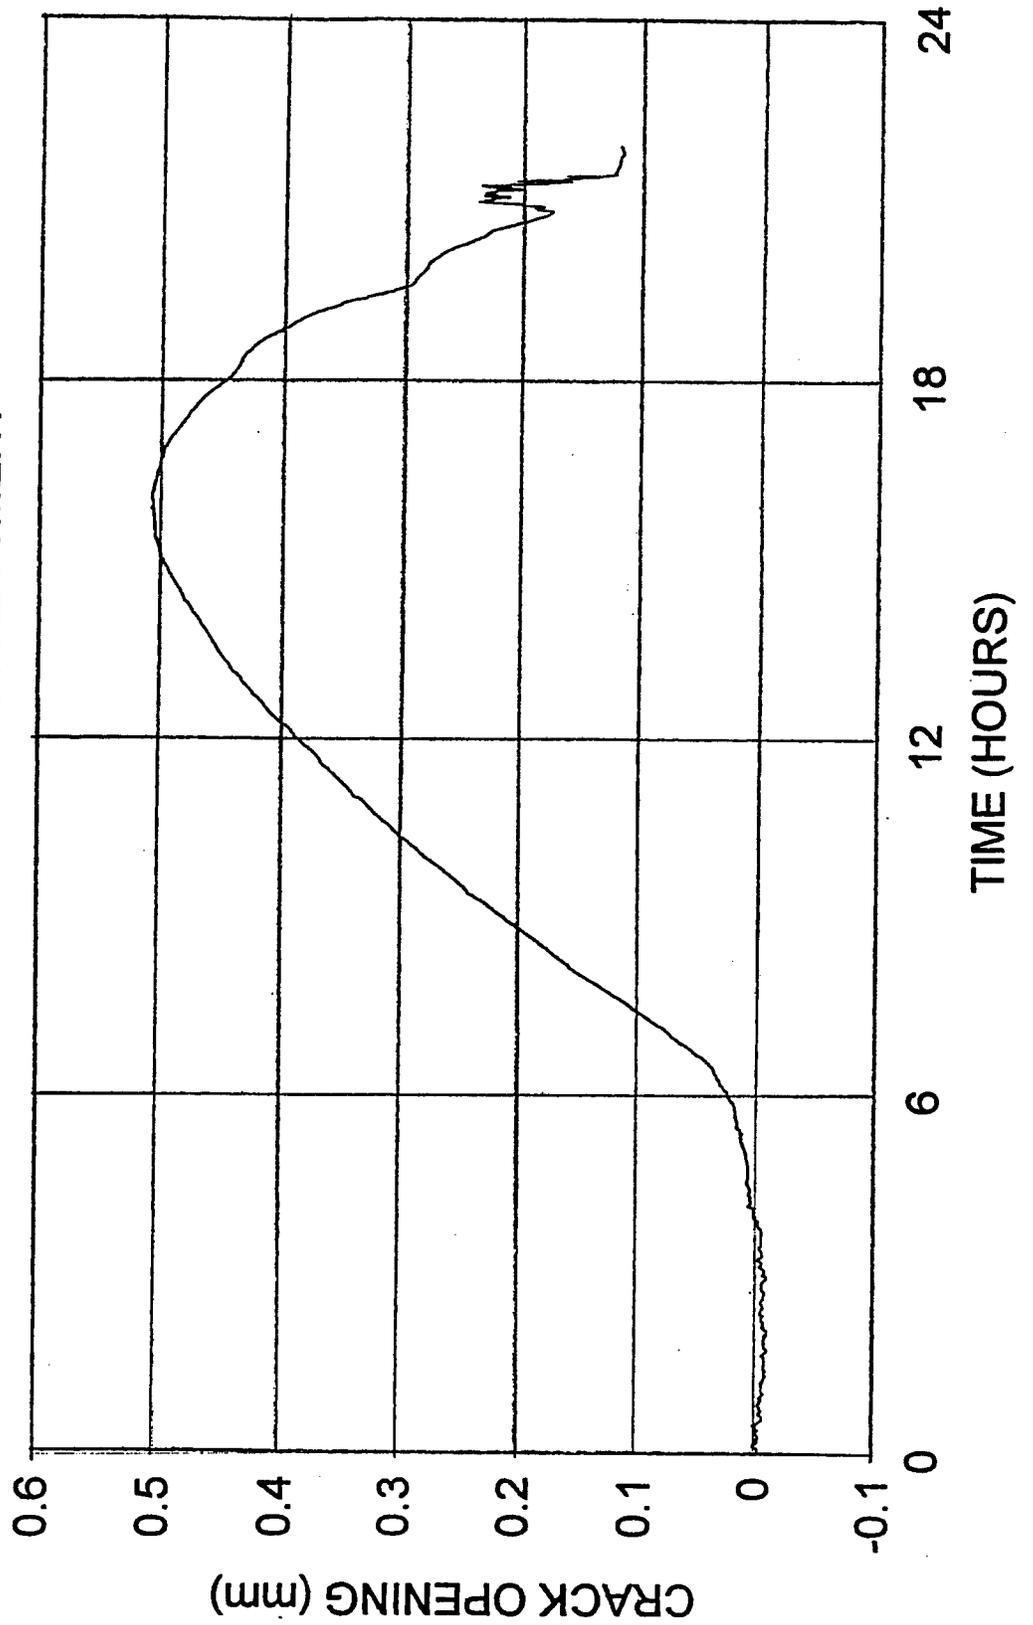
Figure 6.5 Thermally induced transverse keyway movements at a cracked location.
