GEOTEXTILE FABRICS UNDER AN ASPHALT CONCRETE OVERLAY TO RETARD REFLECTIVE CRACKING

FINAL REPORT

East 39th Avenue – East 47th Avenue Section
East Burnside Street, Portland

Experimental Features Project OR 91-03

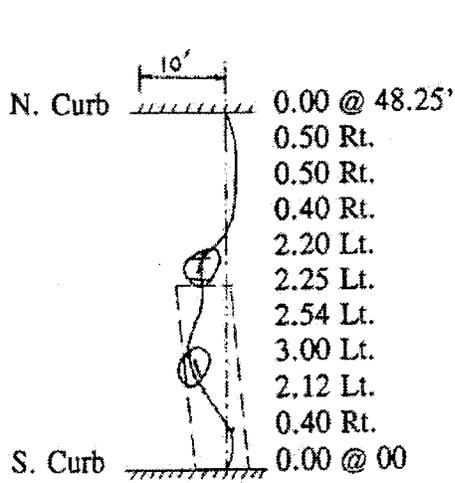
Crack #1, Fabric 1
 E. of N.E. Meikle Pl.
 Single layer of 5-foot wide
 Glasgrid

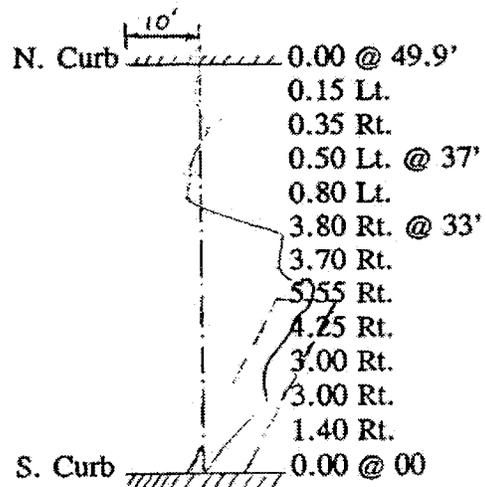
Crack #2, Fabric 2
 W. of 43rd Avenue
 Two sheets of 2-foot wide Polyguard
 placed with 1-foot wide lap

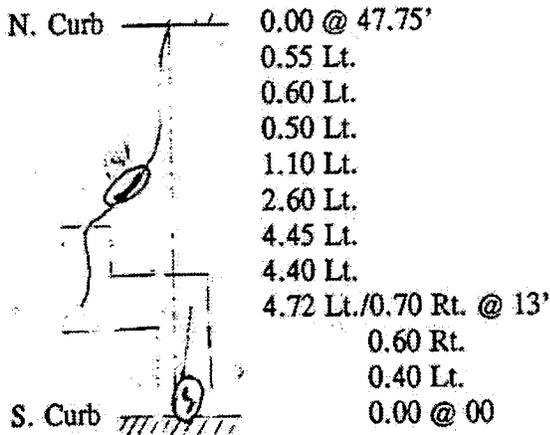
Crack #3, Fabric 1
 E. of 43rd Avenue
 Single layer of 5-foot wide Glasgrid

The four test cracks were also observed. Only very minor reflective cracking was found. Crack #3 was in the best condition with zero linear meters of cracking. Crack #4 had the most reflective cracking, but the location was not conclusive. A curb replacement and widening job after the overlay destroyed one of the reference nails, thus the exact location of the existing crack is not certain. The Polyguard at test crack #4 was not overlapped. Overlap of the Polyguard on the other cracks may have improved the performance of the geotextile.

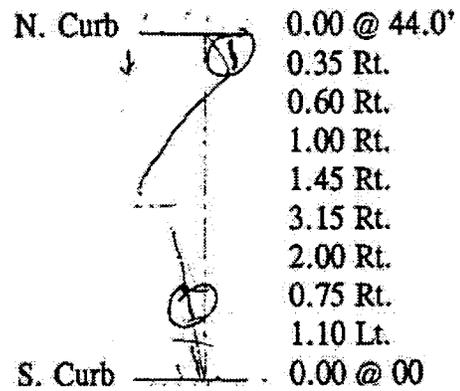
Crack #4, Fabric 2
 W. of 47th Avenue
 Single sheet of 2-foot wide Polyguard

1. The ODOT Research Group, with the City of Portland, should continue to monitor the sections annually to determine the benefits of using geotextiles.
2. The location of crack #4 should be reestablished.

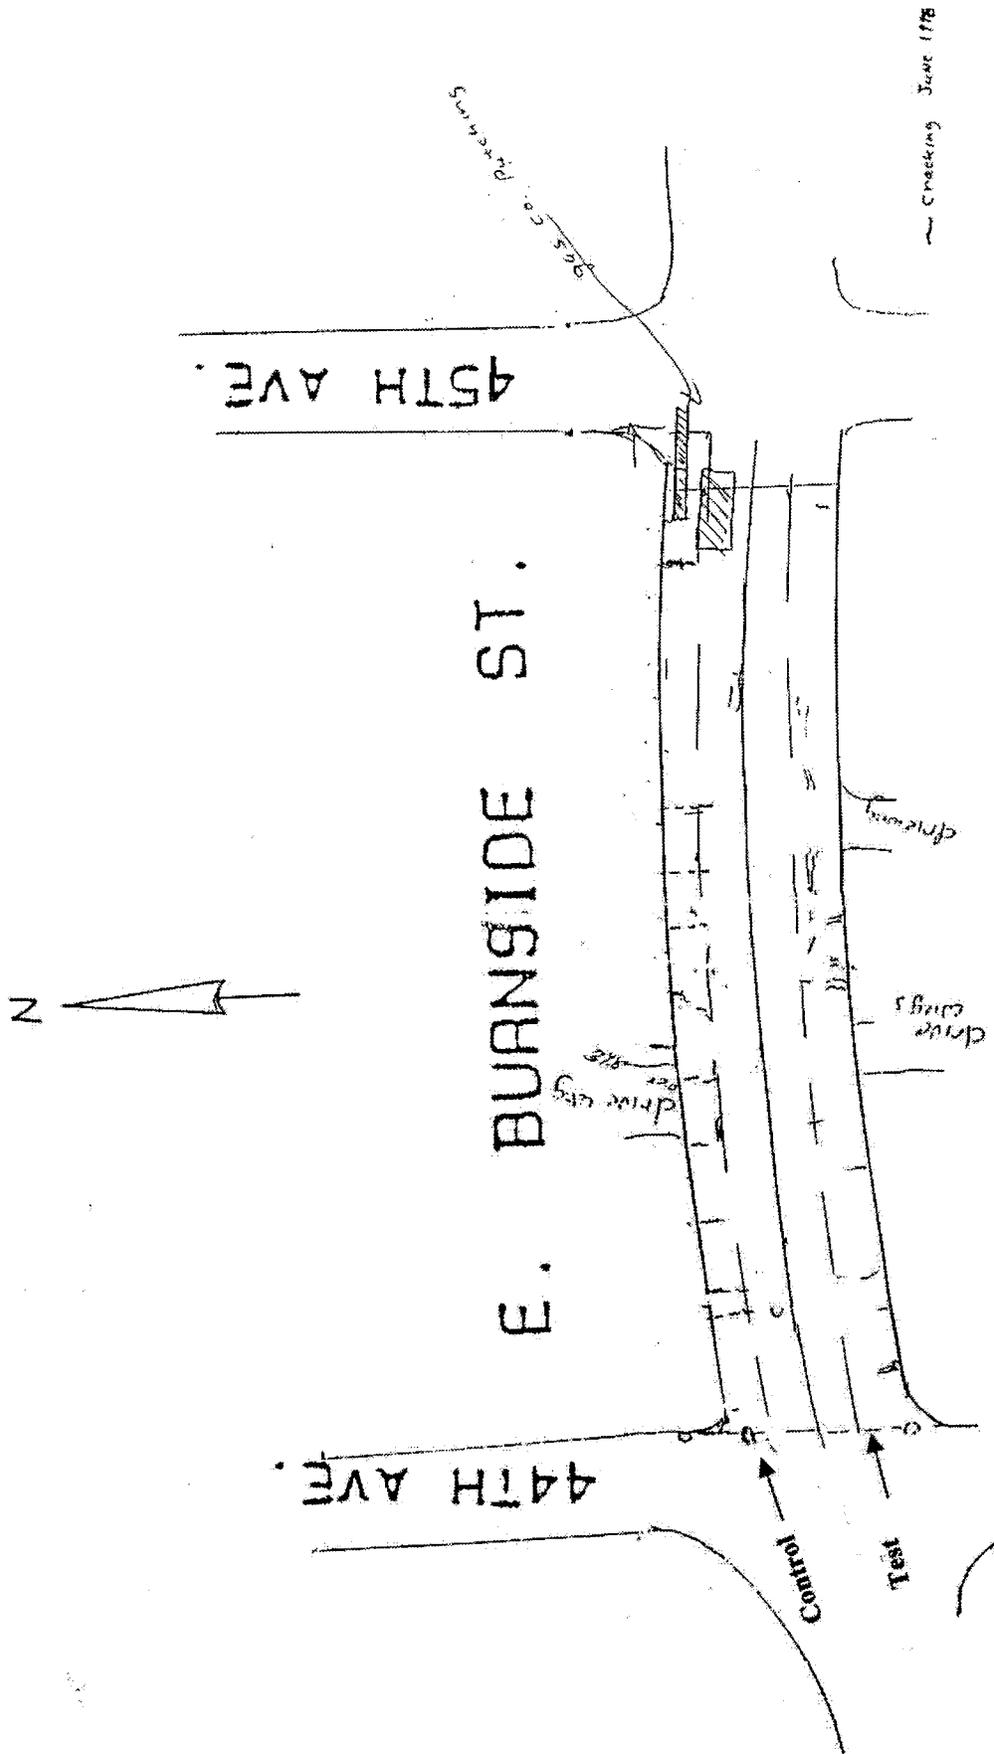
Figure 5.1: Crack Map of Test and Control Sections

The project was evaluated once each year from 1992 to 1998. For the first few years in the reinforced section, only a few cracks were found. In 1996, more and larger cracks started to grow. Longitudinal cracks found in this area were visible on the original pavement after the grinding was completed. The cracks are starting to reflect through the overlay in the test section. However, the total cracking today in either the test or control sections is much less than the original reflective cracks shown in the pre-construction videotape. Figure 5.1 is a sketch of the 1998 noted cracking in the reinforced section and Figures 5.2 and 5.3 include photographs of the test and control sections. Note from the crack map (Figure 5.1) that the control section has slightly more cracking than the test section. Rutting was found to be less than 6 mm.

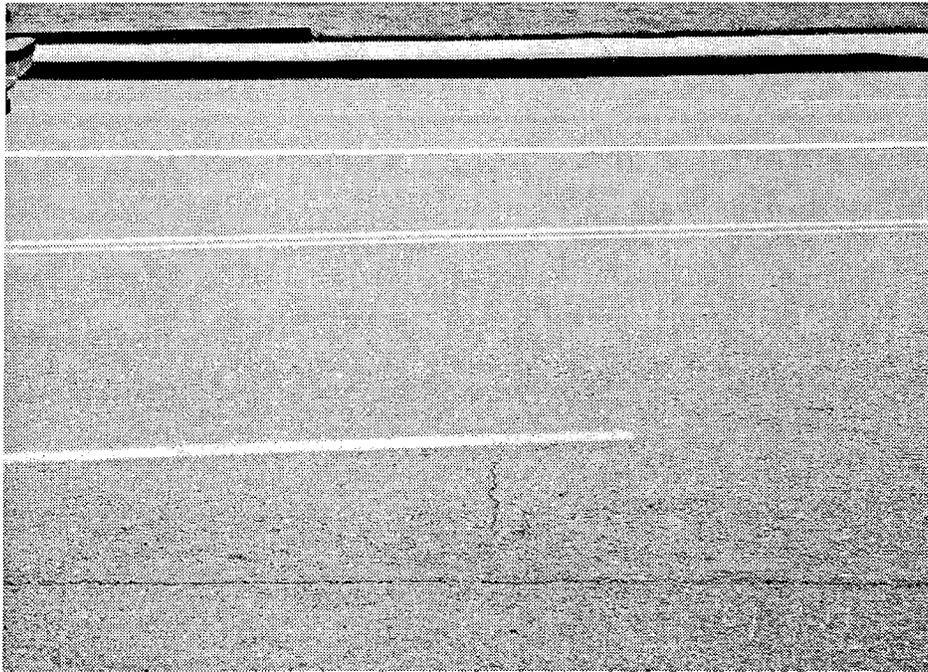
Figure 5.2: Typical View of the Test Section

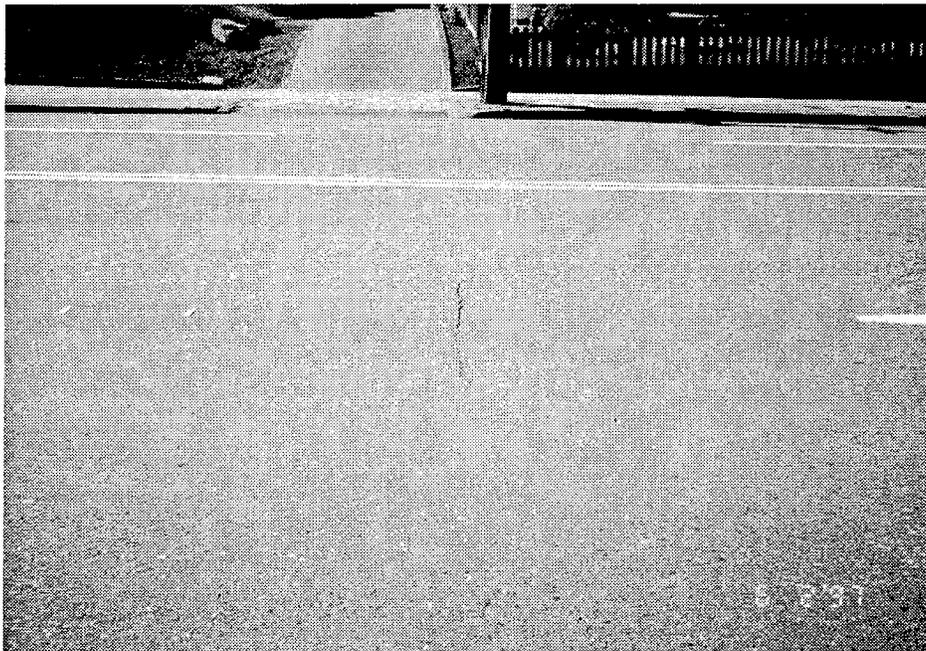
Figure 5.3: Typical Cracking in the Control Section

1. Reflective cracking has developed in both the test and control sections. However, the distress is at a low level and very sparse.
2. The control section has slightly more cracking than the test section. Because they are both at low levels, it is not conclusive if the geotextile has retarded the crack growth.
3. The low level of distress may be the result of a good paving job.
