Testing of State Roadside Safety Systems Volume III: Appendix B— Crash Testing and Evaluation of a Guardrail System for Low-fill Culvert

PUBLICATION NO. FHWA-RD-98-038

APRIL 1999

1. Report No. FHWA-RD-98-038		2. Government Accession No.	
4. Title and Subtitle TESTING OF STATE ROADSIDE SAFETY SYSTEMS VOLUME III: APPENDIX B - CRASH TESTING AND EVALUATION OF A GUARDRAIL SYSTEM FOR LOW-FILL CULVERT		5. Report Date April 1999

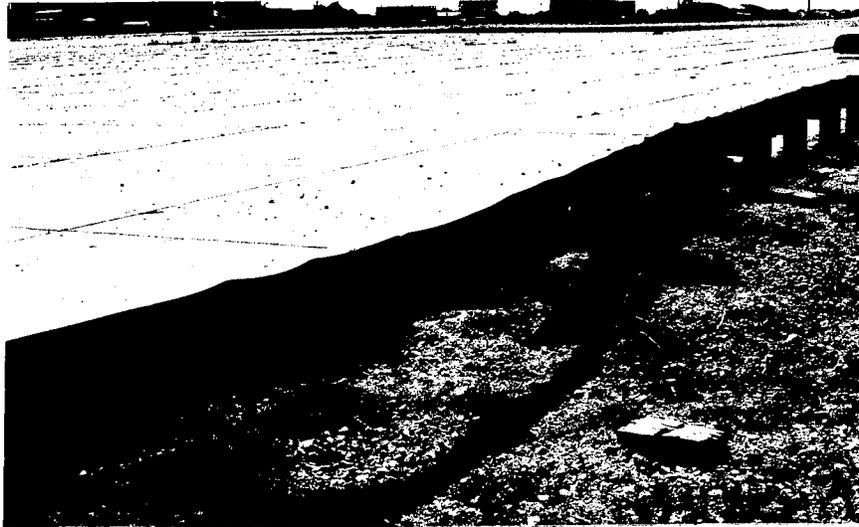
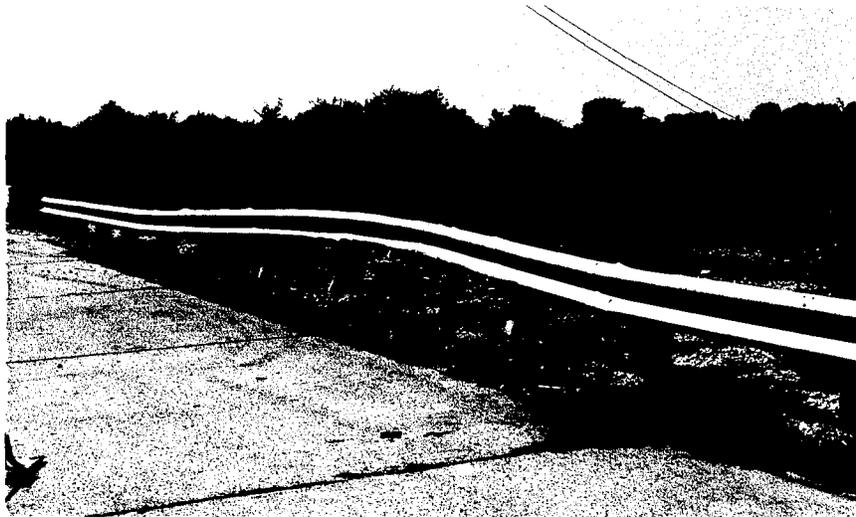
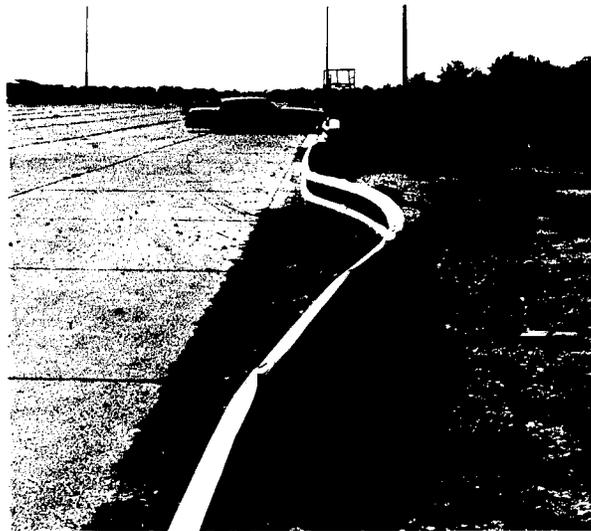
Figure 14. Damage to Washington nested W-beam guardrail after test 7147-2.

The guardrail system received moderate damage, as shown in figure 14. The total length of contact of the vehicle with the guardrail system was 7.2 m (23.5 ft). The maximum permanent deformation of the W-beam rail element was 0.7 m (2.4 ft), located approximately 0.92 m (3 ft) upstream of post 13 (the downstream post of the long span). There was some flattening of the W-beam rail element at the lower corrugation upstream of post 13 as the vehicle pocketed slightly at the post and pressed the W-beam rail element against the blockout and the post.

As can be seen from table 1, post 13 was pushed back 324 mm (12.75 in) at ground level and 714 mm (28.5 in) at the center of the W-beam rail element. The blockout at post 13 was broken and separated from the post and the head of bolt attaching the rail to the blockout and post was pulled through the nested W-beam rail elements. There were also slight movements at the two end anchors.

One suggested change is to increase the length of the nested rail from the minimum of 7.62 m (25 ft) to 11.43 m (37 ft, 6 in) and add a W-beam rail section to the rear of the system to overlap the long span and provide added strength. This suggested change would not affect the impact performance of the system to any degree, but would eliminate the need to have a splice in the middle of the long span, which could be mistaken as a missing post.

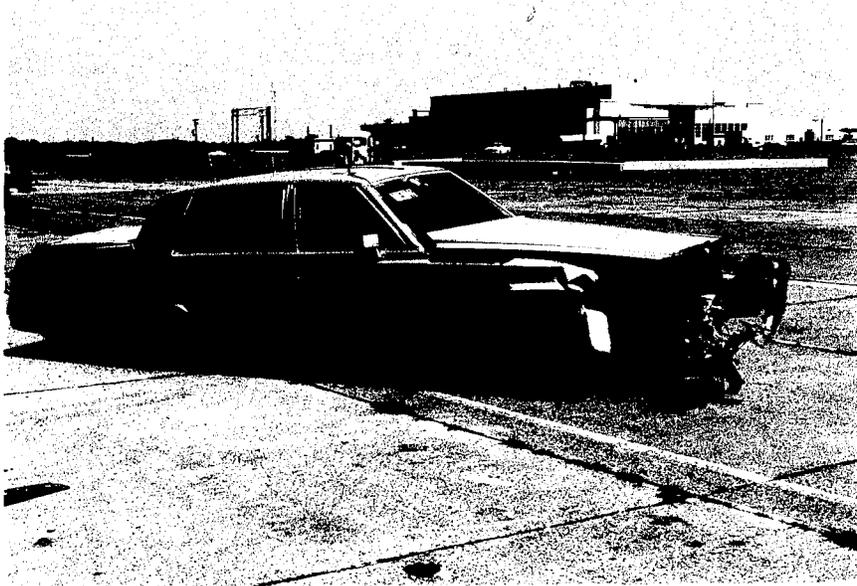
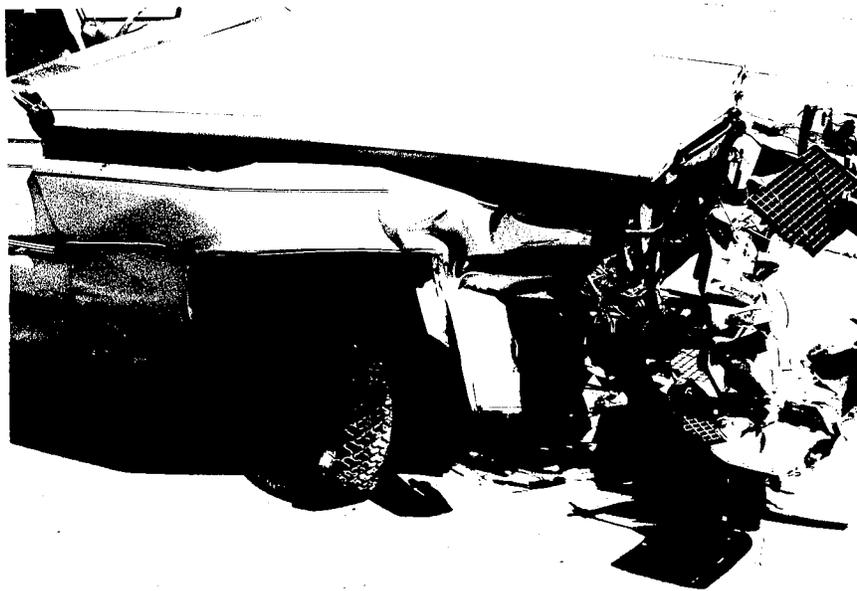
Figure 15. Damage to vehicle test 7147-2.

The vehicle (shown in figure 15) sustained moderate damage to the right side. The tie rod was bent and the windshield was broken. There was damage to the front bumper, hood, grill, radiator and fan, right front quarter panel, right front and rear doors, right rear quarter panel, and the rear bumper. The wheelbase on the right side was shortened from 3.09 m (121.5 in) to 2.95 m (116.0 in). The right front and rear rims and tires were damaged from contact with the posts. Maximum crush to the vehicle was 330 mm (13.0 in) at the right front corner at bumper height. Note that much of the damage to the front of the vehicle was the result of the vehicle impacting the end of a concrete barrier near the end of the vehicle trajectory. It should also be noted that the test vehicle had a fiberglass header panel that made the damage to the front of the vehicle appear much worse than it really was.

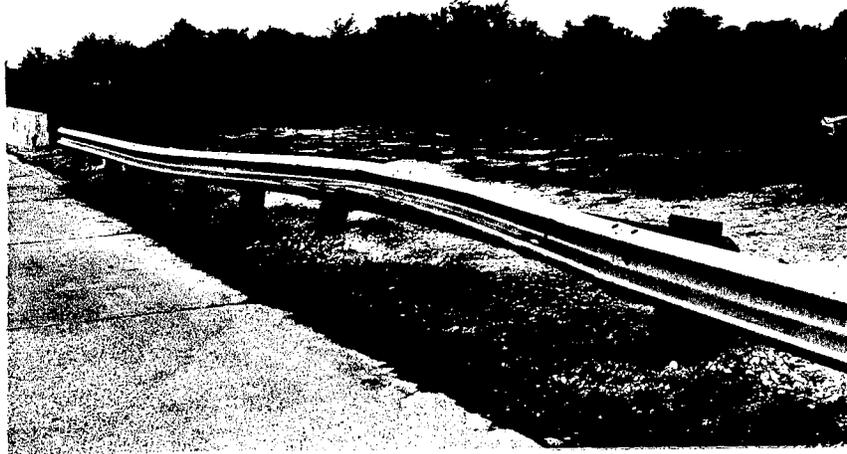
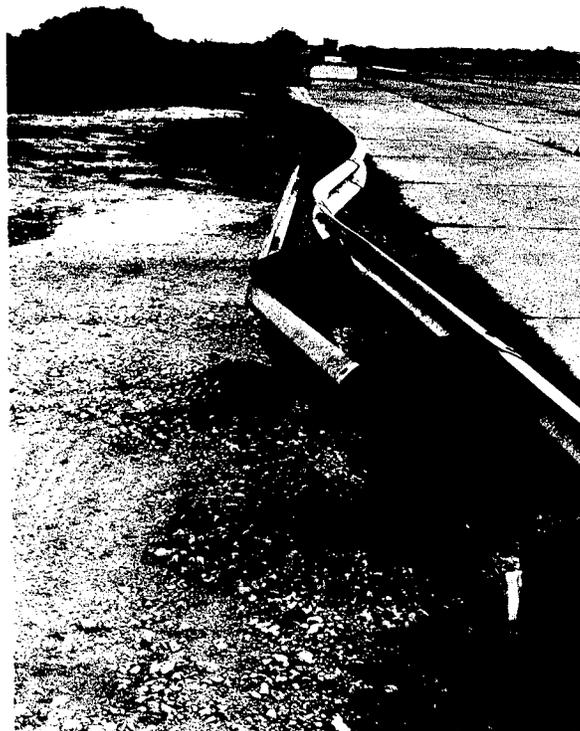
Figure 26. Damage to Washington nested W-beam guardrail after test 7147-4.

The guardrail system received moderate damage, as shown in figure 26. The maximum permanent deformation of the W-beam rail element was 0.7 m (2.3 ft), located approximately in the center of the long span. The rear rail element received a maximum permanent deflection of 0.54 m (21.25 in) at post 12. Movements of post and rail at different posts are summarized in the table below:

As can be seen from table 2, post 12 was pushed back 279 mm (11.0 in) at ground level and 0.51 m (20.25 in) at the center of the W-beam rail element. The blockout at post 11 was twisted and the head of the bolt attaching the rail to the blockout and post was pulled through the nested W-beam rail elements. There was no movement at the two end anchors.

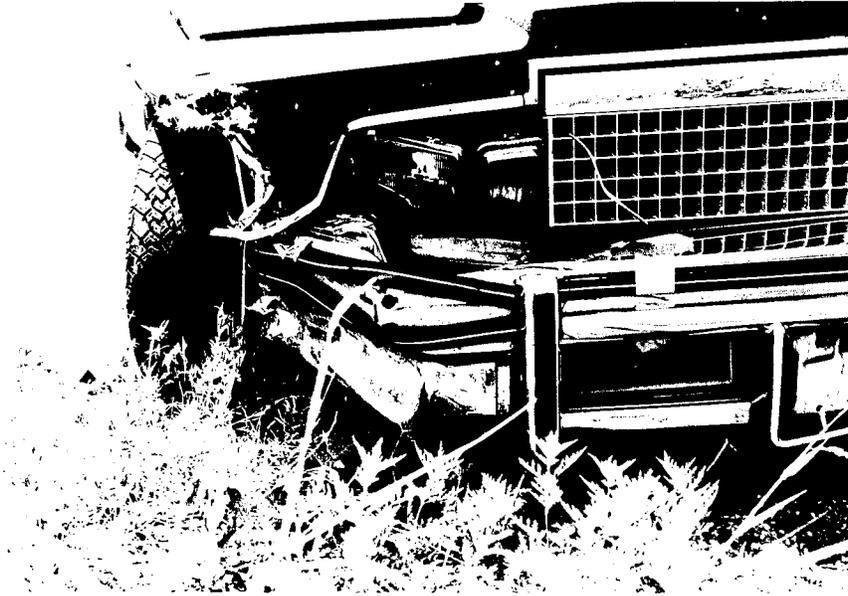
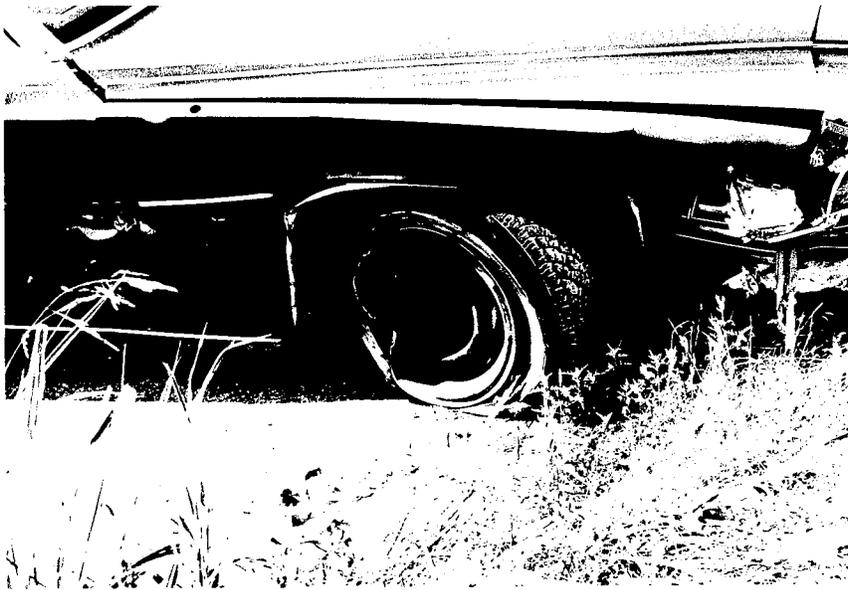
Figure 27. Vehicle after test 7147-4.

The vehicle (shown in figure 27) sustained moderate damage to the right side. The tie rod and lower control arm on the right side were damaged. There was damage to the front bumper, hood, grill, right front quarter panel, right front and rear doors, right rear quarter panel, and the rear bumper. The wheelbase on the right side was shortened from 3.07 m (121.0 in) to 3.06 m (120.5 in). The right front tire and rim were damaged from contact with the posts. Maximum crush to the vehicle was 229 mm (9.0 in) at the right front corner at bumper height. Note that much of the damage to the side of the vehicle (note the tear in the door panels in figure 28) was the result of the vehicle impacting the other guardrail near the end of the vehicle trajectory.

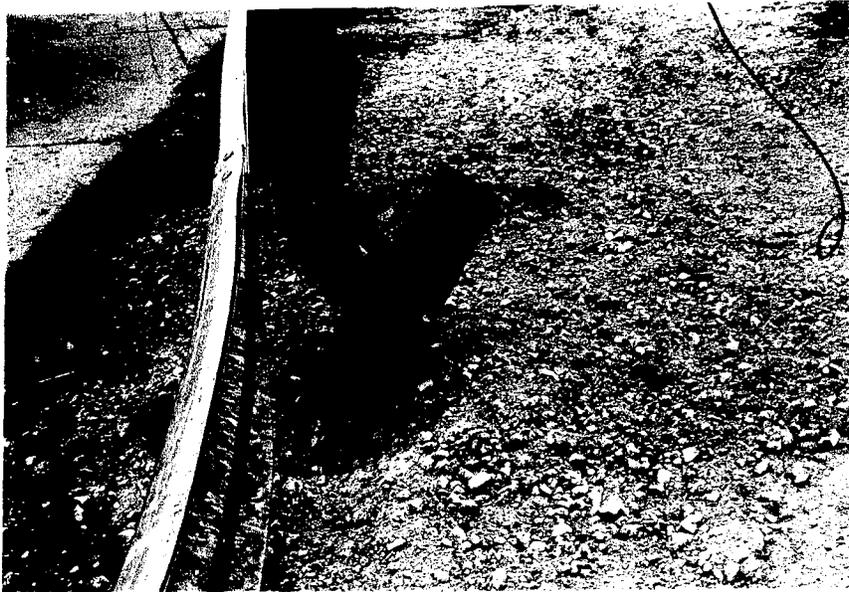
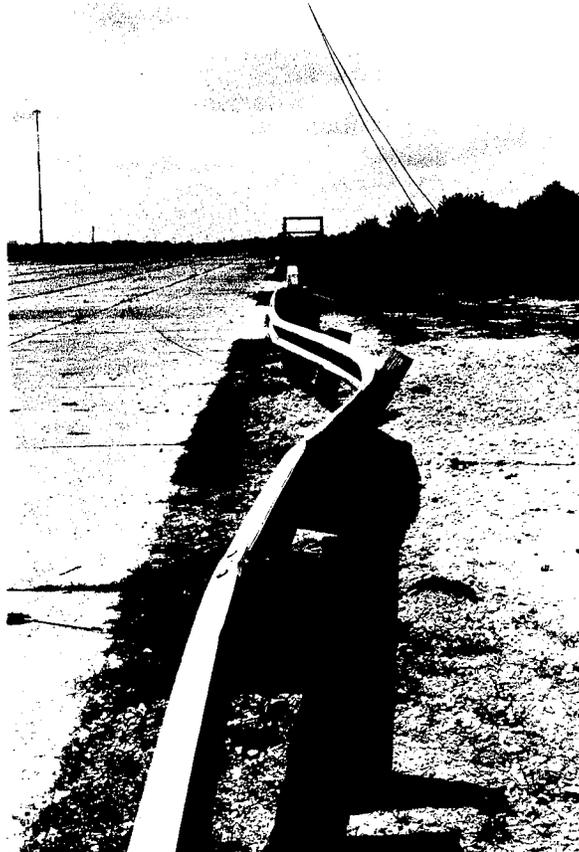
Figure 39. Washington nested W-beam guardrail after test 7147-5.

The guardrail system received moderate damage, as shown in figure 39. The maximum permanent deformation of the W-beam rail element was 0.8 m (2.5 ft), located approximately in the center of the long span. Movements of post and rail at different posts are summarized in the following table:

As can be seen from table 3, post 12 was pushed back 419 mm (16.5 in) at ground level and 584 mm (23.0 in) at the center of the W-beam rail element. The blockout at post 11 was separated from the post and rail elements and the post was split. There was no movement at the two end anchors.

In summary, all three long-span nested W-beam guardrail designs for use over culverts performed very well in crash tests and met all evaluation criteria set forth in NCHRP Report 230. It is therefore recommended that the nested W-beam guardrail design without the W-beam rail section in the rear of the guardrail be approved for field implementation for culverts with clear spans up to 5.72 m (18 ft, 9 in).

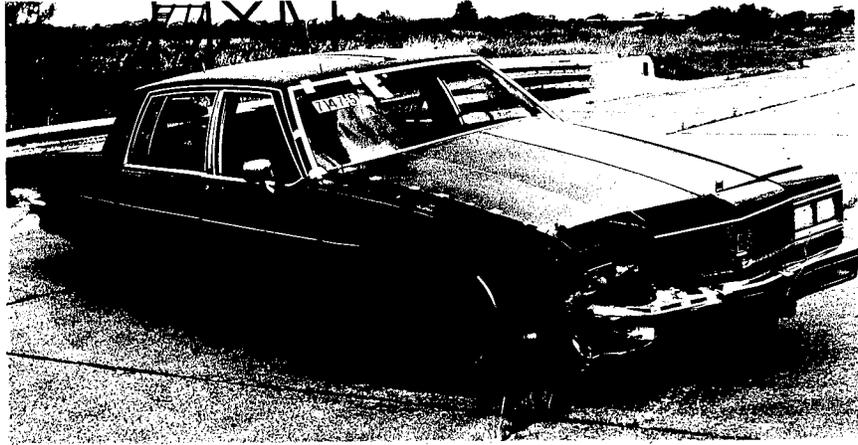
Figure 40. Damage to vehicle after test 7147-5.

The vehicle (shown in figure 40) sustained moderate damage to the right side. The upper control arm on the right side was damaged. There was damage to the front bumper, hood, grill, right front quarter panel, right front and rear doors, right rear quarter panel, and the rear bumper. The wheelbase on the right side was shortened from 3.02 m (119.0 in) to 2.97 m (117.0 in). The right front and rear tires and rims were damaged from contact with the posts. Maximum crush to the vehicle was 203 mm (8.0 in) at the right front corner at bumper height.
