Open Graded Drainage Layer Performance in Illinois

**FINAL REPORT
PHYSICAL RESEARCH REPORT NO. 147
AUGUST 2004**

Illinois Department of Transportation

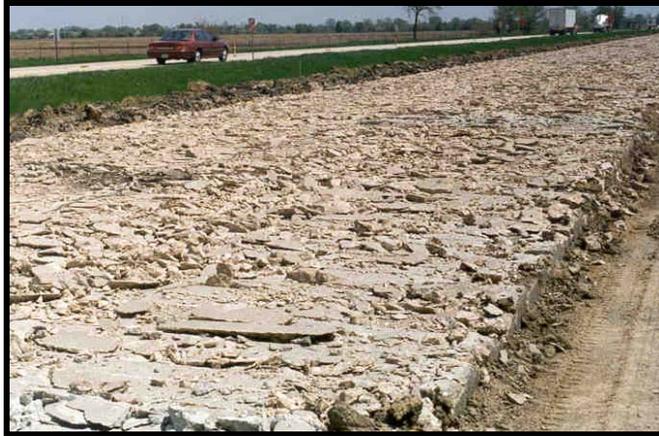
Figure 3

Broken Pavement Prior to Removal

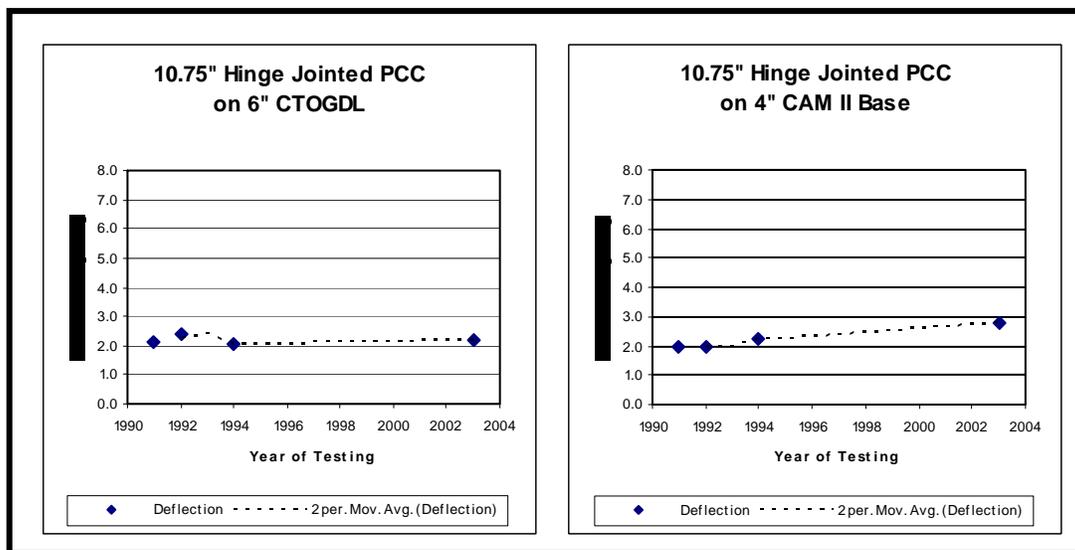
Figure 10
Average FWD Deflections for I-39 at Bloomington

The FWD data for this project indicates that the pavement deflections at the center of each panel have remained constant between 2.0 and 3.0 mils for both the test and control sections. Figure 10 illustrates the FWD test results and a two point moving average trend line for those results. In addition, the load transfer efficiencies for the pavement joints have remained constant between 85.0 and 90.0 percent since construction for both sections.

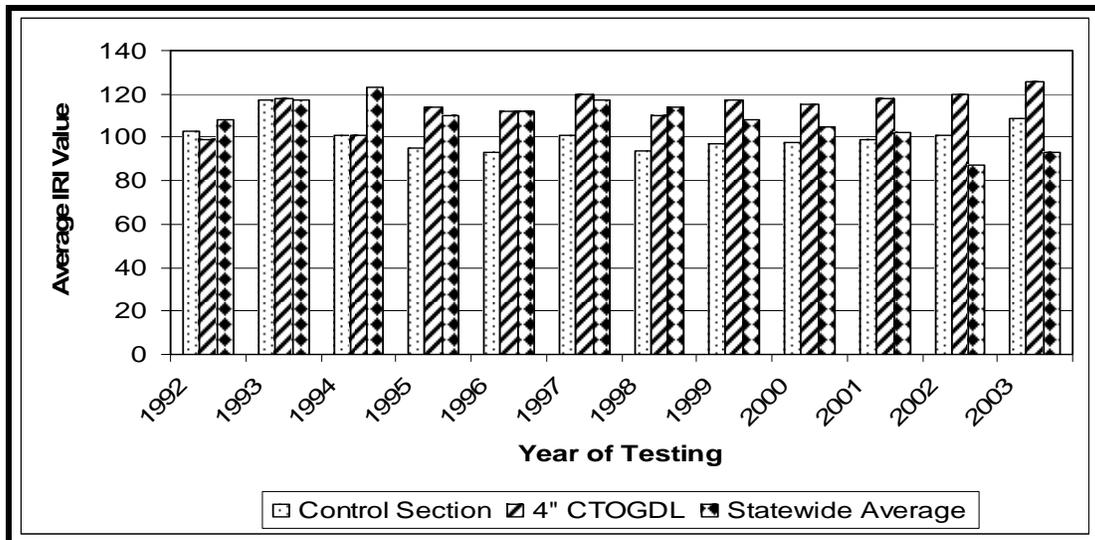
Figure 11
Average IRI Values for I-39 at Bloomington

The IRI data for this project indicates a general increase in roughness for the test section compared to a relatively consistent value of roughness for the control section. When compared to the statewide average, both sections were less than the statewide average after construction but since have increased to a level greater than the statewide average. The graph below in Figure 11 indicates these trends.

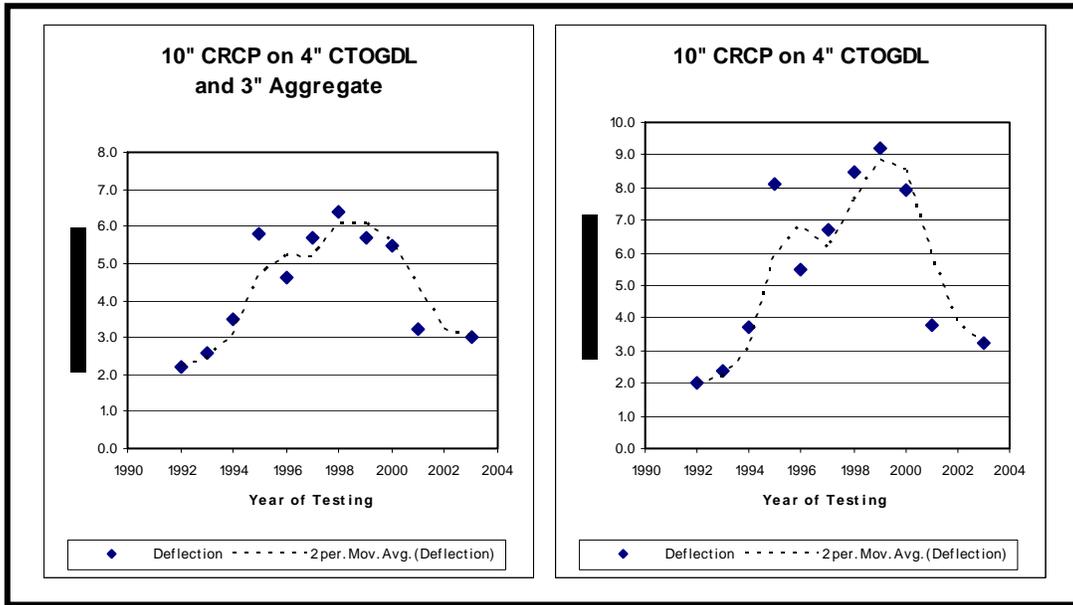
Figure 15
Average FWD Deflections for I-39 at El Paso

The FWD deflections for this project are relatively high for both of the test sections. There was no control section on this project, so no comparison can be made to standard construction practice. Figure 15 illustrates the average FWD deflections and a two point moving average for both the test sections. Comparison of the results indicates that the CTOGDL on the aggregate separation layer performed better than the CTOGDL placed directly on the modified subgrade. The reduction in deflection values that occurs after 1998 is due to the undersealing of the pavement and extensive patching efforts for both sections. The load transfer efficiency of the cracks has remained between 90 and 95 percent for the entire project even with the high deflections.

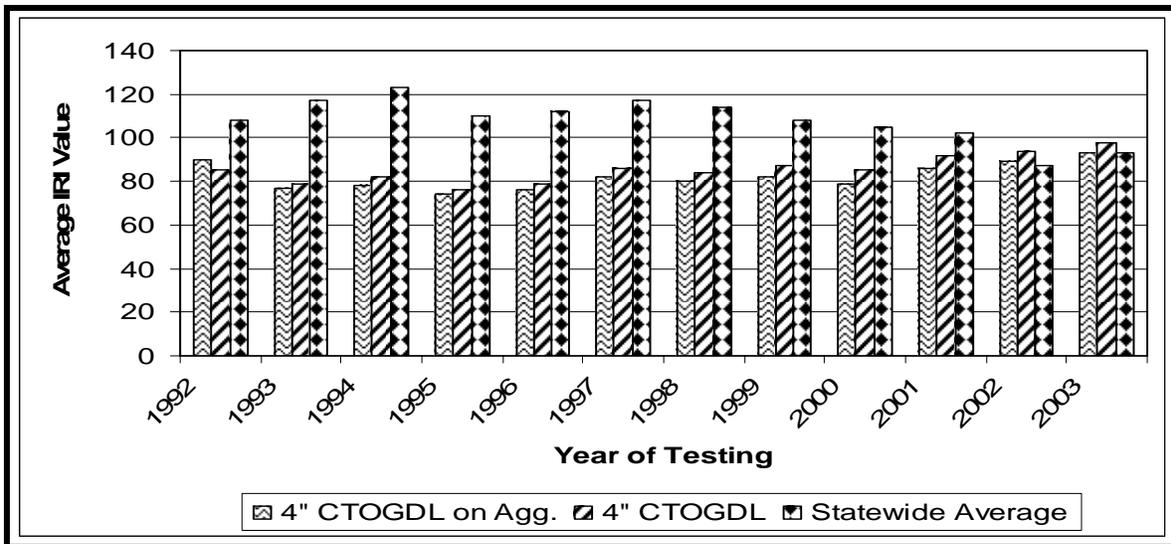
Figure 16
Average IRI Values for I-39 at El Paso

The average IRI values for this project indicate that both test sections were well below the statewide average after construction. This trend continued for most of the last eight years; however, in 2002 the average IRI for the test sections did surpass the statewide average. Additionally, the OGDL test section that was placed on the aggregate separation layer was less rough than the OGDL test section placed on lime modified soil in all years except 1992. Figure 16 below indicates the average IRI values for these test sections as well as the statewide average.

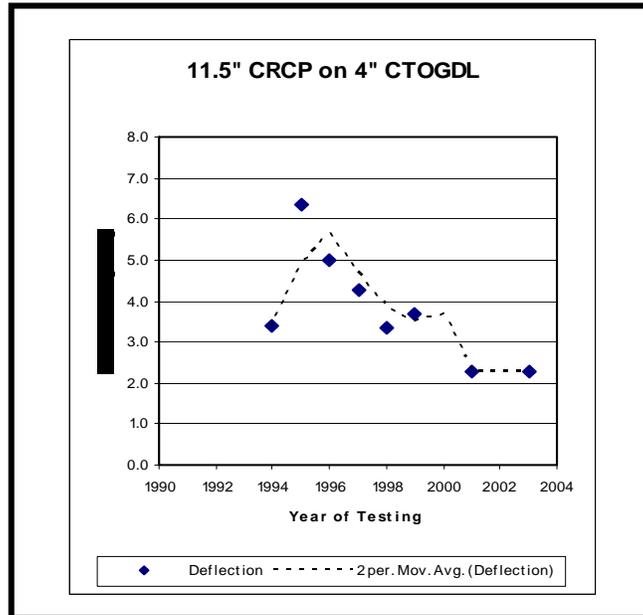
Figure 19
Average FWD Deflections for I-80

average FWD deflections showed an immediate response by dropping down to 5.0 mils within the next year. The general trend of the average deflections has continued to decrease since 1996. Figure 19 illustrates the sudden rise and decline of the average FWD deflections for this project. The load transfer efficiency of the cracks has remained between 90 and 95 percent for the entire project even with the high deflections.

A side effect of the pavement undersealing has been the increase in transverse and longitudinal cracking of the pavement surface. The severity level for some of the transverse cracks has also increased since the undersealing was performed. The development of longitudinal cracks at a regularly spaced interval is alarming due to the potential formation of punchouts at the pavement edge. In addition, the combination of longitudinal and transverse cracks creates a grid pattern of small rectangular blocks across the pavement surface. These small blocks may begin to move independently and fail as the load transfer efficiency of the surrounding cracks is reduced.

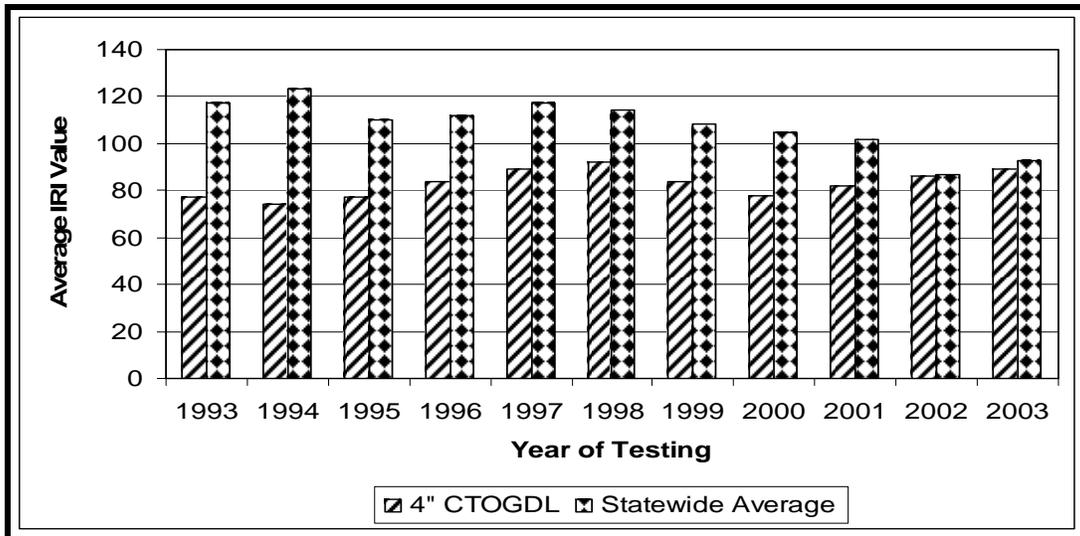
Figure 20
Average IRI Values for I-80

average. Only recently, has the average IRI value reached the level of the statewide average. This trend is displayed in Figure 20.

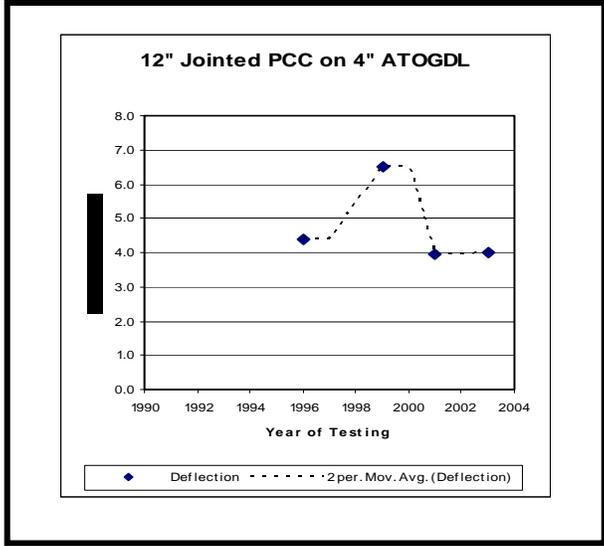
Figure 21
 Average FWD Deflections for Macon County Highway 1

The FWD data for this project is limited. IDOT does not routinely test county highways for investigative FWD deflections, IRI, or CRS values. Figure 21 illustrates the data that is available and a two point moving average for the limited FWD deflection results. The data indicates that the average deflection has fluctuated between 4.0 and 7.0 mils. The majority of the average values fall within the 4.0 to 5.0 mils range, except for the spike value of 6.5 mils in 1999. This outlying average test value may be attributed to poor conditions during the actual testing, and a limited number of tests.
