ROADSIDE HAZARDS

An Evaluation of Roadside Hazards
on the Interstate System

THE ENO FOUNDATION FOR HIGHWAY TRAFFIC CONTROL, INC.
SAUGATUCK, CONNECTICUT, 1968

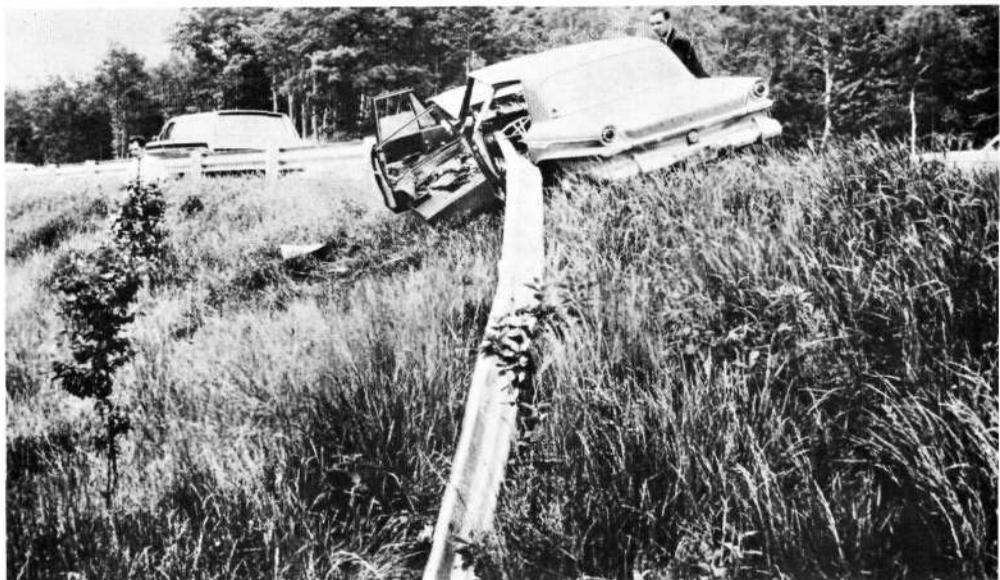
Figure 1. Type of accident that can and does occur when a vehicle strikes the front end of a guardrail. The guardrail penetrated the grill and exited out through the driver's seat. Careful consideration should have been given to burying and/or flaring of the ends of guardrails to minimize the hazards represented by the exposed ends such as in this case.

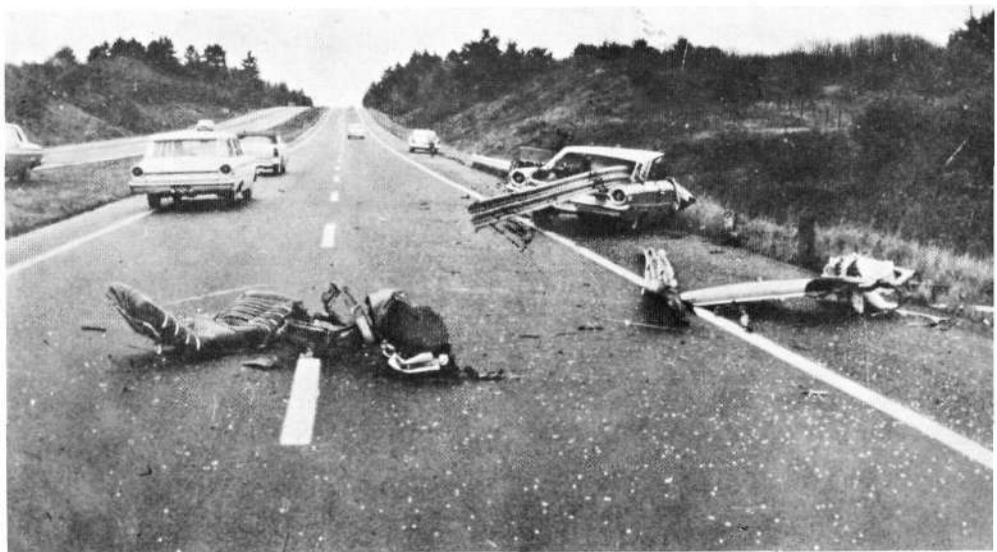
Figure 2. Here the exposed end of the guardrail penetrated the vehicle and passed through the passengers' side and out the rear window.

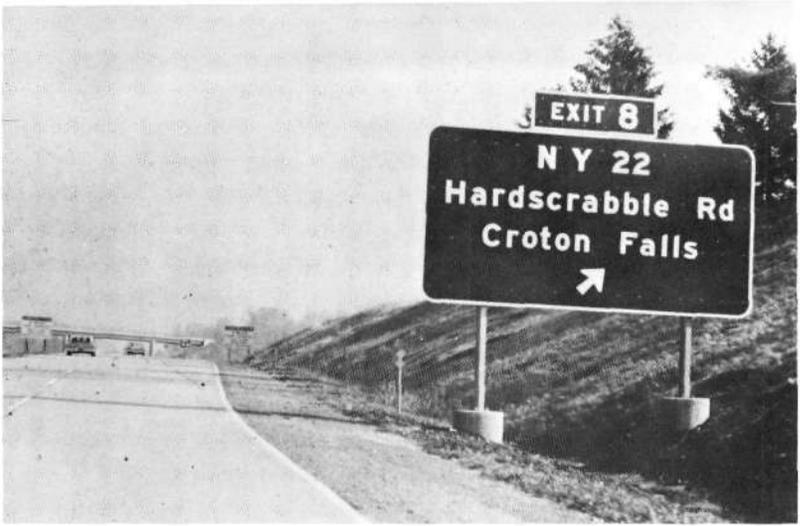
Figure 3. A massive and unprotected ground mounted sign placed at a minimum distance off the edge of the roadway. The supporting posts are 8-inch heavy duty steel I-beams bolted to concrete foundations; the concrete foundations rise approximately 18 inches above the ground level. In installations such as this, careful consideration should be given to placing such signs farther up the embankment, protecting such installations with adequate and sufficient guardrail, or the installation of breakaway type sign supports. Effective December 1, 1967 the Department of Transportation furnished instructions that on new federally aided construction, rigid standards (sign supports, light poles) will not be permitted.

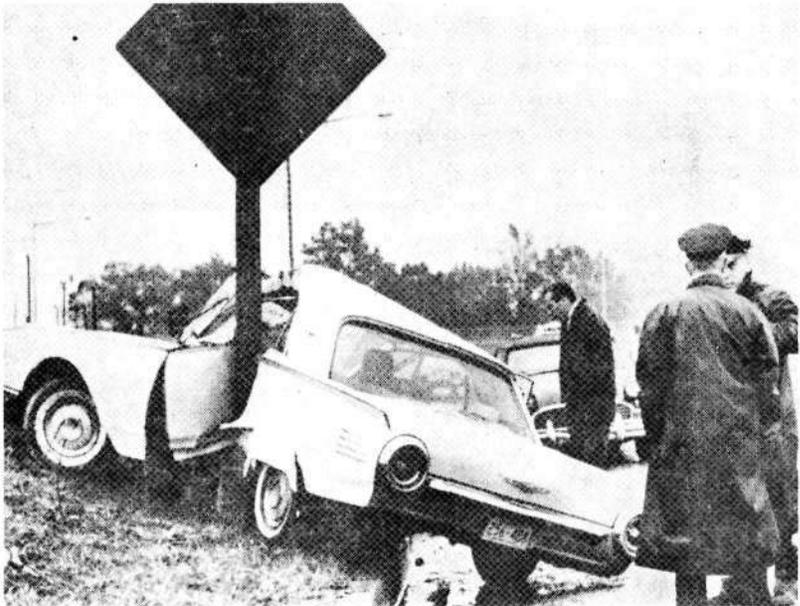
Figure 4. A typical accident resulting from a car striking a fixed object. This illustrates the damage that can be caused by one 6-inch I-beam when struck at relatively low speeds.

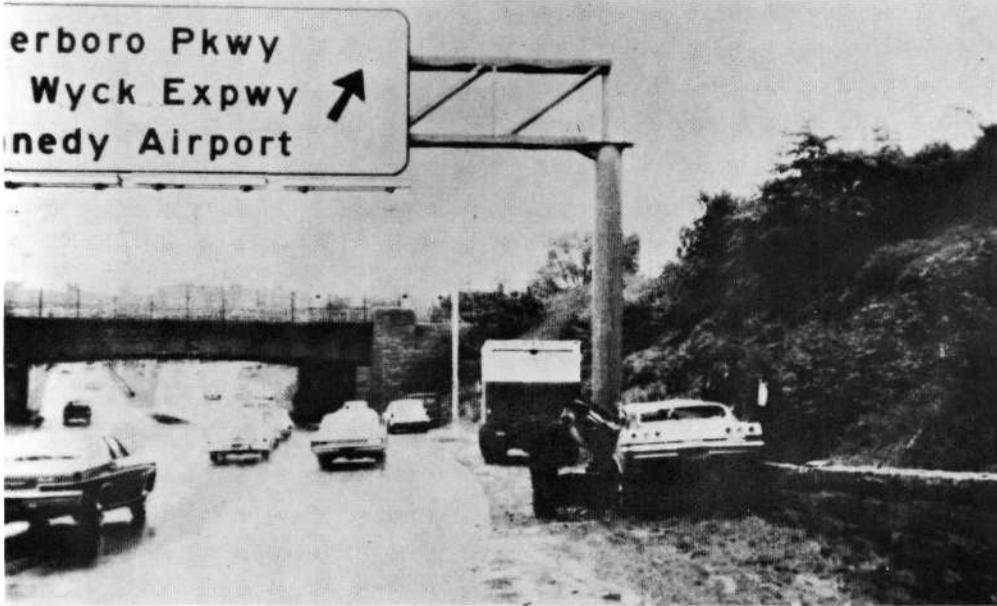
Figure 5. Here is shown a car wedged between the steel sign support and a stone wall. At this particular location, a number of accidents have occurred over the years. The initial guardrail installation was demolished in one of the accidents and subsequently removed. The hazard was thereafter left unprotected and this accident then occurred. Consideration should be given to the placement of this steel sign support behind the relatively smooth stone wall or the proper installation of adequate and sufficient guardrail to protect against the steel sign support.

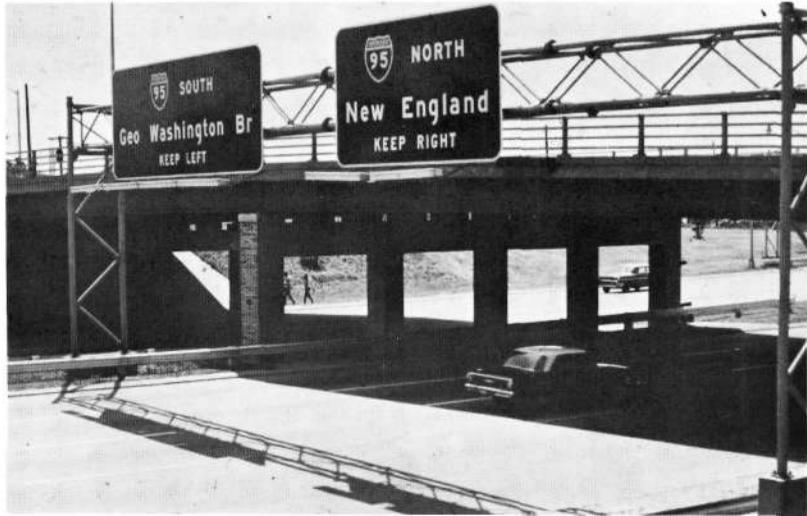
Figure 6. Placement of an overhead sign structure approximately 25 feet in front of an existing bridge structure. In situations such as this, careful consideration should be given to the placement of the signs on the structures themselves, thus eliminating the roadside hazards created by the sign supports at the ground level. Another factor would be that of economy; a sign truss of this dimension exclusive of the sign faces could cost as much as \$10,000-12,000.

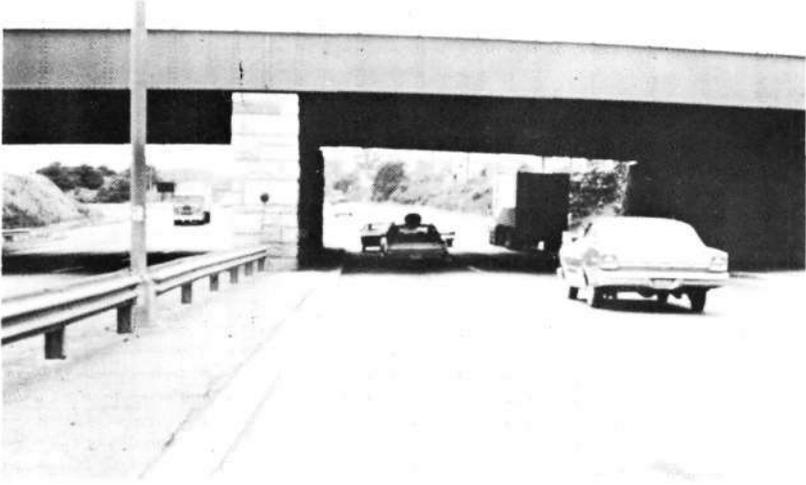
Figure 7. Installation of a median barrier rail. The rail was not carried around and through the median pier; as a result, an out-of-control vehicle could slide along this rail and be guided into the stone pier.

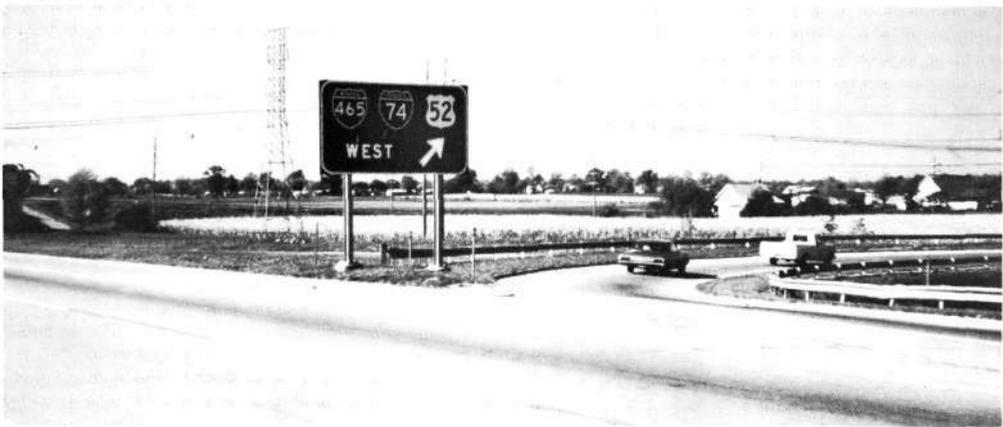
Figure 8. Placement of a massive ground mounted sign directly in the gore area. These sign supports are 8-inch steel I-beams embedded in concrete. Certain studies have revealed that there are four times as many accidents taking place in the gore area as on other segments of the highway systems. Guardrail has been installed for a distance of several hundred feet on the outside of the curve and the leading end of the rail has been brought between the two steel sign supports; the end of the rail creates an additional roadside hazard and the rail does not offer any protection from the sign supports. The installation of the guardrail on the outside of the curve is highly questionable because the area behind the gore is level and clear for many hundreds of feet and would provide a relatively easy escape area for an out-of-control vehicle, but the vehicle could not get to this escape area because the guardrail would prevent it.

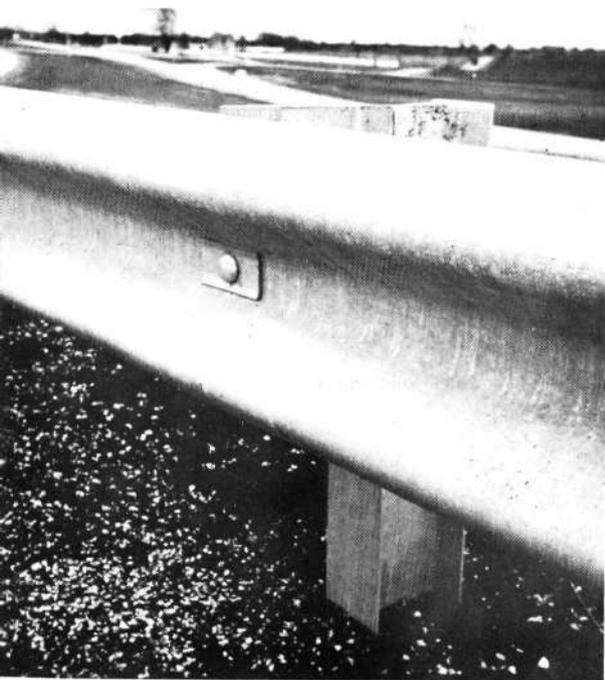
Figure 9 *left*. This view illustrates several principles of good guardrail installation. First, the rail is blocked out from the post, which prevents the wheel of the vehicle from snagging the post, which would result in a violent stop. Second, there is a good flat surface on the approach to the rail so that the barrier has an opportunity to perform as designed. Third, the washer placed over the head of the mounting bolt makes the guardrail and posts perform as a system, rather than independently.

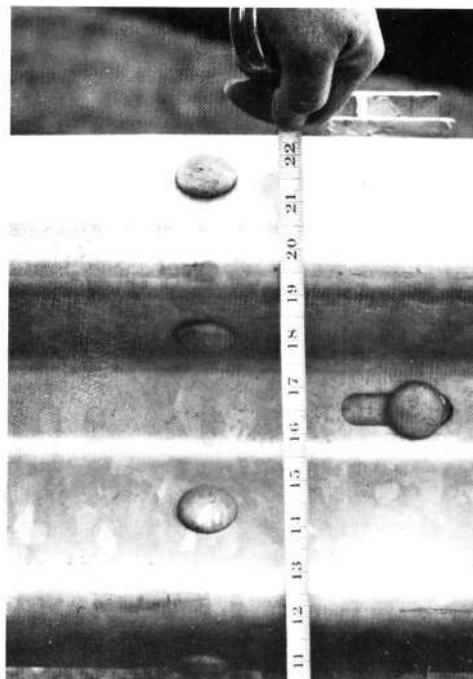
Figure 10 *right*. Some W-beam guardrail is mounted with the top edge only 22 inches above the ground level, which is generally considered lower than desirable. Note the absence of washers and blocks.

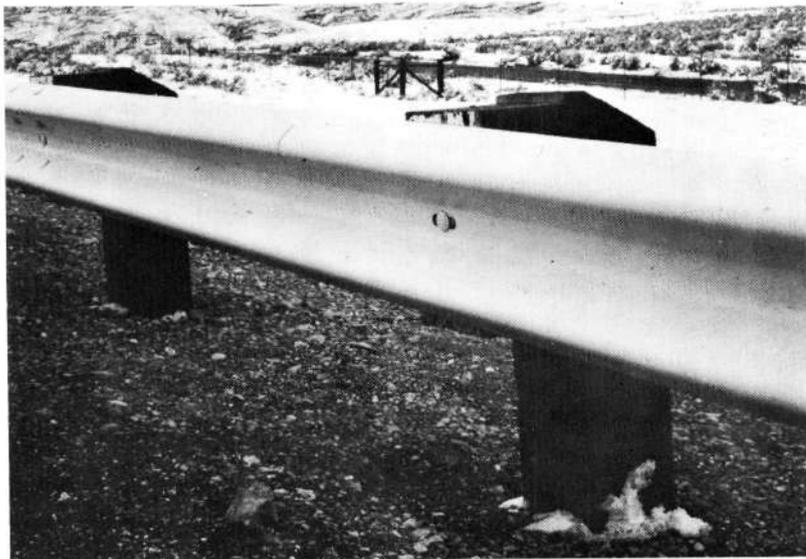
Figure 11. This is a properly blocked-out section of rail with 6' 3" post spacing, which has been painted white for increased visibility. However, the inexpensive washers which prevent bolt heads from pulling through the W-beam rail were not used on this project.

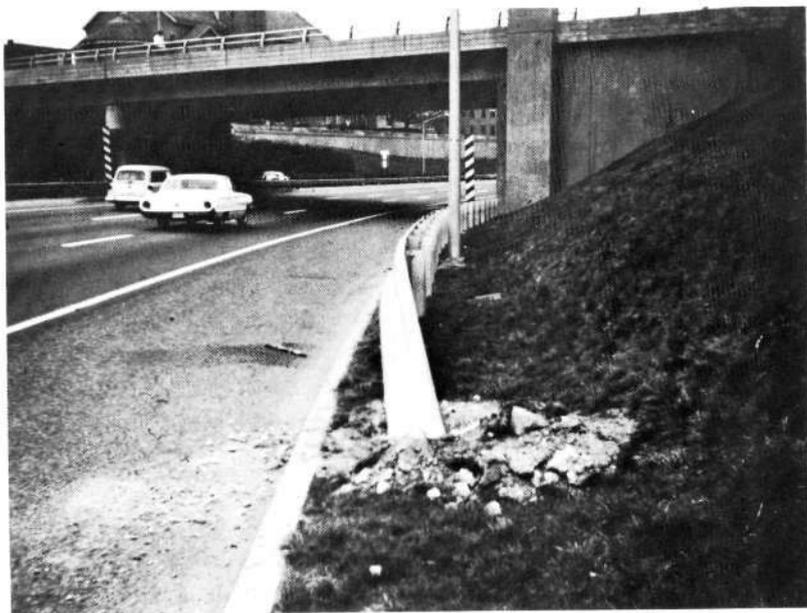
Figure 12. Here is a commendable corrective treatment where the rail on the approach to the structure is twisted, slightly flared, and buried in the cut slope.

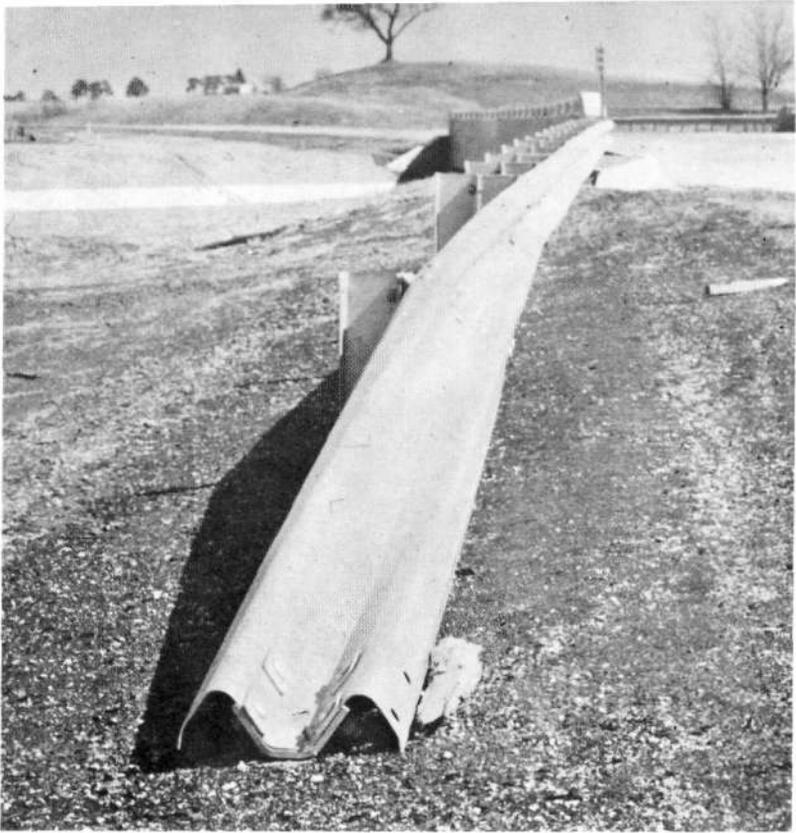
Figure 13. Here is another guardrail turned and anchored at ground level on the approach to a bridge structure. Some designers prefer to have even less of the end of the rail exposed. Note the undesirable projection of the bridge curb in the background.

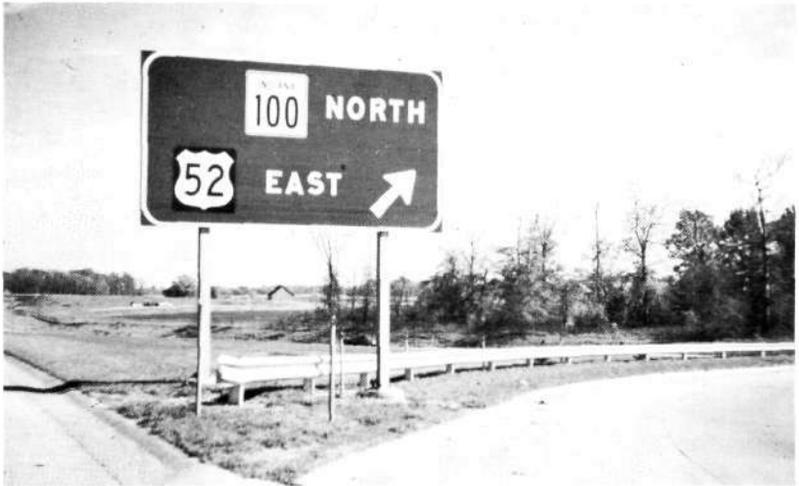
Figure 14. Freeway exits like this sometimes have excessive guardrail in the gore area. A vehicle running off the roadway could have multiple difficulties, striking both the exposed guardrail and the heavy sign supports. With a reasonably flat gore area, removal of the guardrail from the target position and the installation of a breakaway or yielding type sign support is the indicated solution.

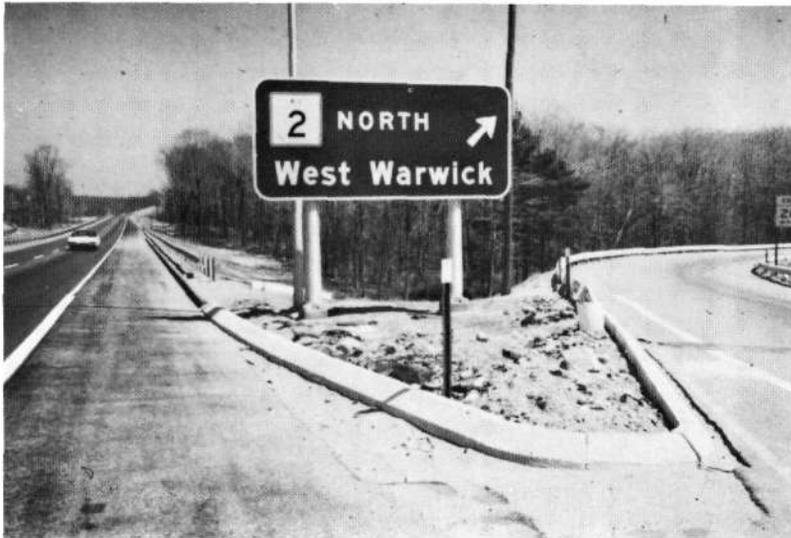
Figure 15. This gore might be safely traversed by an out-of-control vehicle if it were not for the heavy sign installation.

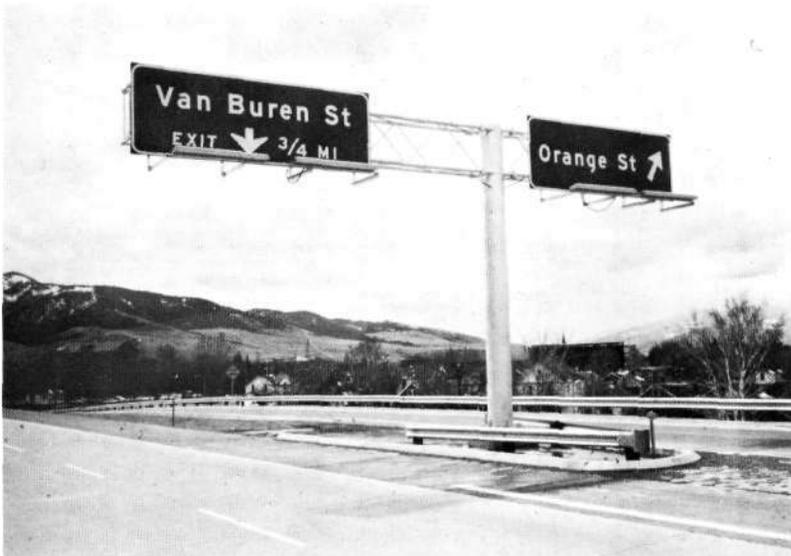
Figure 16. This exit gore is the site of a butterfly mounting for the overhead signs shown. The central support is 24 inches in diameter and rests atop a steel base and a raised curb within the gore area. The guardrail completes the installation of a truly monumental obstacle. In most instances of this kind, the motorist is better served by an overhead sign bridge located a few hundred feet in advance of the gore, and the hazard is markedly less.

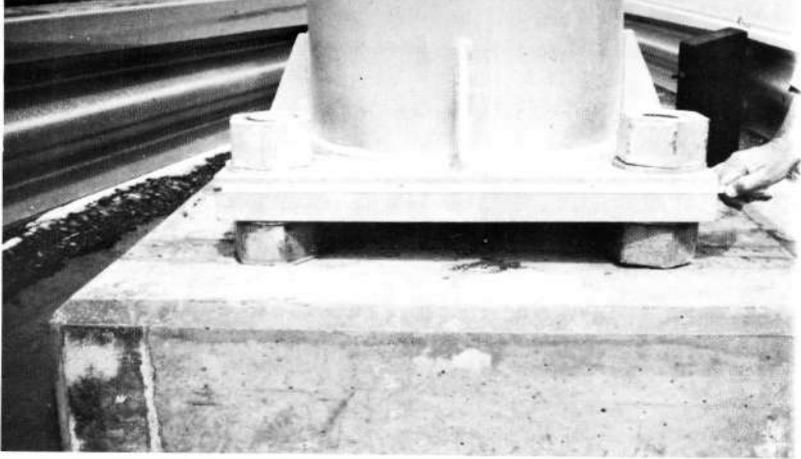
Figure 17. These are details of the heavy base supporting the butterfly sign installation just shown. The steel plate is 32 inches square and three inches thick – all bolted to a concrete base, which itself is virtually an immovable object.

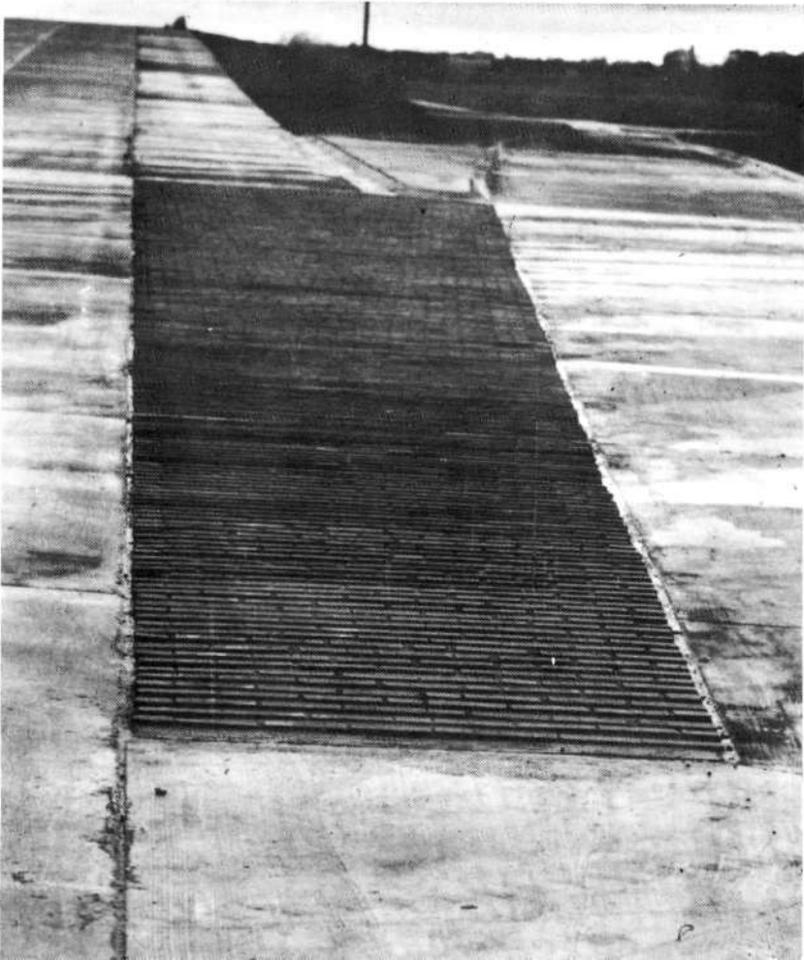
Figure 18. Here is a unique treatment employed at an exit ramp in the neutral area in advance of a gore. A rough surface has been introduced to give an audible and tactual signal to the driver. An area so treated can be quite effective if it is placed in a longitudinal and lateral location which is correctly oriented to the pattern of traffic movement.

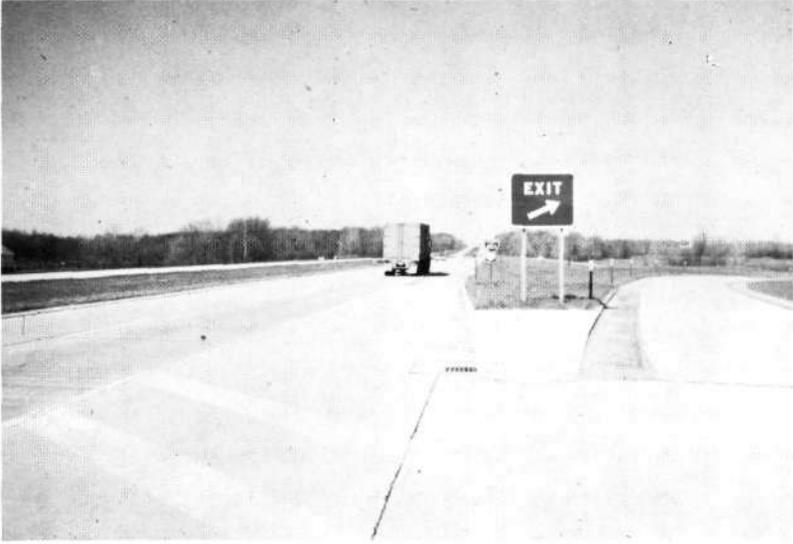
Figure 19. This gore location has several good features. There is a yielding type sign mounting, a nearly flat gore area, and a sloping paved section very slightly raised in the apex of the gore. A driver should be able to drive through this gore without suffering any violent effects.

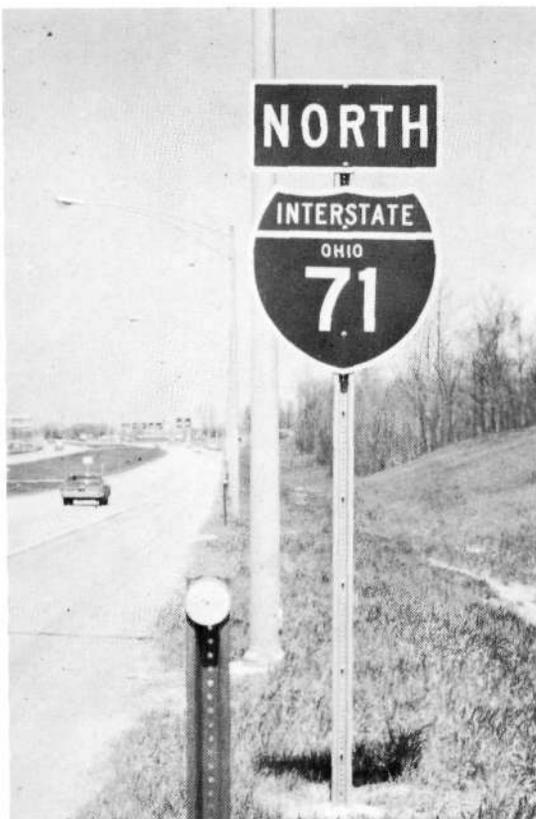
Figure 21 *left*. In some states the supports for the standard Interstate route markers are yielding posts of the U-section type, wood posts or other supports of breakaway design. Elsewhere, the same route markers are mounted on much heavier posts.

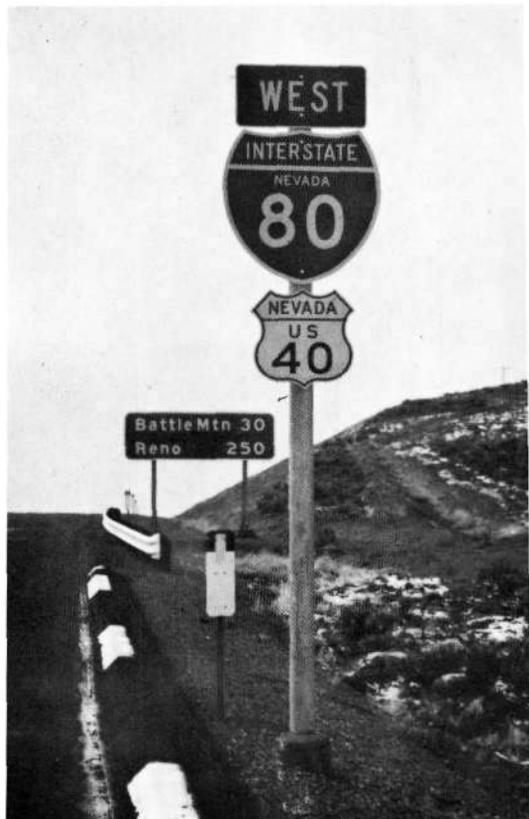
Figure 22 *right*. The support for this Interstate marker is a round steel pole which would not readily yield if hit by a vehicle. It could be made safer if located farther from the roadway or behind the guardrail installation in the background.

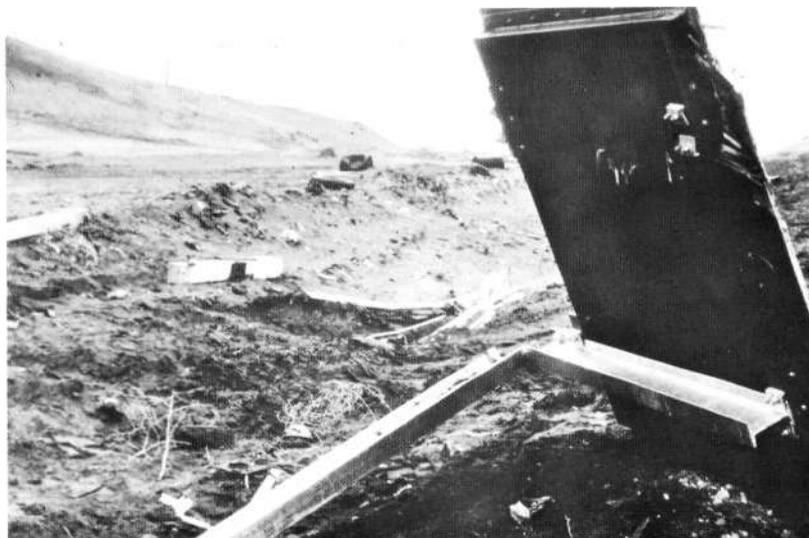
Figure 23. The performance of a breakaway sign frequently results in destruction of the installation instead of the vehicle or its occupants. The intended action occurred in the hinge joint just below the sign and at the base of the sign support, permitting the car to go on through without serious injury.

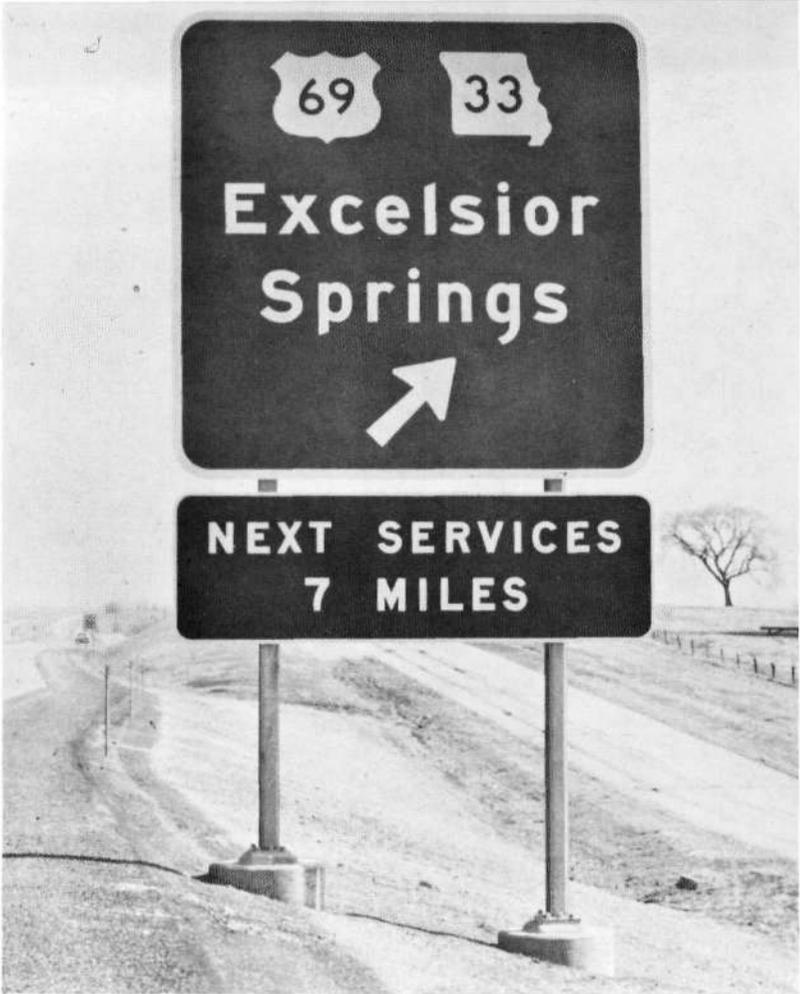
Figure 25. Three factors make this sign installation hazardous. It is unnecessarily close to the traveled way, the supports are massive, and the concrete footings are far enough above ground level to cause damage.

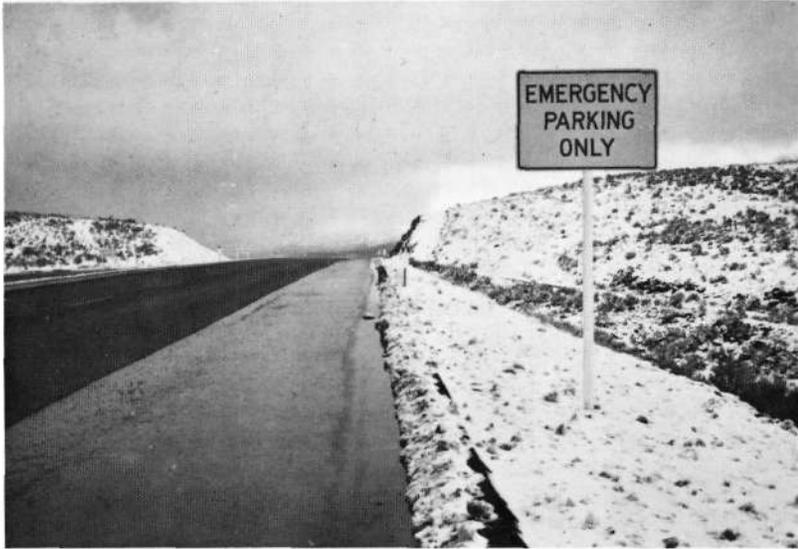
Figure 27. The “emergency parking only” sign is one more sign that should be used on a selective basis according to need.

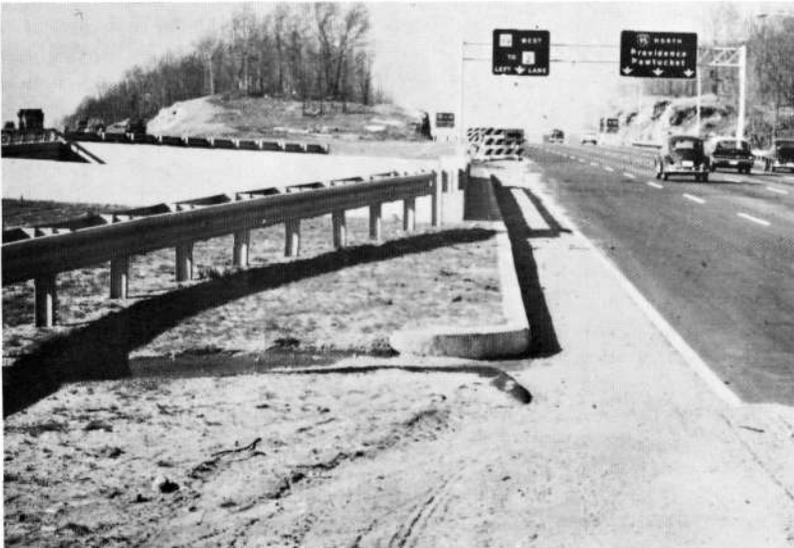
Figure 28. The combination of the guardrail and the roadside curb constitutes a noticeable deficiency because of the lack of harmony in their alignment. Early planning and coordination of all features of the roadside will avoid this problem.

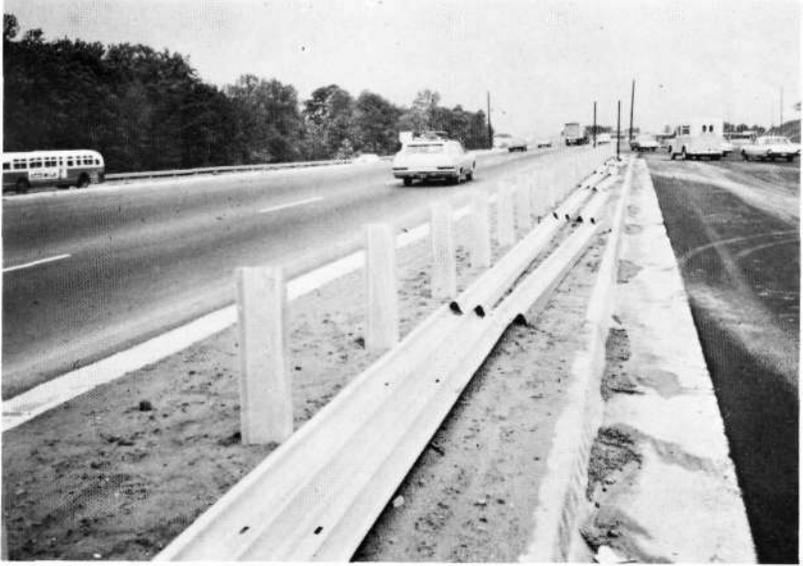
Figure 29. Here the median barrier is being constructed on a raised median. The curb is not likely to improve the performance of the barrier.

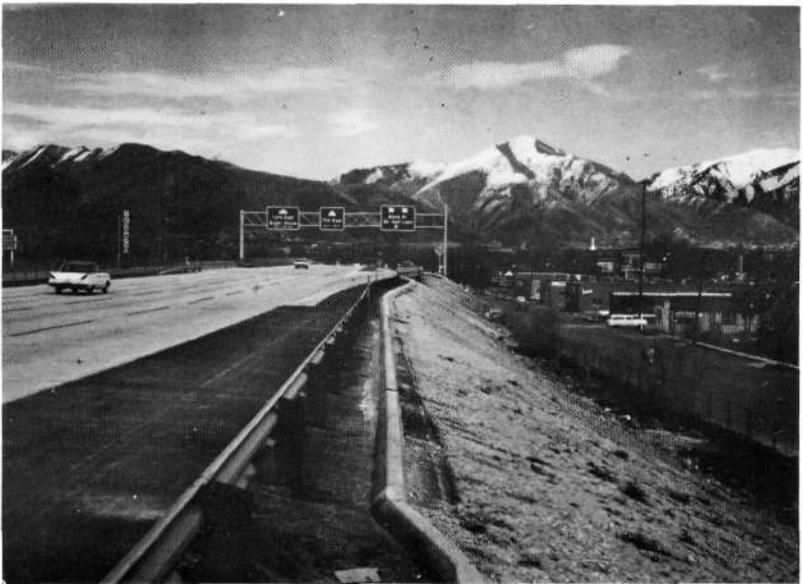
Figure 30. Effective use of curbs on Interstate freeways is important to safety. This curb is located behind the guardrail out of the line of traffic and performs an essential drainage function.

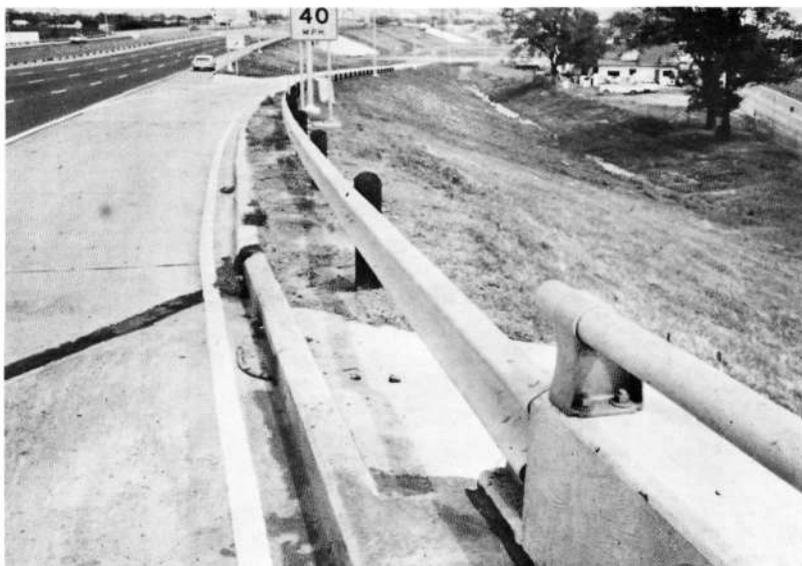
Figure 31. On this project the curb is in front of the guardrail, in contrast with the preceding illustration. With such a condition, a vehicle may be airborne before it strikes the barrier. A clear level surface in front of any barrier helps to assure that it will perform in the manner for which it was designed.

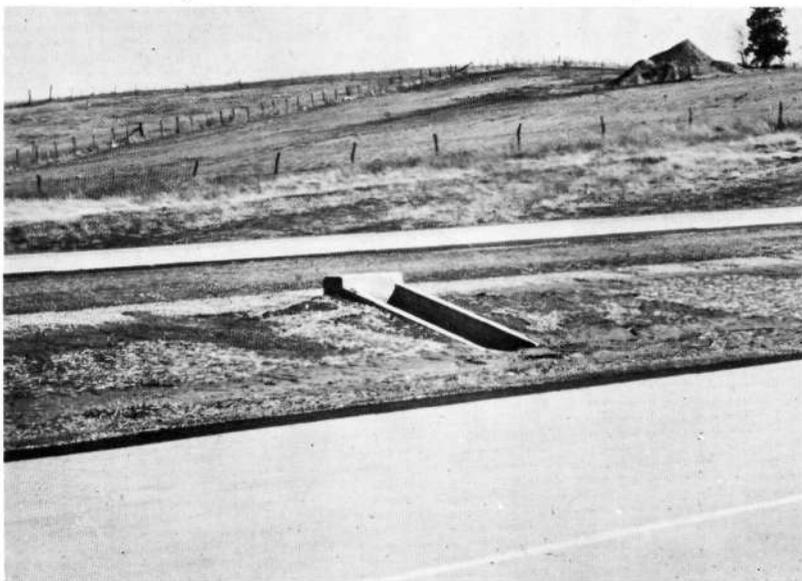
Figure 32. A headwall left unnecessarily high in the median presents a hazard when other roadside conditions are favorable.

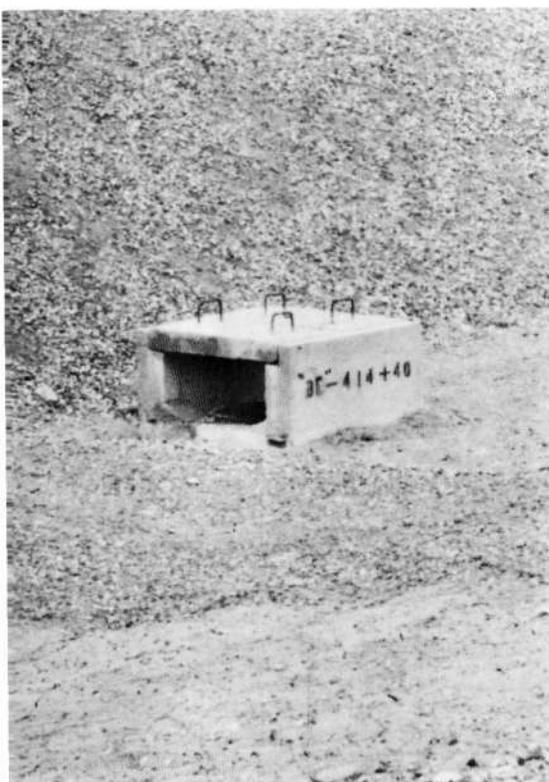
Figure 33 *left*. A concrete box inlet that projects above normal ground level as this one does is an obvious obstruction for vehicles that happen to stray into the median at this point.

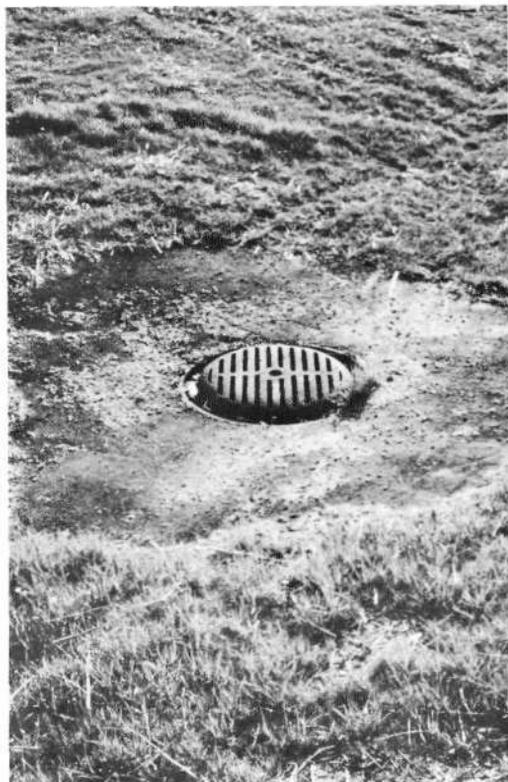
Figure 34 *right*. There are several designs of flush median inlets that function well and cause no problem for vehicles that inadvertently get into the median area.

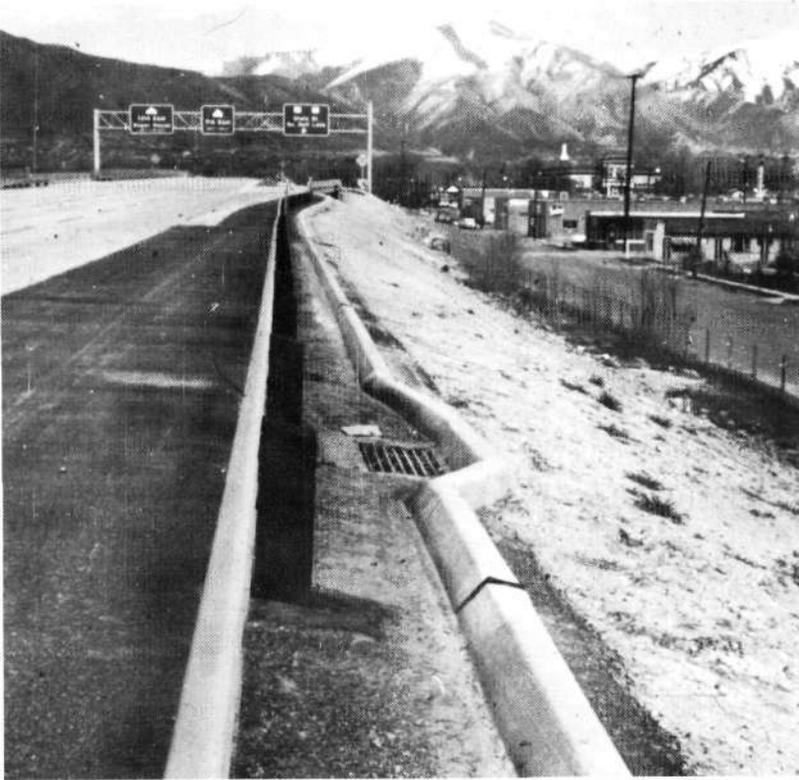
Figure 35. This drainage system is entirely behind the guardrail on a project built within a relatively limited width of right-of-way. It appears to be performing satisfactorily and presents no roadside hazard.

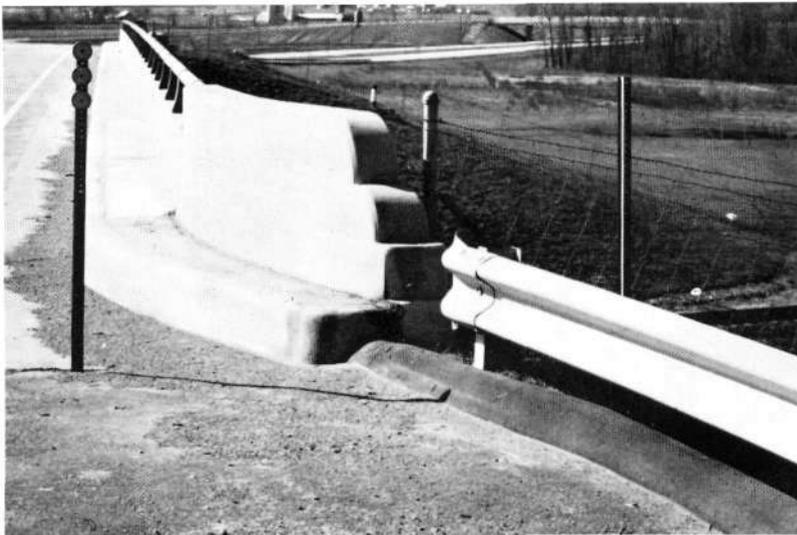
Figure 36. Roadway shoulders should be extended with their full width across bridge structures. In this case, the bridge roadway shoulder was only partial width, which builds in a roadside hazard.

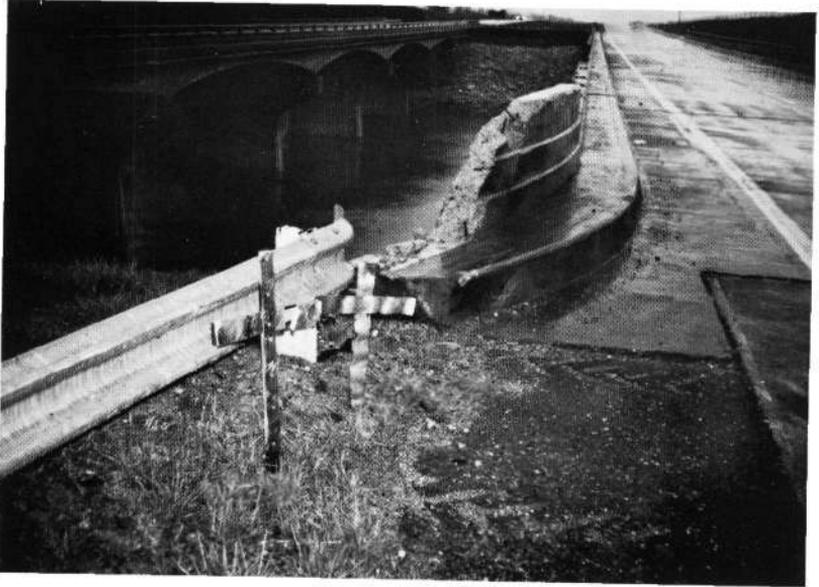
Figure 37. This is a scene of a double fatality. A vehicle struck a bridge parapet where the design was similar to that shown in the previous picture.

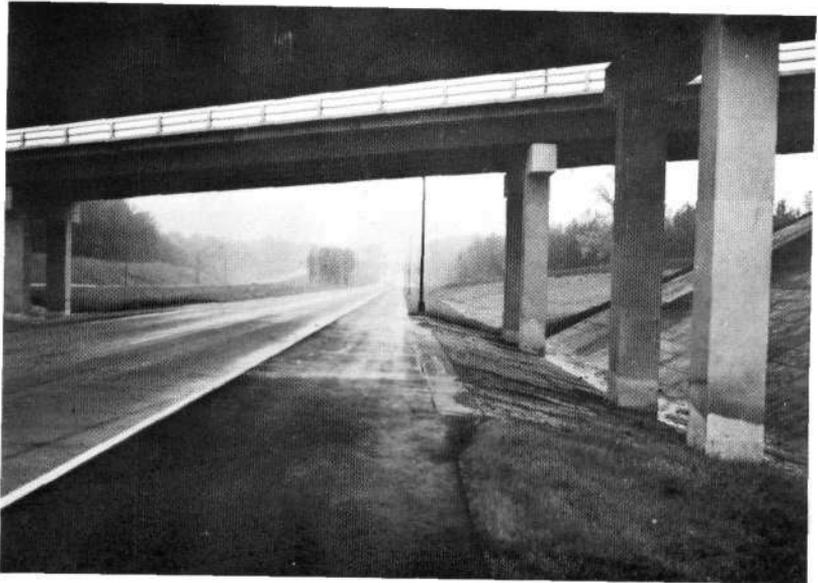
Figure 38. Where multiple piers carry twin bridges over this Interstate route, there are four destructive targets on each side.

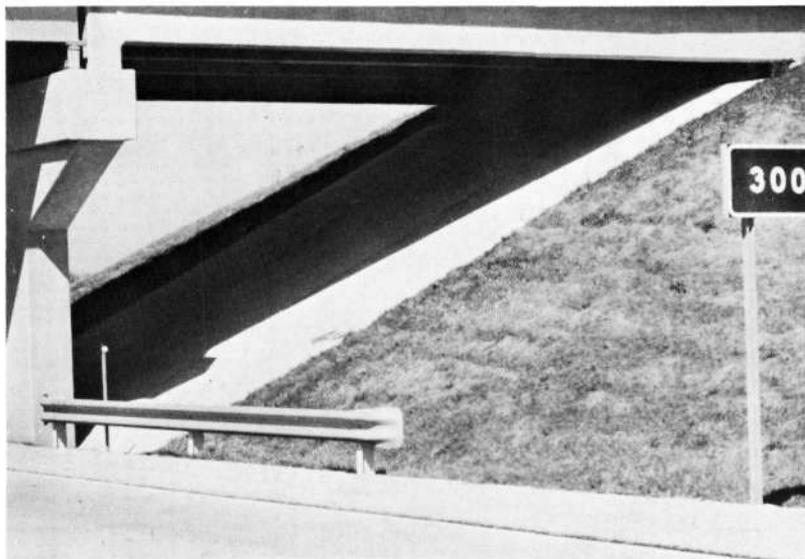
Figure 39. On this project, only one section of guardrail 25 feet long is used in advance of the side piers. This is too short to give any real protection to drivers who run off the roadway.

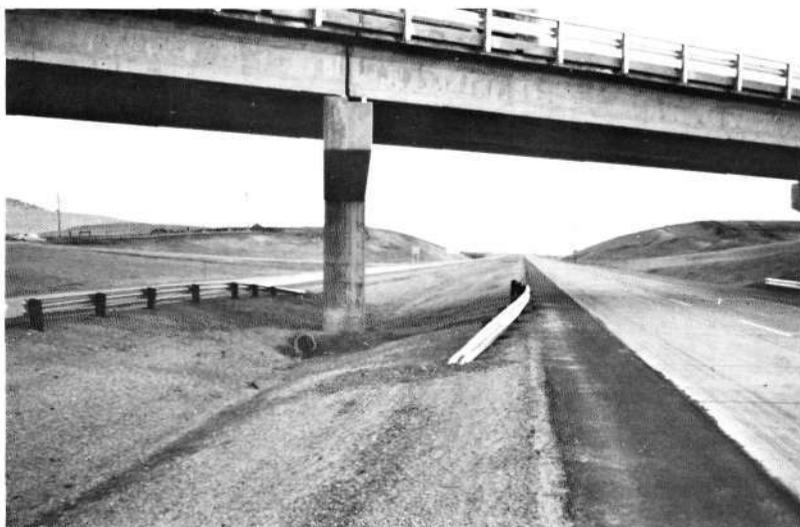
Figure 41. This guardrail at a bridge pier in the median has a good approach end treatment but would be a more effective shield if it were extended farther in advance and placed closer to the center pier.

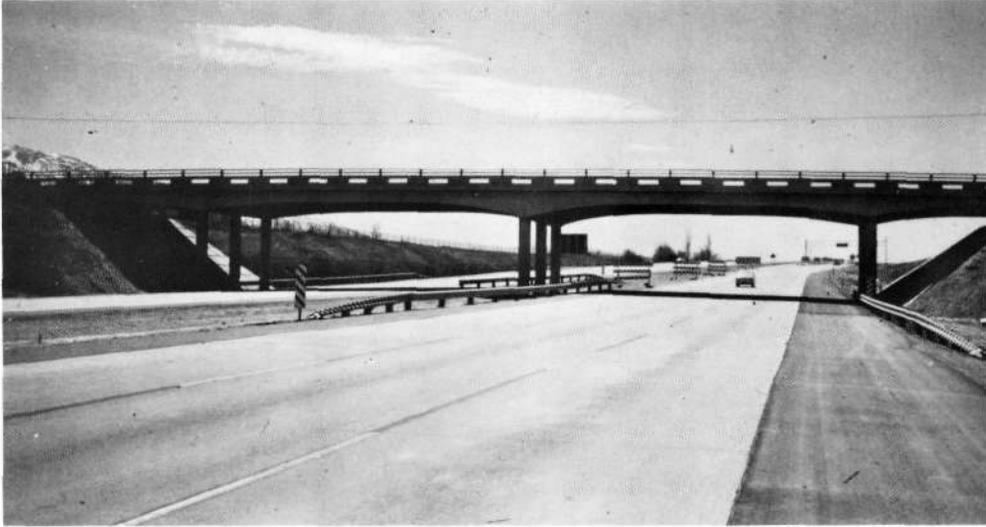
Figure 43. Guardrail ends are flared slightly away from the roadway and rail is carried through the undercrossing. This makes it much less likely that a motorist will come in contact with the concrete piers in the median or at the roadside.

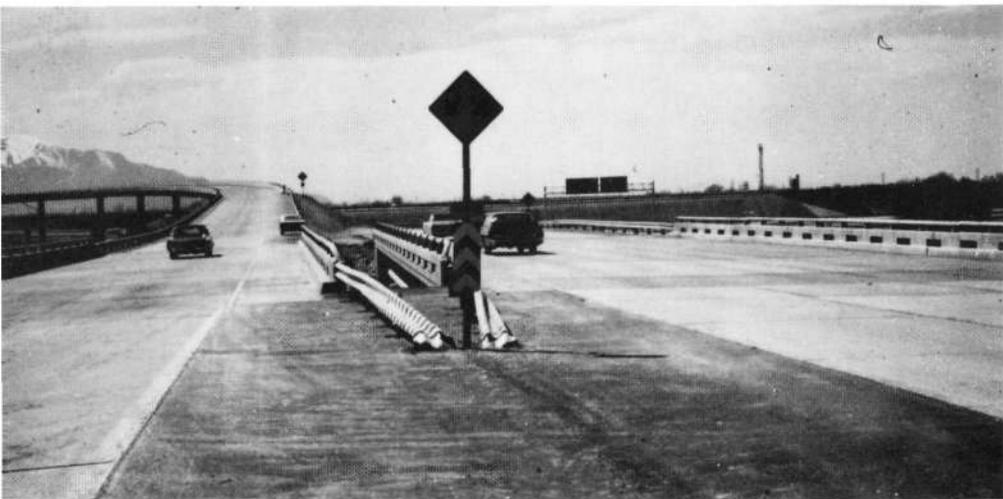
Figure 45. Here the two bridges are so close together that it is difficult to understand why a single structure would not be safer and more economical. With the single structure, the two parapet walls and the advance guardrail in the median would naturally be eliminated.

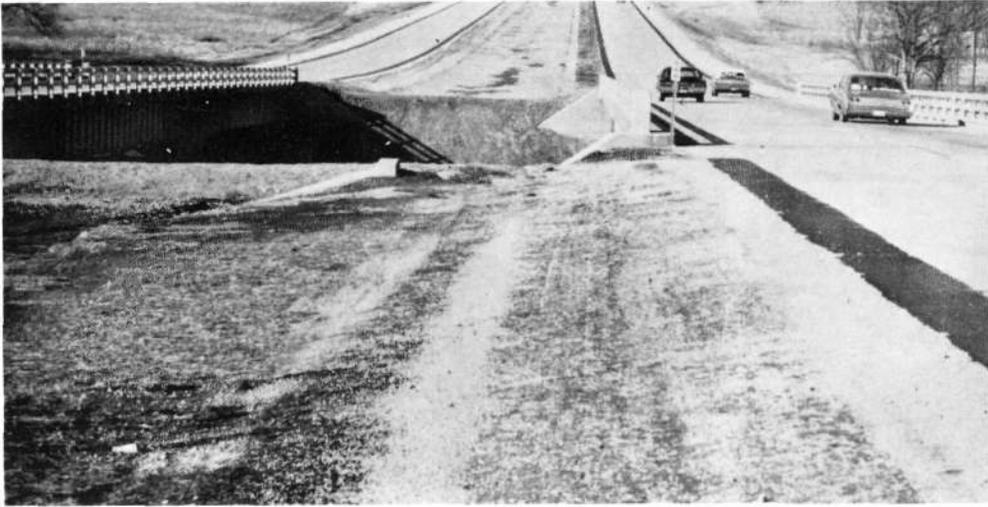
Figure 47. Here is a dual bridge where there is no protection on the median side to prevent drivers who stray into the median from dropping to the roadway below. The culvert headwall exposed near the center of the opening is an additional feature contributing to the hazard potential of this location.

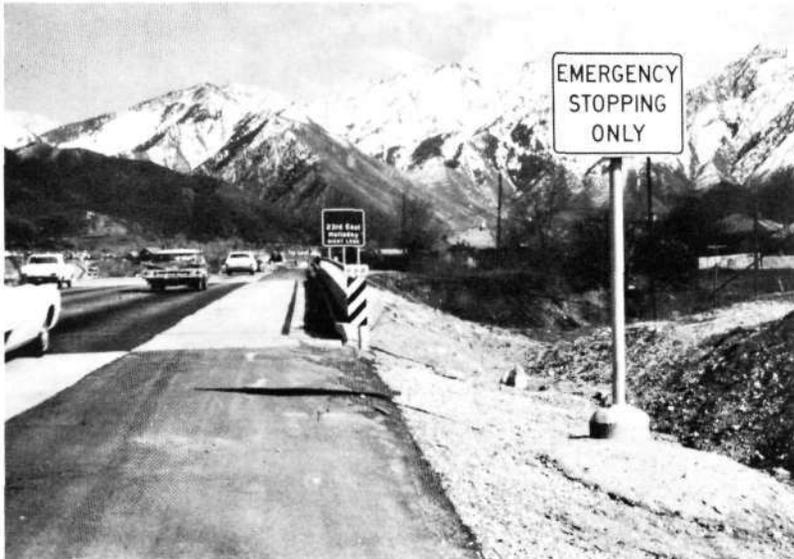
Figure 48. There is no approach guardrail in advance of this structure. The exposed concrete parapet wall is marked only by a reflectorized bridge panel. The sign message adds an ironic touch.
