ROADSIDE HAZARDS

An Evaluation of Roadside Hazards
on the Interstate System

THE ENO FOUNDATION FOR HIGHWAY TRAFFIC CONTROL, INC.
SAUGATUCK, CONNECTICUT, 1968

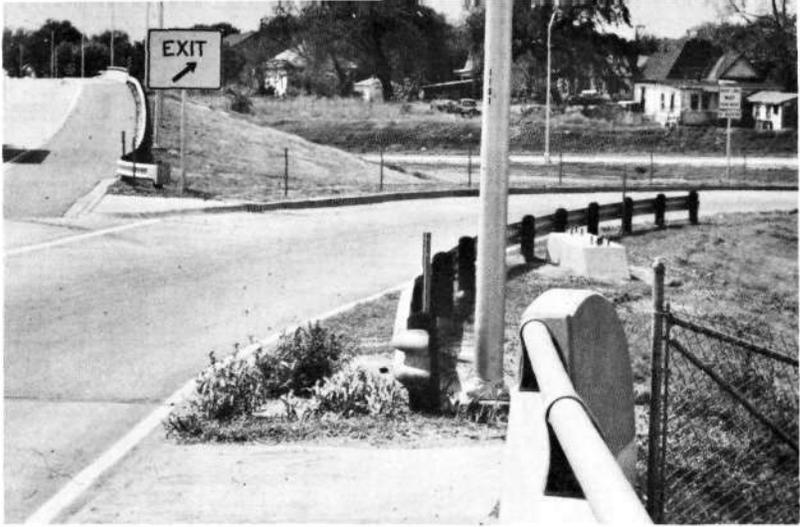
Figure 49. Better lateral location of the guardrail and the light standard in relation to the bridge railing would have prevented this irregularity in the cross-section. Note the large concrete footing in the right background. Such footings should be kept at ground level wherever exposed.

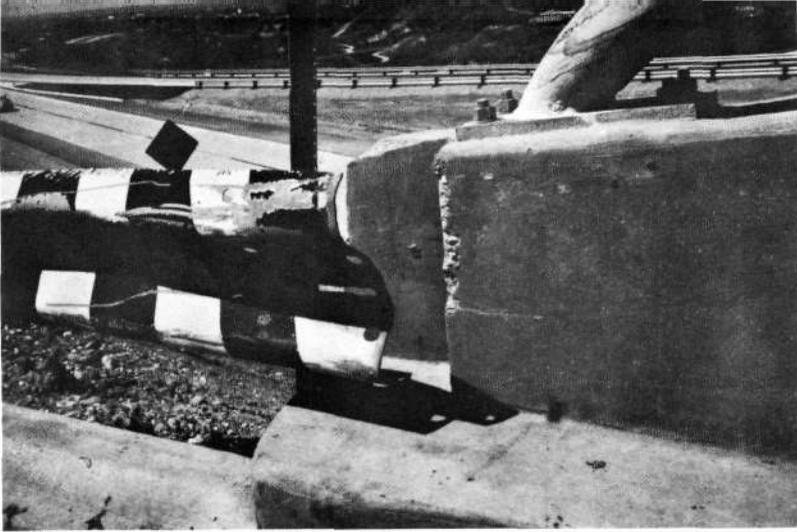
Figure 51. This is a view of a transition installation that was struck by a passing vehicle. The single bolt and relatively weak anchorage are not adequate for the violence of a traffic collision.

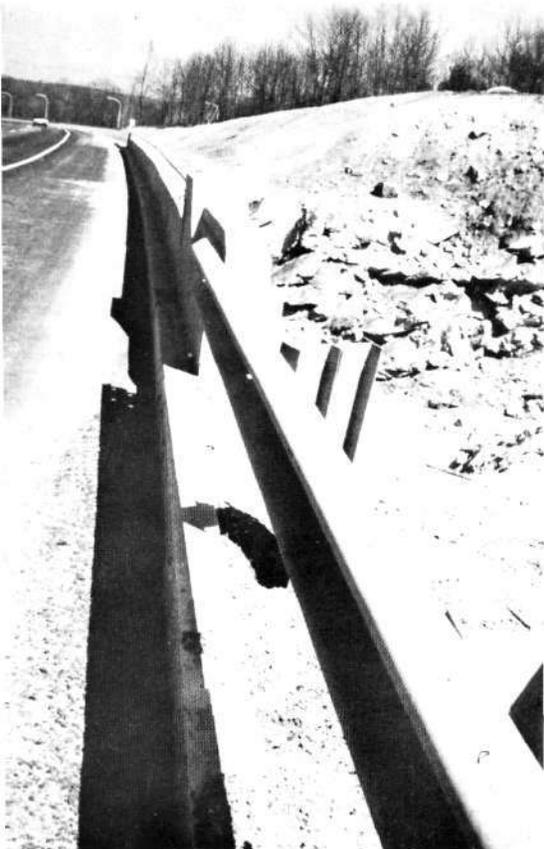
Figure 53 *left*. The favorable feature here is the overlapping of the approach guardrail on the bridge parapet. The lateral strength of this transition may be questionable but it does provide some smooth sliding surface for vehicles that stray off the roadway.

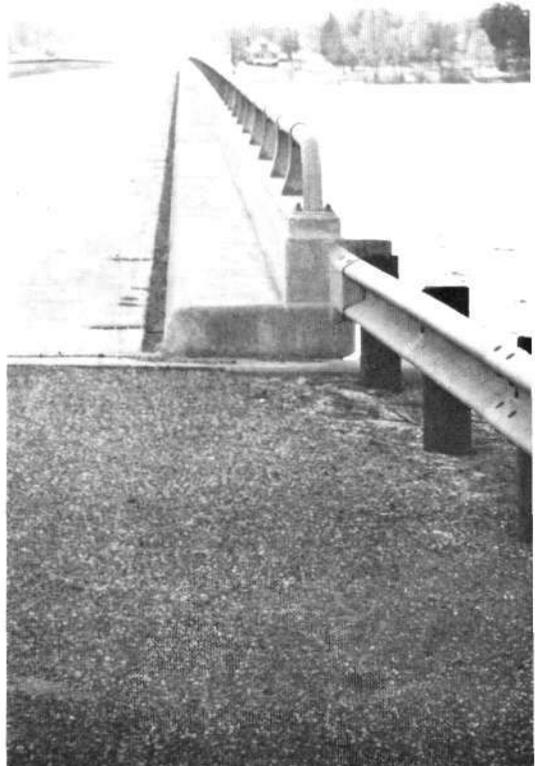
Figure 54 *right*. At this structure, no anchorage is provided between the guardrail and parapet wall, and the safety walk and curb limit the effectiveness of the bridge railing.

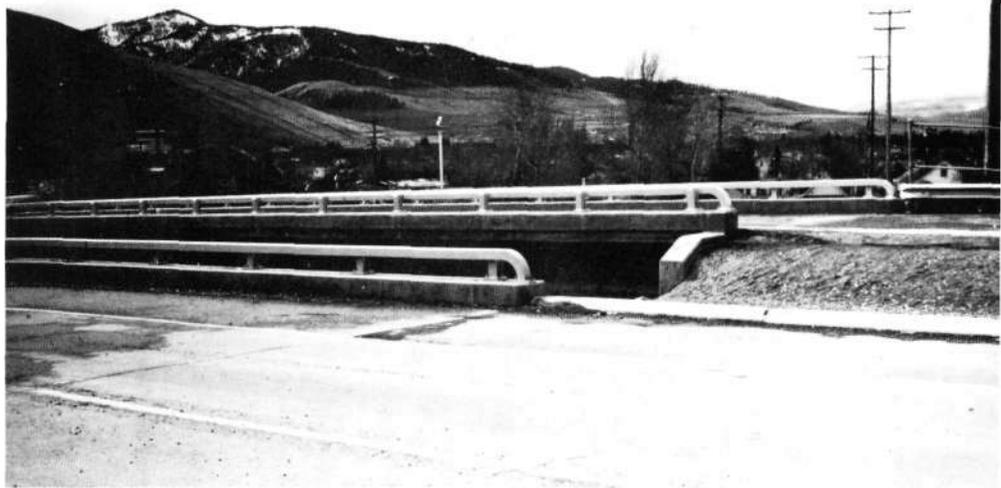
Figure 55. At this dual bridge, where the transition from guardrail to bridge railing has been largely ignored, the bridge rail is quite low, no more than 27 inches above the roadway.

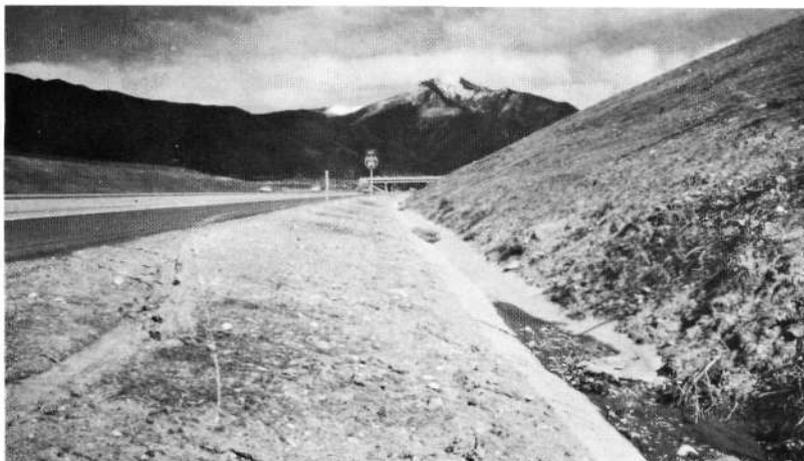
Figure 57. The paved V-ditch at the bottom of the side slope is a substantial hazard and vehicles leaving the roadway at this point might readily overturn. A ditch with a rounded bottom would have superior safety characteristics.

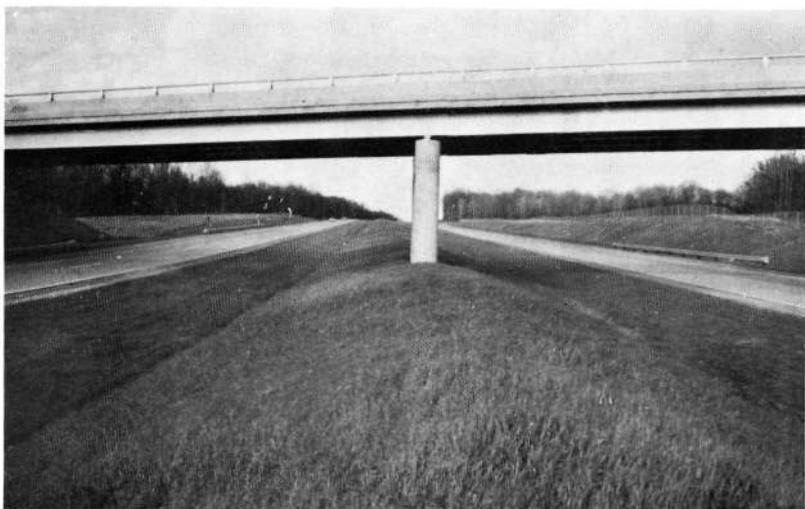
Figure 58. Good attention was given to slopes and separate drainage for each roadway. The mounded median in the vicinity of the center piers on this project gives a degree of protection against this hazard for vehicles that leave the roadway.

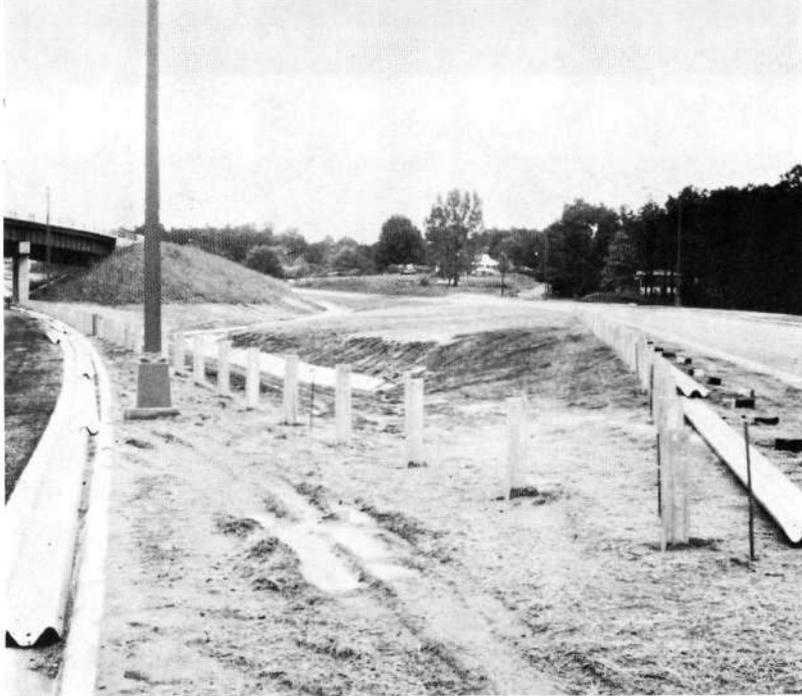
Figure 59. Light standards located too close to the roadway edge make little contribution to safety. The guardrail here is behind the light standards. The gore area itself is quite flat and the need for guardrail in such a situation would seem to be open to question.

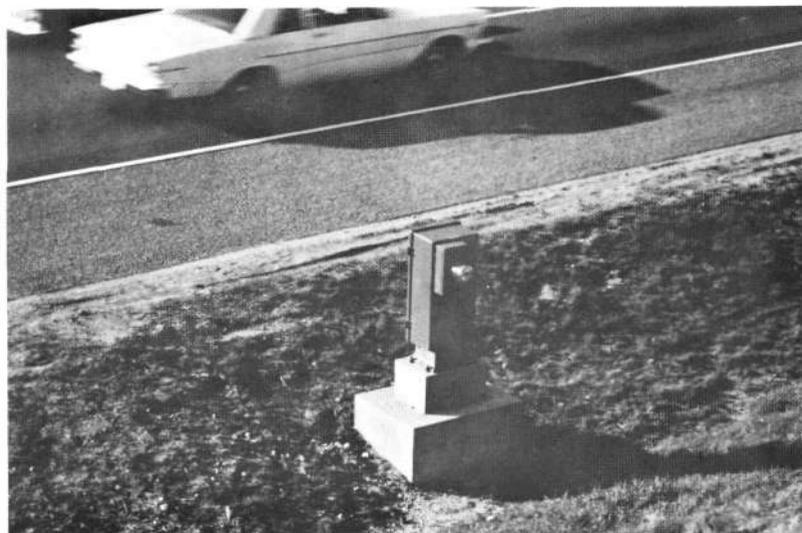
Figure 60. Units to control roadway lighting are sometimes placed close to the edge of the traveled way. If proper advance consideration has been given to safety, this hazard need not exist.

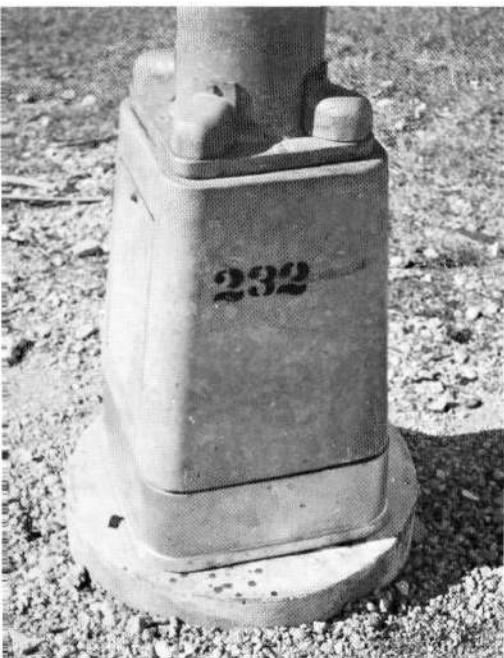
Figure 61 *left*. The slip-base unit shown can be used to adapt otherwise hazardous light poles to a safer design. When this installation is hit by a car, the lower section breaks readily and the pole is easily dislodged. The frangible insert can be rather cheaply added at many locations, sometimes for as little as \$25 per pole.

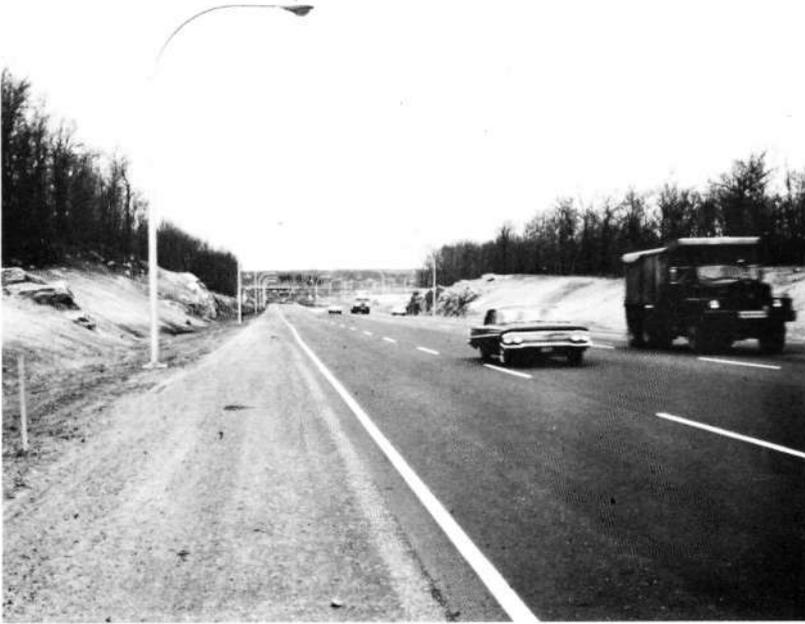
Figure 63. In some states, light standards made of frangible metal are not shielded in any way with guardrail installations. Because guardrails are themselves a hazard, they should not be used except when the consequences of their installation are less severe than would be true if they were not installed.
