**SAFETY PERFORMANCE EVALUATION OF  
THE STEEL-BACKED LOG RAIL**

Transportation Research Report No. TRP-03-35-92

**FHWA Contract No. DTFH71-90-C-00035**

December 1992

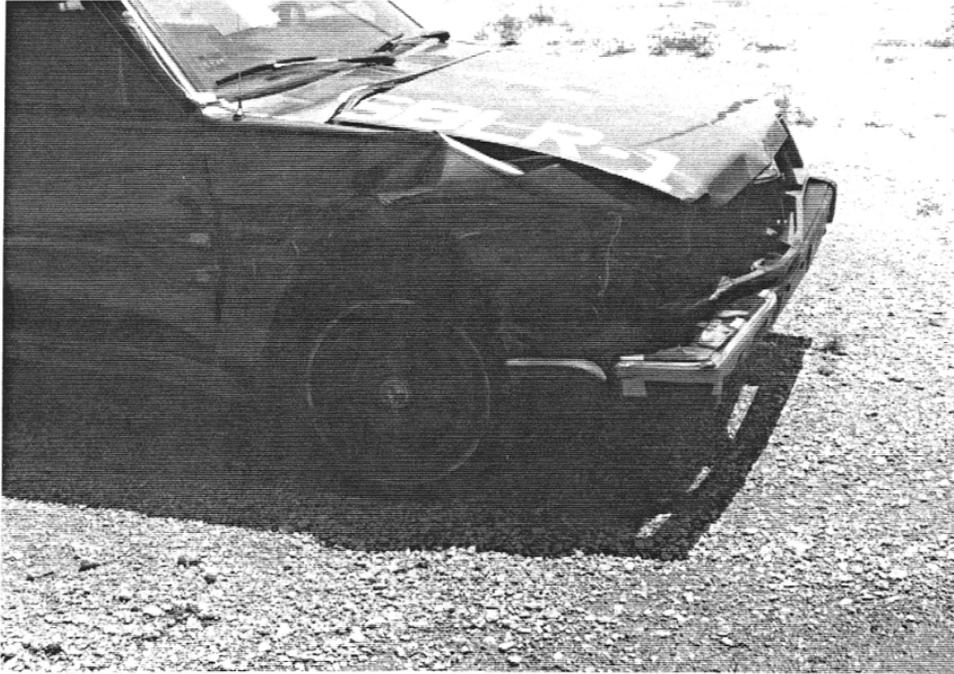
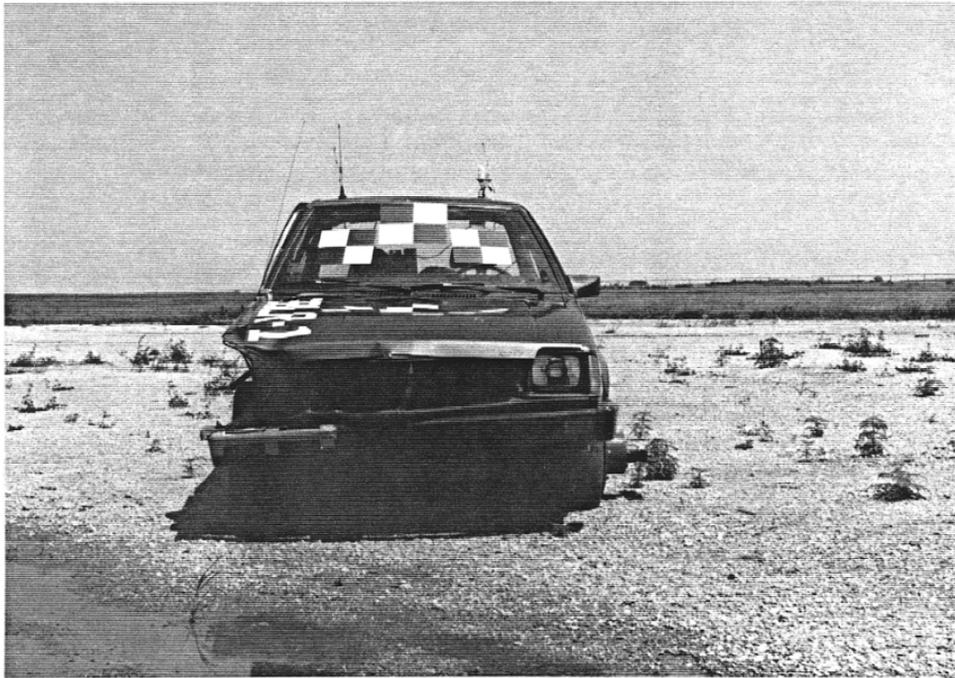
**FIGURE 16.** Vehicle Damage, Test SBLR-1

Test vehicle damage was relatively minor and was largely limited to the right-front quarter panel and passenger door, as shown in Figure 16. There was no intrusion or deformation of the occupant compartment. Vehicle crush measurements are shown in Figure 17.

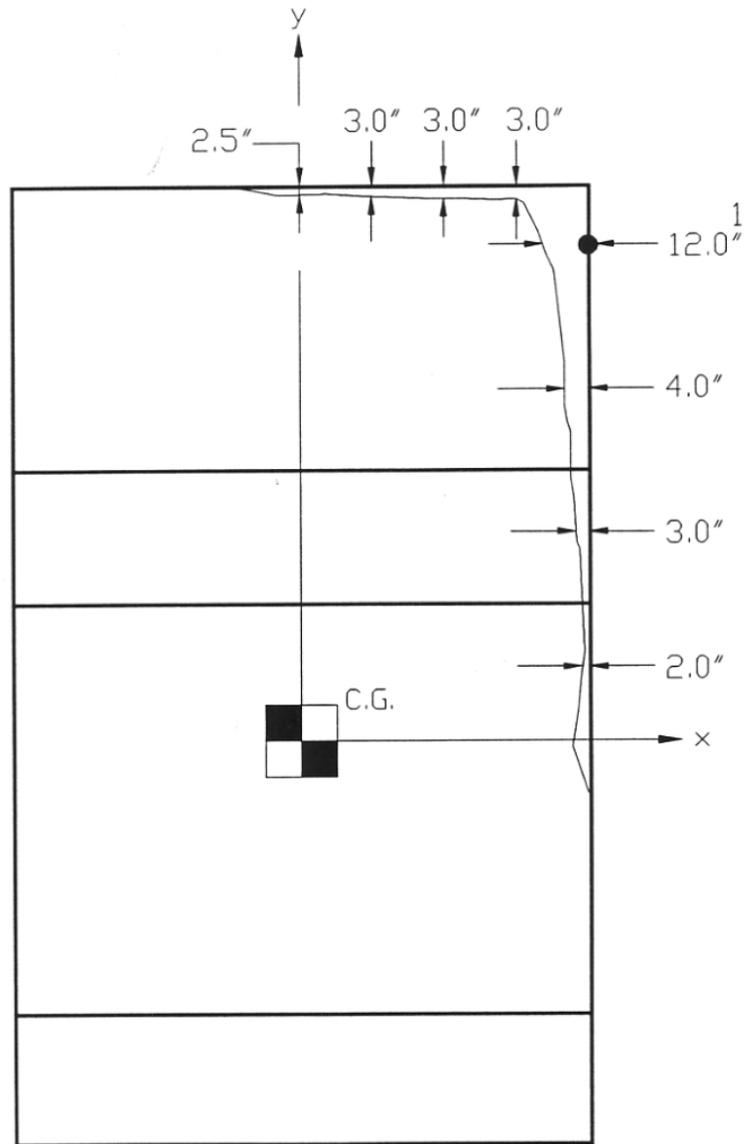
**FIGURE 17. Vehicle Crush Measurements, Test SBLR-1**

<sup>1</sup>-Maximum static crush distance of 12" occurred at (24",54") marked by the point.

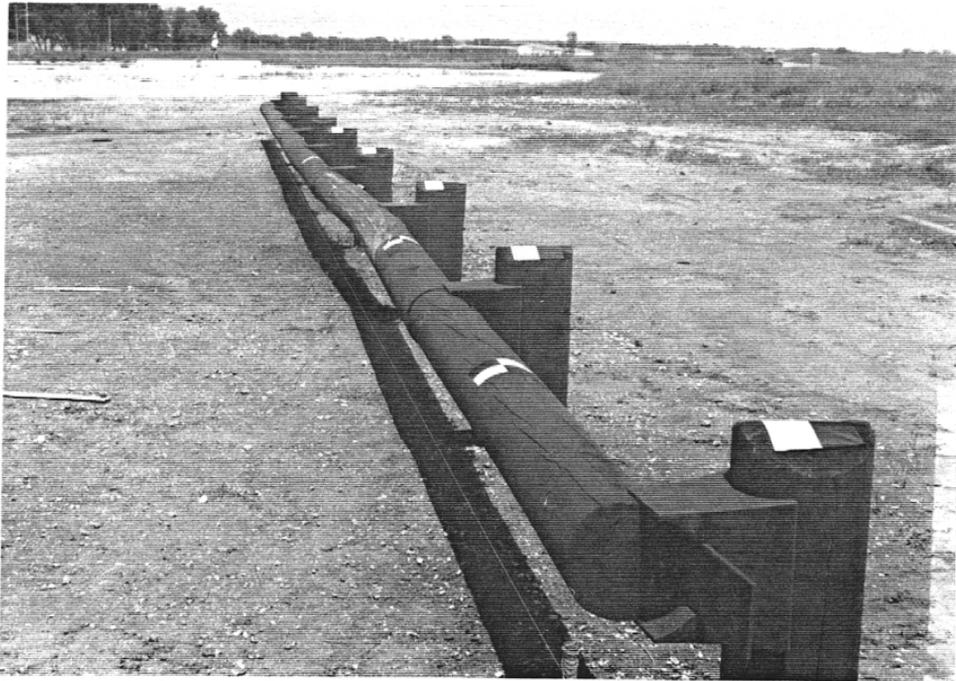
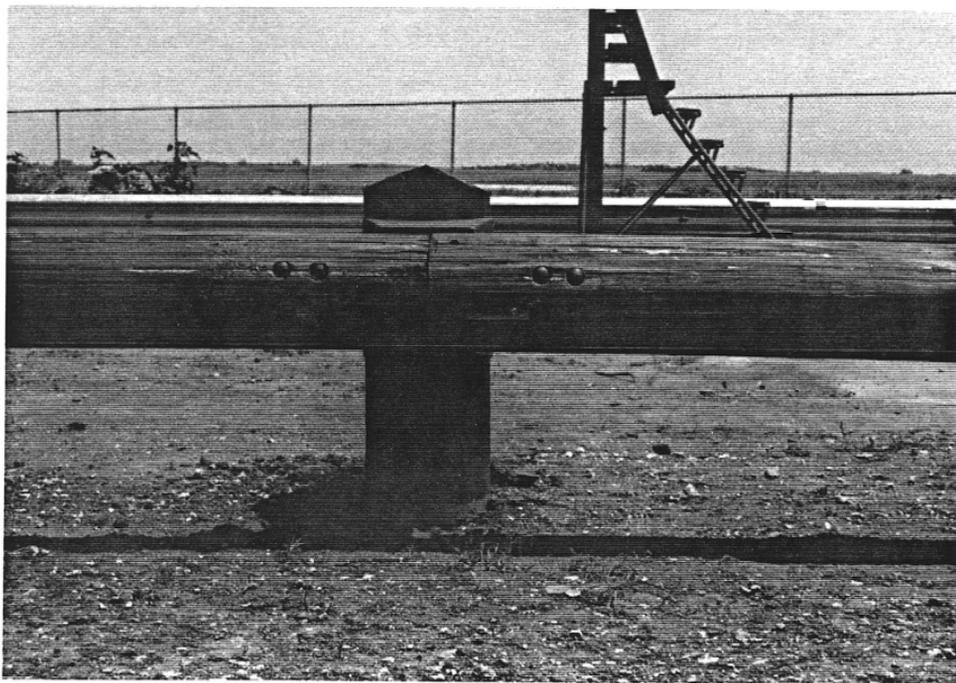
**FIGURE 18.** Log Rail Damage, Test SBLR-1

Damage to the Log Rail consisted of minor scrapes on the surface of the rail and a maximum permanent deflection of  $2 \frac{1}{16}$  in. at the first post after impact. This damage can be seen in Figure 18. The effective coefficient of friction was found to be 1.02 and would be classified as "marginal" according to the AASHTO Guide Specifications for Bridge Railings (5).

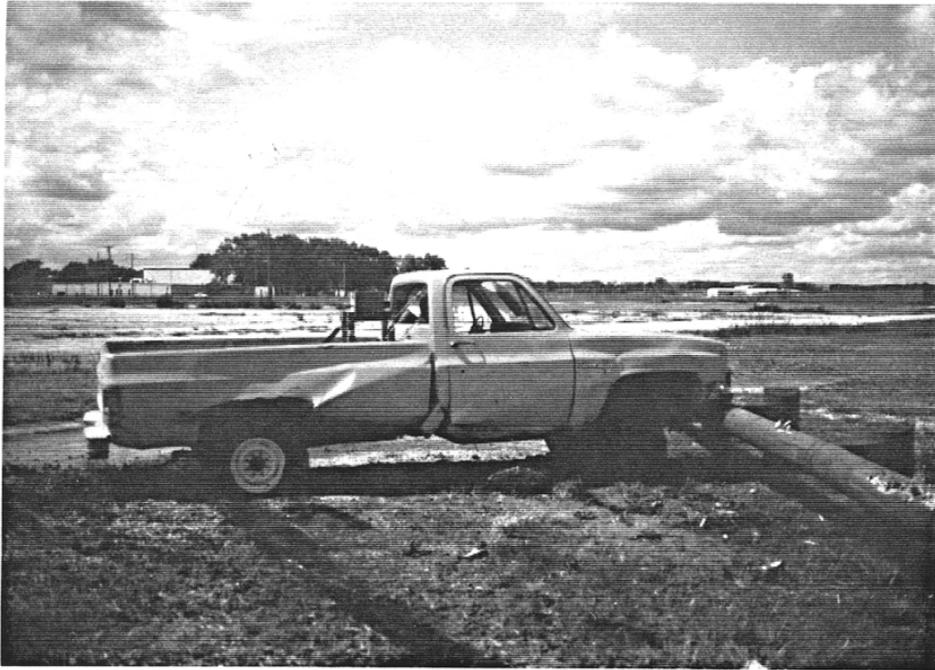
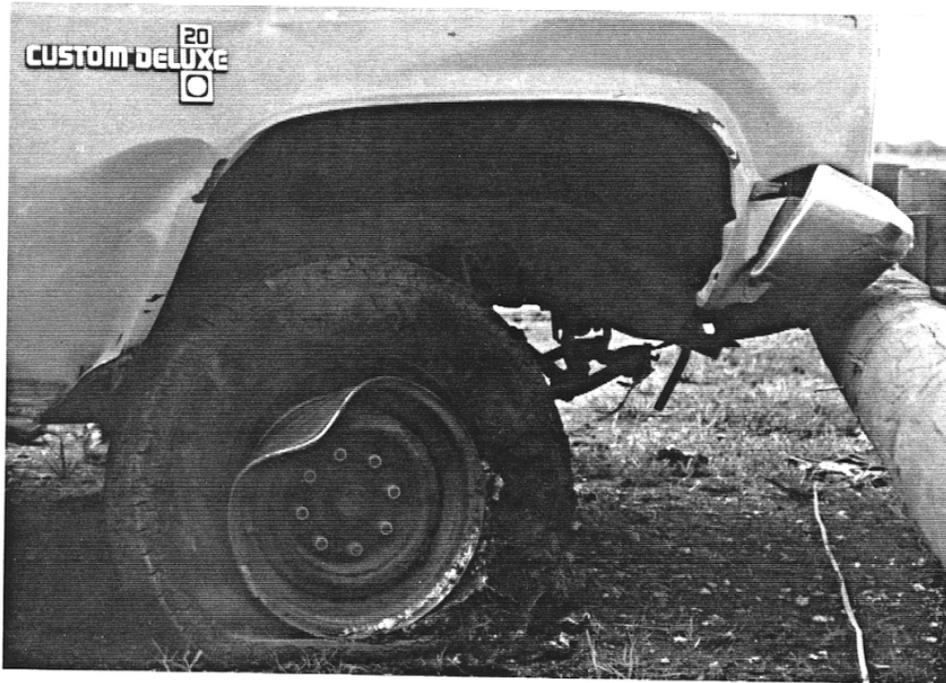
**FIGURE 24.** Vehicle Damage, Test SBLR-2

Test vehicle damage, shown in Figure 24, was limited to the undercarriage on the right-front corner and along the right side. Vehicle crush measurements are shown in Figure 25. The vehicle remained upright both during and after the test, and there was no intrusion of the occupant compartment.

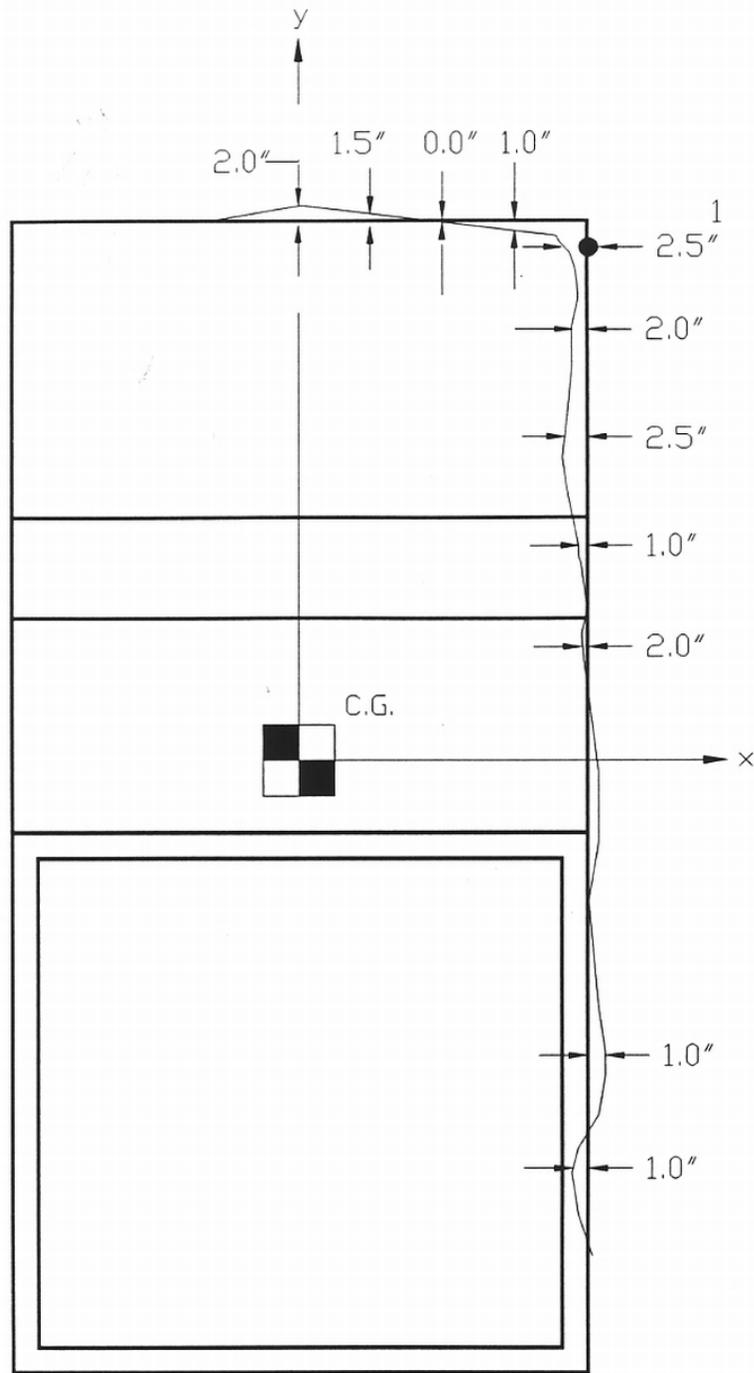
**FIGURE 25.** Vehicle Crush Measurements, Test SBLR-2

<sup>1</sup>-Maximum static crush distance of 2.5" occurred at (36",96") marked by the point.

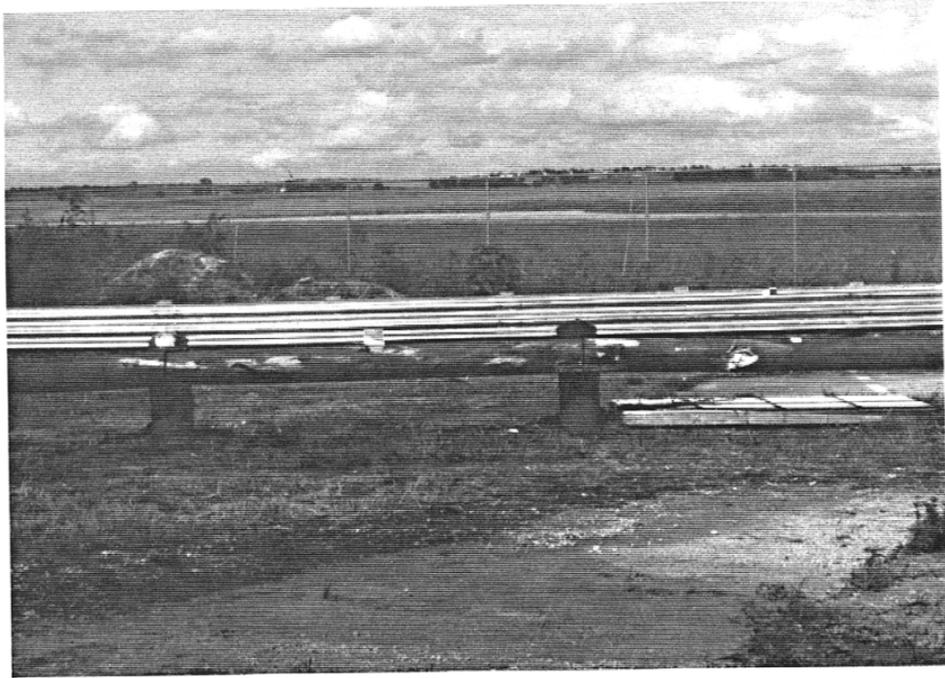
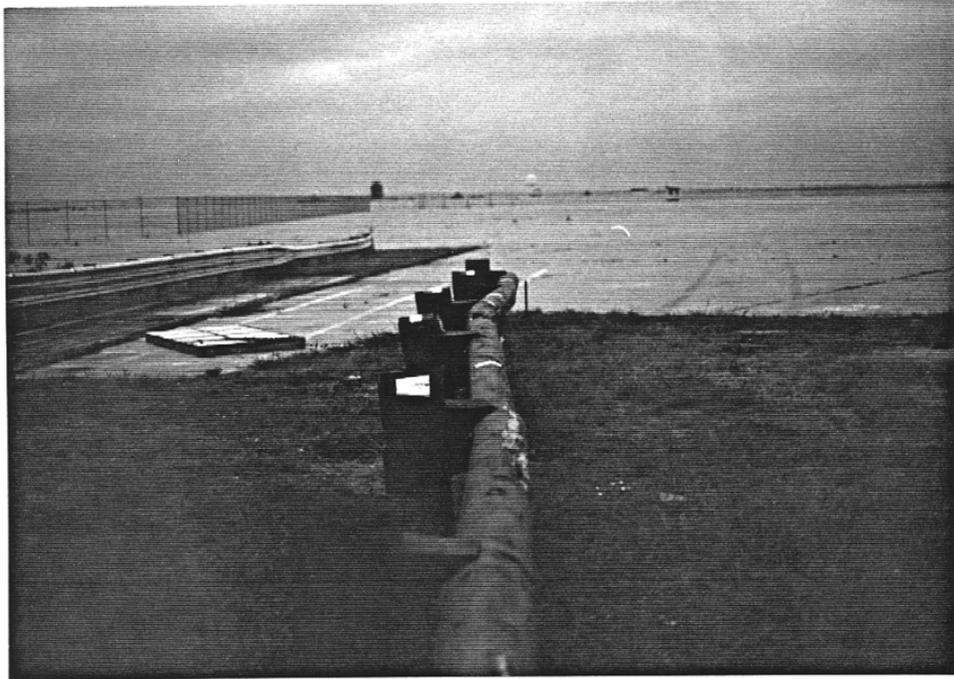
**FIGURE 26.** Log Rail Damage, Test SBLR-2

Damage to the log rail consisted of scrapes and gouges along the traffic face and at some of the posts. A maximum permanent deflection of 9 1/8 in. was measured at Post No. 3. The damaged barrier is shown in Figure 26.
