Report No. FHWA-KS-07-6
FINAL REPORT

THE EFFECTIVENESS OF THE FLY-ASH SLURRY INJECTION METHOD TO ELIMINATE DEPRESSED TRANSVERSE CRACKS

Victoria Felker
William H. Parcels, Jr., P.E.
Kansas Department of Transportation
Topeka, Kansas

January 2009

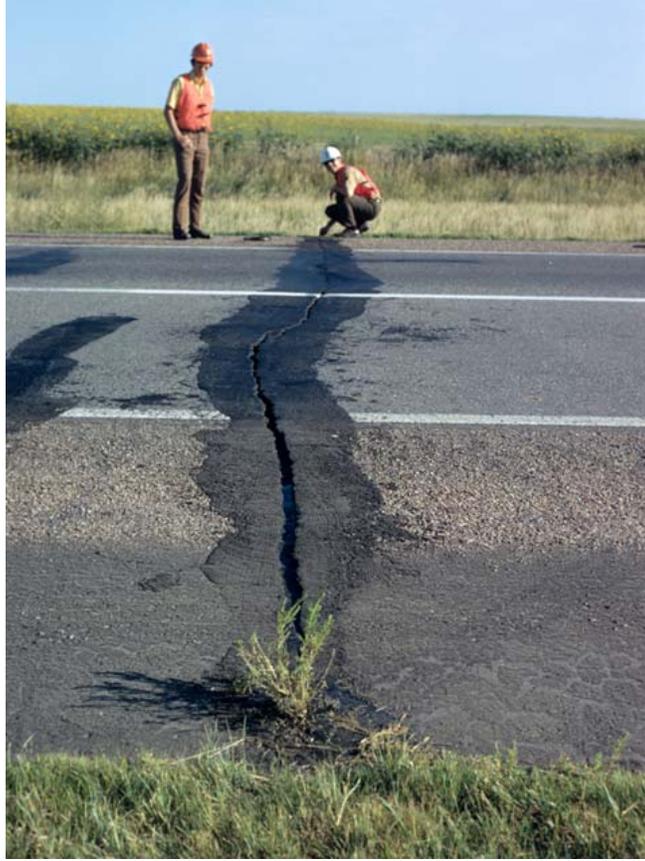
Figure 1: Transverse cracks on I-70

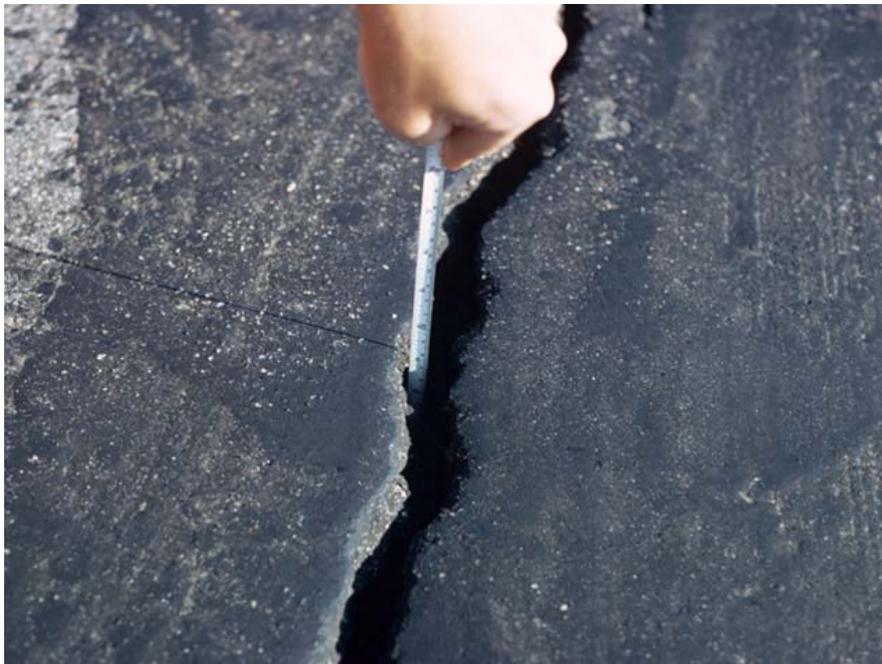
A review of the history of transverse cracking on I-70 in the western half of Kansas reveals that very wide cracks (top down, shown in Figure 2) developed in cold weather, and no suitable treatments were available from the 1960s through the 1980s. Maintenance forces continually tried to seal the cracks; however, the cracks continued to grow wider and the depression deeper. It was common to have cracks about 60 ft. apart 4 to 5 in. wide, depressed 2 to 3 in., and extended across all lanes and the shoulders. Pavements were all built during the 1960's utilizing primarily local materials (high % sand-gravel). After 27 years, it was estimated that over a mile of pavement had been "lost" on this 250 mile section of I-70 (Ramamurti and Jayaprakash 1987).

Figure 2: The nature of transverse cracking asphalt pavements on I-70

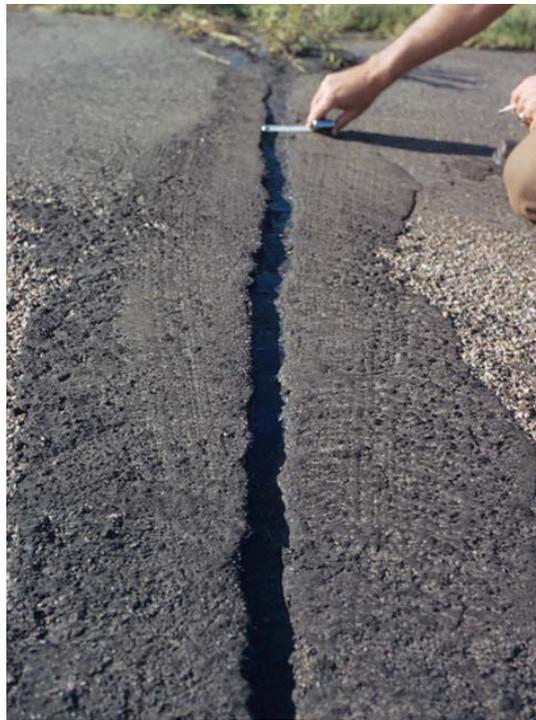
Transverse cracking of asphalt pavements is a costly pavement distress occurring in Kansas, which experiences prolonged periods of below freezing temperatures during the winter months. The cracks are caused by low-temperature-induced tensile stresses that exceed the tensile strength of the pavement material. Another factor that may have contributed to the initiation and growth of the transverse cracks was the use of locally available aggregate (sand and gravel) and locally produced asphalt that lacked low-temperature ductility. The majority of these cracks occur in the transverse direction, relative to the pavement and with regular frequency along the roadway shown in Figure 3.

Figure 3: Examination of transverse cracks

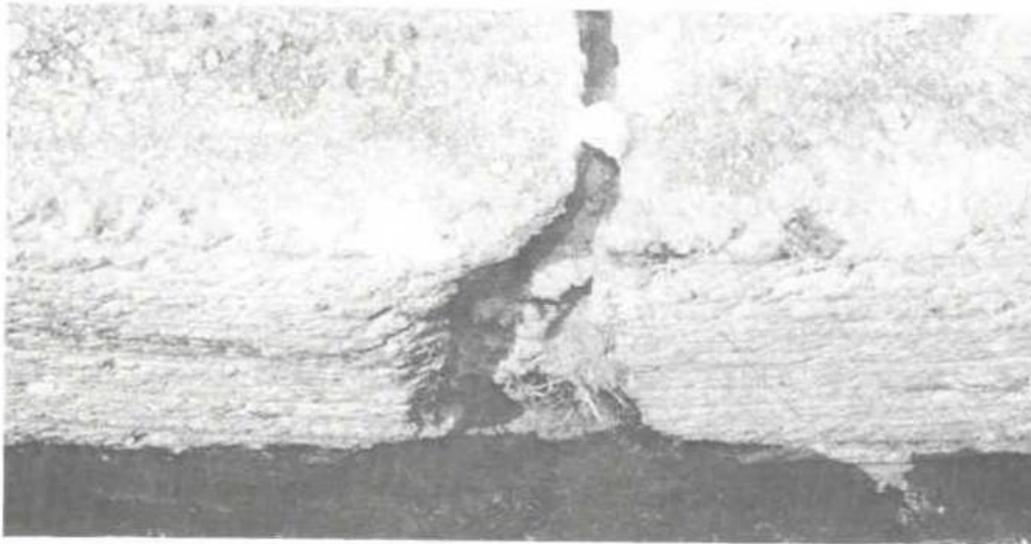
Figure 4: Photograph of vertical profile of crack. Inverted trough shaped deterioration is in the center of the bottom half of the photograph. The transverse crack at the pavement surface shows in upper center of photograph (Ramamurti and Jayaprakash 1987).

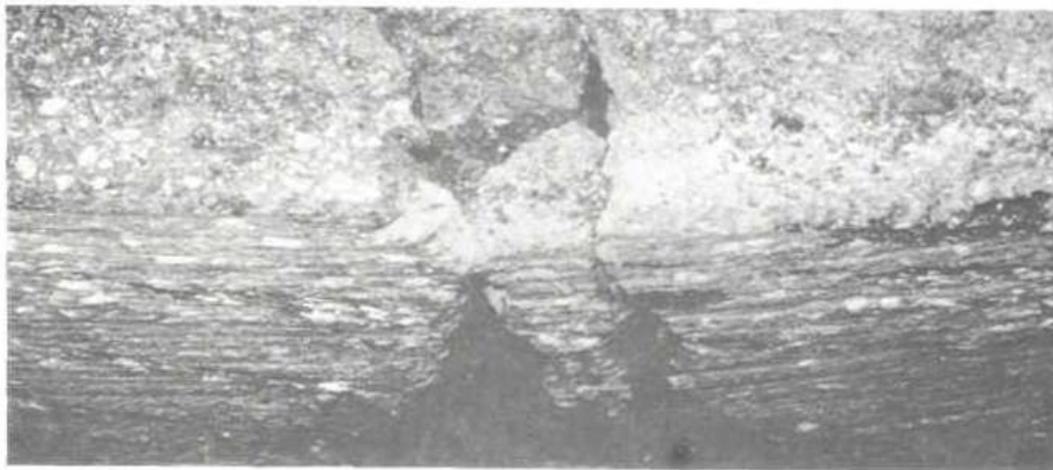
Figure 5: Photograph of vertical profile of a crack. Note the transverse crack width at the pavement surface in the center of the upper half of the photograph. The crack flares out downward. Loosely held rubble like material in the center of the deteriorated area (Ramamurti and Jayaprakash 1987).

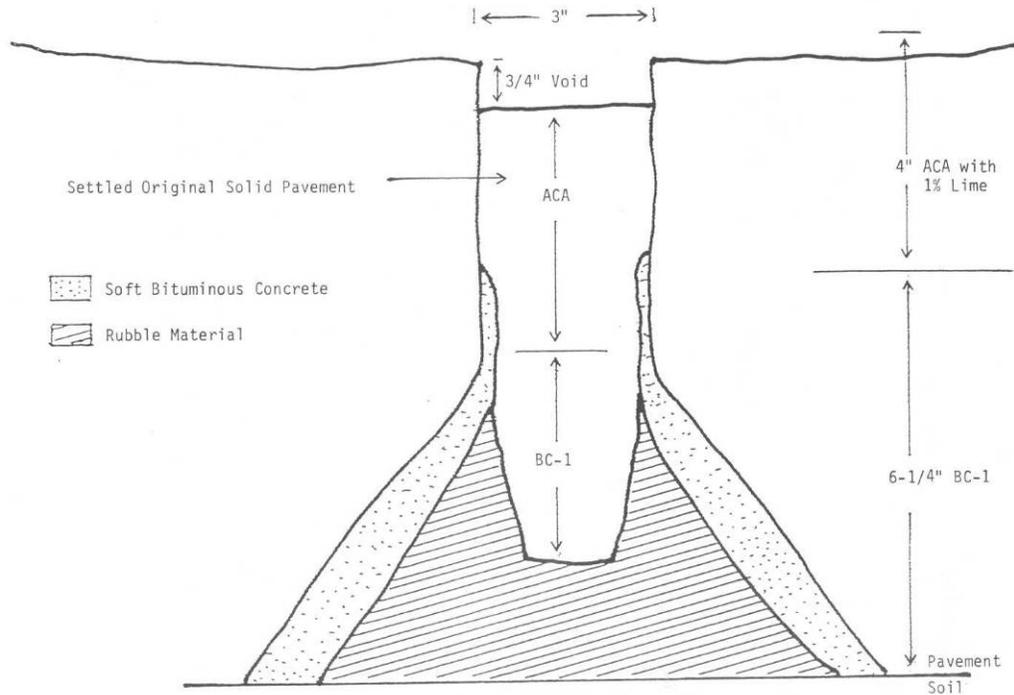
Figure 6: Vertical profile at a transverse crack in bituminous pavement. The inverted trough shaped deterioration is mostly within BC-1 with no added lime (Ramamurti and Jayaprakash 1987).

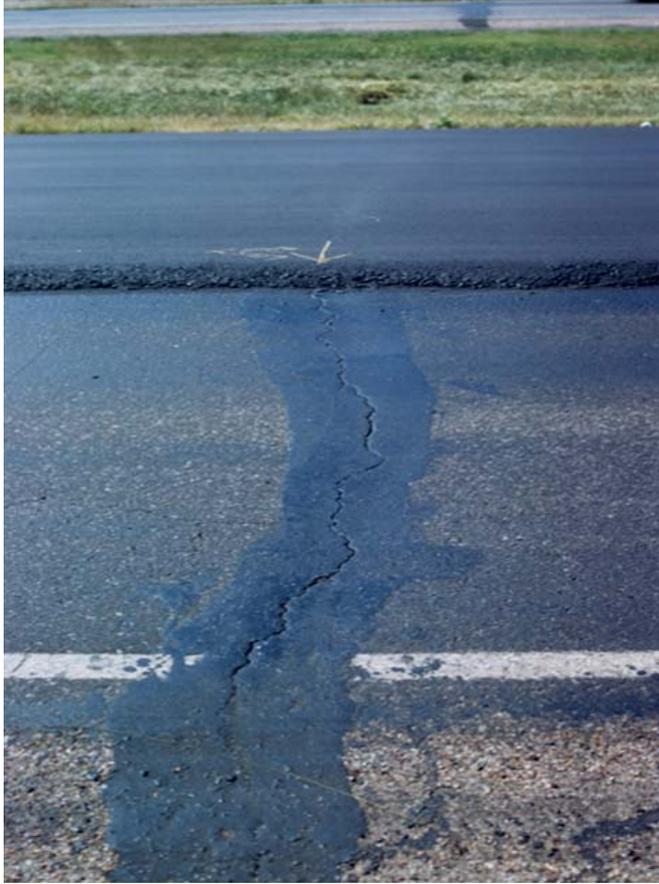
Figure 7: Some remedial repair methods did not work well.

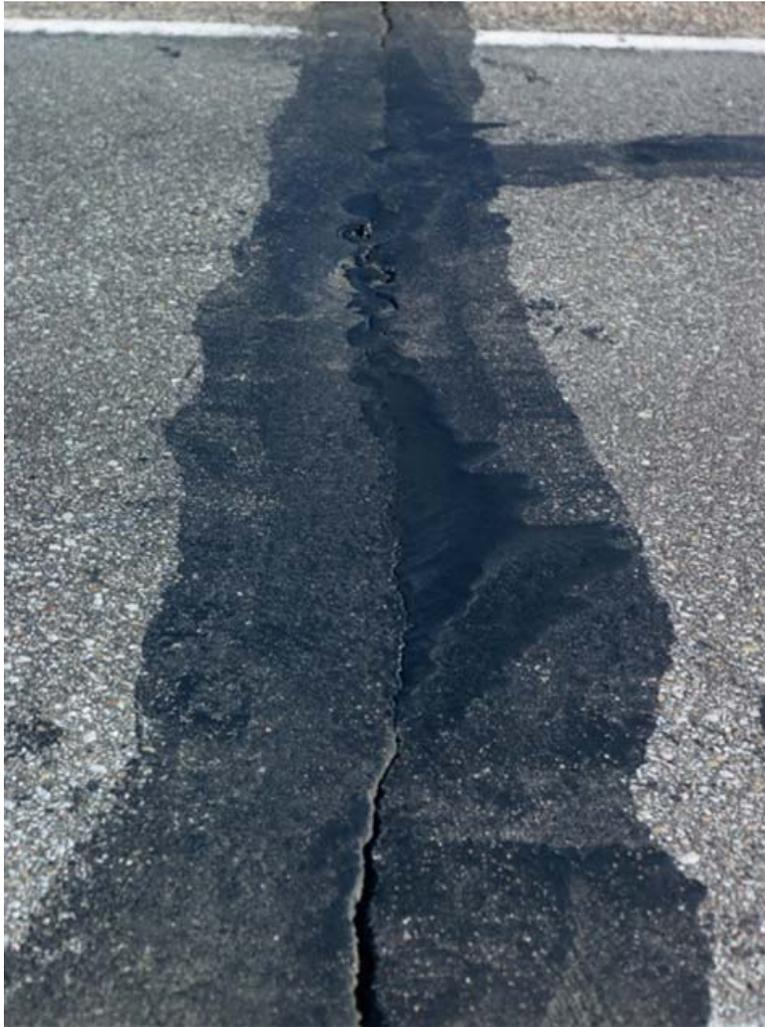
Figure 8: The use of a fiberized asphalt crack sealing material

In June 1987, a Fiberized asphalt crack sealing material was placed on a test section on K-4 north of US-24 in Jefferson County, Kansas in the vicinity of MP 336.95 to 337.2 in the northbound lane. The material was provided and placed by Musselman and Hall Contractors, of Kansas City, Mo., as a no cost demonstration of the cut polypropylene fiber reinforced asphalt crack sealer. The mixture was heated in an oil bath pot and was pumped through a small hose and nozzle into the cracks and onto the surface to form a band about 6 inches wide. The transverse cracks ranged from $\frac{1}{4}$ inch to 1.5 inches wide and most had some sidewall depression. The centerline longitudinal crack was $\frac{1}{4}$ inch or less

and no depression was noted. The volume of material used was enough to fill the crack which had not been cleared out. No attempt was made to fill the entire depressed area. On September 20, 1989, the performance of the crack sealer was evaluated after 27 months exposure to weather and traffic. Generally speaking, the product had failed as a crack sealer.

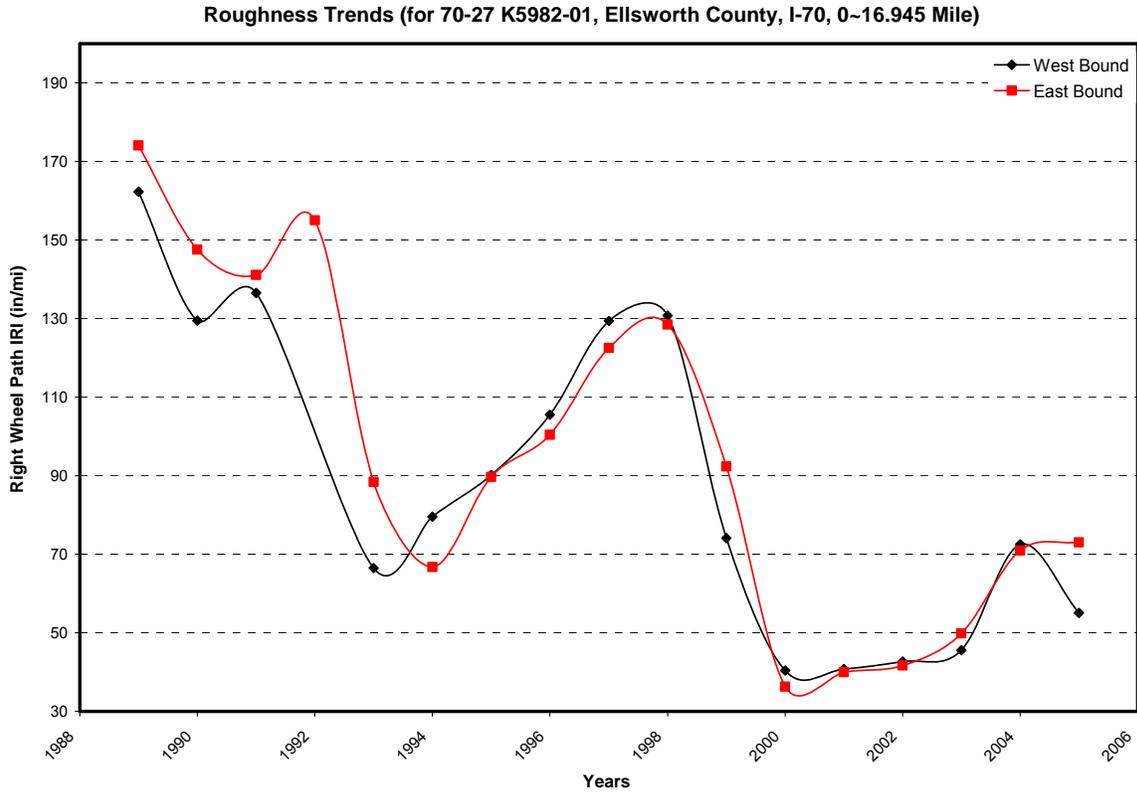
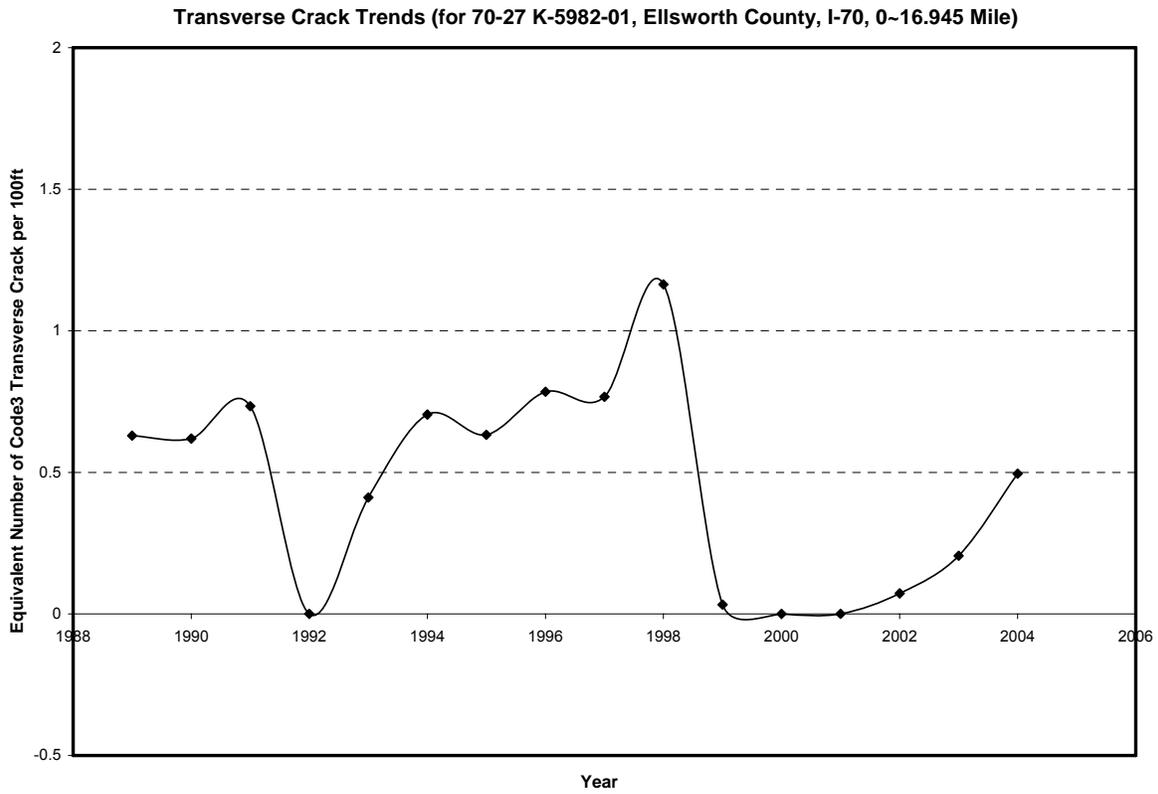
Figure 10: K-5982-01, completion date 2000 with a 70% improvement

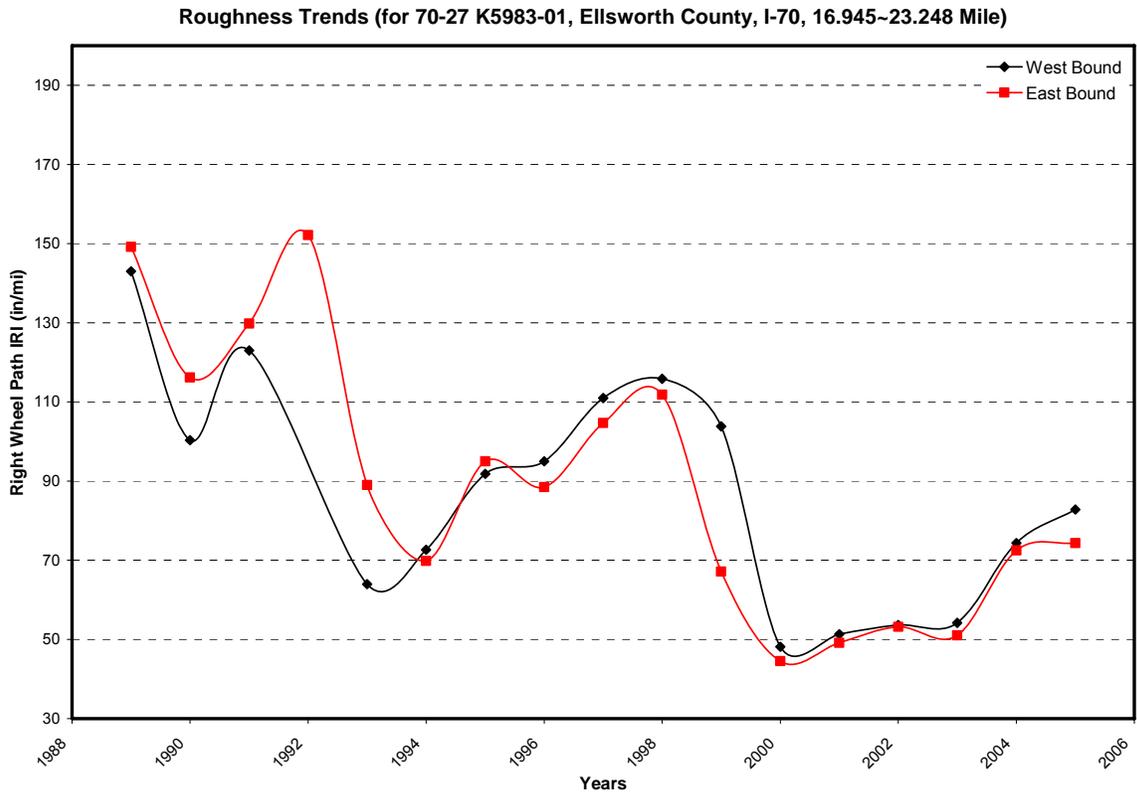
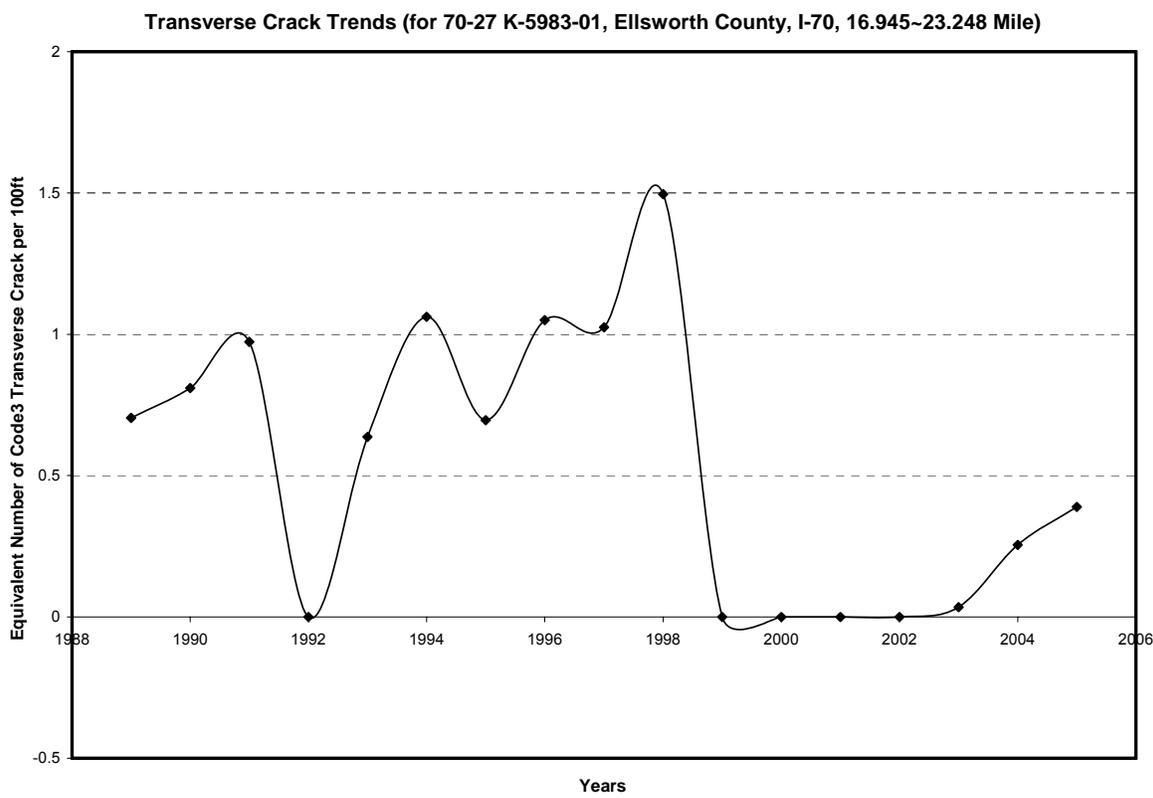
Figure 11: K-5983-01, completion date 2000 with a 61% improvement

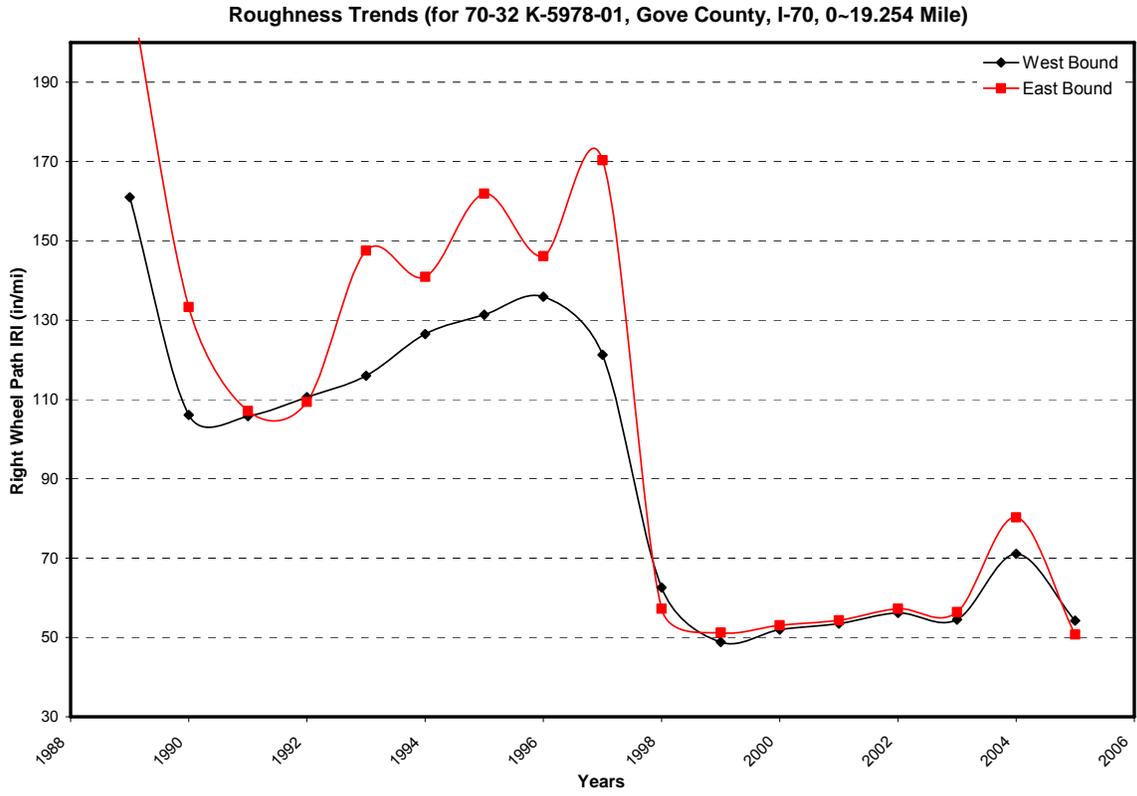
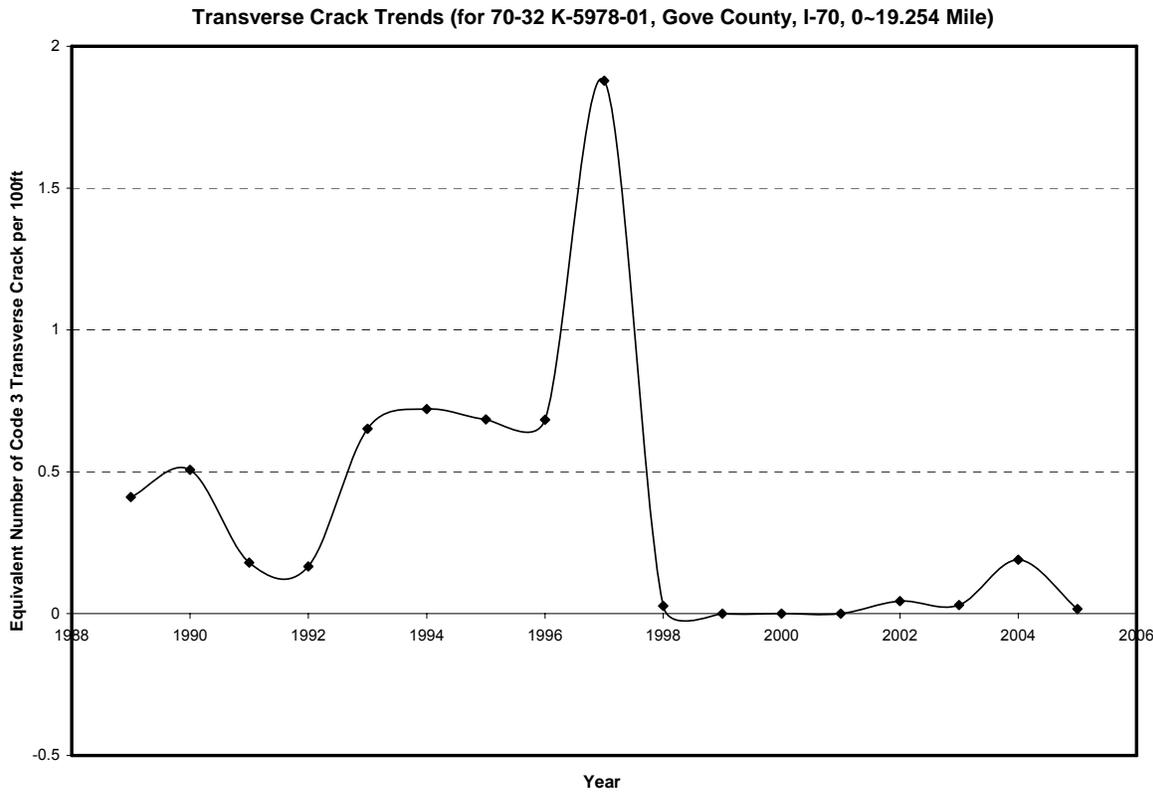
Figure 12: K-5978-01, completion date 1998 with a 68% improvement

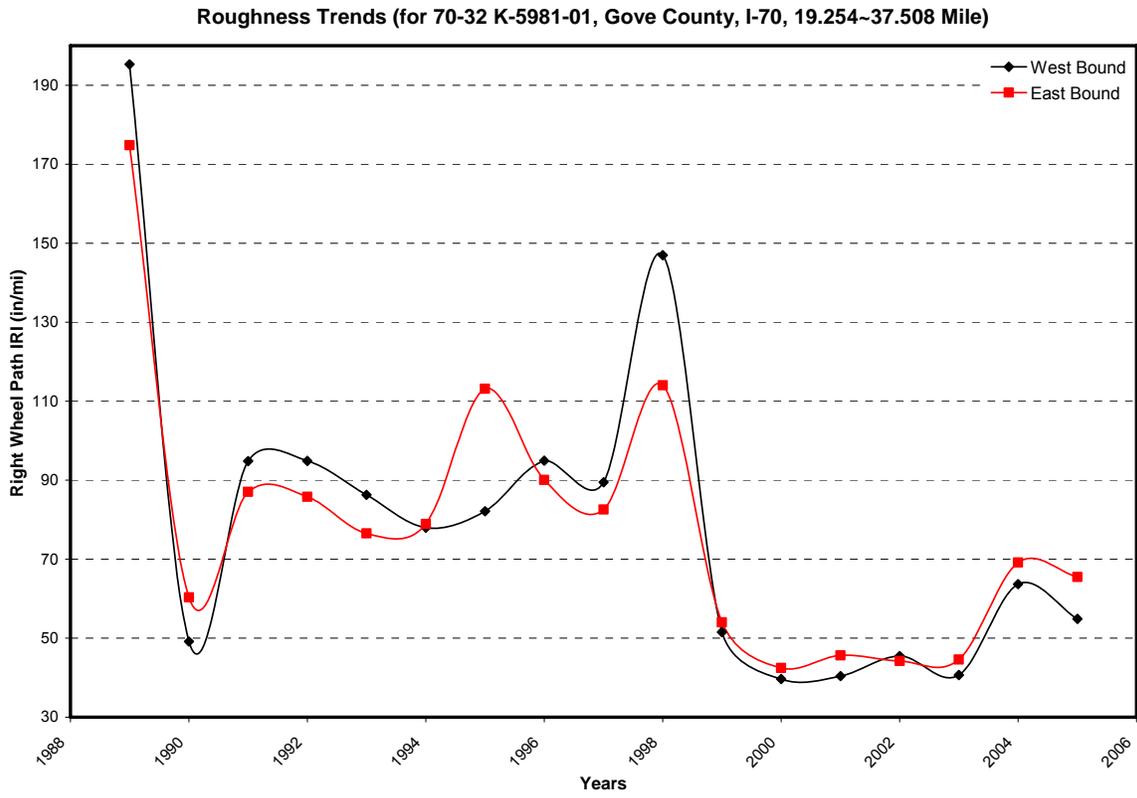
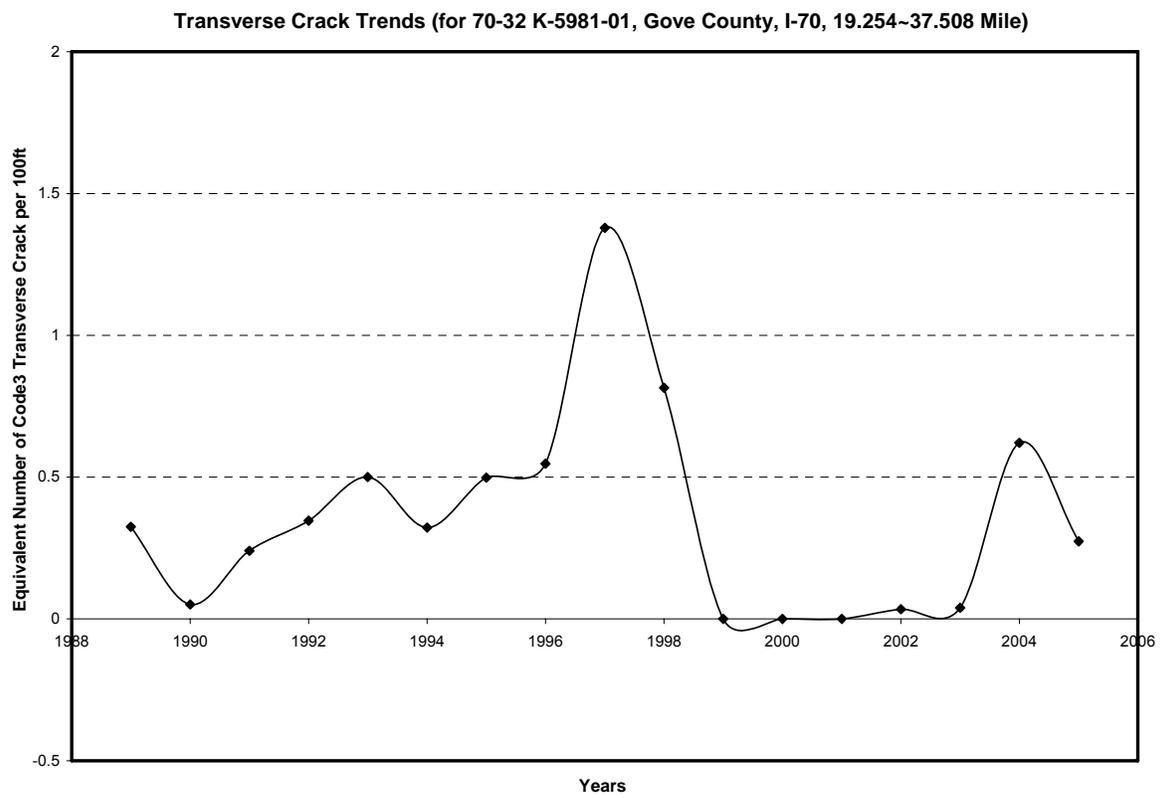
Figure 13: K-5981-01, completion date 1999 with a 70% improvement

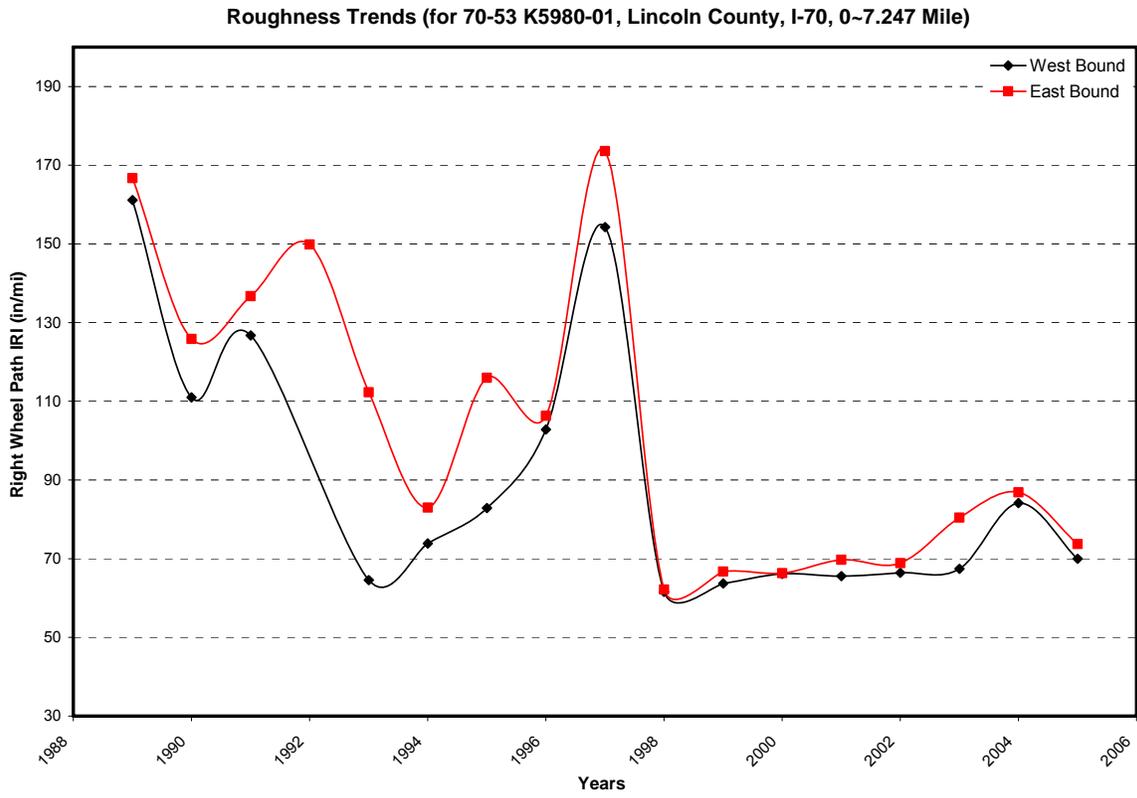
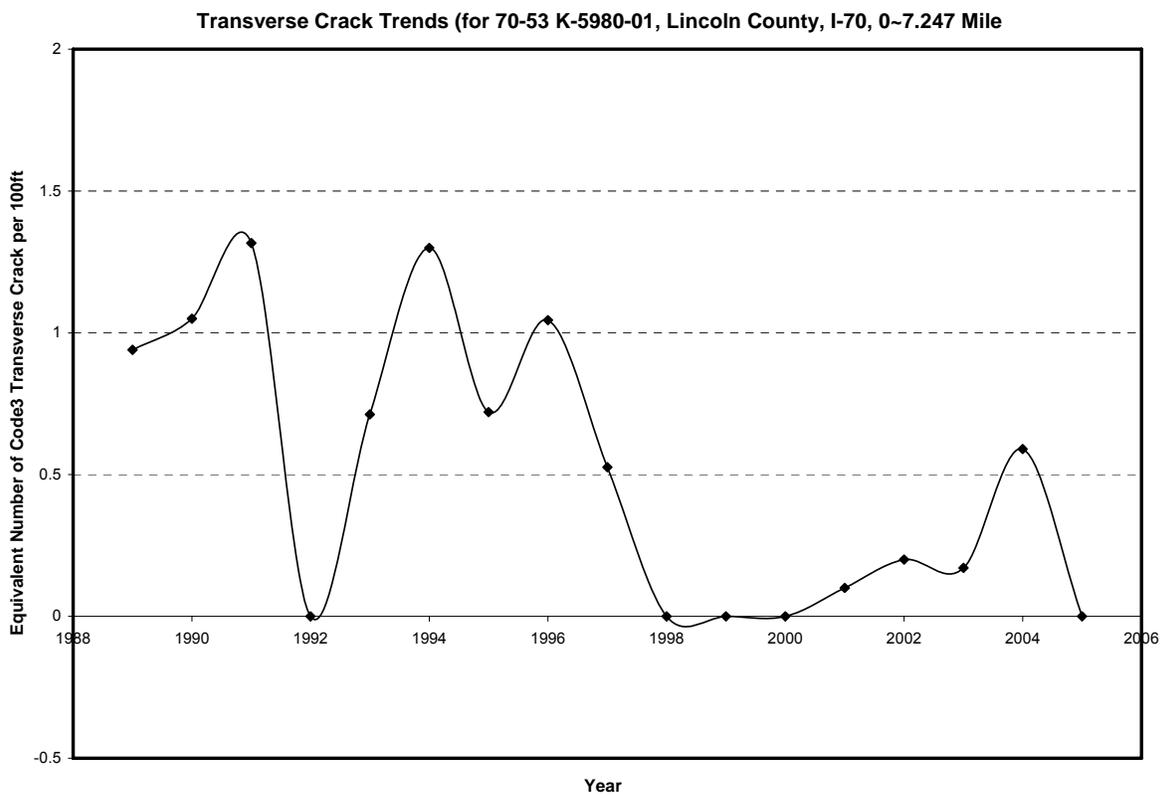
Figure 14: K-5980-01, completion date 1998 with a 63% improvement

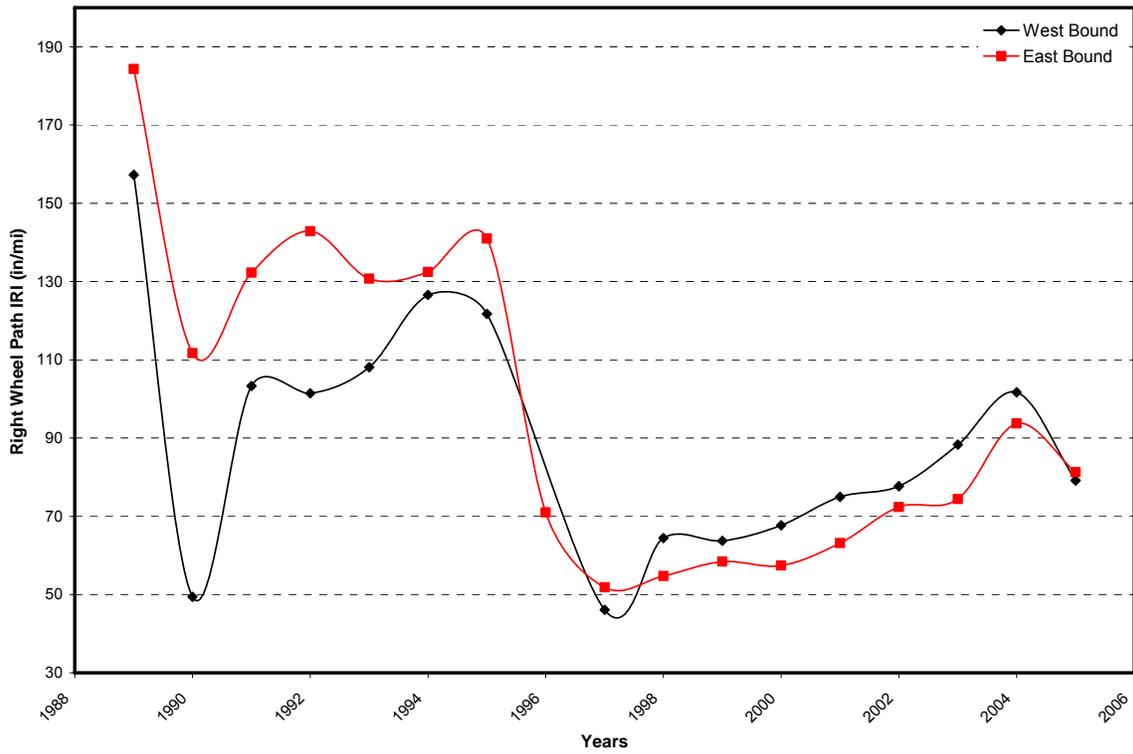
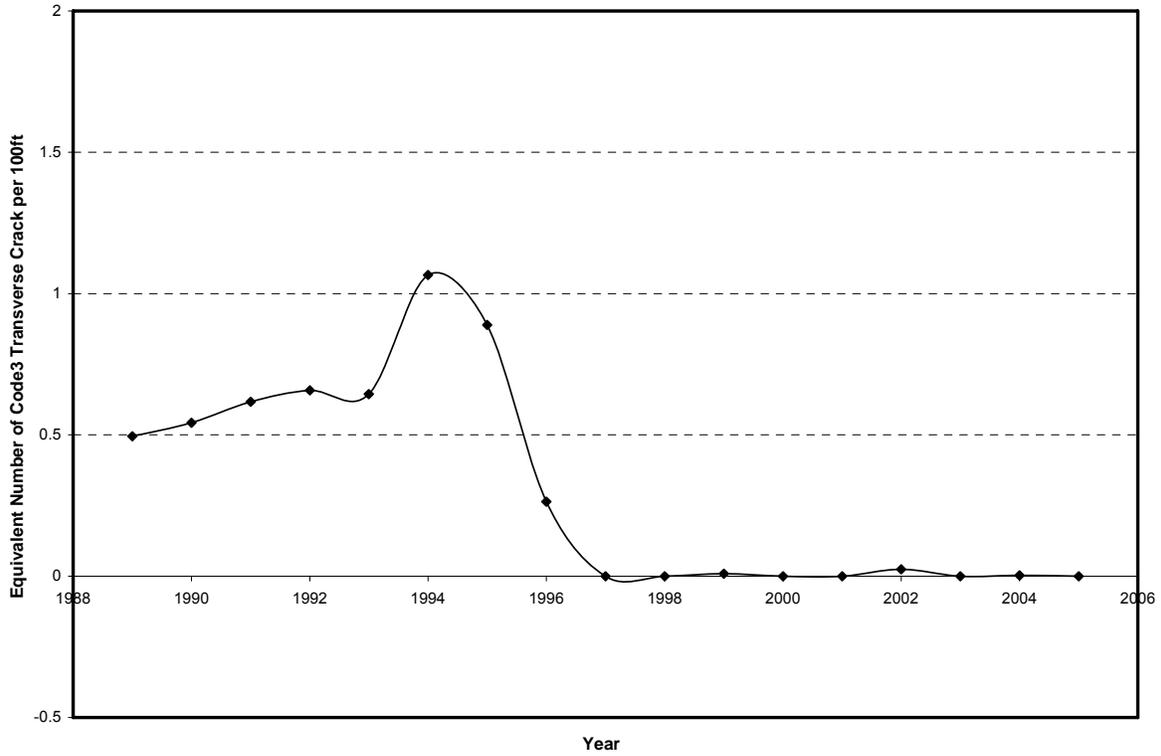
Figure 15: K-2610-02, completion date 1997 with a 64% improvement

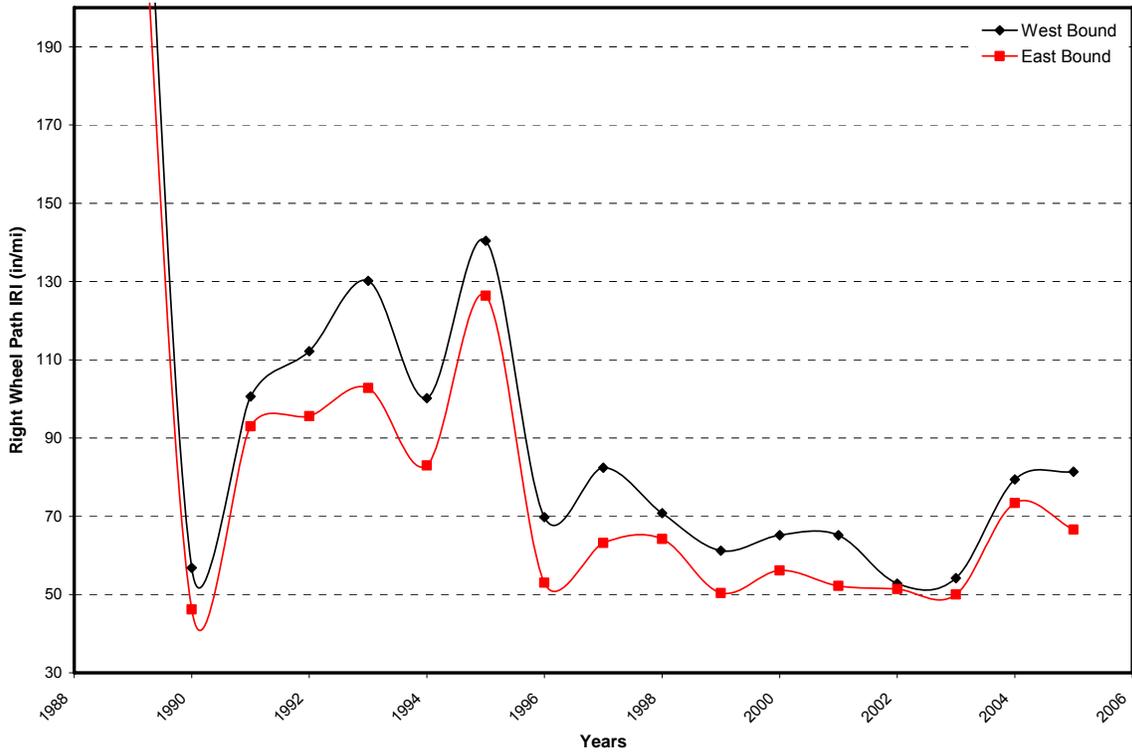
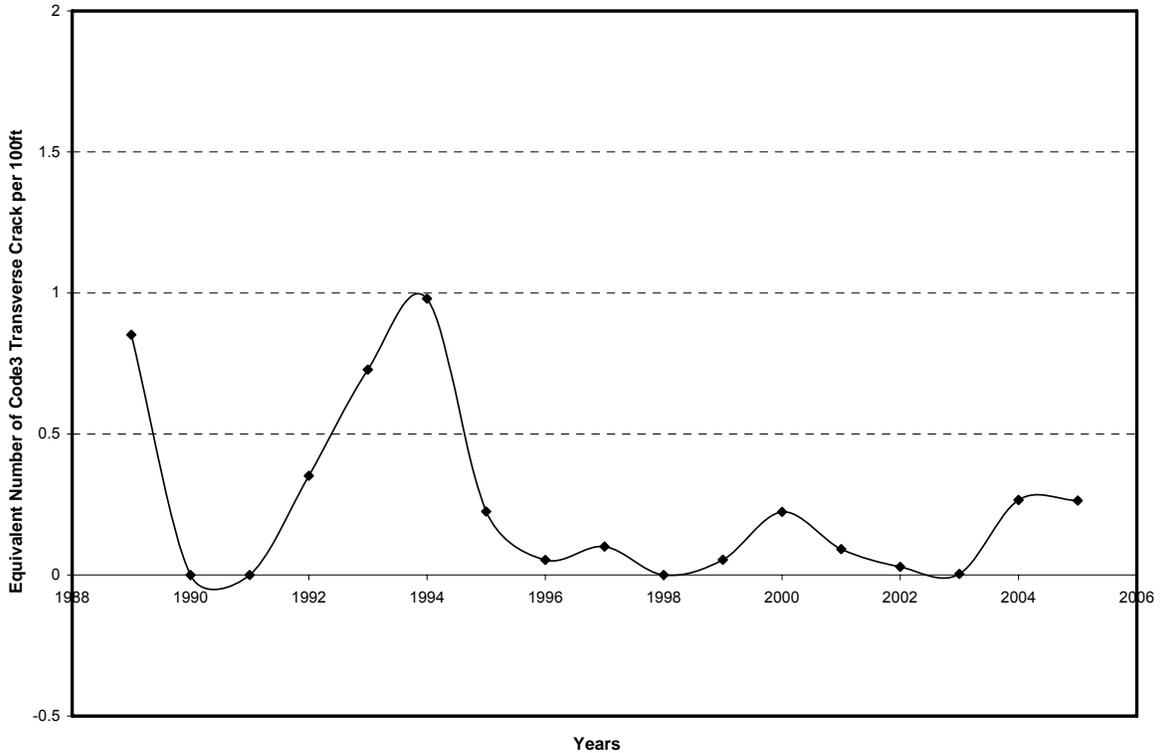
Figure 16: K-5572-01, completion date 1996 with a 56% improvement

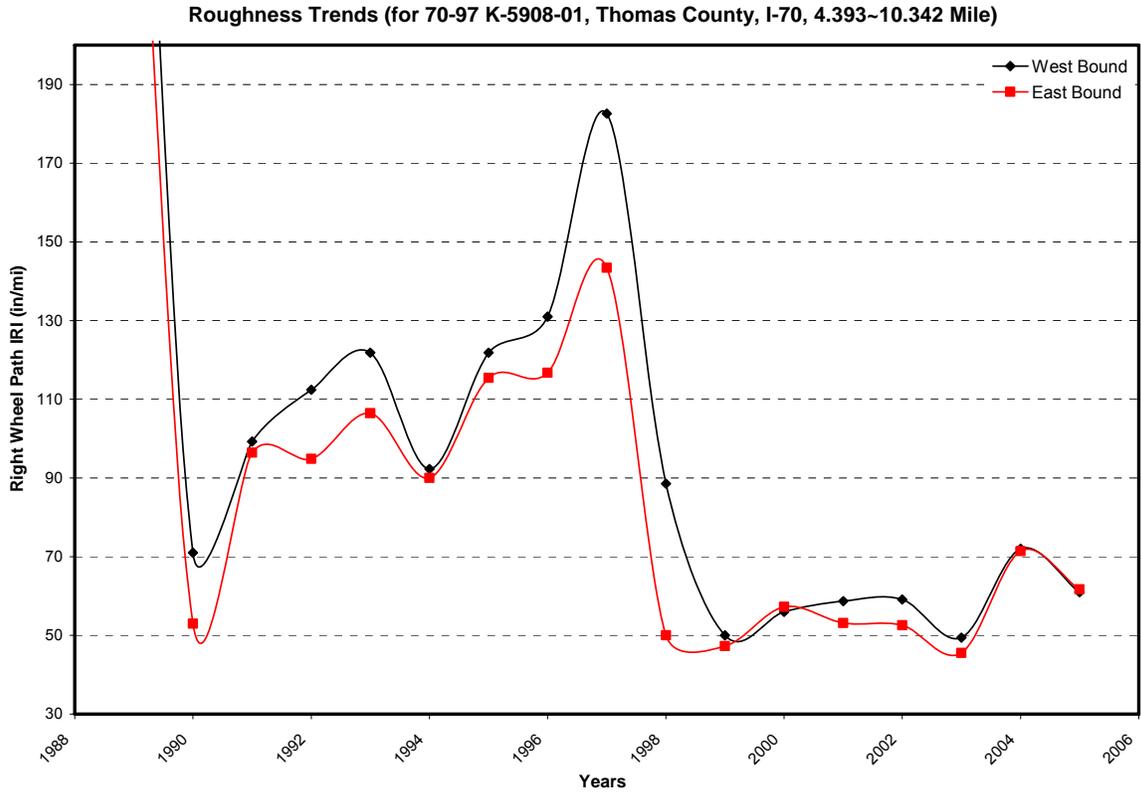
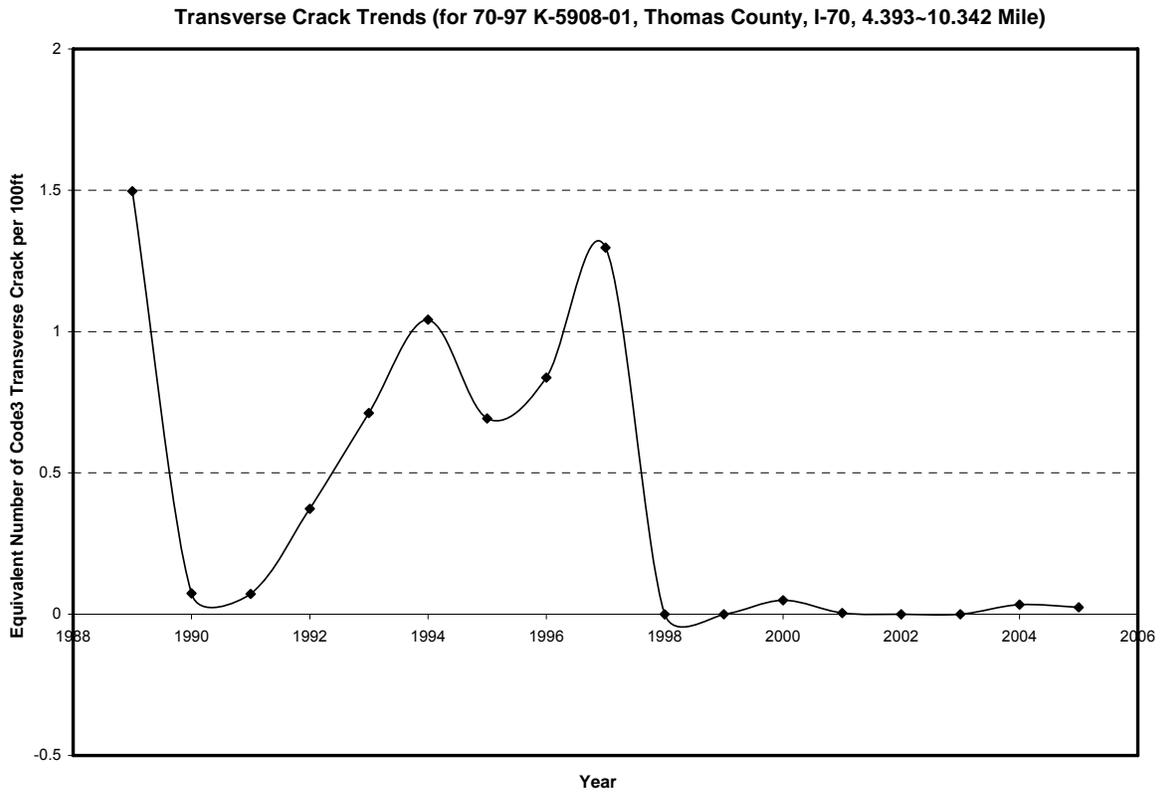
Figure 17: K-5908-01, completion date 1998 with a 71% improvement

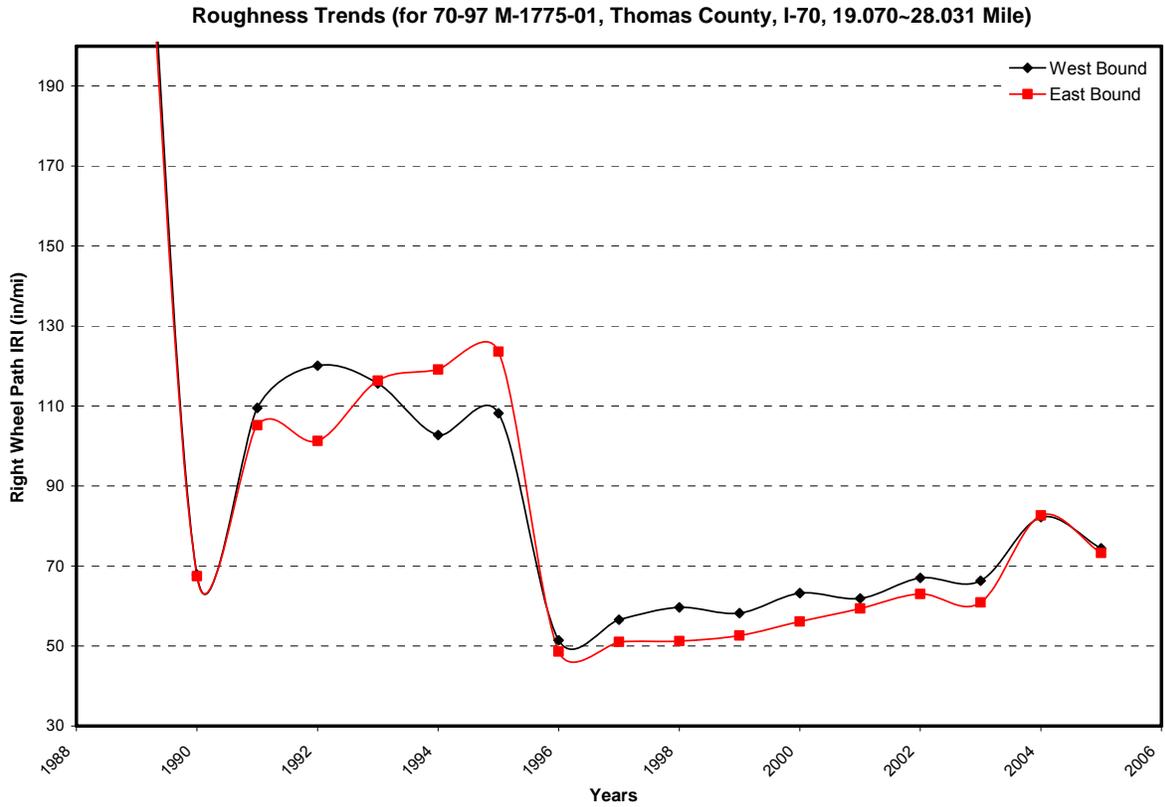
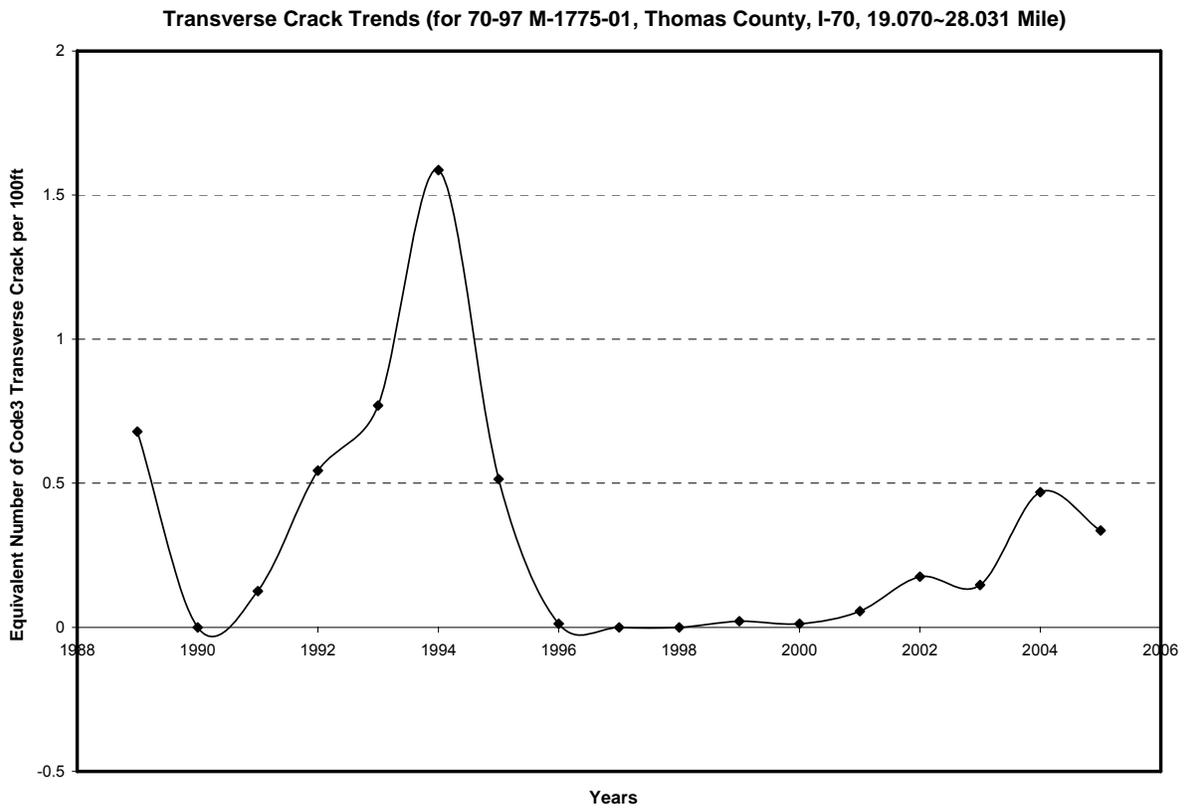
Figure 18: M-1775-01, completion date 1996 with a 60% improvement
