Report No. FHWA-KS-07-6
FINAL REPORT

THE EFFECTIVENESS OF THE FLY-ASH SLURRY INJECTION METHOD TO ELIMINATE DEPRESSED TRANSVERSE CRACKS

Victoria Felker
William H. Parcels, Jr., P.E.
Kansas Department of Transportation
Topeka, Kansas

January 2009

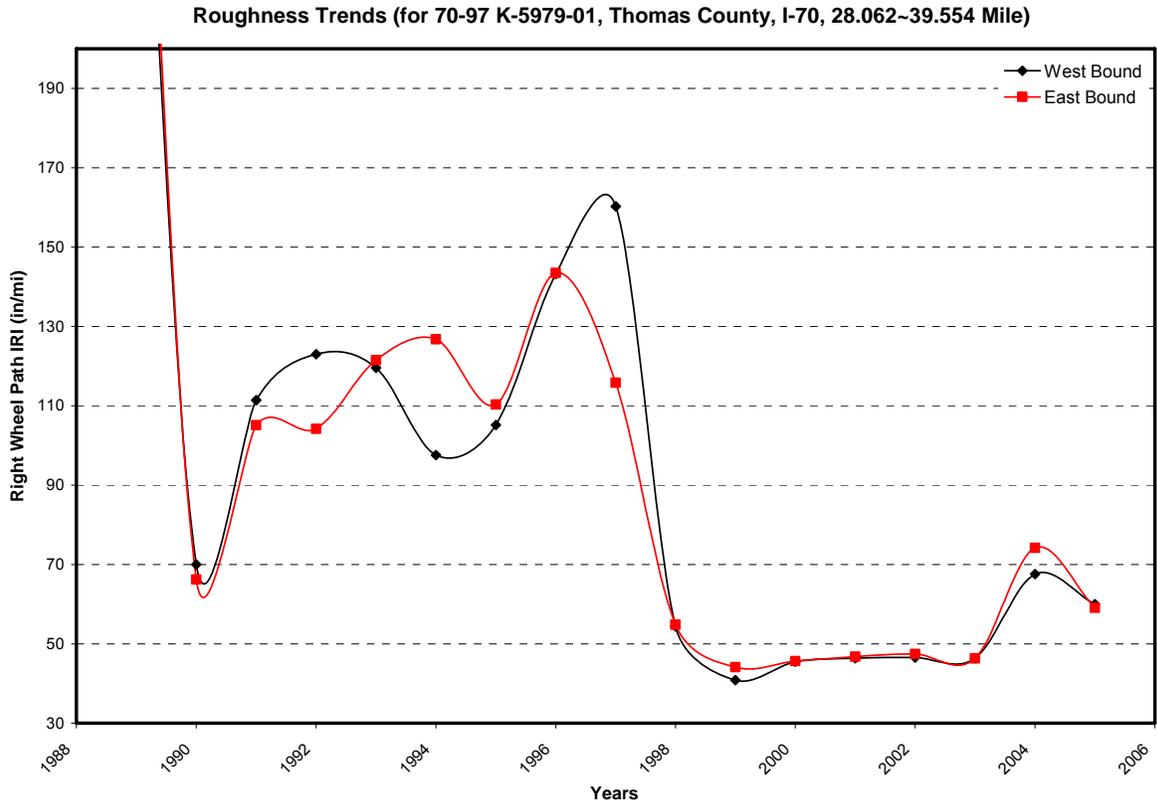
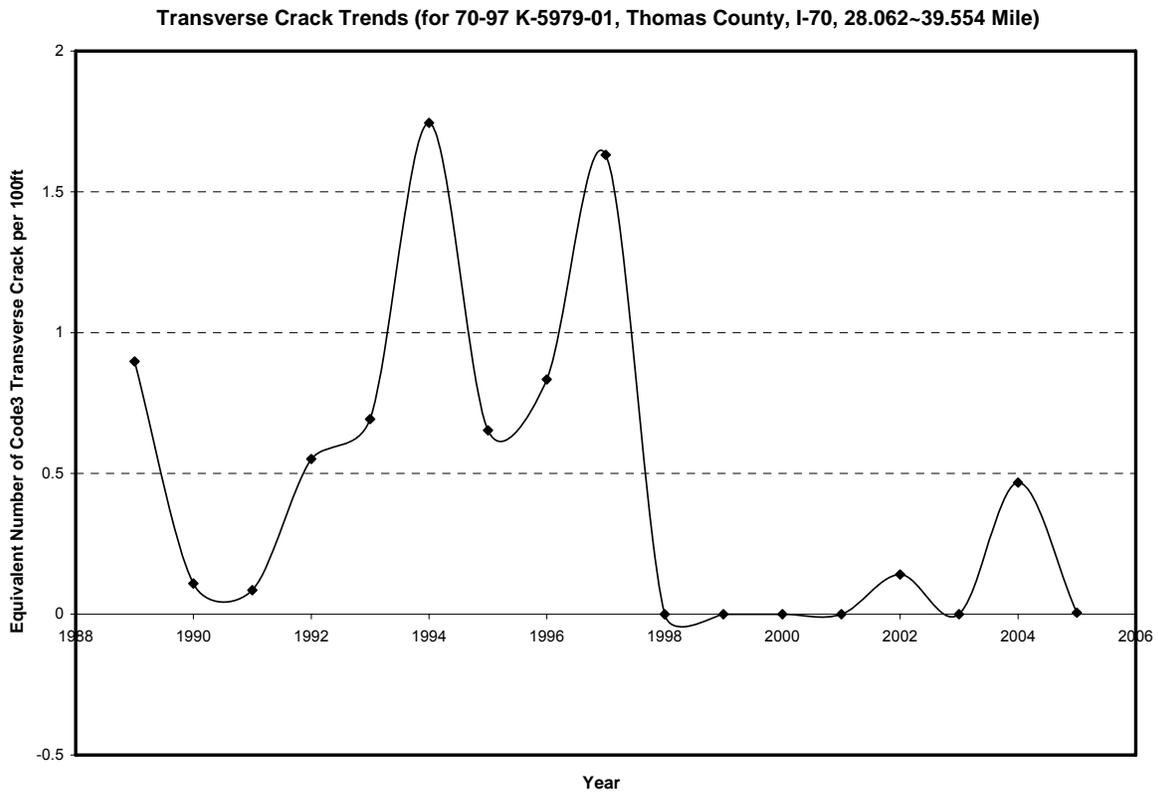
Figure 19: K-5979-01, completion date 1998 with a 75% improvement
