**CORROSION EVALUATION OF
BRIDGES WITH EPOXY-COATED REBAR
Contract No. BD544-23
Final Report to Florida Department of Transportation**

UNIVERSITY OF SOUTH FLORIDA
Tampa, FL 33620
February 28, 2009

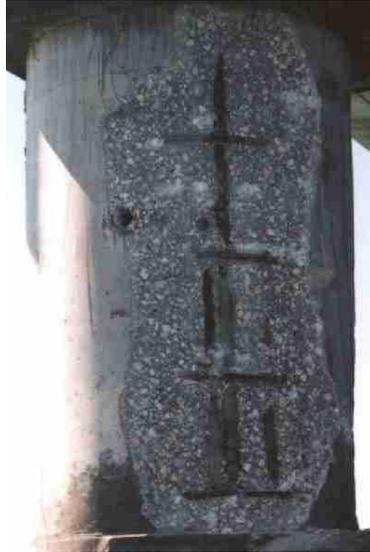
The following is a brief description of corrosion observations for this group [1] with updated results. Typical spalls (Fig. 2) affected a projected area of $\sim 0.3 \text{ m}^2$ on the surface of the concrete. Longitudinal cuts on the ECR surface with a sharp knife permitted easy peeling of the coating from the corroded regions, revealing extensive solid dark undercoating corrosion products typically magnetic and electronically conductive [11]. Occasionally, significant amounts of acidic liquid rich in chloride and iron were found as well [3,6]. Coating disbondment was also found on rebar locations adjacent and away from corroding regions. This disbondment without significant corrosion was found to be widespread in ECR after it was in service for a few years in Florida marine substructure conditions of all this and the other groups, even in the absence of chloride contamination of the concrete next to the rebar [1,5]. Examination of the underside of coatings from numerous ECR samples from all bridge groups, did not reveal any correlation between this disbondment and the usual forms of surface contamination expected in the coating process [1,5]. Concrete resistivity readings as low as $\sim 1 \text{ k}\Omega\text{-cm}$ in the tidal region indicative of high chloride diffusivities [1,12,13].

Figure 2. Typical Spall Appearance (7MI). Figure from Ref [1].

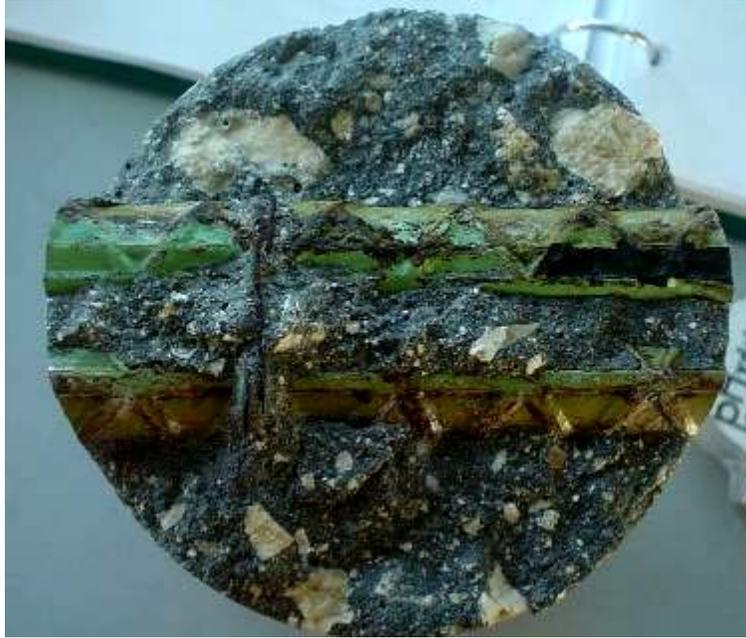
In VA1, two shafts were cored in five locations fully exposing ECR in three cores. Two of those cores were an on-crack and off-crack pair at the largest vertical crack, 46 cm AHT. The ECR, both on- and off- the main crack showed extensive corrosion (Figure 6a). Lesser but still significant corrosion distress was observed on samples from a core at 165 cm AHT. There, the distress was limited to small coating breaks of rusty appearance and to thin rust spots and discoloration on as much as 10% of the steel substrate observed after removal of the coating. ECR was fully exposed at four core locations in SNK, including a low elevation on- and off-crack pair that showed significant corrosion but not as severe as in VA1/2. Complete coating disbondment was observed on all ECR samples from both bridges. Where it could be examined, backside contamination was ~<1%. The average epoxy coating thickness was ~0.2 mm (Figure 5), generally consistent with product specifications. Vertical and horizontal ECR exposed by coring in the same column were mostly found to be electrically continuous. Half-cell potential mapping of the ECR (Figure 7a) generally showed potential values (more negative than -300mV CSE), traditionally indicative of corrosion activity for plain rebar in atmospherically exposed concrete. Although potential may not be a reliable indicator of active corrosion of ECR in marine concrete, it is noted that all the rebar which had showed visual signs of corrosion were similarly negative. Concrete resistivity (Figure 8a) reached <5 k Ω -cm, indicative of highly permeable concrete. A general trend of lower resistivity at low elevations was consistent with

a) VA1 Drilled Shaft (VA2A2)~45 cm AHT on crack (0.33 mm).

Figure 6. Severe ECR corrosion in Group 2 bridges

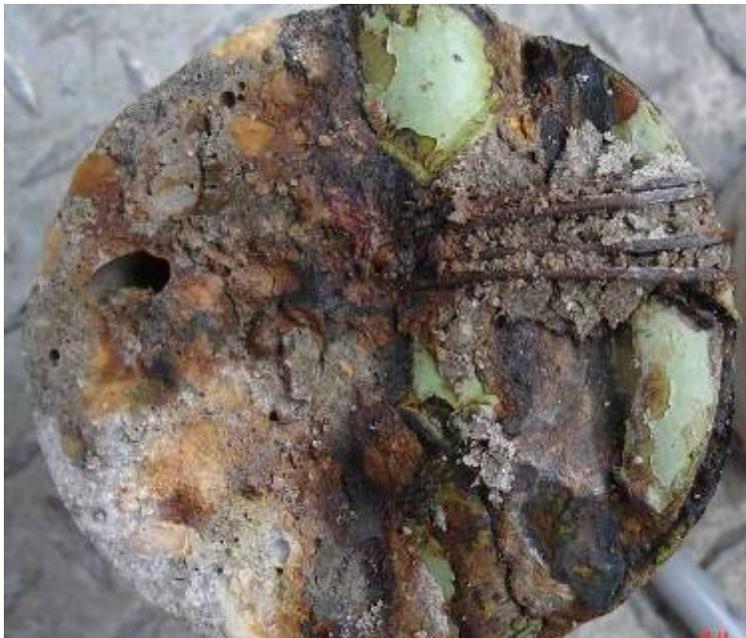
William Marler (CHO). Two of 20 footers from the ten high elevation piers had cracks wider than 1.0 mm; ten of the footers had cracks larger than 0.2 mm. Minor concrete cracking was typical on all of the footers. Vertical and map-type cracking was observed on one of 20 columns from the high elevation piers. Rust bleedout was observed on two columns and one strut. The origin of that bleedout was not confirmed as samples of reinforcement were not obtained, but corrosion of reinforcement may be possible. Core samples were extracted from two footers each with one wide vertical crack (1.0 and 0.63 mm wide respectively). Approximately 0.42 m² and 0.1 m², respectively, of concrete around the crack locations seemed to be delaminated as determined by hammer sounding. Extensive corrosion of the reinforcing steel (Figure 6b) was observed on both footers at elevations 8.9 to 17.8 cm above high tide level, both where the crack intersected steel and in adjacent sound concrete locations. Lack of coating adhesion to the steel substrate was observed for all extracted ECR. The concrete cover to vertical bar ranged from 7.1-10.4 cm; nominal design cover was 10.2 cm. Highly negative half-cell steel potentials were measured, -400 to -552 mV CSE. In plain steel rebar such potentials would likely be reflective of the observed ongoing corrosion, but it is cautioned that potential readings in epoxy coated rebar, especially in wet concrete, may not be always reliable indicators of corrosion condition. Concrete surface resistivity measurements on the columns ranged from 46 to 128 kΩ-cm on the columns at elevations 0.6 to 2.4 m AHT. Concrete resistivity on the footer ranged from 16 to 63 kΩ-cm at elevations 0 to 0.55 m AHT. The large aggregate consisted of river rock. The volumetric porosity of the concrete was ~14%. All seven ECR samples from this bridge (sound and cracked concrete locations) showed significant loss of coating adhesion and severe corrosion of the steel bar.

b) CHO. Footer (CHO29S1). ~9 cm AHT.

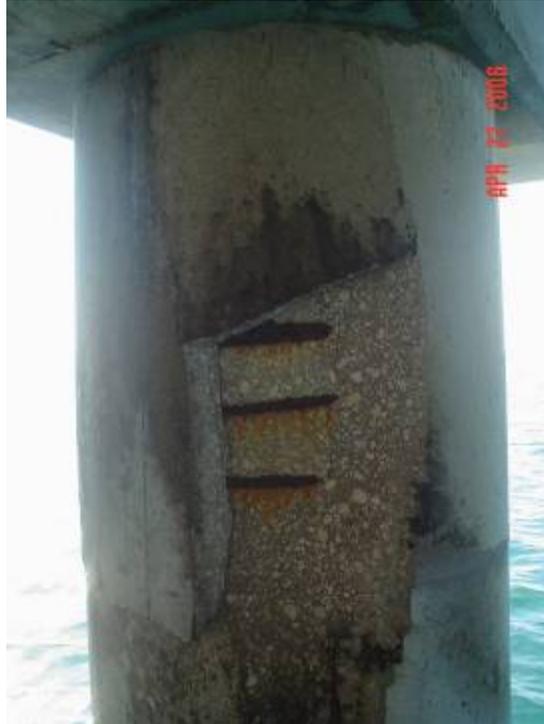
Channel 2 (CH2). Corrosion evaluations at CH2 for the current investigation were cursory but those and records [15] from FDOT routine surveys showed extensive corrosion damage not unlike that observed at the Group 1 bridges (Figure 10). Typical corrosion distress is characterized by extensive concrete cracking (as wide as 1.3 mm with spalled concrete (average ~ 2.9 m²) typically in the splash area but with several instances extended to above and below it. As in the Group 1 bridges, the concrete in CH2 showed indications of high permeability. At 25 y age the chloride concentration at ~ 15 cm reinforcement depth and elevations 0.3-2 m AHT was as much as 6.5 kg/m³. Assuming a typical chloride surface concentration value [9] $C_s \sim 20$ kg/m³, D_{app} was estimated to be in the order of $\sim 10^{-7}$ cm²/s. Low concrete resistivity (3-30 k Ω -cm) was measured as well at elevations 0.3-1.5 m AHT. Severe coating distress and disbondment was observed at spalled concrete locations. ECR in areas away from distressed concrete locations was not tested.

Figure 10. Extensive corrosion damage (CH2)

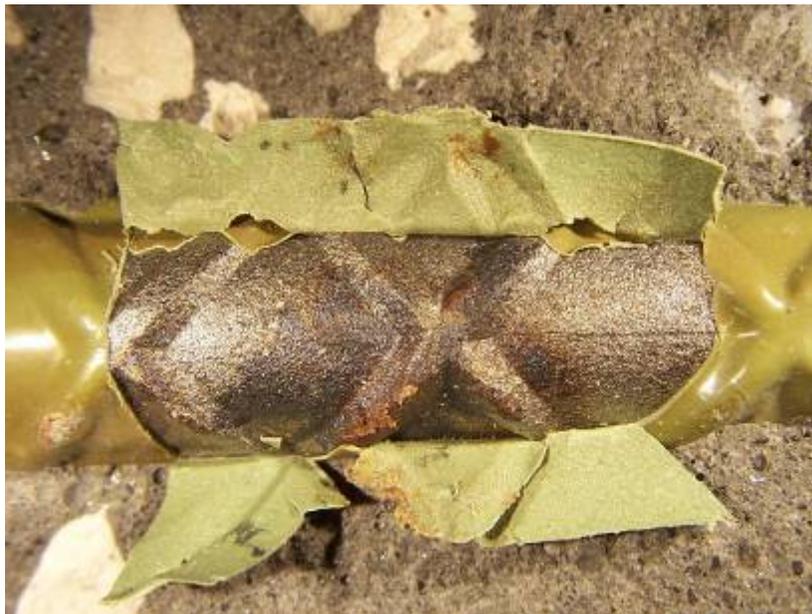
In the low elevation samples the coating could be easily separated from the substrate on the entire specimen surface, indicating complete coating disbondment. Backside coating contamination was typically observed on 1-2% of the peeled coating. Consistent with field observations, vestigial rusting was observed on the steel substrate exposed by coating breaks. The steel surface exposed after removing the coating was mostly bright metal with some discolored zones around the coating breaks. No preferential corrosion or coating disbondment was observed at the ECR zone intersected by a crack, compared to the rest of the rebar segment. In the cap beam coring, complete coating disbondment was observed on seven of the ten ECR samples, while failure of the coating upon knife peeling was mostly cohesive on the remaining three samples. Backside coating contamination in the disbonded samples and presence of rust and discoloration were comparable to those noted in the low elevation samples. No correlation was found between the presence or position of the crack and the extent or location of rusting or coating disbondment in the ECR segments.

Figure 11. Typical steel and undercoating condition in disbonded ECR extracted from SSK, showing minor rust at coating breaks, and nearby discoloration of the metal surface. Trestle cap beam, 7.5 m AHT (SSK 140E2).

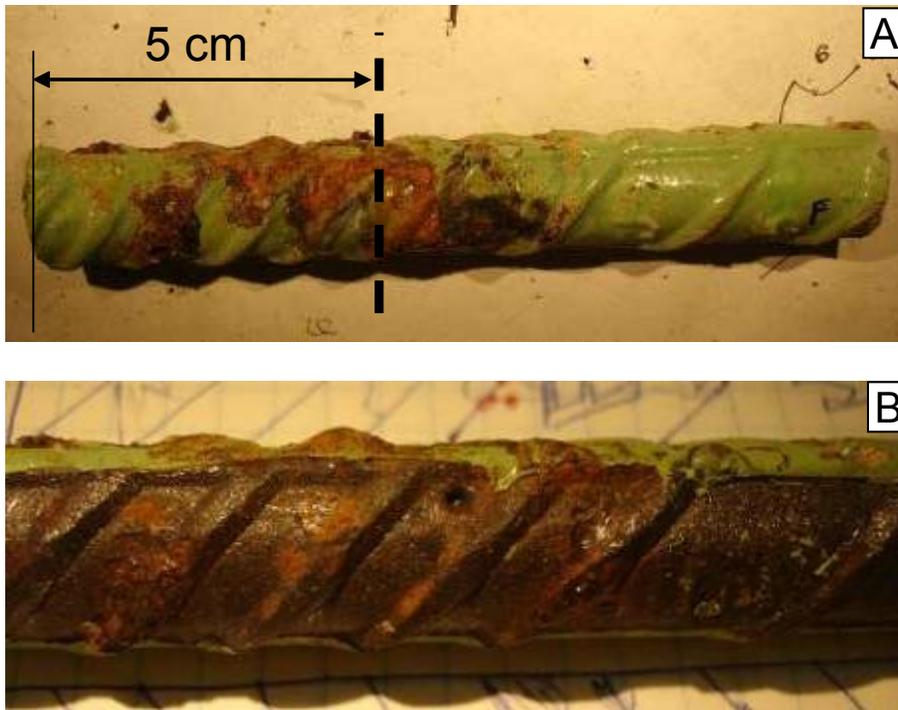
Figure 24. ECR corrosion at crack location (HFB59E1).
 A. Corrosion products on bar surface. The line represents the location of the crack intersection. B. Appearance after partially removing the coating and exploring into the corrosion products.

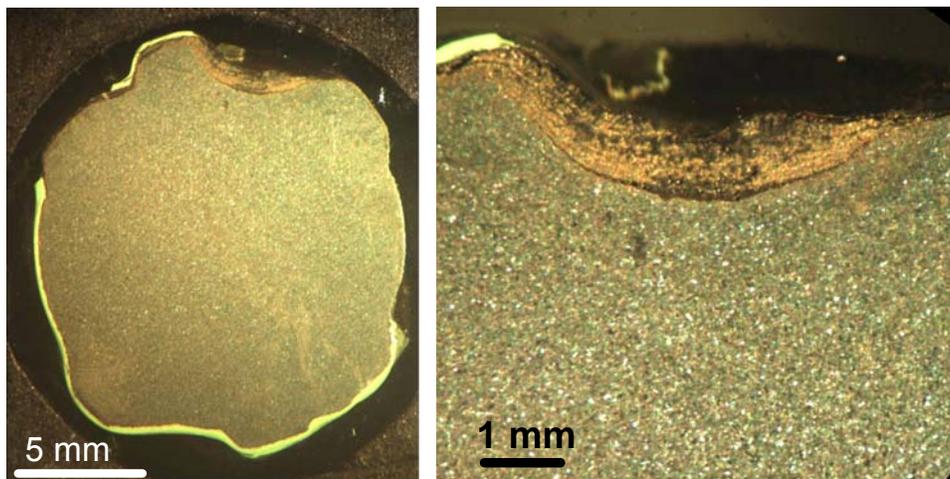
Figure 25. Cross section of ECR bar showing severe corrosion at a crack location of HFB59E1. Left: Entire Bar cross-section. Right: Close up of corrosion penetration.

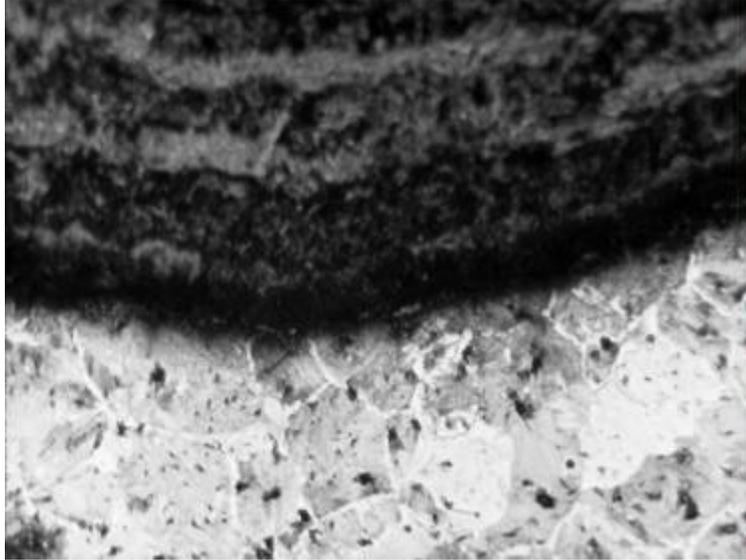
Figure 26. Corrosion product - base metal interface showing progression of corrosion into the microstructure of the rebar steel (HFB59W1).
