FINAL REPORT
Report No. FHWA-WY- 10/01F

**EVALUATION OF TREATMENT OPTIONS
FOR ASR-AFFECTED CONCRETE**

by
Kim Basham PhD, PE
KB Engineering, LLC
1716 Capitol Avenue
Cheyenne, WY 82001
kbasham@KBEngLLC.com

December 11, 2009

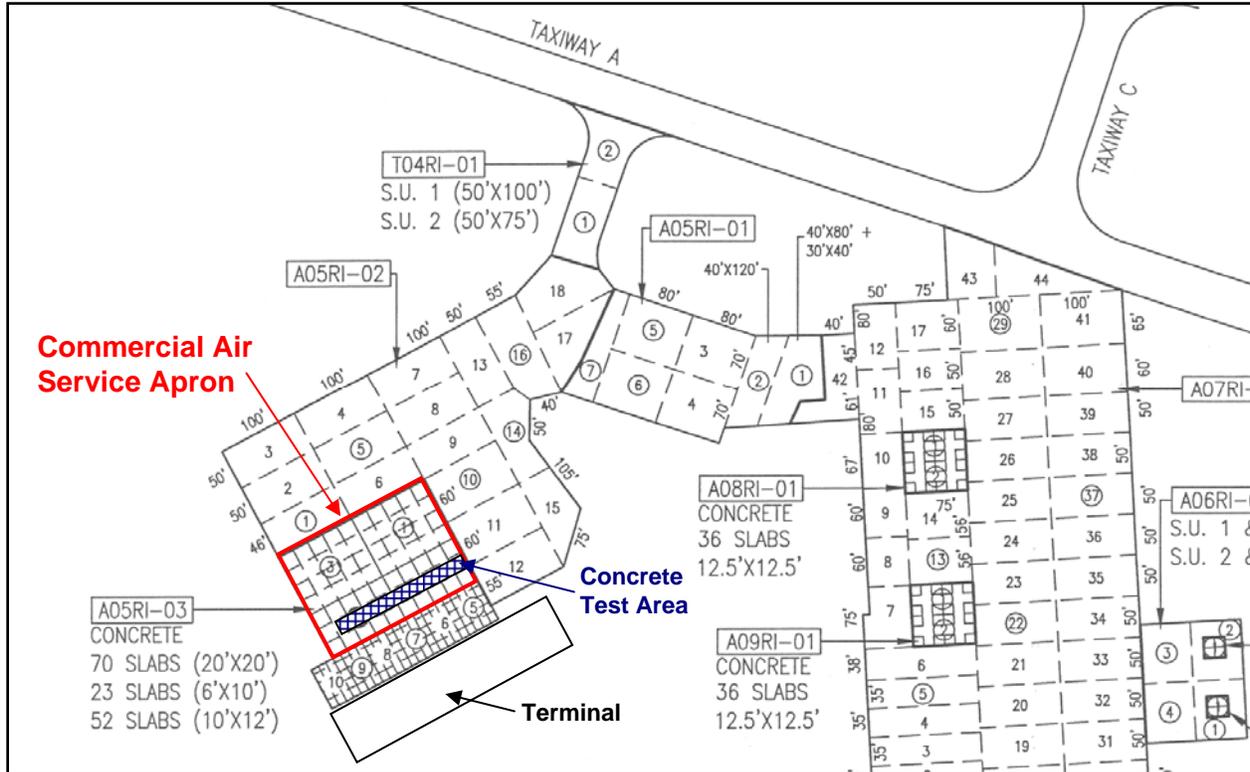
Figure 1.2 Commercial air service apron at the Riverton Regional Airport. The apron consisted of a 12 inch thick Portland cement concrete pavement (PCCP). The cross-hatched rectangular area north of the air terminal was the concrete test area used in this research.

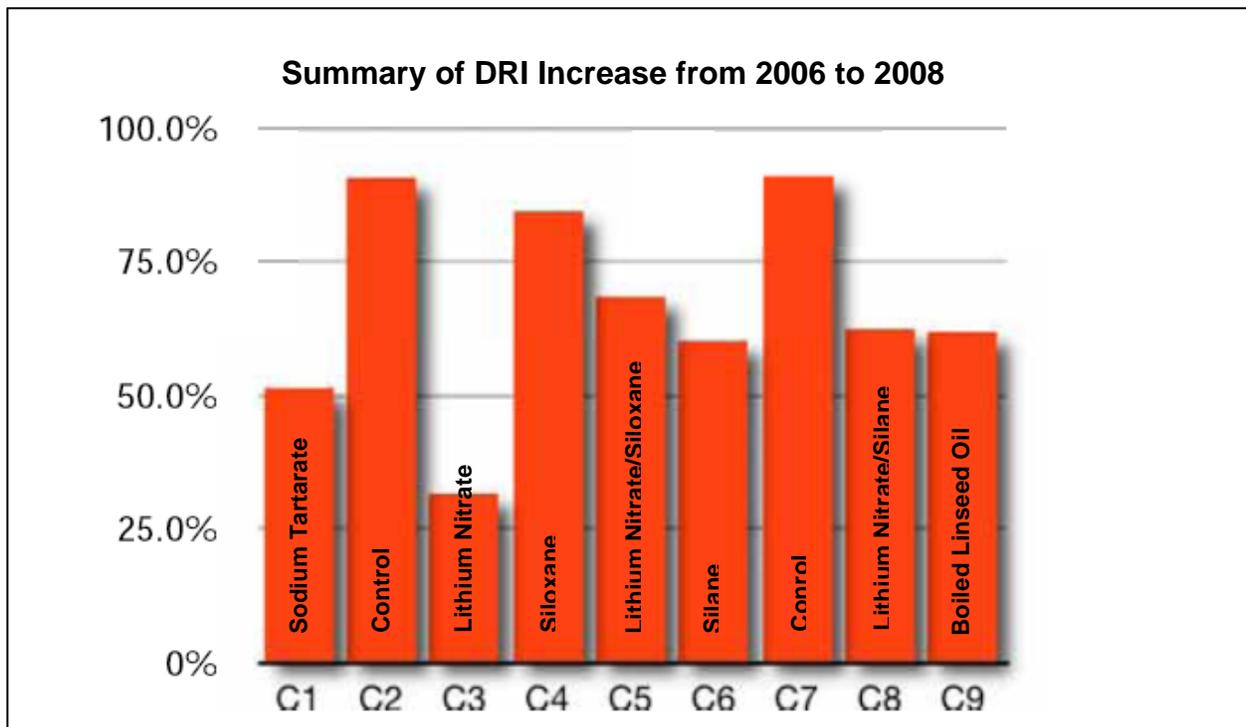
Figure 4.2 Summary of DRI increases from before and after cores (DRP’s report – Appendix D).

As shown in Figure 4.1 above, all DRI scores increased indicating that ASR related concrete damage increased during the two-year evaluation period. Except for the DRI score of 340 for Core C10-A in the before set, these scores are fairly consistent with an average of 206 and a standard deviation of 20. However, the DRI score for Core C3-A is noticeable less than the other scores. Except for the Core C3-E in the after set, DRI scores are rather consistent with average of 344 and a standard deviation of 51.

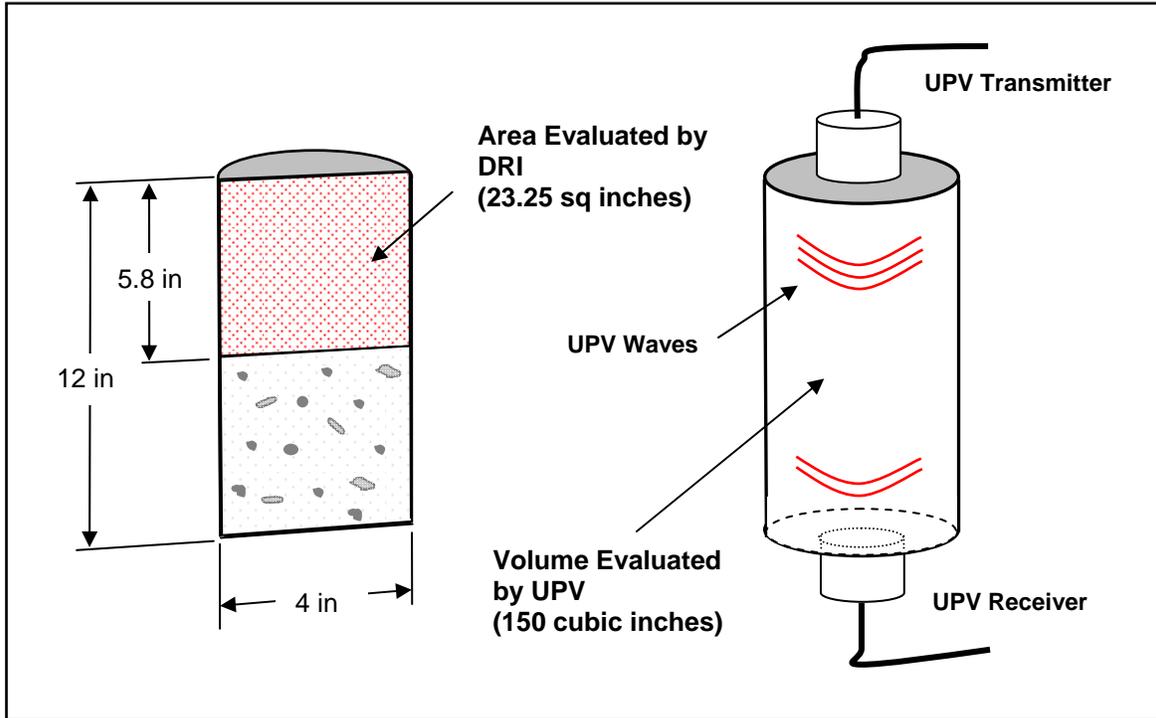
Figure 5.1 Comparison of the amount of concrete evaluated by DRI versus UPV.

Illustrations in Figure 5.1 show that DRI evaluates approximately 50 percent of a cross-sectional plane located in the upper portion of the core; whereas, UPV evaluates the entire volume of the core. Most likely, the different amount of concrete being evaluated for each evaluation method was primarily responsible for the poor correlation of the two methods.

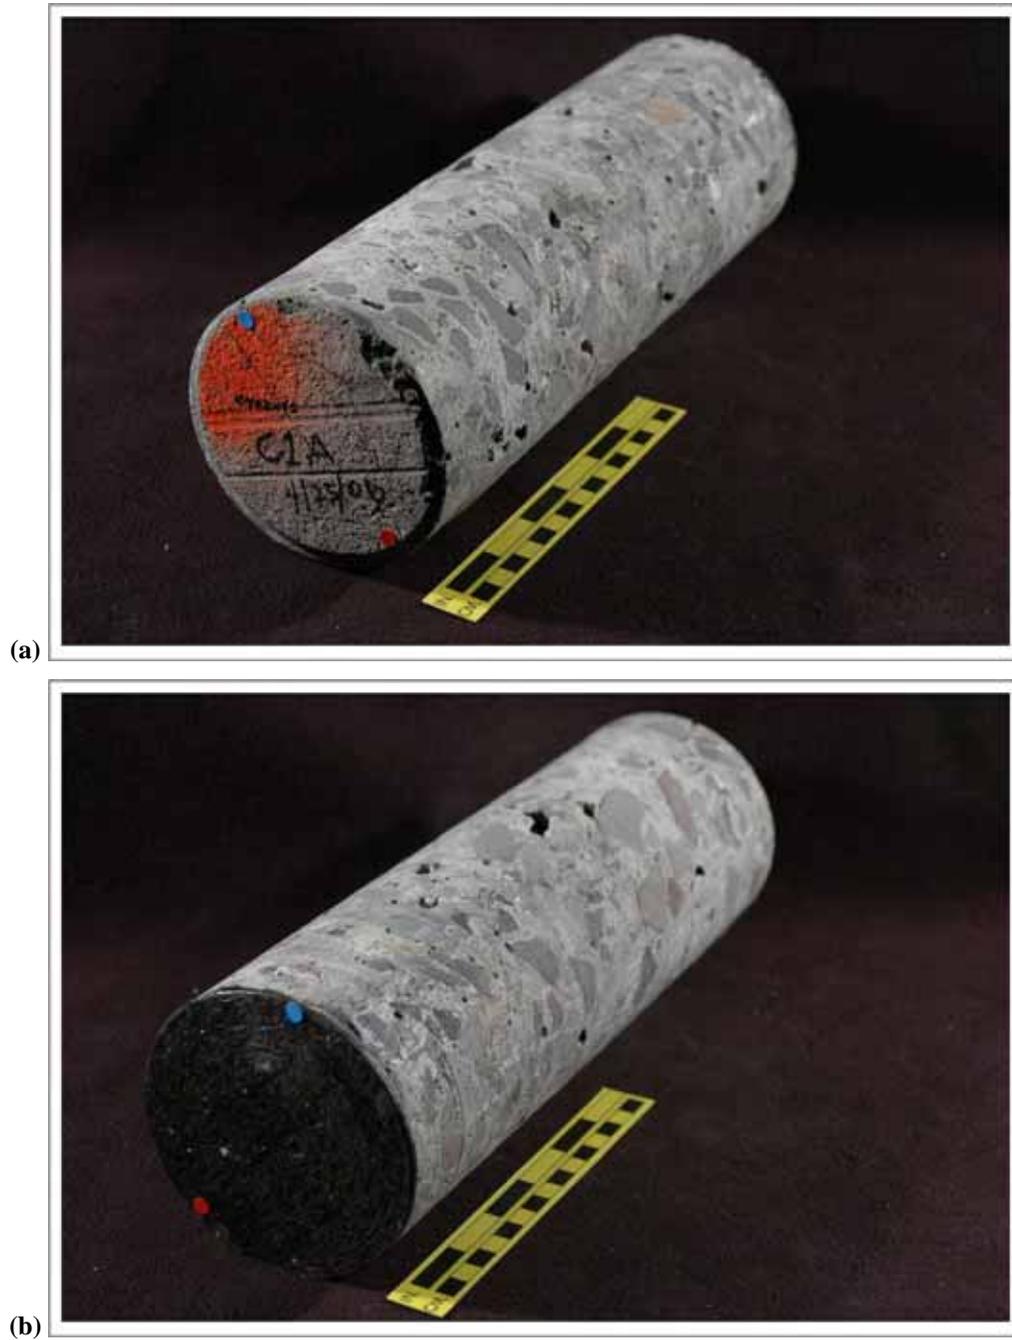
Figure A1. C1A. Photographs of sample in as-received condition showing (a) top and (b) bottom surface of core. Red and blue dots show the orientation of saw-cuts used to prepare the sample.

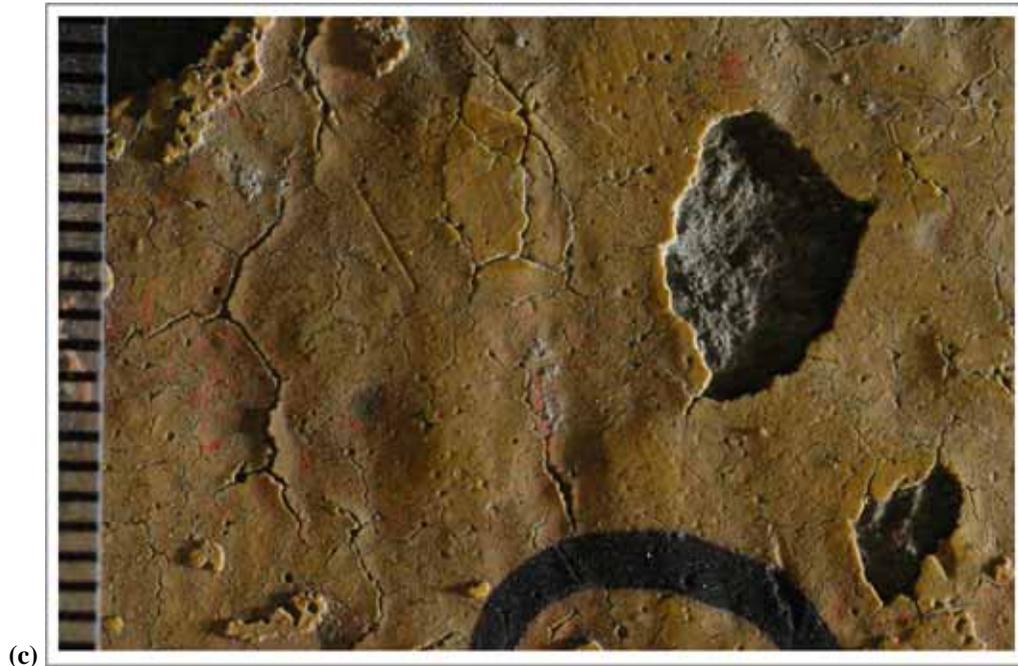
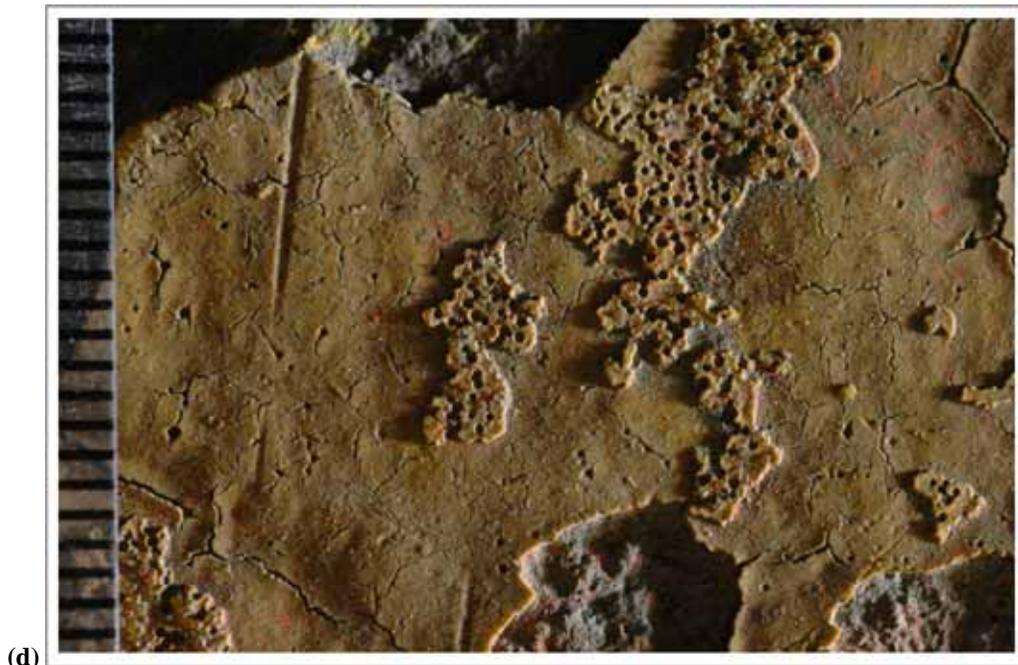
Figure A2 (cont'd). C2A. Photographs of sample in as-received condition showing top surface detail. Scale in millimeters.

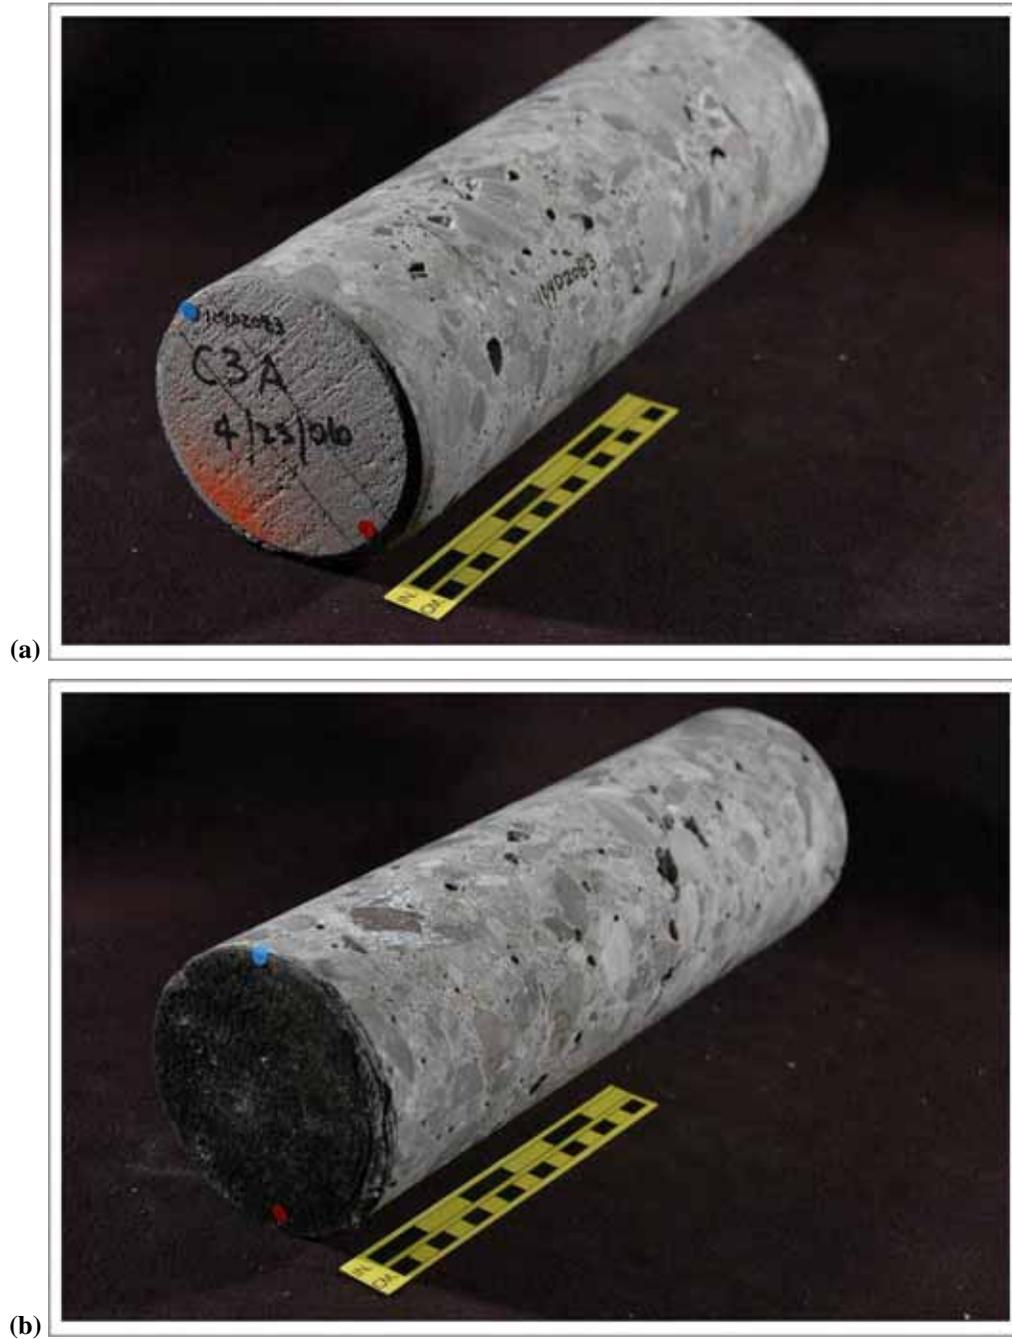
Figure A3. C3A. Photographs of sample in as-received condition showing (a) top and (b) bottom surface of core. Red and blue dots show the orientation of saw-cuts used to prepare the sample.

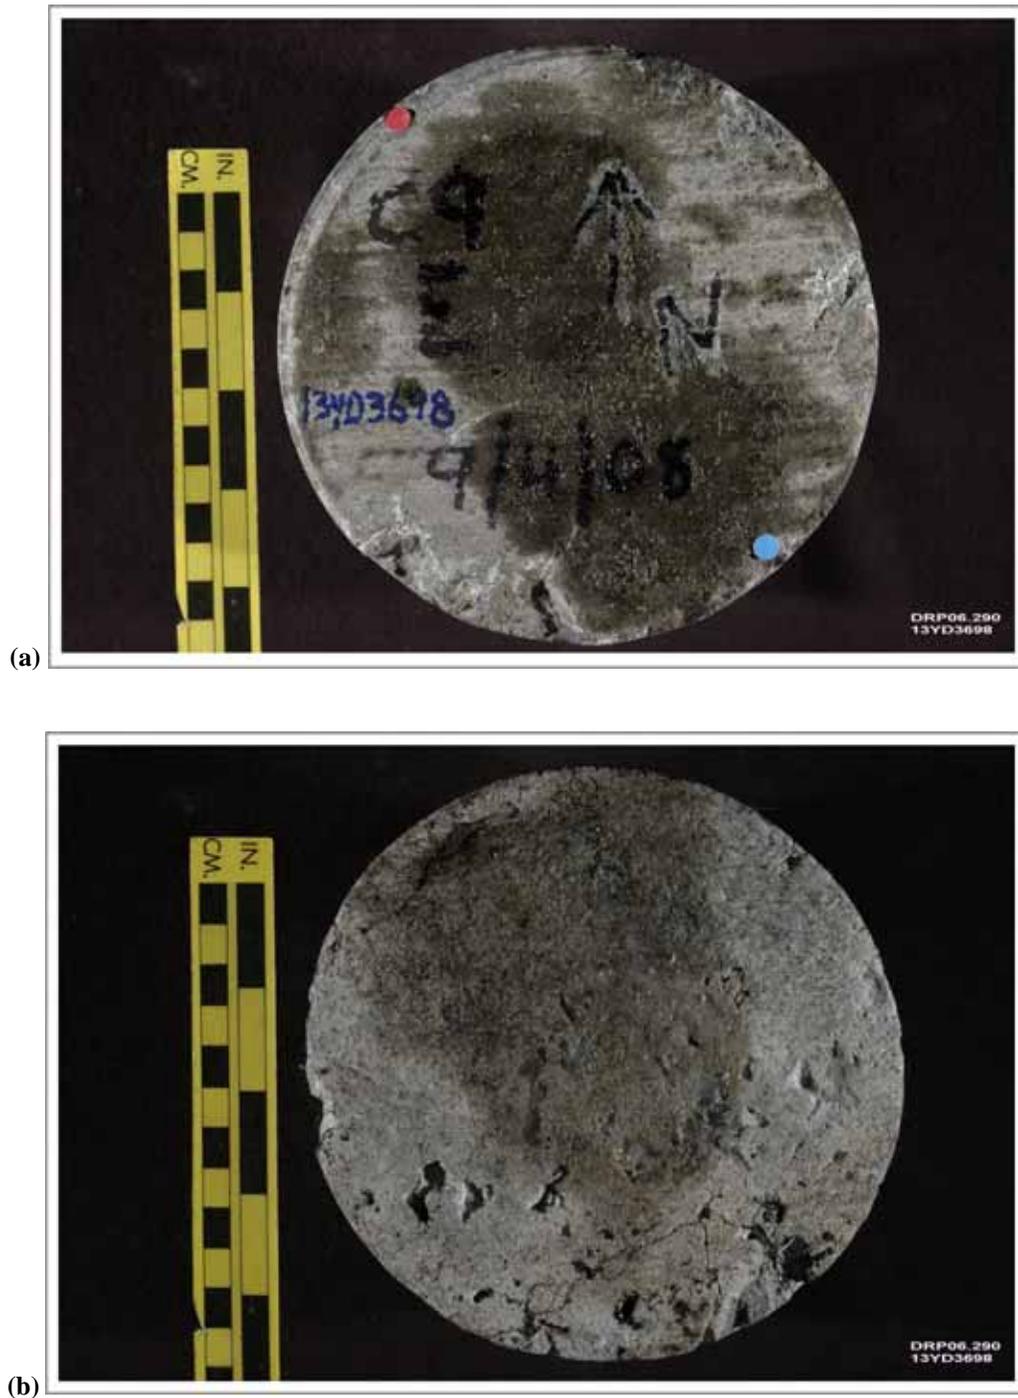
C9E	13YD3698	Cracking on the top surface of core 50 mm long, up to 0.5 mm wide ; scaling near the edges; white deposits on top surface; consolidated air voids and reaction rims present on the side of the core; grease spots on top & bottom surface

Figure A19. C9E. Photographs of sample in as-received condition showing (a) top and (b) bottom surface of core. Red and blue dots in (a) show the orientation of saw-cuts used to prepare the sample.

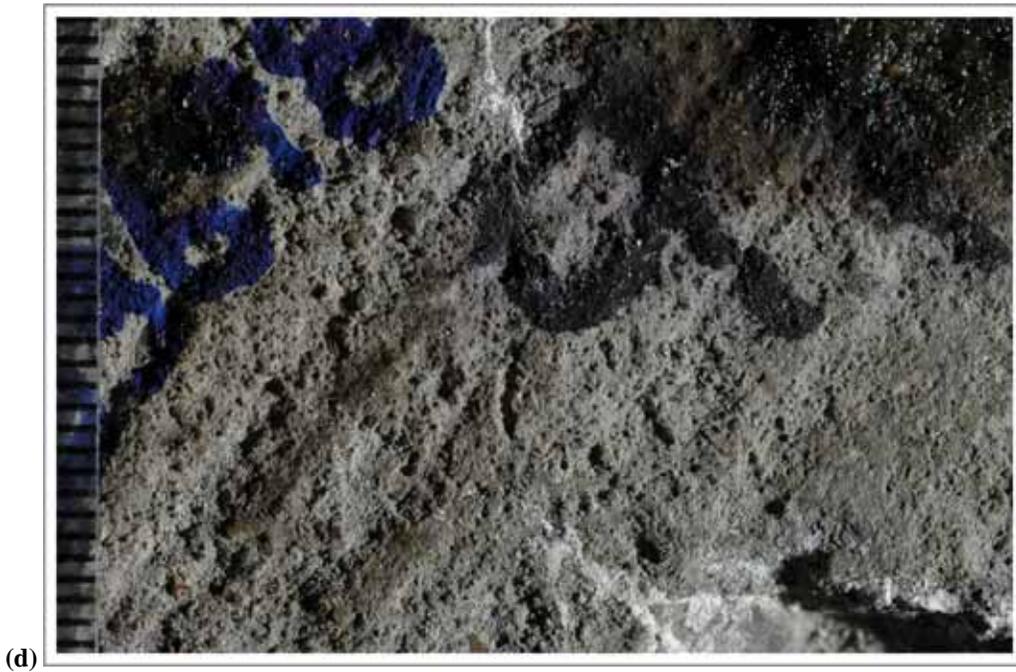
Figure A19 (cont'd). C9E. Photographs of sample in as-received condition showing (c) side of core and (d) detail of top surface. Scale in (d) millimeters.
