**REASSEMBLY OF POINT PLEASANT BRIDGE
DOCUMENTATION OF STRUCTURAL DAMAGE
AND
IDENTIFICATION OF LABORATORY SPECIMENS**

Ernest G. Wiles

**STRUCTURES AND APPLIED MECHANICS DIVISION
OFFICE OF RESEARCH AND DEVELOPMENT**

July 1970

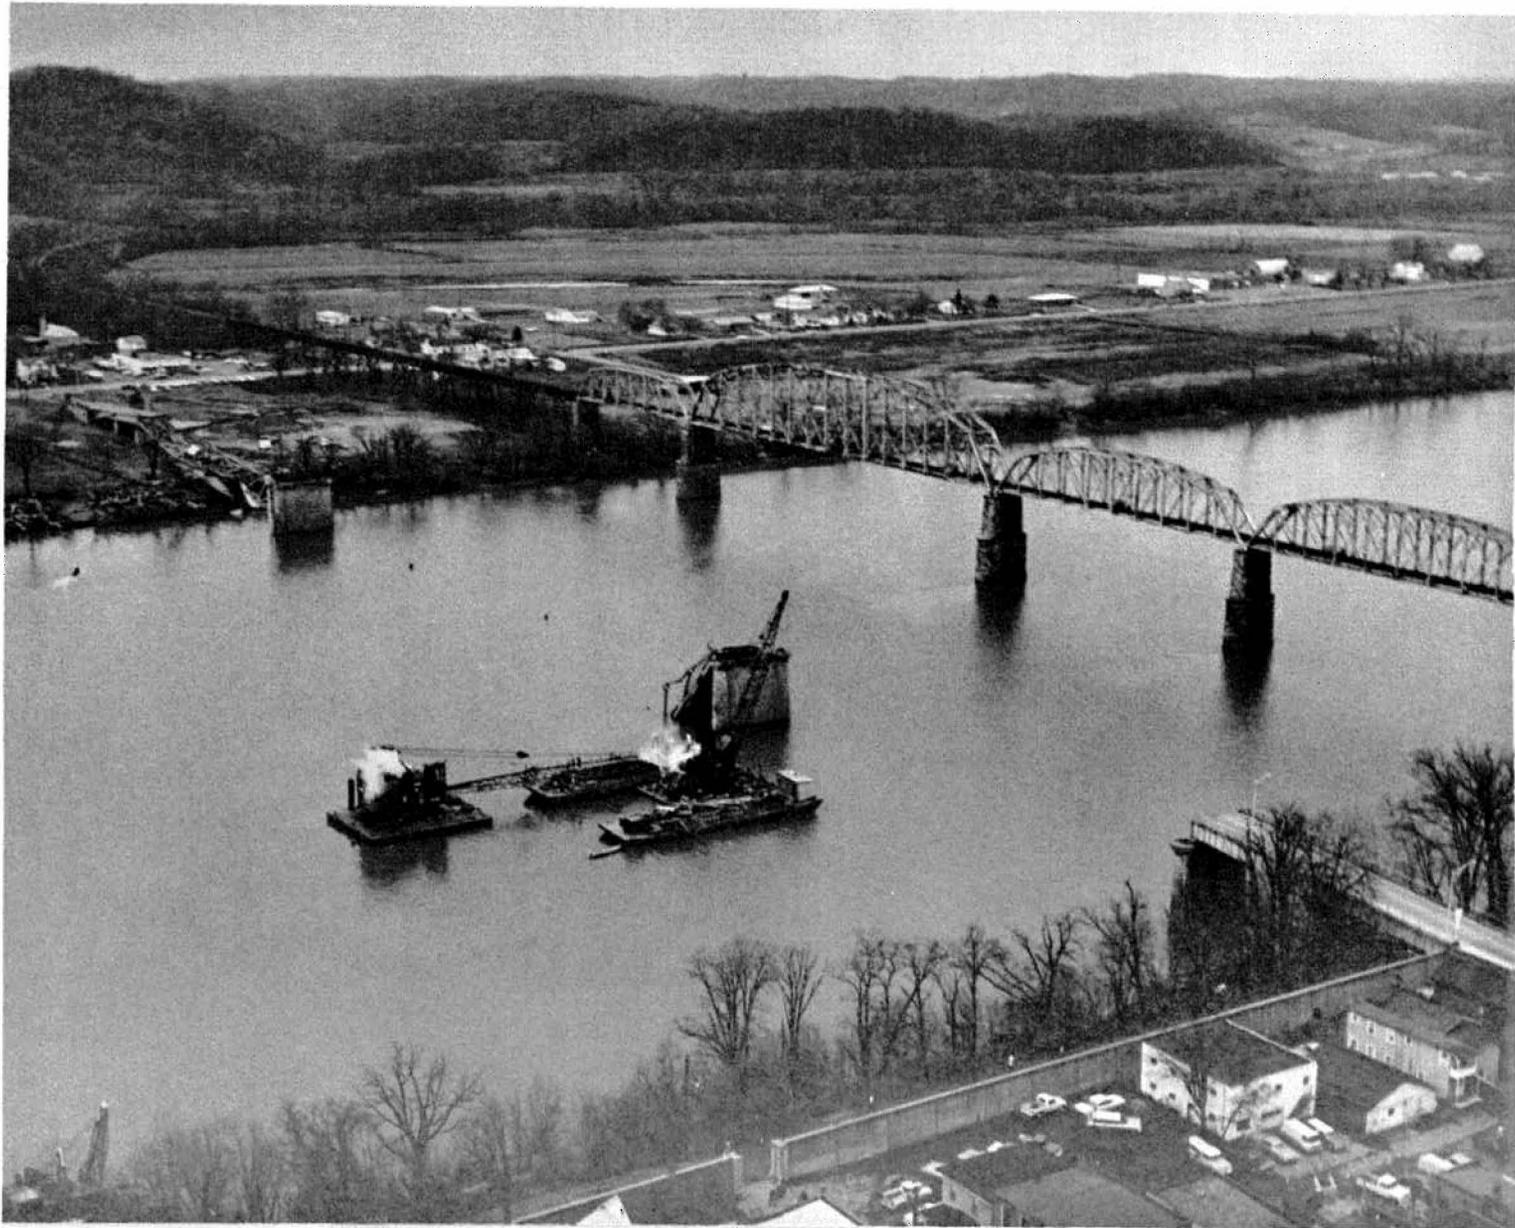
Figure 1 - Derrick barges engaged in salvage operations in the area of West Virginia side span.

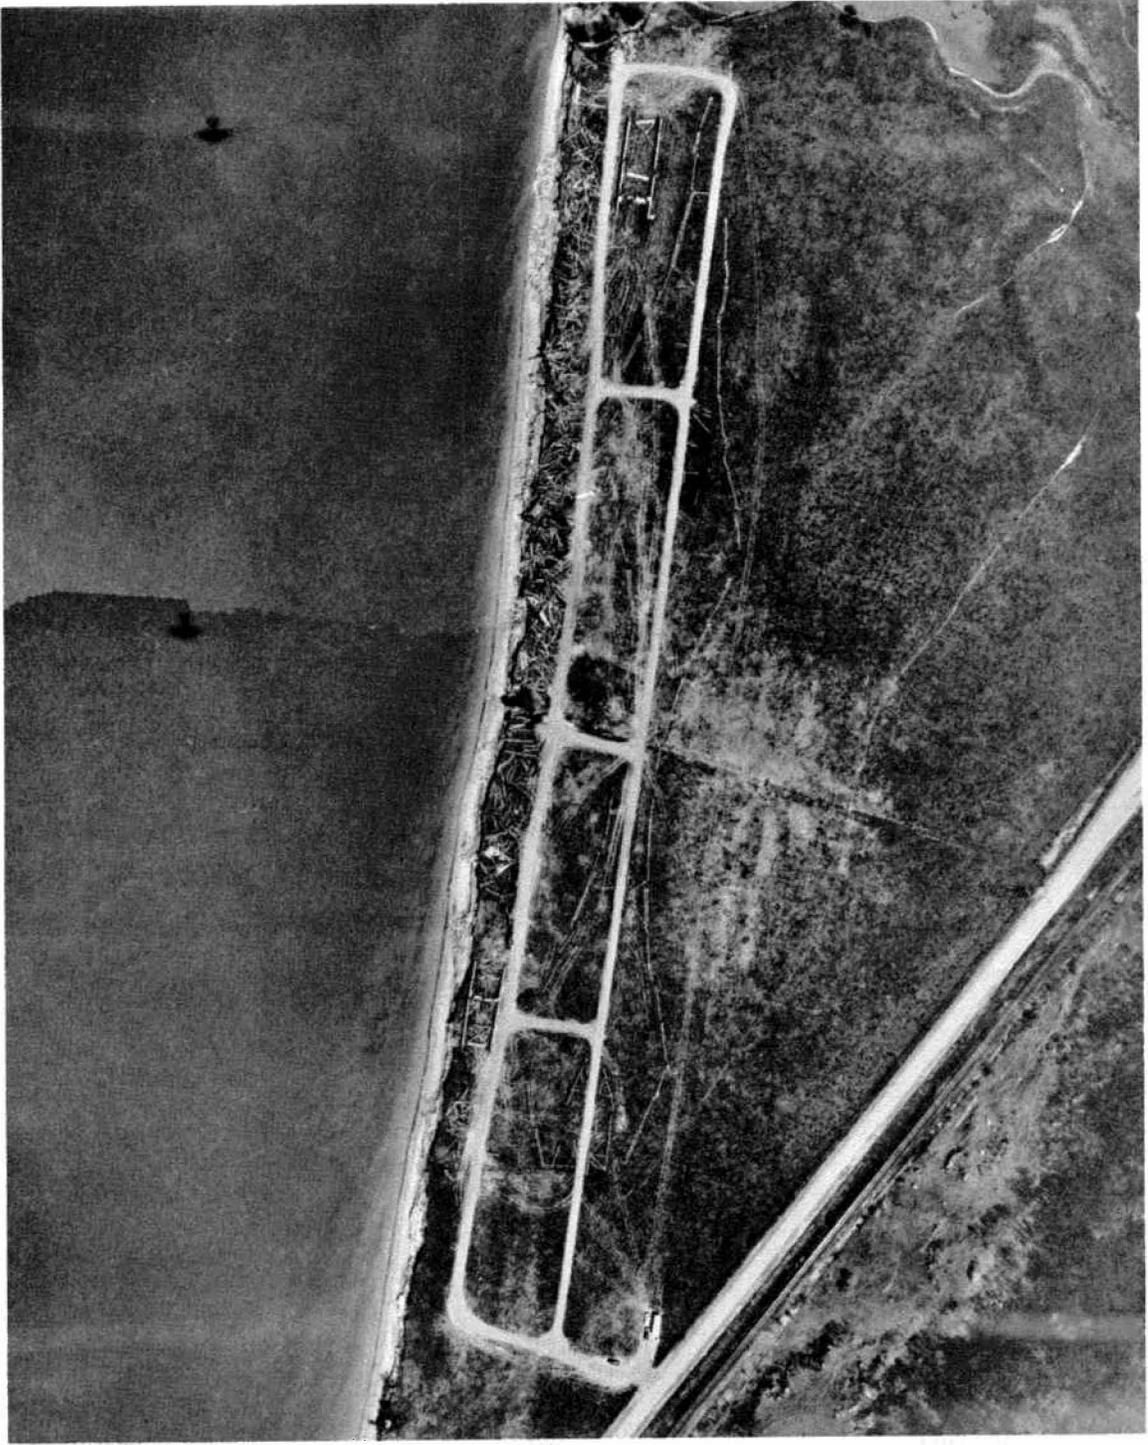
The reassembly site was designed in such a way that the trusses and eyebar chains would be laid out on the ground separated by a gravel road simulating the bridge deck. Additional gravel roads were made so that cranes could pick up the steel from the stockpile on the bank and place it in the proper position on the ground. An aerial view of the reassembly site is shown in Figure 2. The eyebar chains can be distinguished in position on the ground. The north or upstream side of the bridge is nearest the river. The Ohio end of the bridge is at the left side

of the figure. Also the two towers can be seen partially reassembled in separate areas adjacent to the stockpile of salvaged material. The Ohio tower is the one at the right side of the picture. The hanger straps were also placed in a separate location for later identification. Most of the steel at the reassembly site was taken from the river and consisted of the West Virginia side span, the main span and part of the Ohio side span. The section of the bridge that fell on the Ohio bank was stockpiled on the Ohio shore.

Figure 2 - An aerial view of the reassembly site.

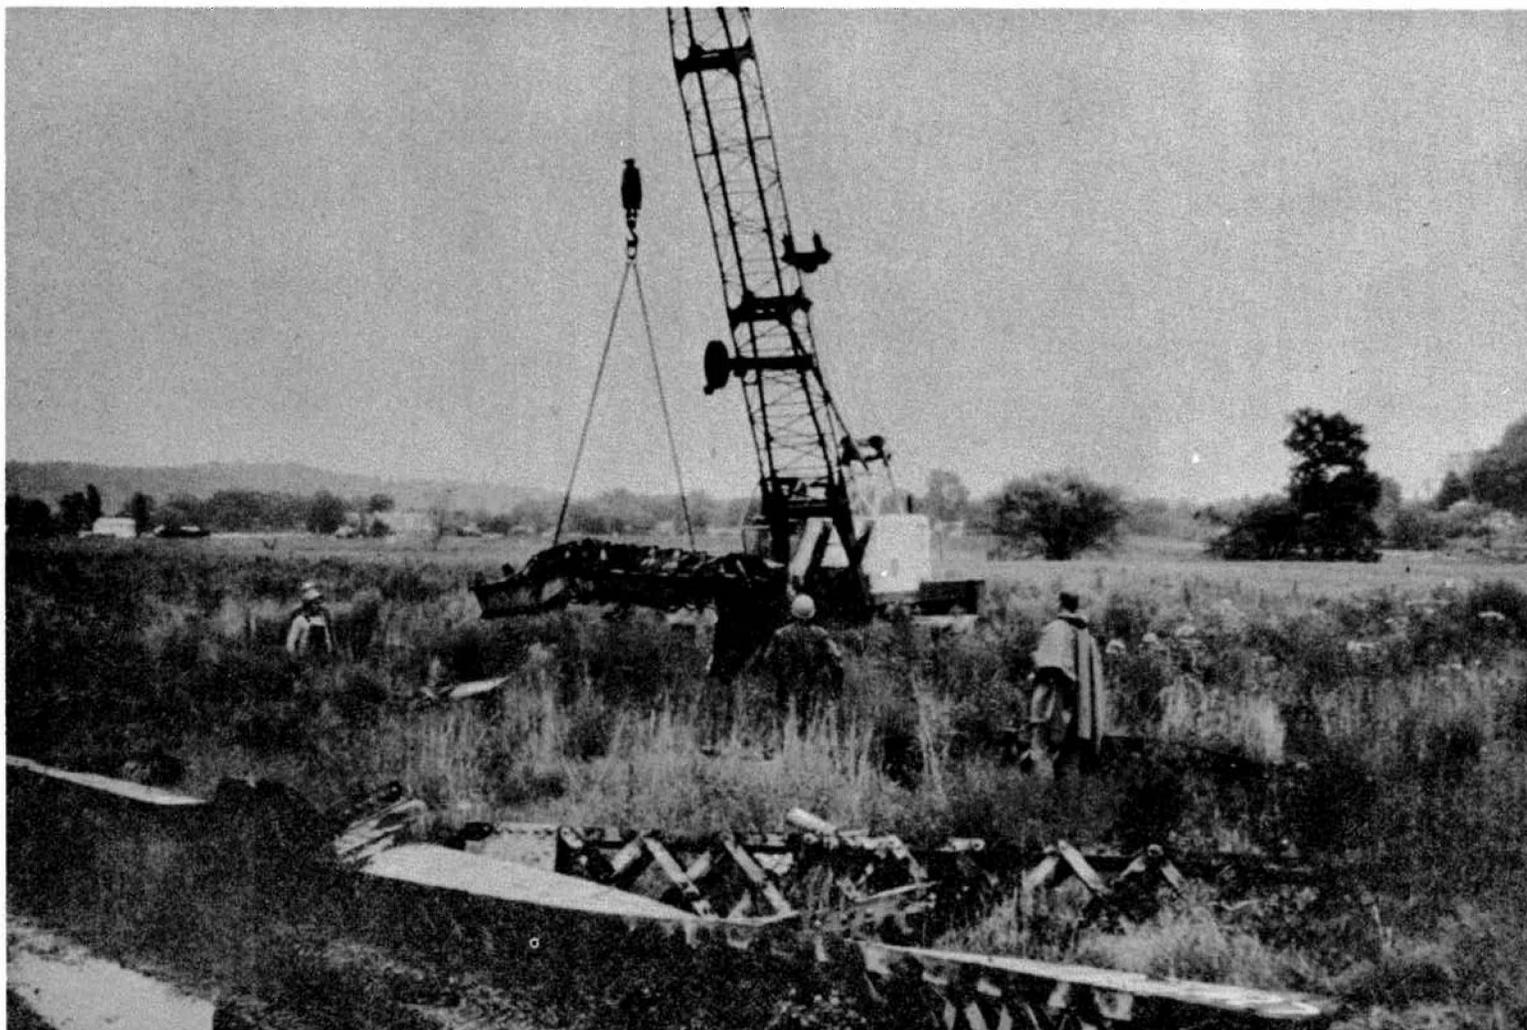
Each piece of steel that had been placed was examined to make sure it had been positioned properly and that pieces still missing in the puzzle were located and placed in positions by crane as shown in Figure 3.

Figure 3 - Crane engaged in reassembly operations; positioning a fractured member in its proper position.

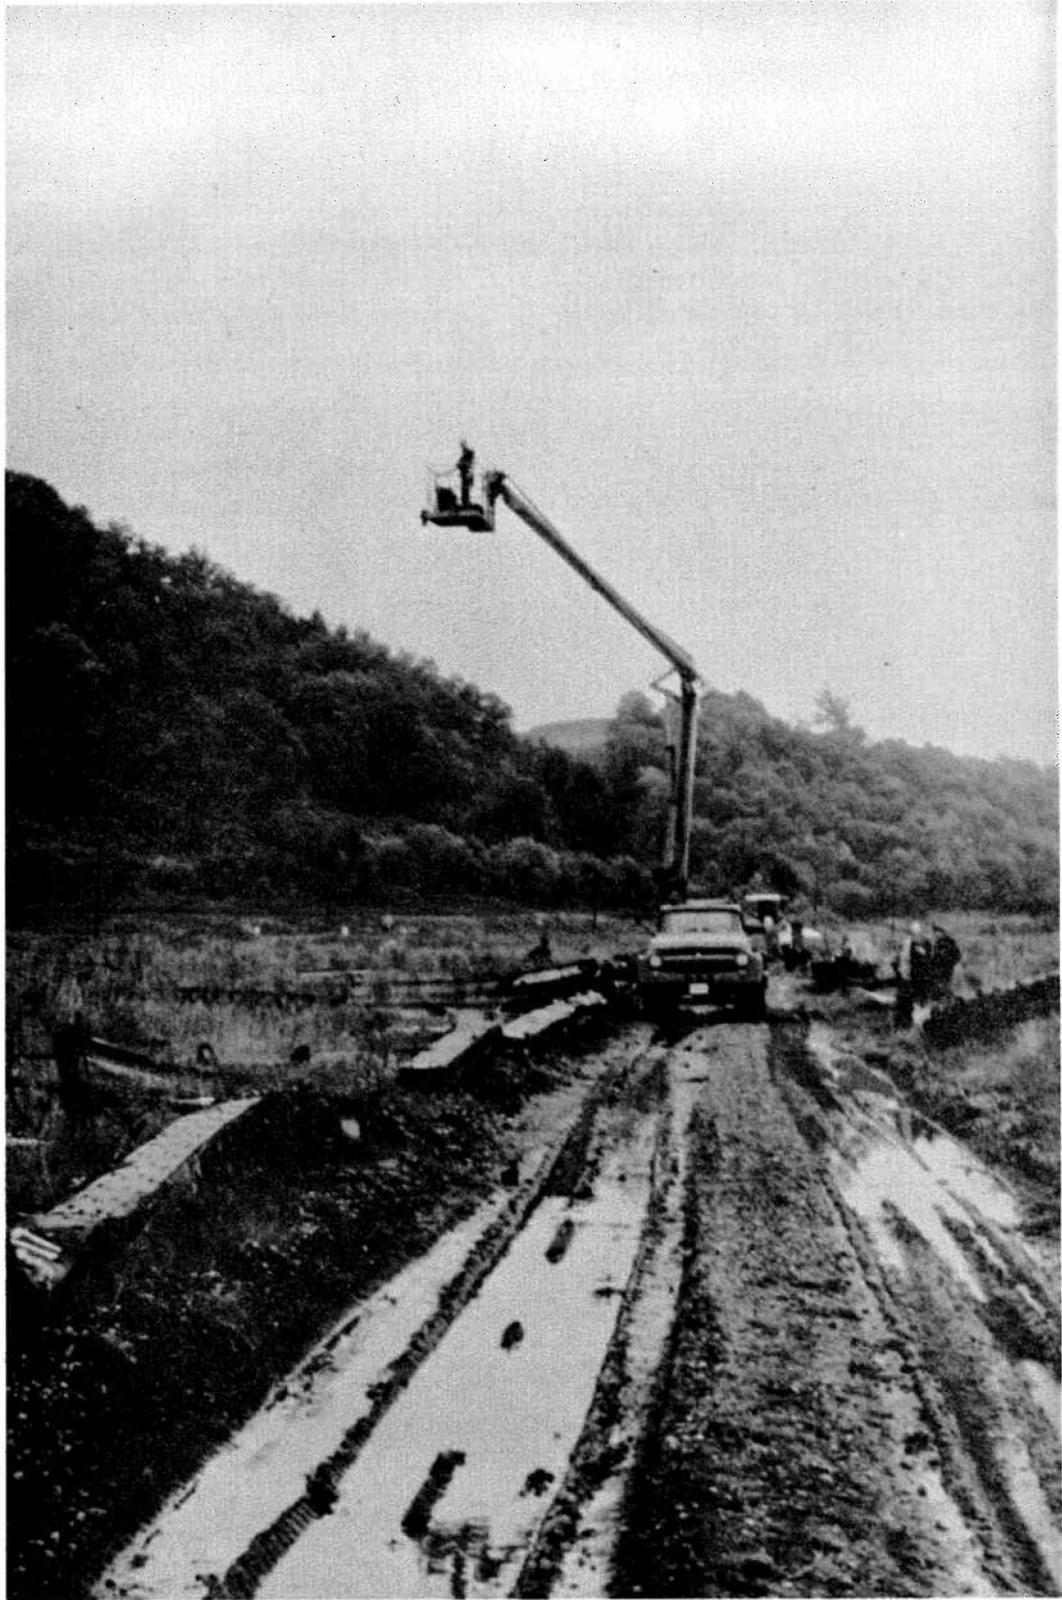
At the same time that this work was proceeding, photographs of completed sections were being taken from the platform of a giraffe approximately 30 feet above the steel at the reassembly site as shown in Figure 4. Photographs were taken at approximately 25 foot intervals along each truss. The elevated platform was positioned so that an overlap of approximately 40 percent between photographs was obtained. The 101 photographs obtained were later fitted together into two 25-foot long continuous strips and mounted on kraft paper to form a montage of each side of the bridge. Originals of the two montages are on file at the Fairbank Highway Research Station for reference with this report. In addition to the consecutive identification numbers that showed on the pieces, panel point identification figures and a yardstick for a scale were also put in place for each photograph. In this way each photograph could be clearly identified and the print could be enlarged so that the yardstick scales were the same size for each finished photograph. This adjustment was essential to care for any variations in the height of the giraffe platform and in the focus of the camera.

Figure 4 - Photographs being taken of the reassembled bridge pieces.
