Dowel Bar Retrofit Performance in Wisconsin

Dowel Bar Retrofit Performance in Wisconsin
Research Study # WI-98-05

Report # WI-02-10

Prepared by:
Irene K. Battaglia, M.S.
Construction and Materials Support Center
UW-Madison

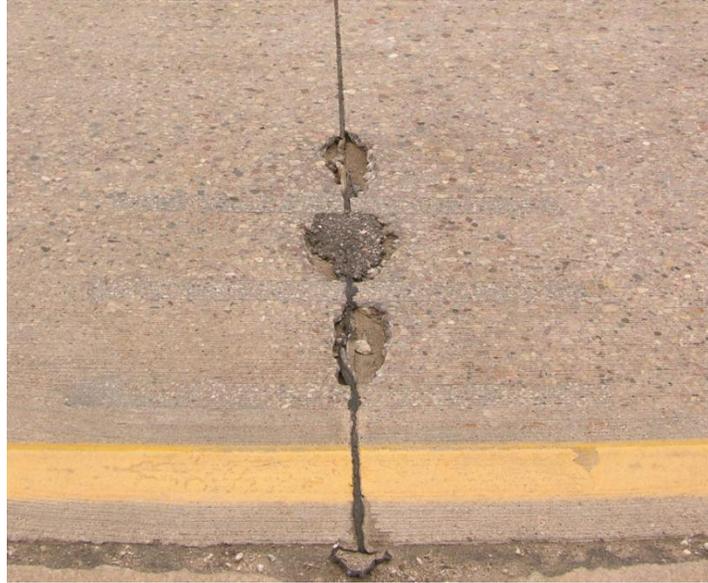
The DBR test sections on USH 45 were inspected visually in April 2010, after six years in service. Excellent performance was noted in the test sections that used Tamms Speed Crete (60 and 80 percent extension) for the slot fill material (eastbound PL and both westbound lanes). A few instances of joint deterioration were noted in these areas, but these distresses were typically present between the dowel slots (Figure 9).

Figure 9. Joint deterioration between dowel slots on USH 45, 2010.

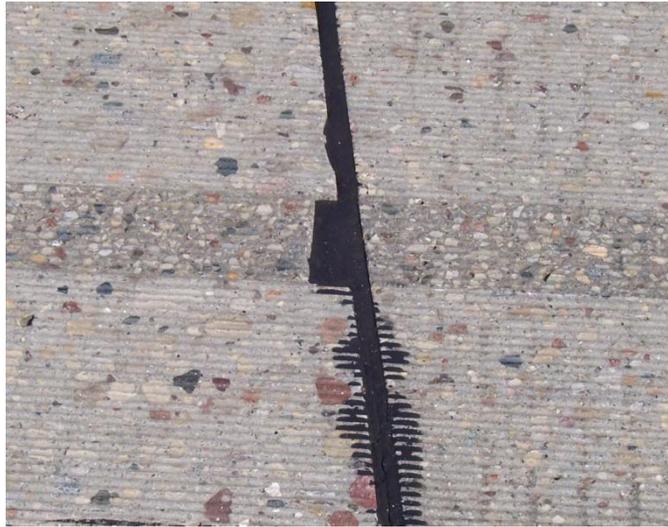
Figure 10. Misalignment of foam core board on STH 21, 2007.
