Appendix C
M-59 Core Site

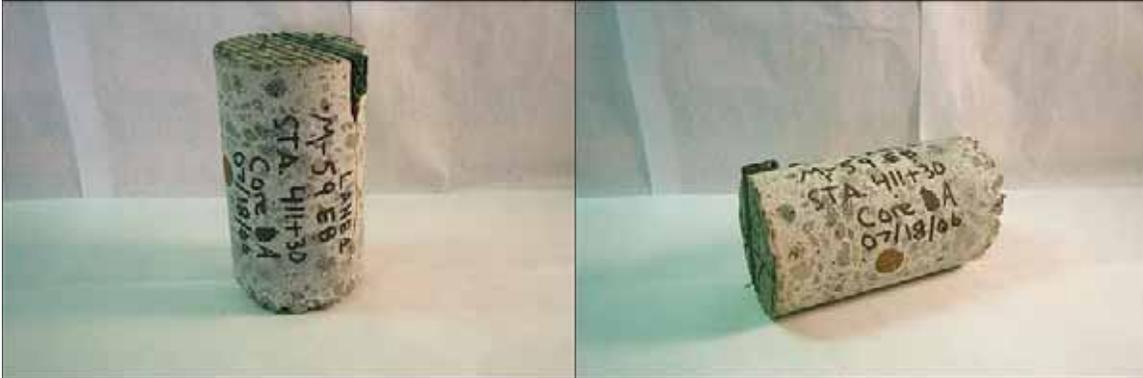
EB M-59, outside lane, constructed 1997/98, station 411+30, at joint, core A, (MTU ID 59-01).

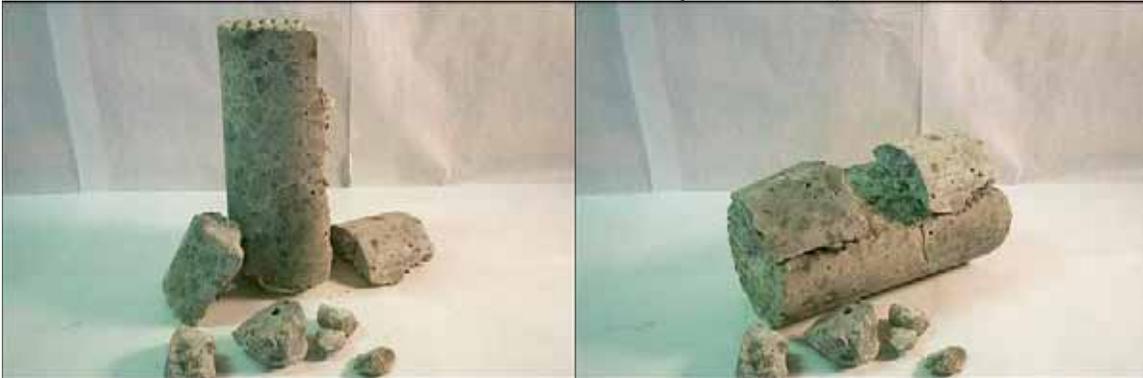
EB M-59, outside lane, constructed 1997/98, station 411+30, at joint, core B, (MTU ID 59-06).

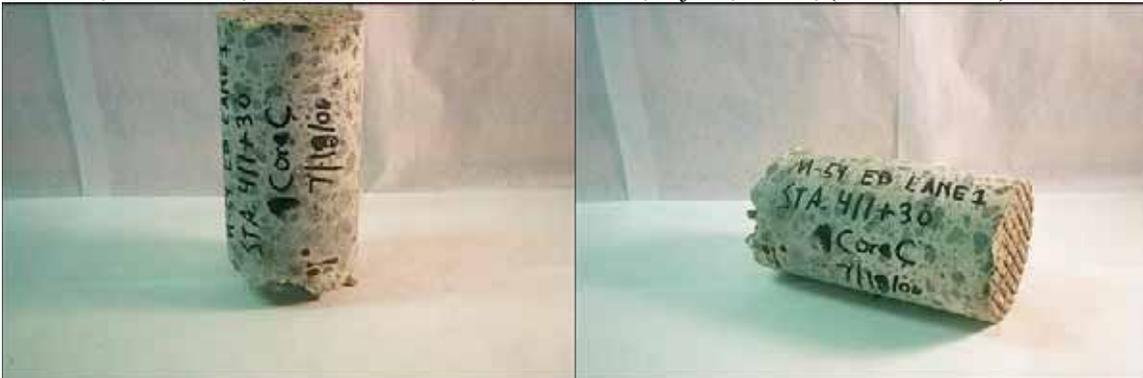
EB M-59, outside lane, constructed 1997/98, station 411+30, away from joint, core C, (MTU ID 59-02).

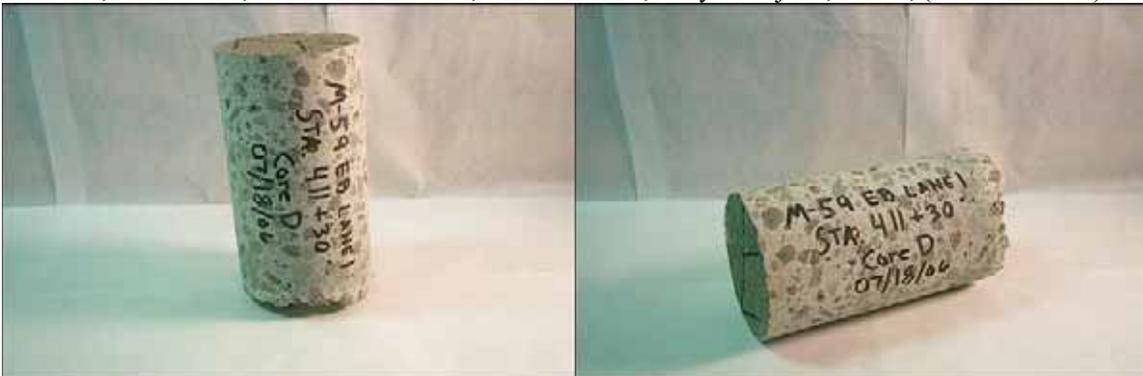
EB M-59, outside lane, constructed 1997/98, station 411+30, away from joint, core D, (MTU ID 59-03).

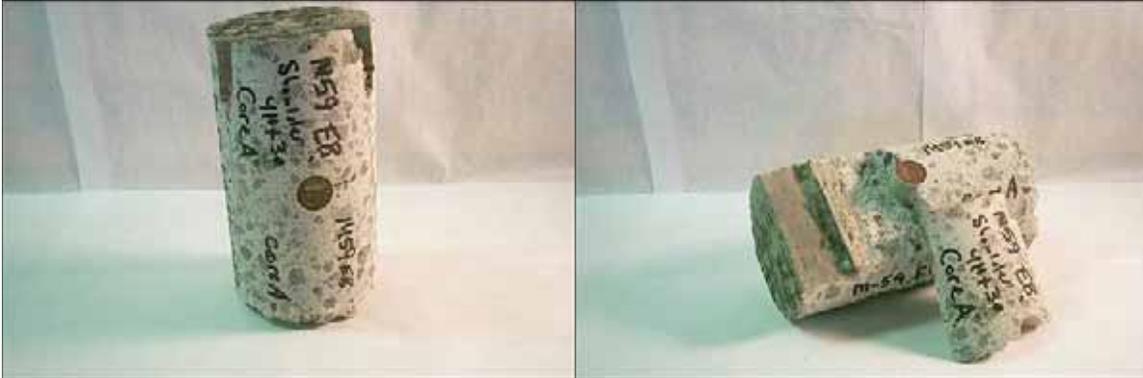
EB M-59, shoulder, constructed 1997/98, station 411+30, at joint, core A, (MTU ID 59-05).

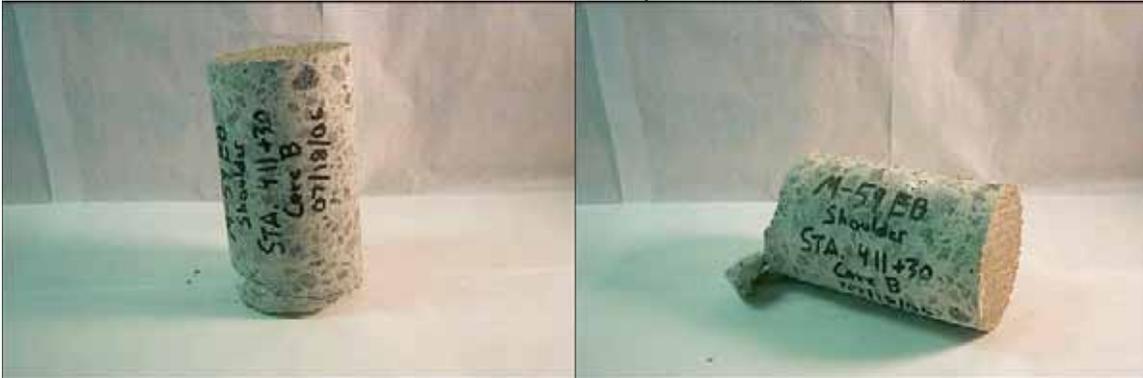
EB M-59, shoulder, constructed 1997/98, station 411+30, near joint?, core B, (MTU ID 59-04).

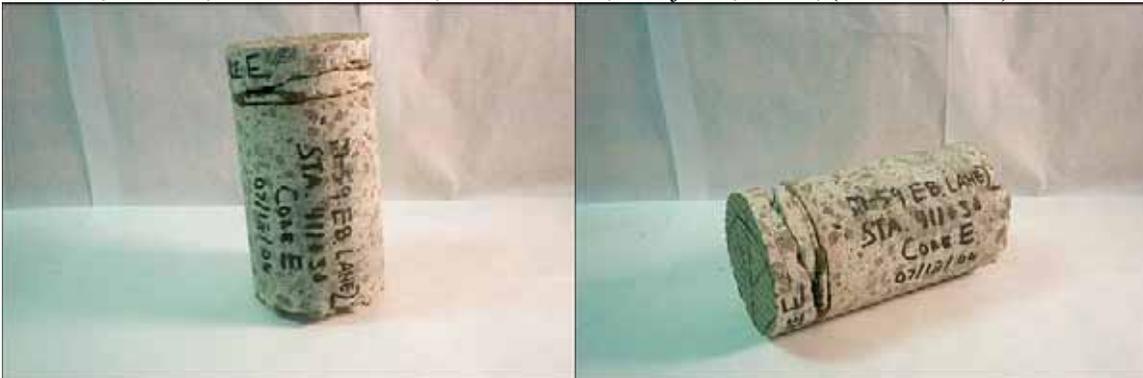
EB M-59, middle lane, constructed 1997/98, station 411+30, near joint?, core E, (MTU ID 59-07).

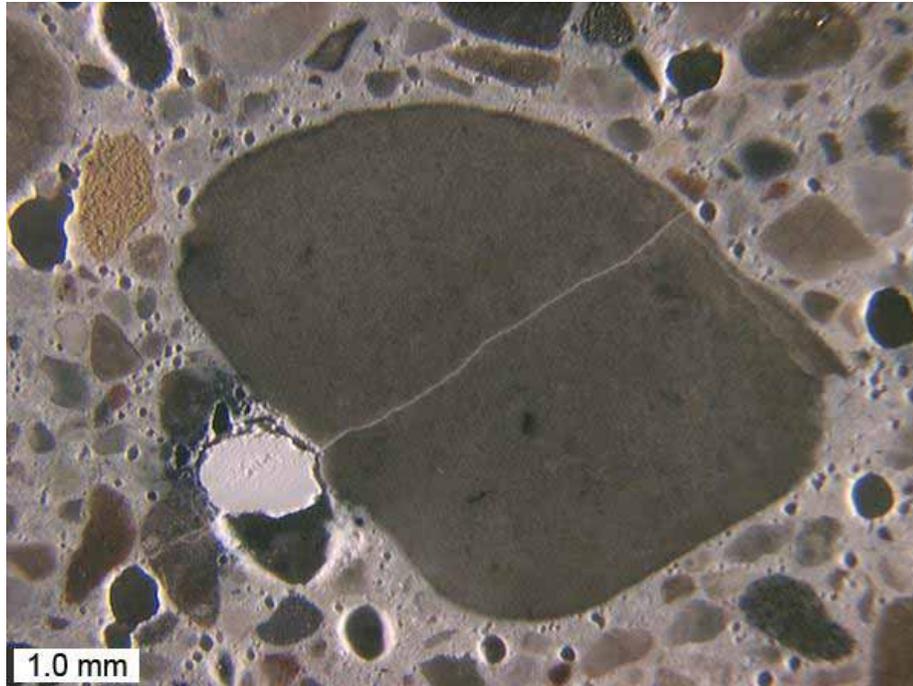
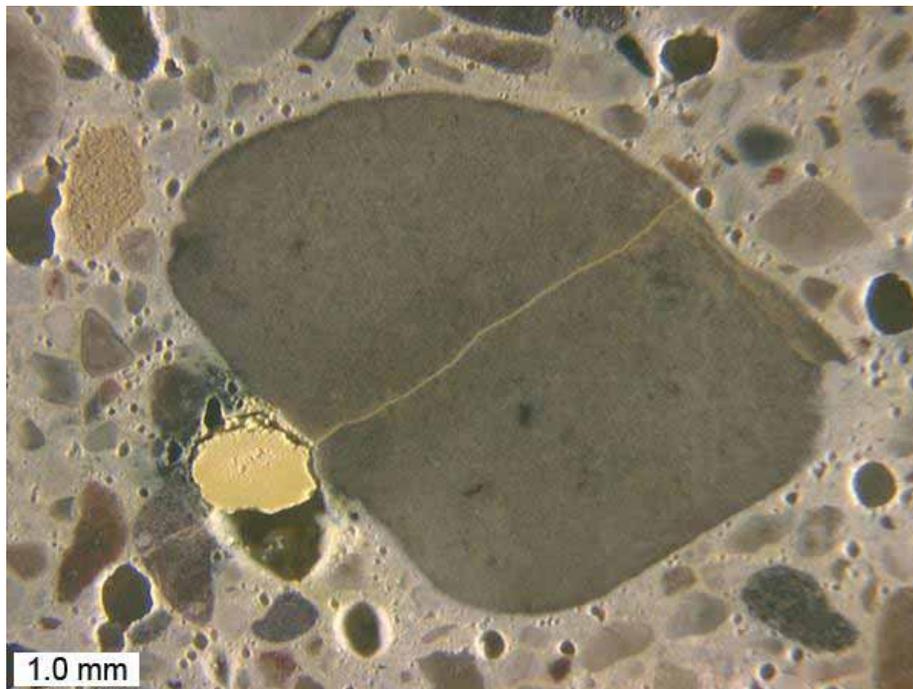
Alkali silica reaction in fine aggregate and associated cracking, before and after sodium cobaltinitrite stain, polished slab from top half of M-59, constructed 1997/98, outside lane, away from transverse joint, core C, MTU ID M59-02.

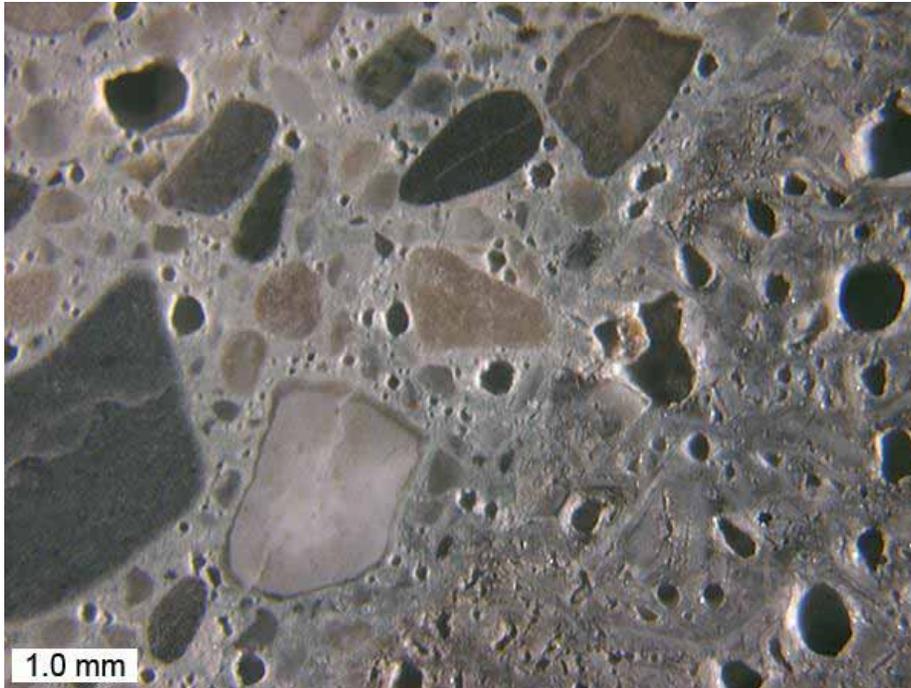
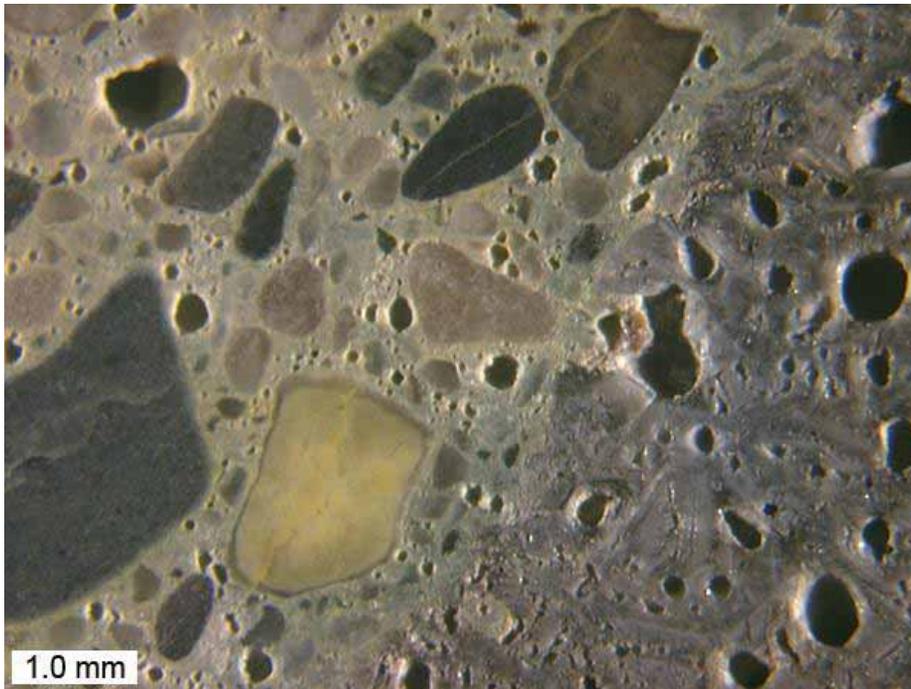
Alkali silica reaction in fine aggregate and associated cracking, before and after sodium cobaltinitrite stain, polished slab from top half of M-59, constructed 1997/98, outside lane, away from transverse joint, core C, MTU ID M59-02.

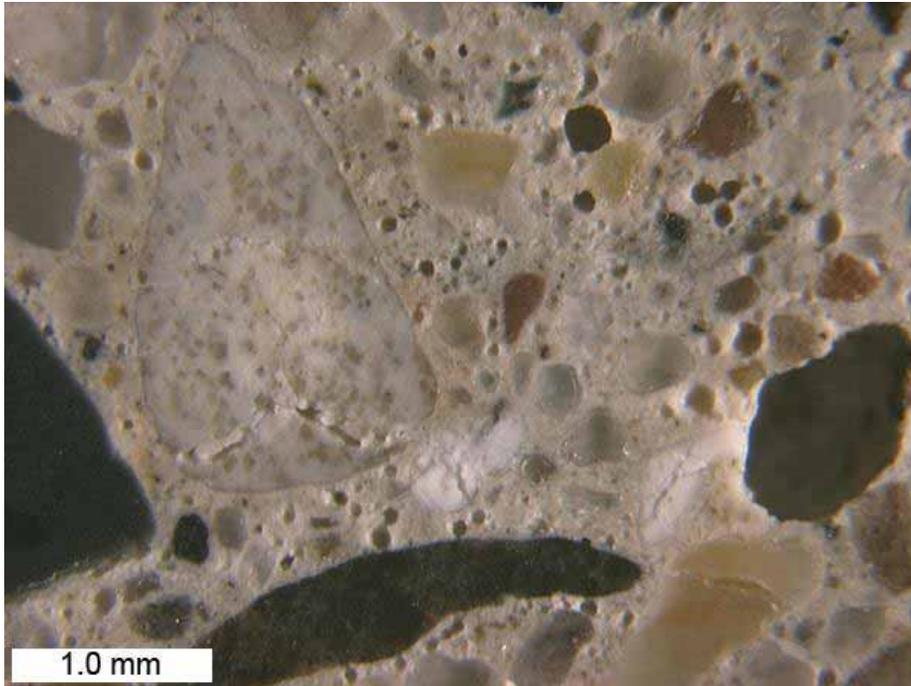
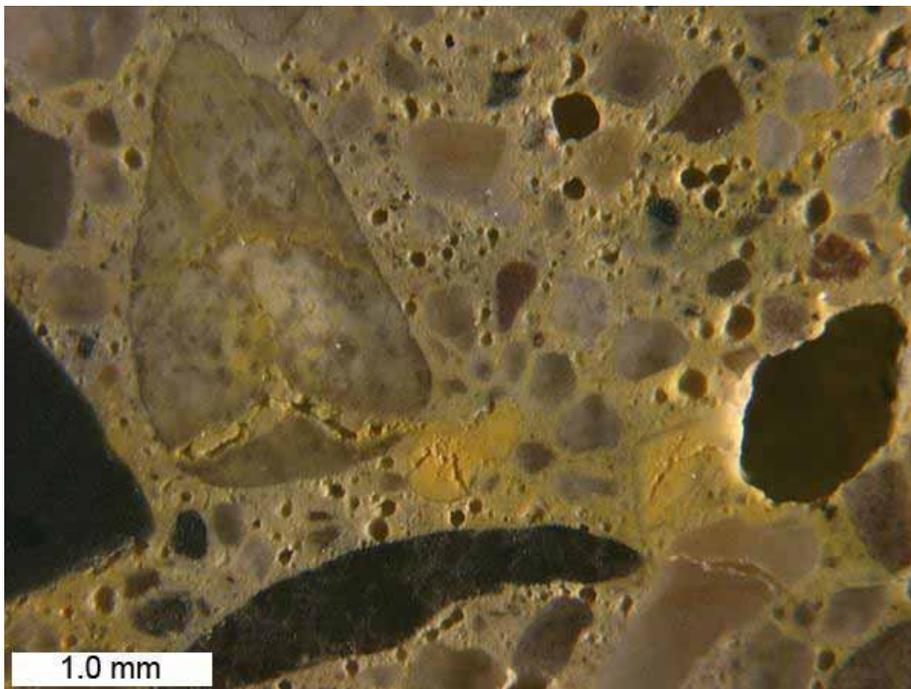
Alkali silica reaction in fine aggregate and associated cracking, before and after sodium cobaltinitrite stain, polished slab from top half of M-59, constructed 1997/98, outside lane, away from transverse joint, core C, MTU ID M59-02.

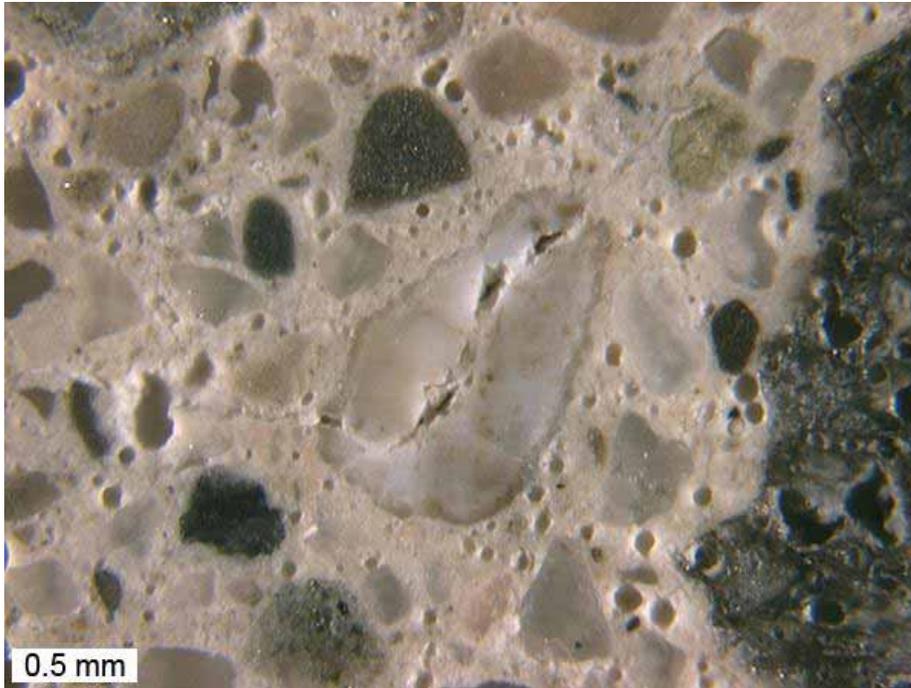
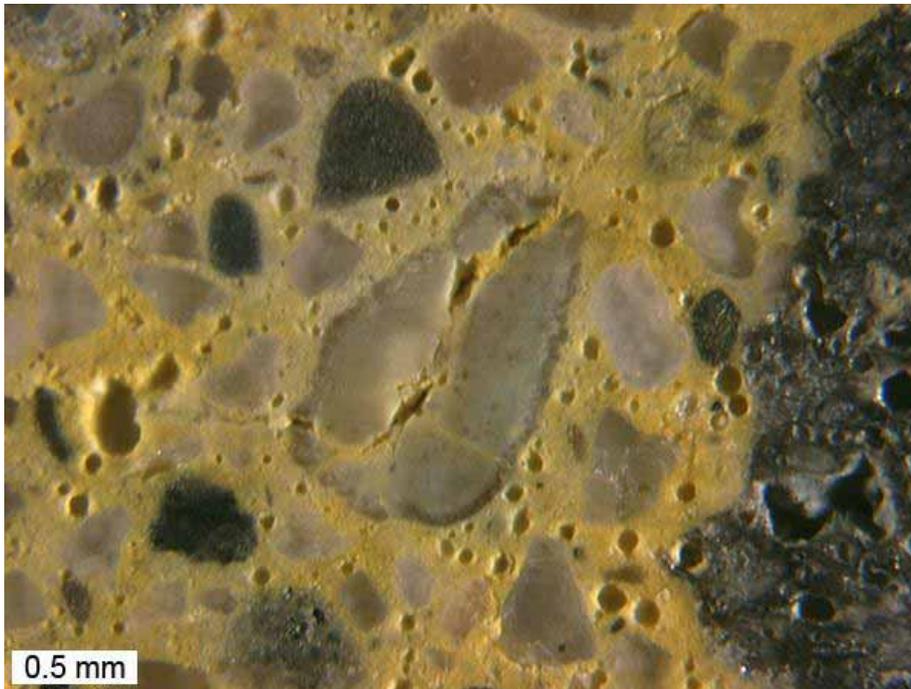
Alkali silica reaction in fine aggregate and associated cracking, before and after sodium cobaltinitrite stain, polished slab from top half of M-59, constructed 1997/98, outside lane, away from transverse joint, core C, MTU ID M59-02.

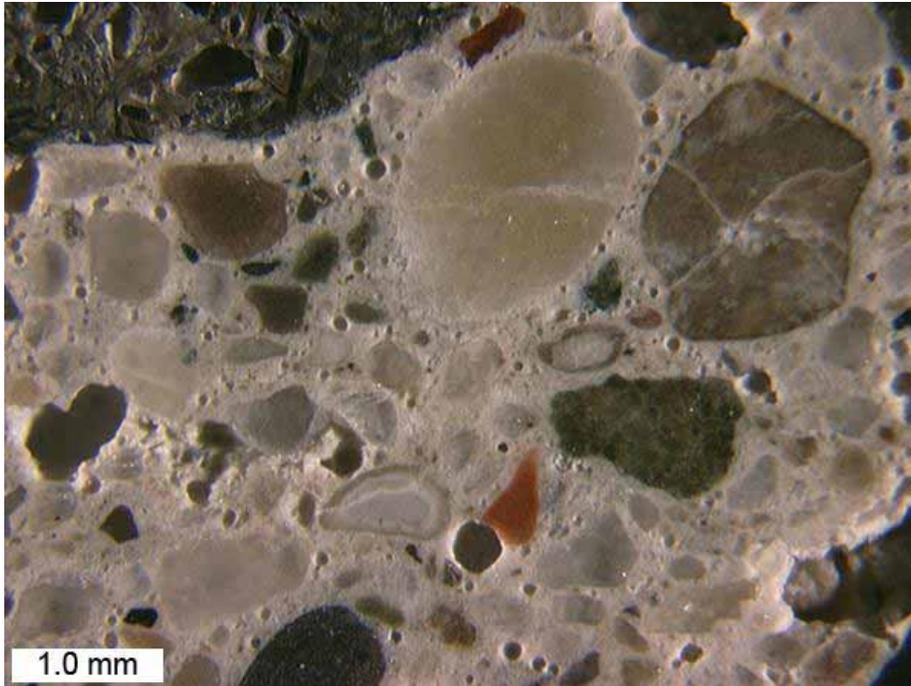
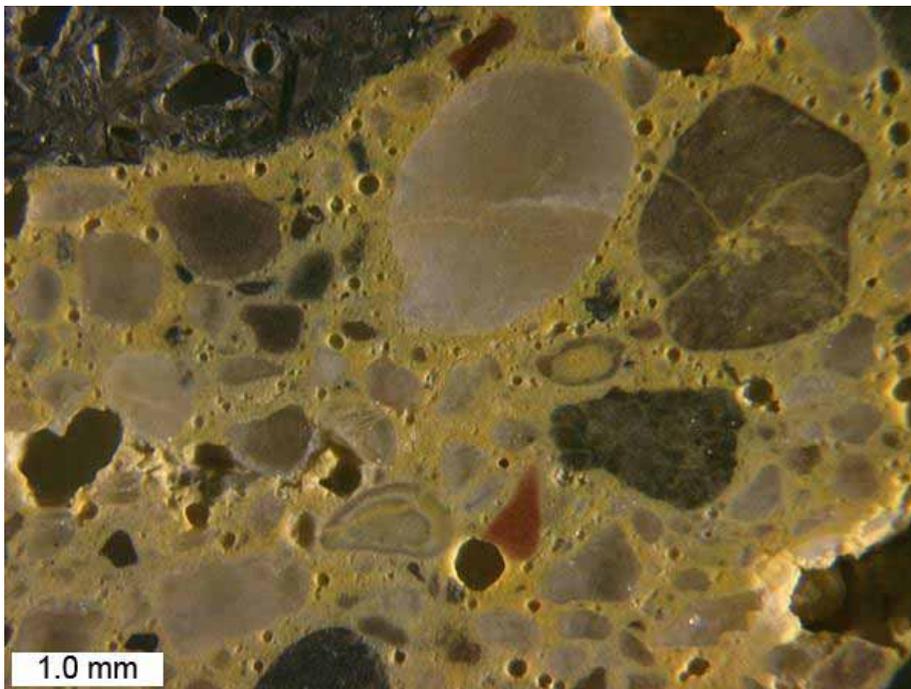
Alkali silica reaction in fine aggregate and associated cracking, before and after sodium cobaltinitrite stain, polished slab from top half of M-59, constructed 1997/98, outside lane, away from transverse joint, core C, MTU ID M59-02.

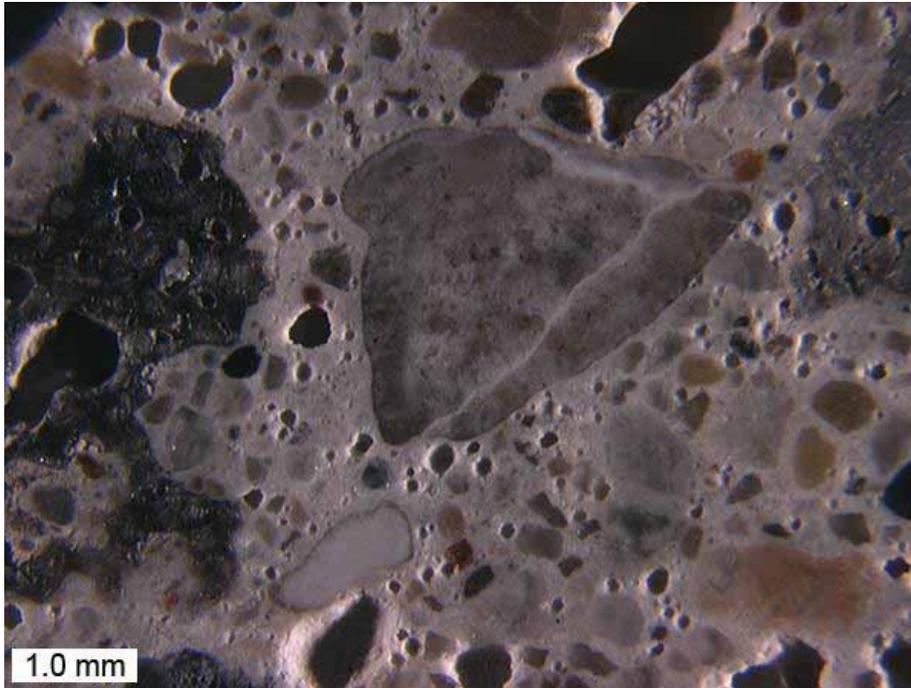
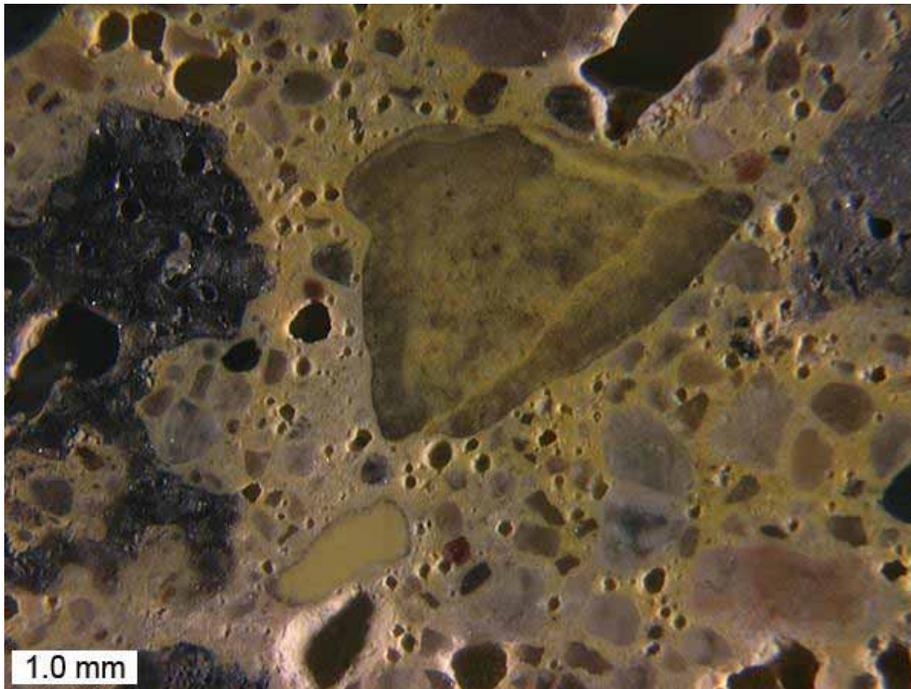
Alkali silica reaction in fine aggregate and associated cracking, before and after sodium cobaltinitrite stain, polished slab from top half of M-59, constructed 1997/98, outside lane, away from transverse joint, core C, MTU ID M59-02.

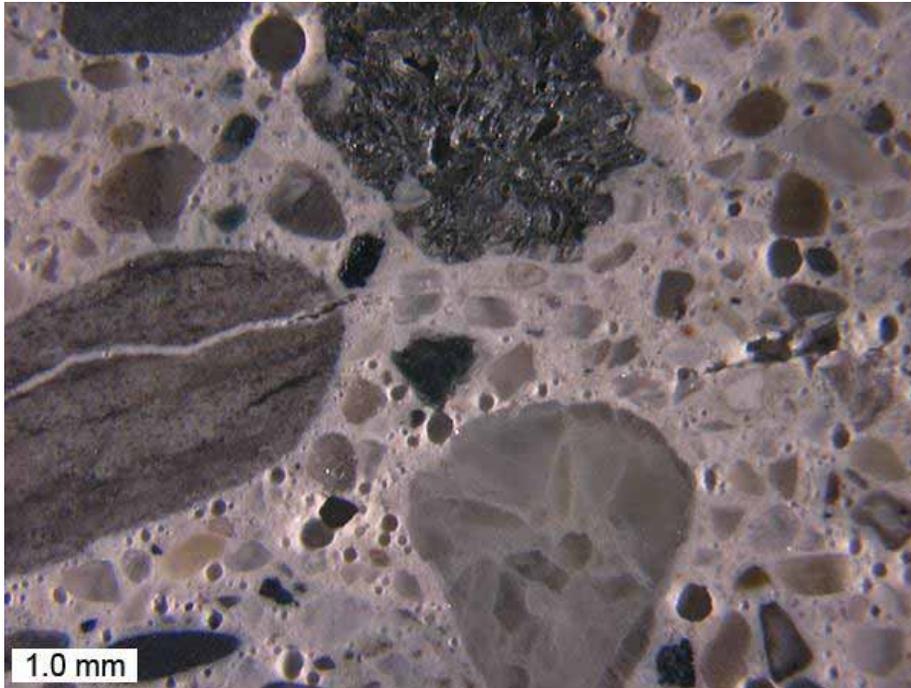
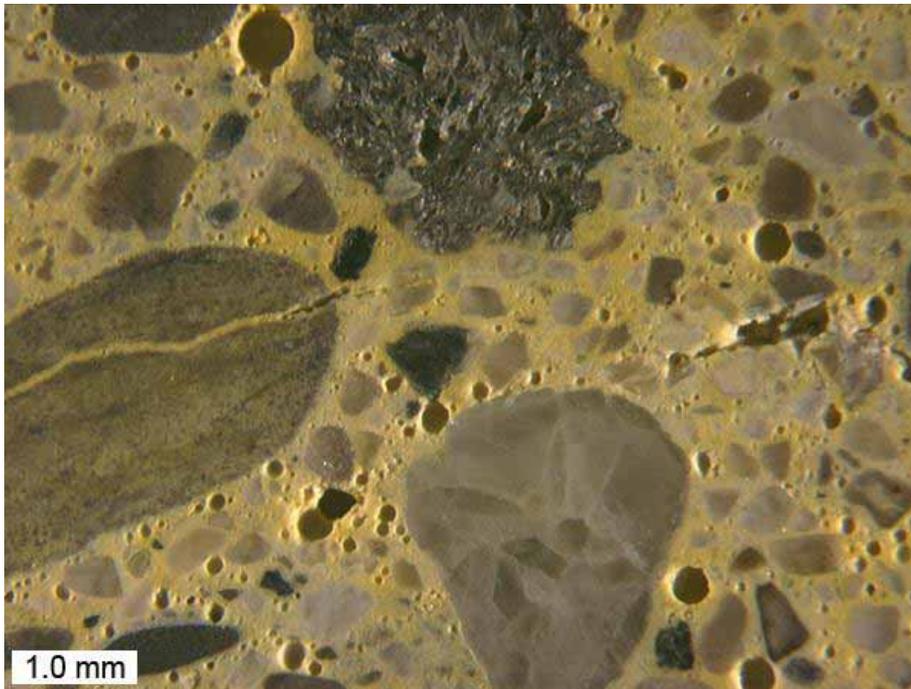
Alkali silica reaction in fine aggregate and associated cracking, before and after sodium cobaltinitrite stain, polished slab from top half of M-59, constructed 1997/98, outside lane, away from transverse joint, core C, MTU ID M59-02.

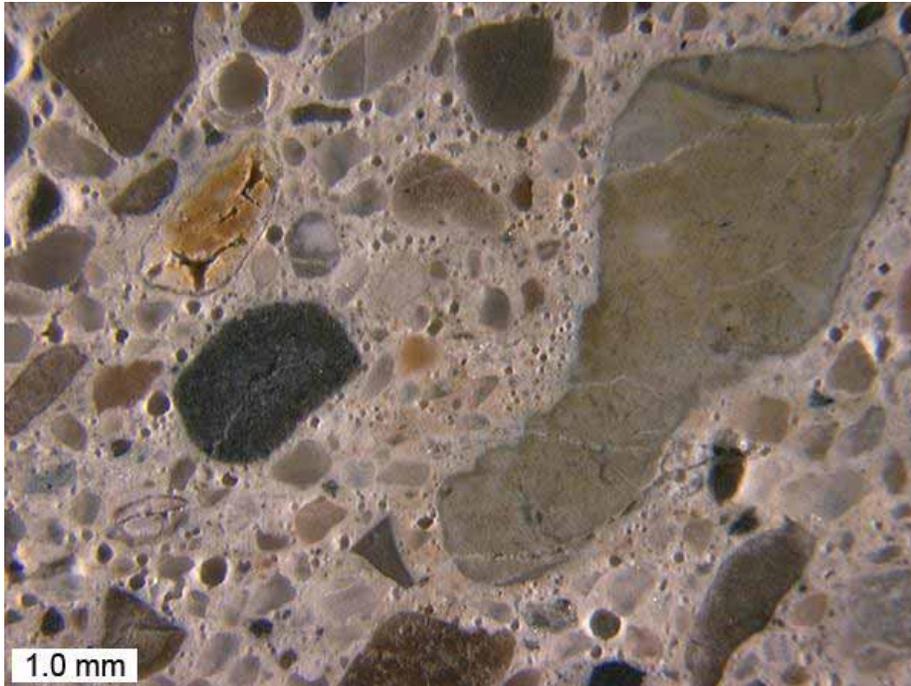
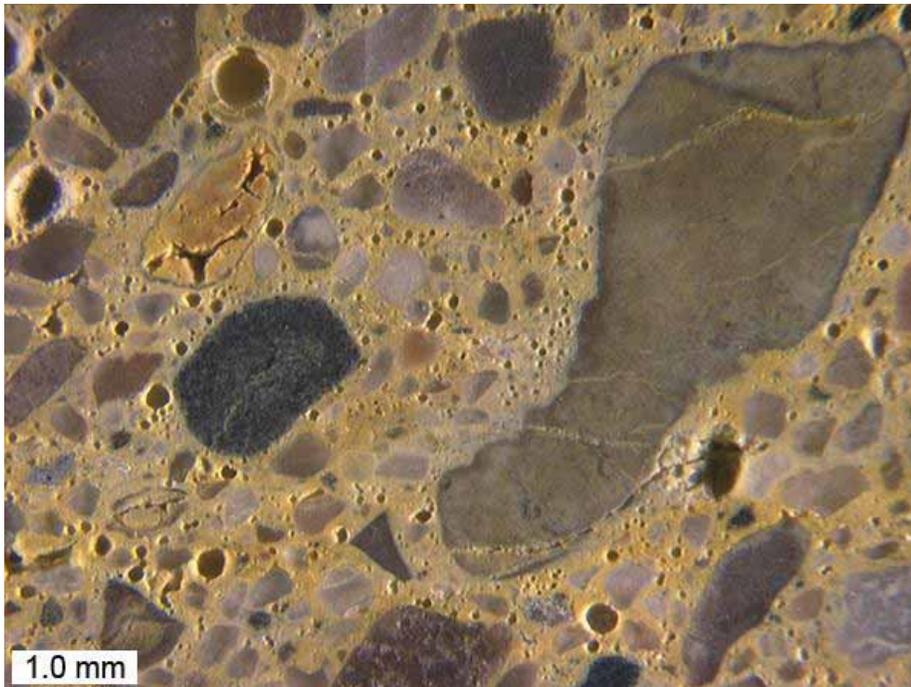
Alkali silica reaction in fine aggregate and associated cracking, before and after sodium cobaltinitrite stain, polished slab from top half of M-59, constructed 1997/98, outside lane, away from transverse joint, core C, MTU ID M59-02.

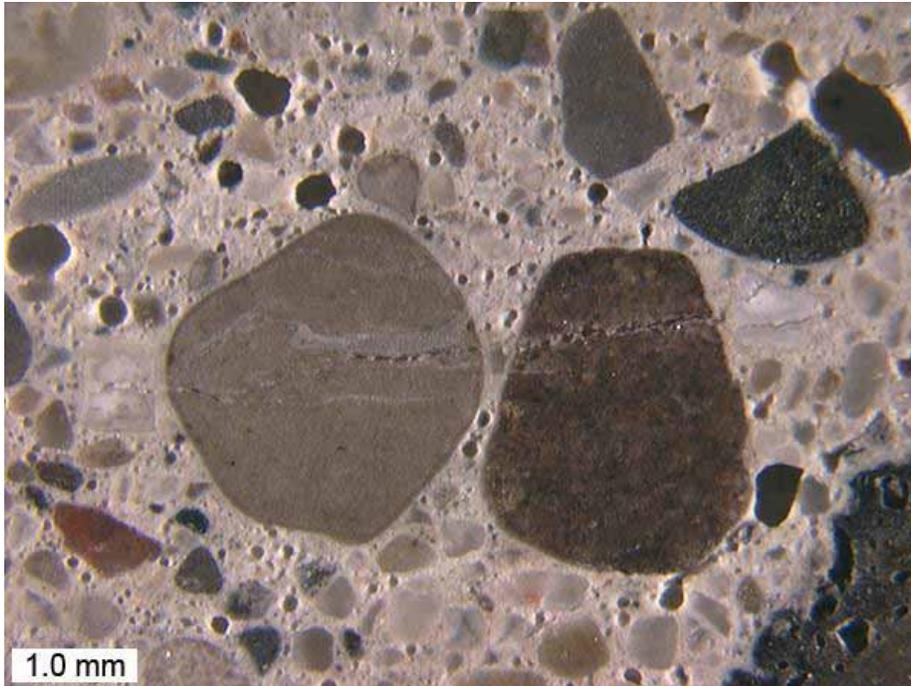
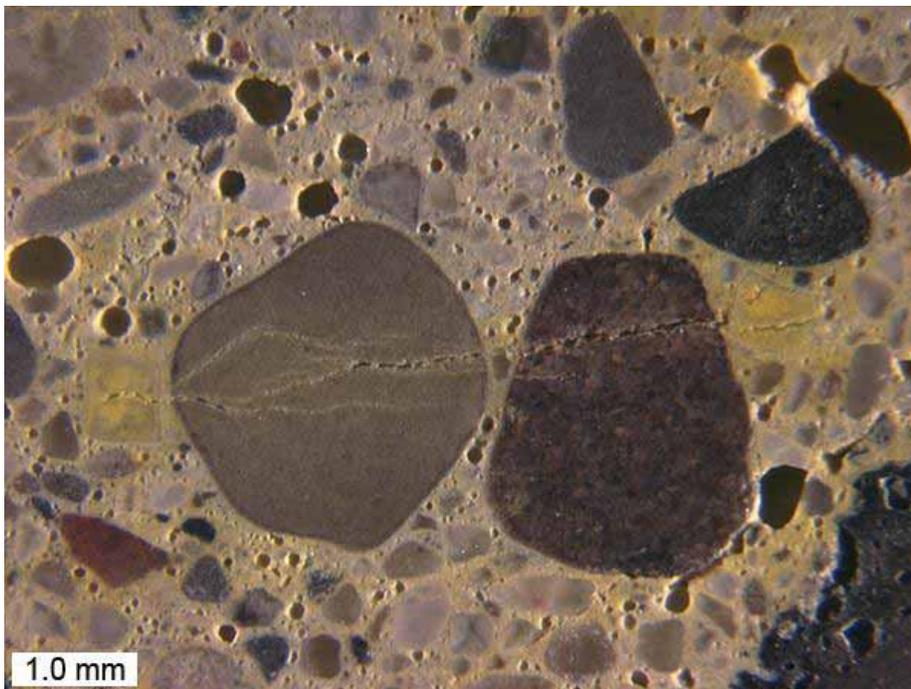
Alkali silica reaction in fine aggregate and associated cracking, before and after sodium cobaltinitrite stain, polished slab from top half of M-59, constructed 1997/98, outside lane, away from transverse joint, core C, MTU ID M59-02.

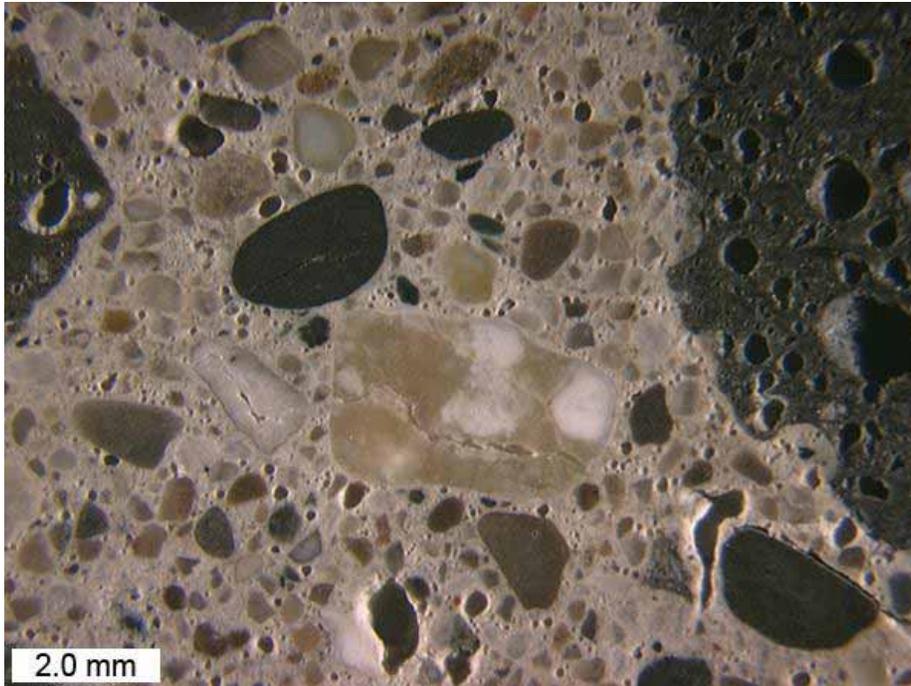
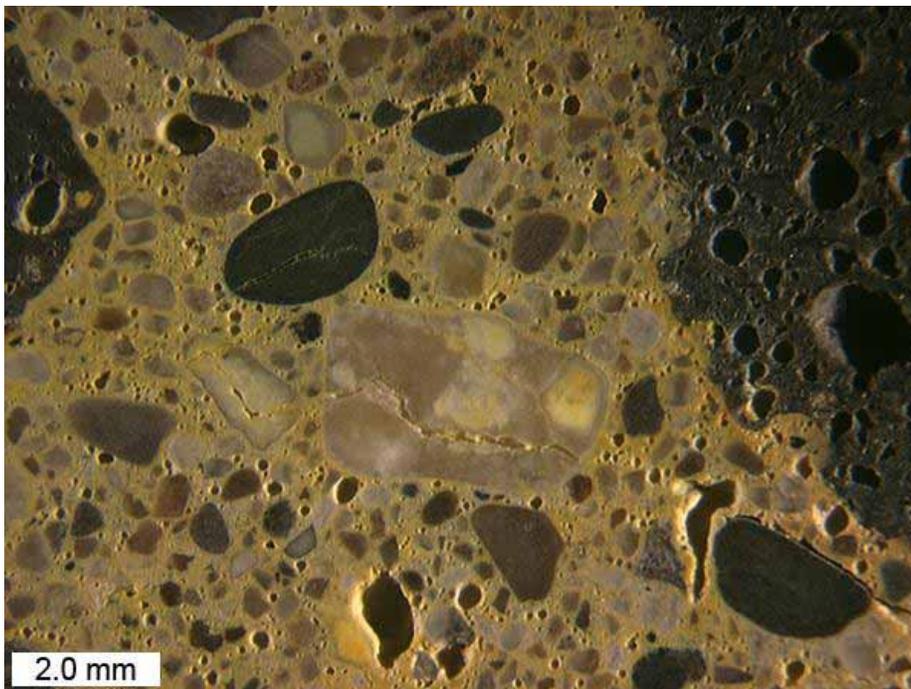
Alkali silica reaction in fine aggregate and associated cracking, before and after sodium cobaltinitrite stain, polished slab from top half of M-59, constructed 1997/98, outside lane, away from transverse joint, core C, MTU ID M59-02.

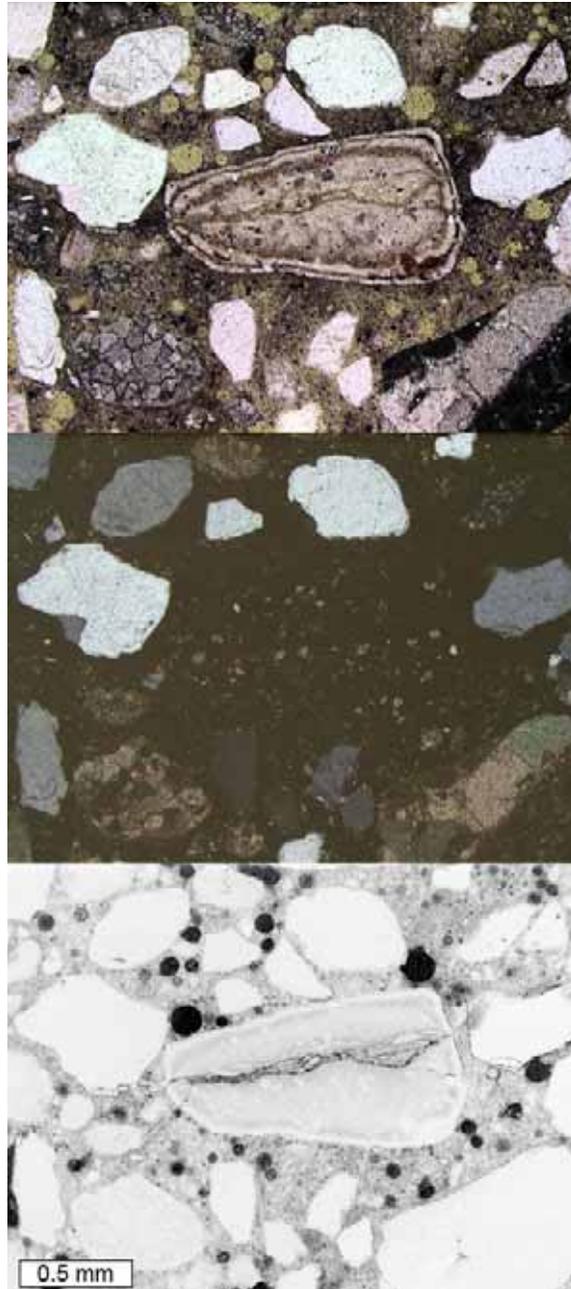
Example of chert particle exhibiting deleterious alkali-silica reaction, from thin section prepared from core from M-59, at joint, MTU ID M59-01. From top to bottom: transmitted light, crossed-polars, and epifluorescent mode images.
