Publication No. FHWA-RD-93-121

Testing of Small and Large Sign Support Systems FOIL Test Numbers: 92F040

U.S. Department of Transportation
Federal Highway Administration

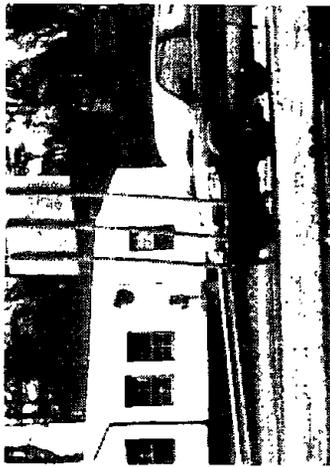
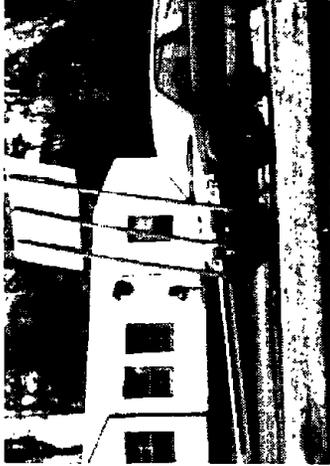
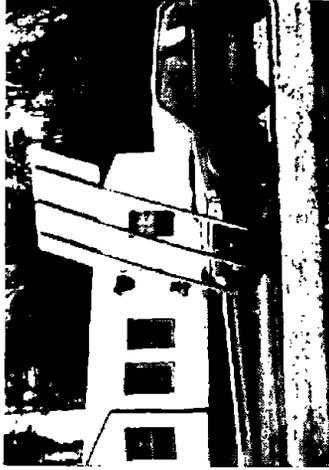
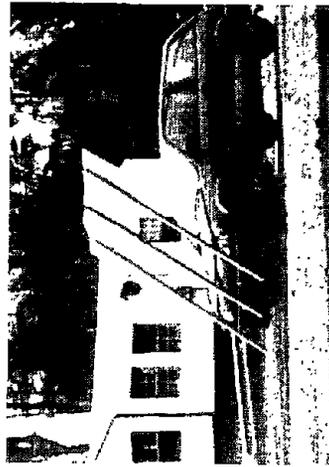
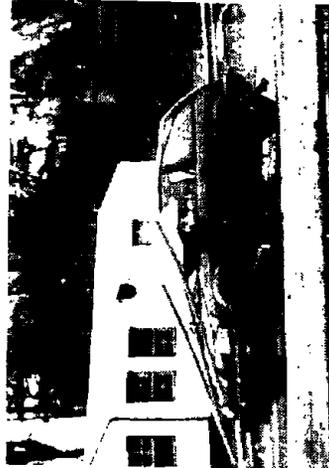
Figure 2. Test photographs during impact, test 92F040.

The bumper made contact with all three sign posts but did not significantly collapse. The three square tube sign posts bent around the front end of the test vehicle. The three square tube posts buckled 0.014 s after contact. The vehicle begins to ridedown the sign posts but the square tube fractured at the impact point on the posts approximately 0.028 s into the impact event. The square tube anchors did not plow through the strong soil during impact. The square tube anchors were pulled up slightly by the vehicle. The anchors of the center and right posts fractured at the bottom of the splice, where the inserted smaller tube ends inside the larger anchor. The left post fractured 1 in (25.4 mm) above ground just above the corner bolts that spliced the two pieces of square tube. The vehicle broke through the square tube posts and pushed on the remaining sign posts rotating the top of the sign down towards the vehicle. The sign made contact with the roof-windshield joint at 0.080 s. The impact of the sign on the roof and windshield caused severe denting of the roof and shattered the windshield. The roof attained its maximum crush at approximately 0.108 s. The sign rebounded off the roof and slid down off the front end of the vehicle and briefly impaled the ground in front of the test vehicle. The vehicle struck the sign again and launched it up and away from the test vehicle. The vehicle's brakes were applied and the vehicle came to a stop prior to colliding with the FOIL catch fence. The sign stub remaining at the location of impact consisted of three 24-in (609.6-mm) square tube sections bent over, laying flat on the ground. The six corner bolts did not fracture or tear through the perforated square tube during impact.
