Publication No. FHWA-RD-93-117

July 1994

Testing of Small and Large Sign Support Systems FOIL Test Number: 92F036

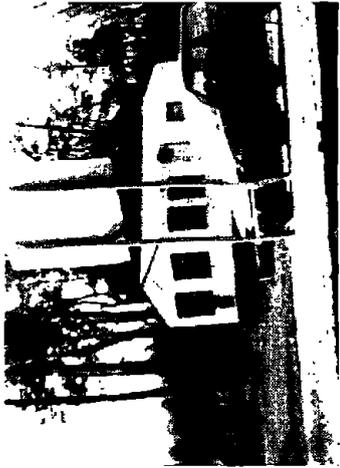
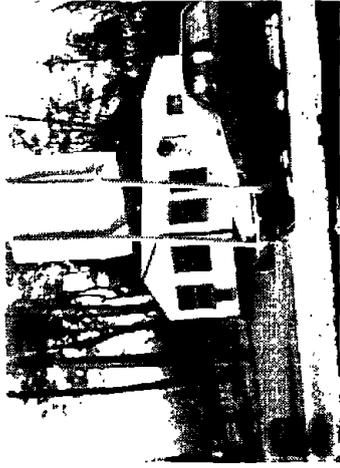
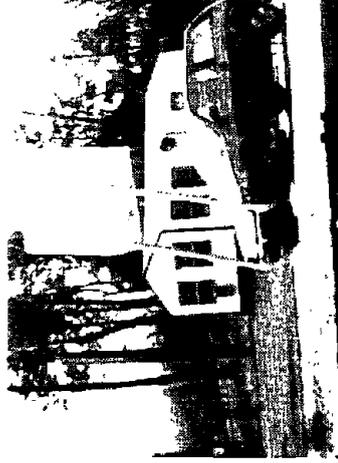
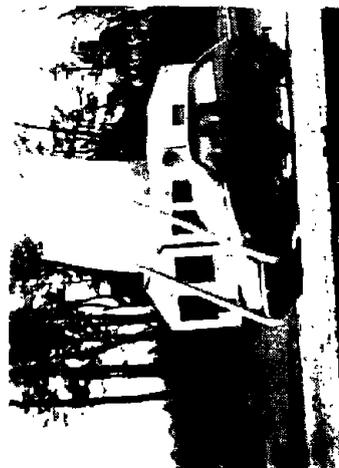
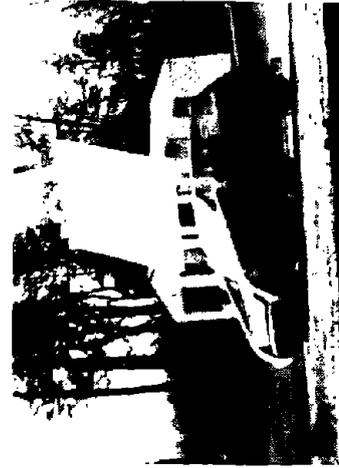
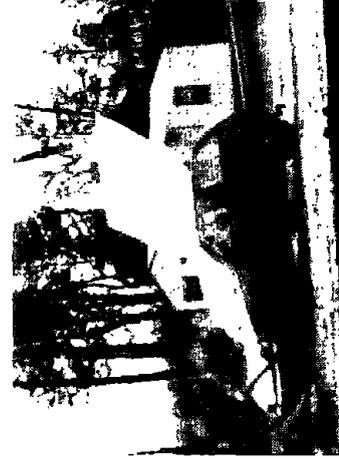
Figure 2. Test photographs during impact, test 92F036.

The bumper made contact with both sign legs and the fiberglass posts began to collapse. The vehicles left bumper support made contact with the left sign post while the right sign posts was struck by the vehicle's bumper at the right head lamp. The left sign post collapsed 0.006 s after contact. The right post had collapsed by 0.012 s. The vehicle continued forward riding down the sign posts. From 0.014 s to 0.044 s, the sign panel bolts had pulled through the aluminum panel separating the panel from the fiberglass posts. The vehicle rides down the two posts, causing them to wrap around the vehicle's front end. The tips of each post came down and struck the vehicle at each outside edge of the windshield, slid off and struck the side-view mirrors. The tip of the posts made contact at 0.080 s. The impact with the windshield was not significant enough to penetrate the occupant compartment. The free falling sign panel grazed the roof of the vehicle at 0.112 s. The sign panel was not a hazard to the test vehicle, it landed on top of the foundations in the weak soil. The vehicle completely flatten and tore the fiberglass posts as it rode down the sign system. The vehicle passed through without difficulty. The brakes were applied and the vehicle yawed slightly clockwise and skidded to a stop prior to impacting the FOIL catch fence.

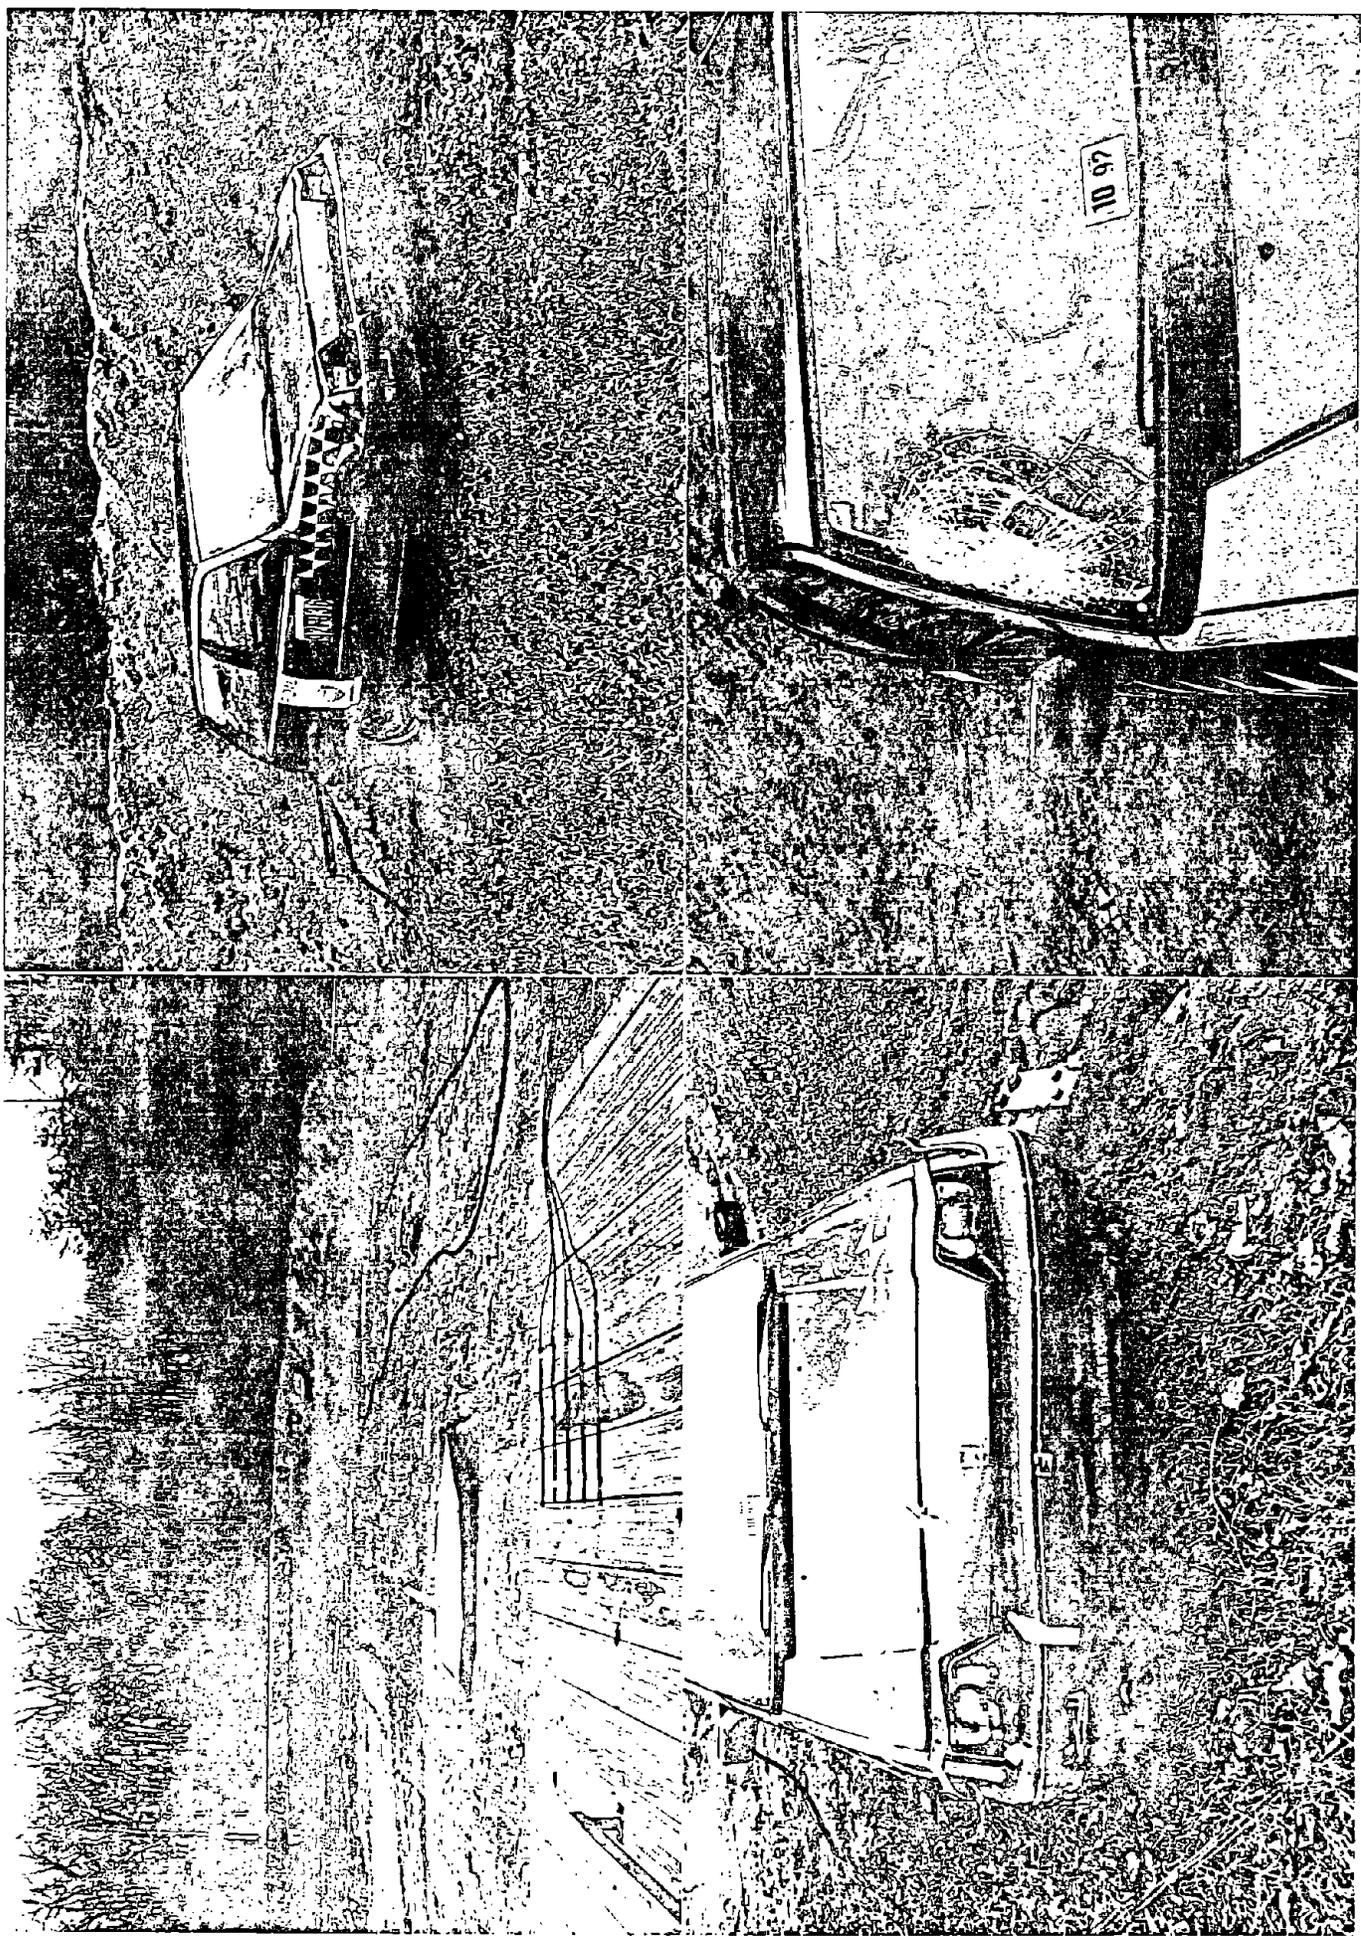
Figure 10. Post-test photographs of test 92F036.

Damage to the vehicle consisted of light damage to the bumper and header panel. The damage was to plastic bumper parts and not to any structural members. The maximum crush measured after the test was recorded to be 1 in (25.4 mm). None of the sign components impaled the occupant compartment, although the tip of the sign posts did crack the windshield on the passenger side of the vehicle.

Damage to the sign consisted of two ripped and frayed fiberglass posts. The sign panel and all hardware were in usable condition after the test. The concrete foundations did not move during the impact event. New posts could be installed in the foundations with no complication.

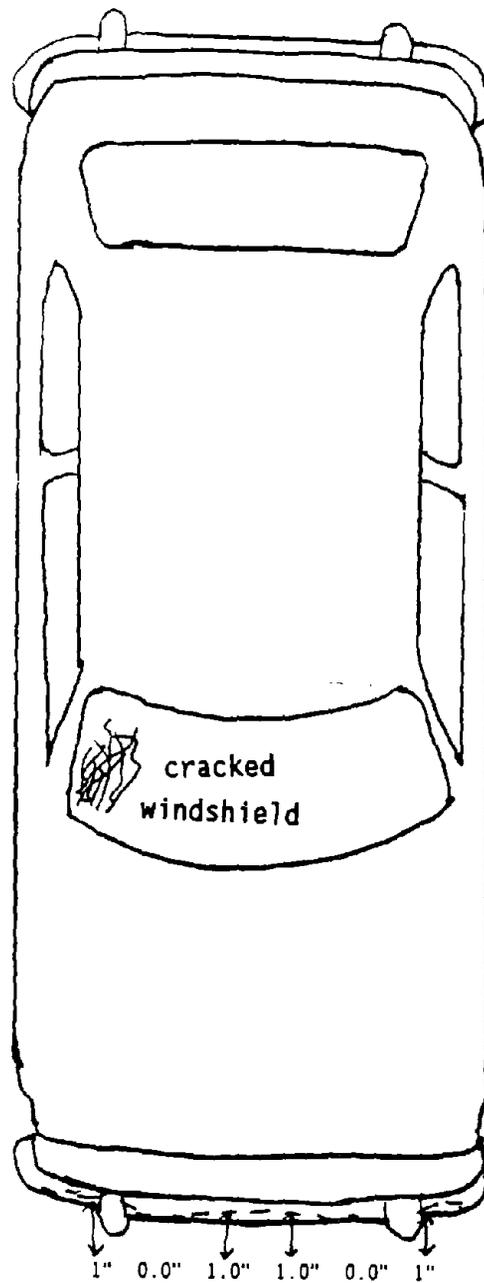
Figure 12. Sketch of vehicle crush, test 92F036.

Max = 1.0 in
