Publication No. FHWA-RD-93-113

# Testing of Small and Large Sign Support Systems FOIL Test Numbers: 92F024 and 92F025

11. Contract or Grant No. DTFH61-91-Z-00002	
12. Sponsoring Agency Name and Address Office of Safety and Traffic Operations R&D Federal Highway Administration 6300 Georgetown Pike McLean, VA 22101-2296				13. Type of Report and Period Covered Test Report, August 1992

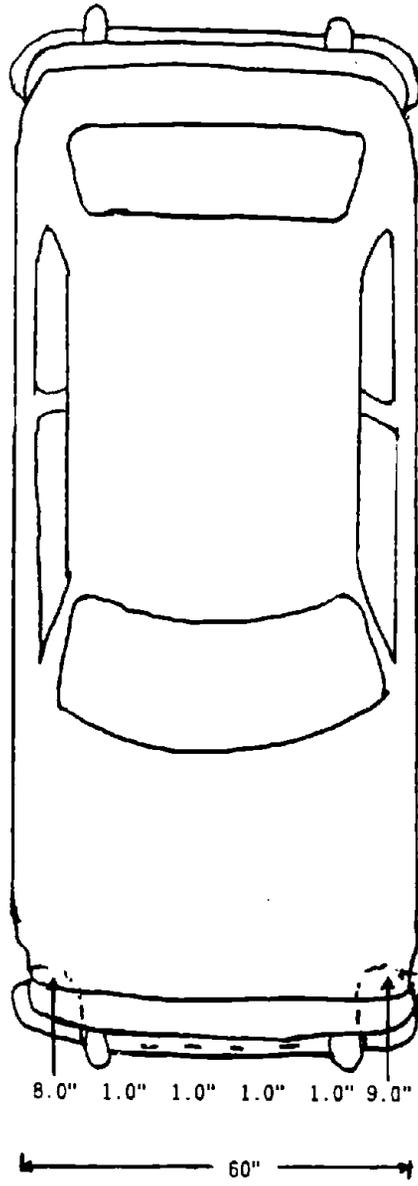
Figure 19. Sketch of vehicle crush, test 92F025.

Damage to the vehicle consisted of damage to the bumper and a dent on either side of the hood. The two parking lights just below the bumper were shattered along with both headlights and plastic cosmetic bumper elements. The u-channel penetrated the bumper on the outside edge of each bumper support. The penetration was deep enough to cause damage to minor frame members behind the headlights. No damage was inflicted on the roof or windshield. None of the sign components impaled the occupant compartment.

Max Crush = 9 in
