Publication No. FHWA-RD-93-111

# Testing of Small and Large Sign Support Systems FOIL Test Number: 92F023

U.S. Department of Transportation  
**Federal Highway Administration**

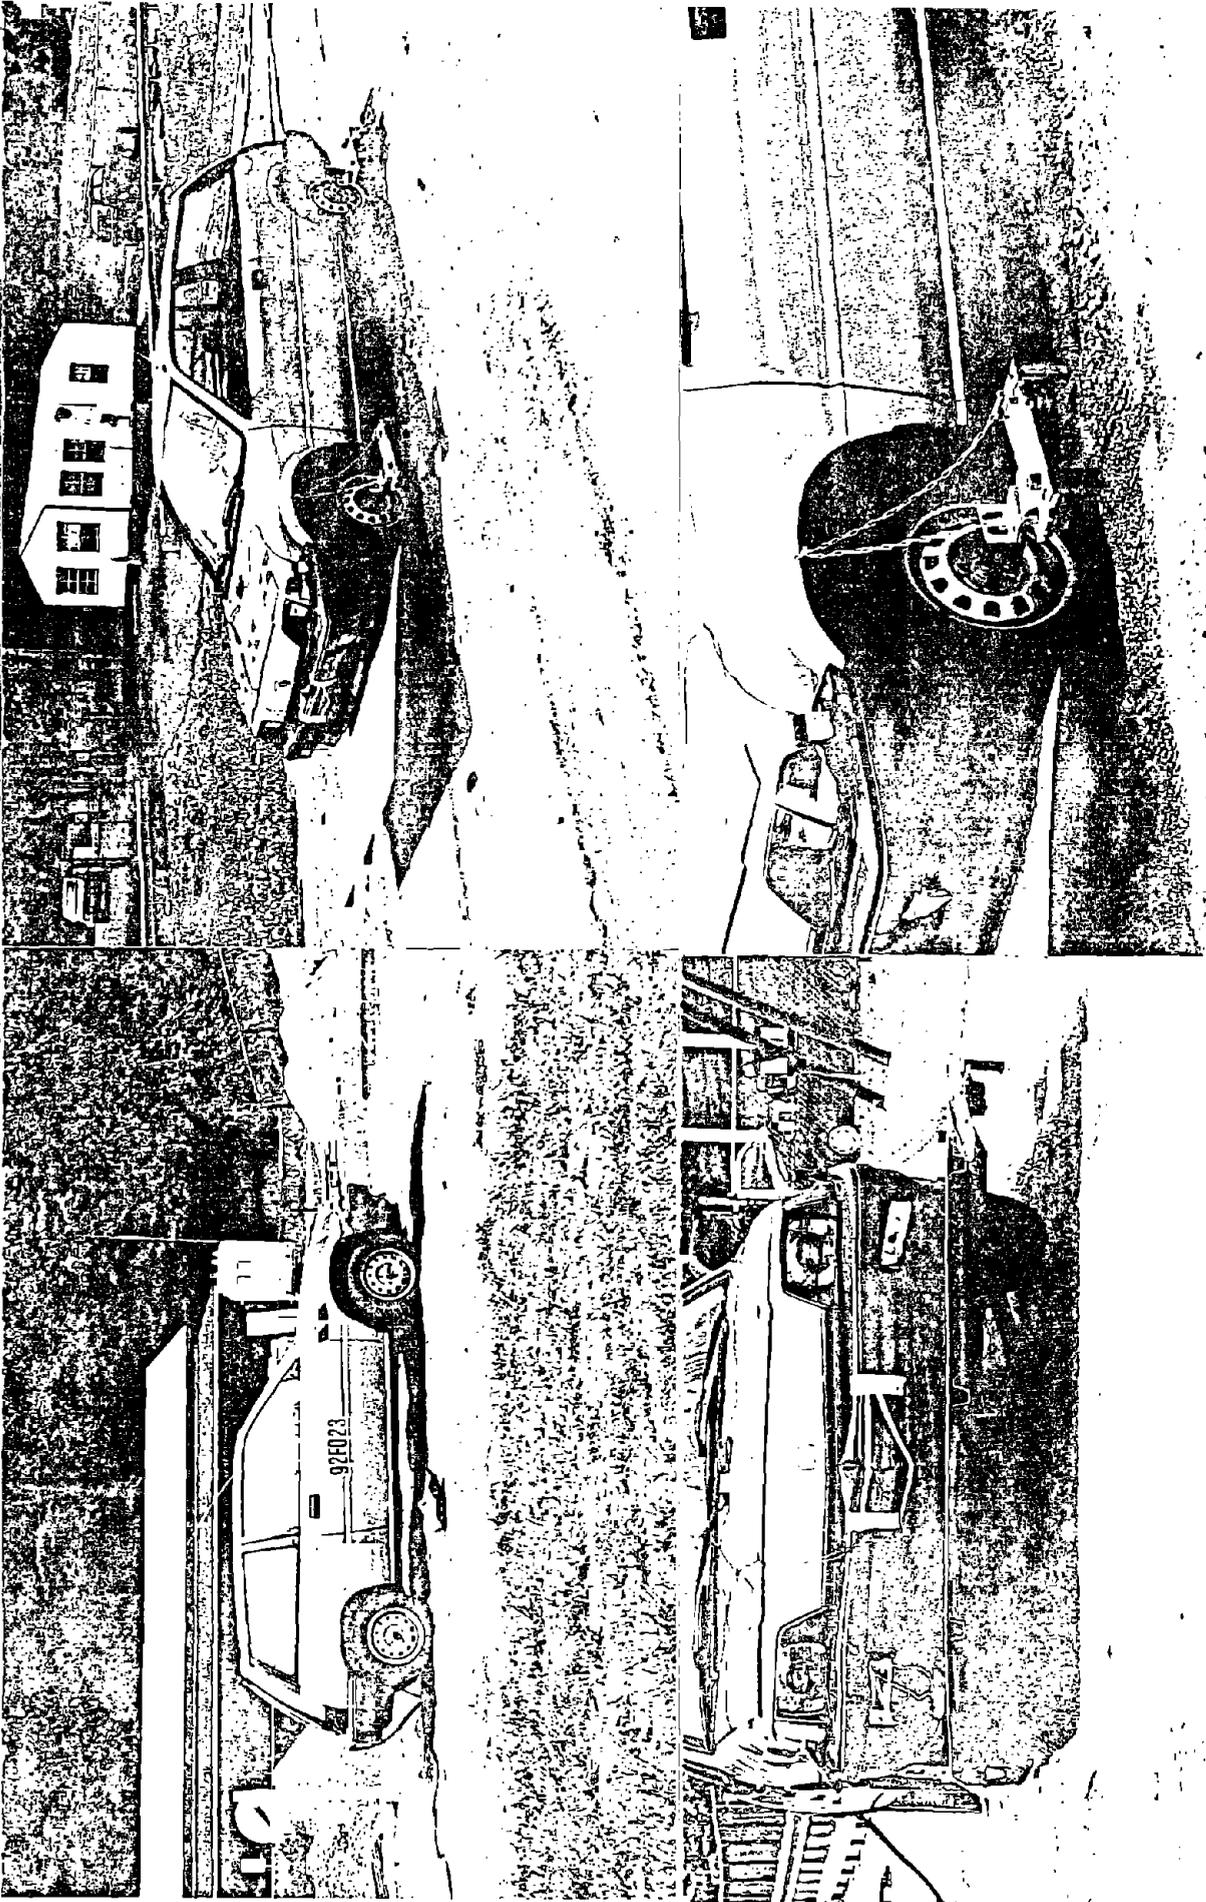
Figure 11. Post-test photographs of test 92F023.

Damage to the vehicle consisted of minor damage to the bumper and grill. The center of the bumper was dented 3 in (76.2 mm), the right and left side of the vehicle sustained minor damage to the cosmetic plastic bumper elements. The occupant compartment was intact after the test. Damage to the sign system consisted of three bent and twisted u-channel posts. The sign posts were removed from the ground after the test and a bend was recorded 12 in (304.8 mm) below the groundline. The panel was in good condition after the test. No sign components impaled the occupant compartment.
