Publication No. FHWA-RD-93-098
July 1994

Testing of Small and Large Sign Support Systems FOIL Test Number: 92F011

U.S. Department of Transportation
Federal Highway Administration

This test report contains the results of a crash test performed at the Federal Outdoor Impact Laboratory (FOIL) in McLean, Virginia. The test was performed on a small sign support system at 20 mi/h (8.9 m/s), test 92F011. The vehicle used for this test was a 1984 Honda Civic. The purpose of this test was to evaluate the low-speed safety performance of a dual legged steel 4 lb/ft (5.95 kg/m) u-channel sign support. The performance evaluation was based on the latest requirements for breakaway supports as specified in Volume 54, Number 3 of the Federal Register dated January 5, 1989. These criteria specify, in part, that the occupant change in velocity must be 16 ft/s (4.9 m/s) or less, that the significant test article stub height remaining after impact be no more than 4 inches (102 mm), and that there can be no occupant compartment intrusion.

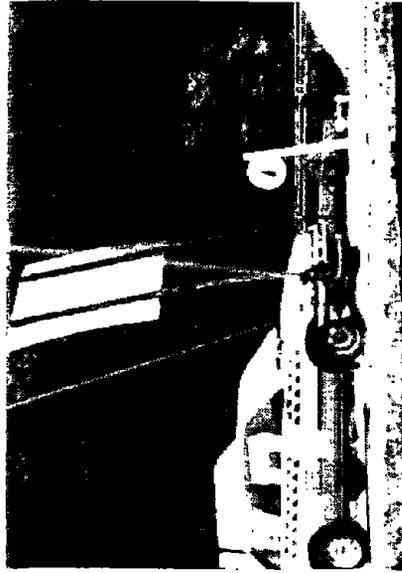
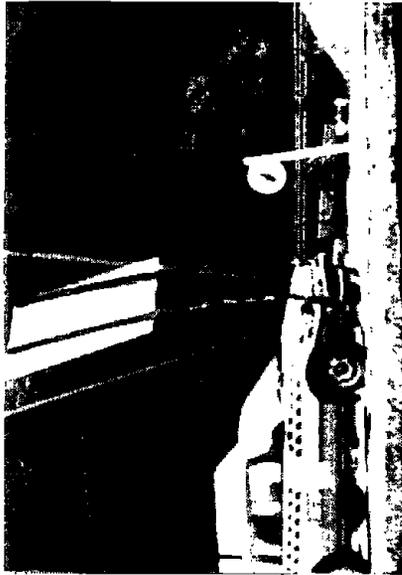
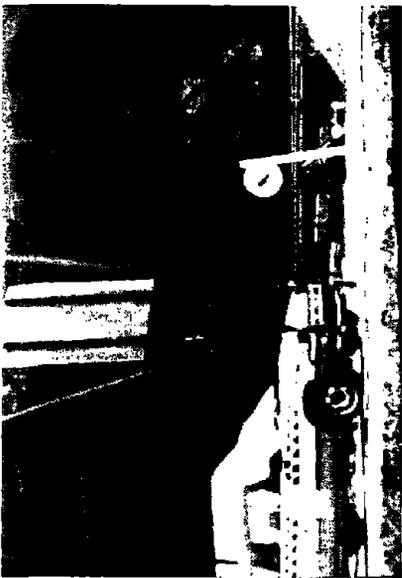
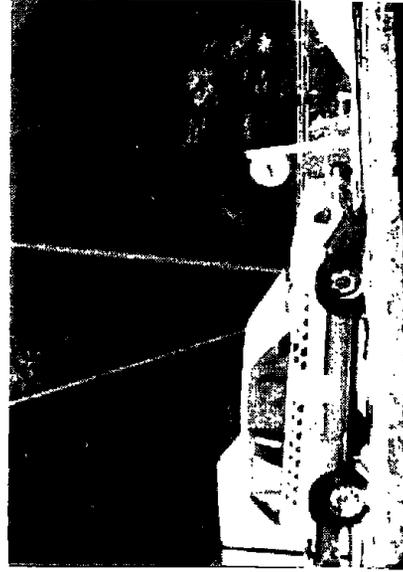
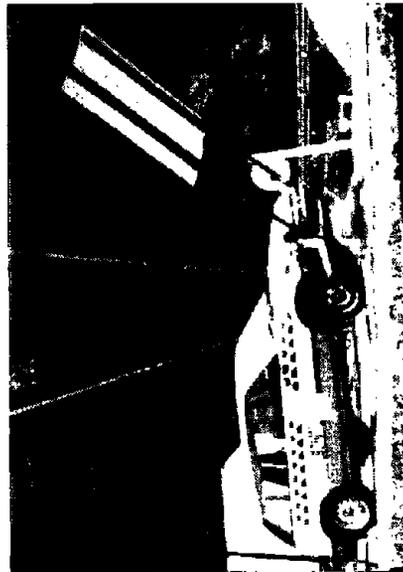
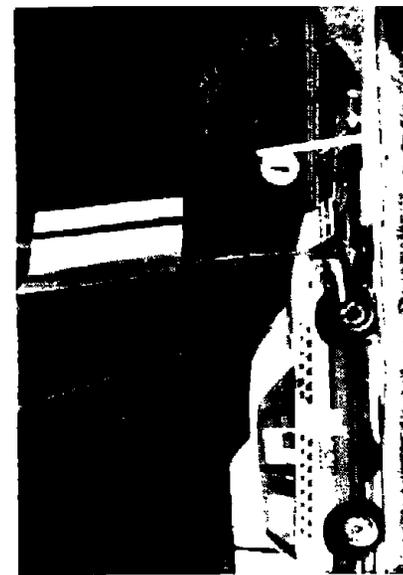
Figure 3. Test photographs during impact, test 92F011.

The bumper made contact with both sign legs and began to collapse and the u-channel legs began to bend away from the vehicle. The force required to break the four grade nine splice bolts was higher than the resistive force the weak soil could maintain. The u-channel began to plow through the weak soil. Additional energy was consumed pushing the u-channel through the weak soil and bending each sign leg. The breakaway mechanism, breaking the splice bolts, activated too late in the impact event for the vehicle to pass through the sign system. The splice bolts failed while the vehicle climbed the sign legs pushing the sign over backwards. Two grade 9 bolts, the upper bolt of each leg failed in tension while the lower two bolts failed in shear.

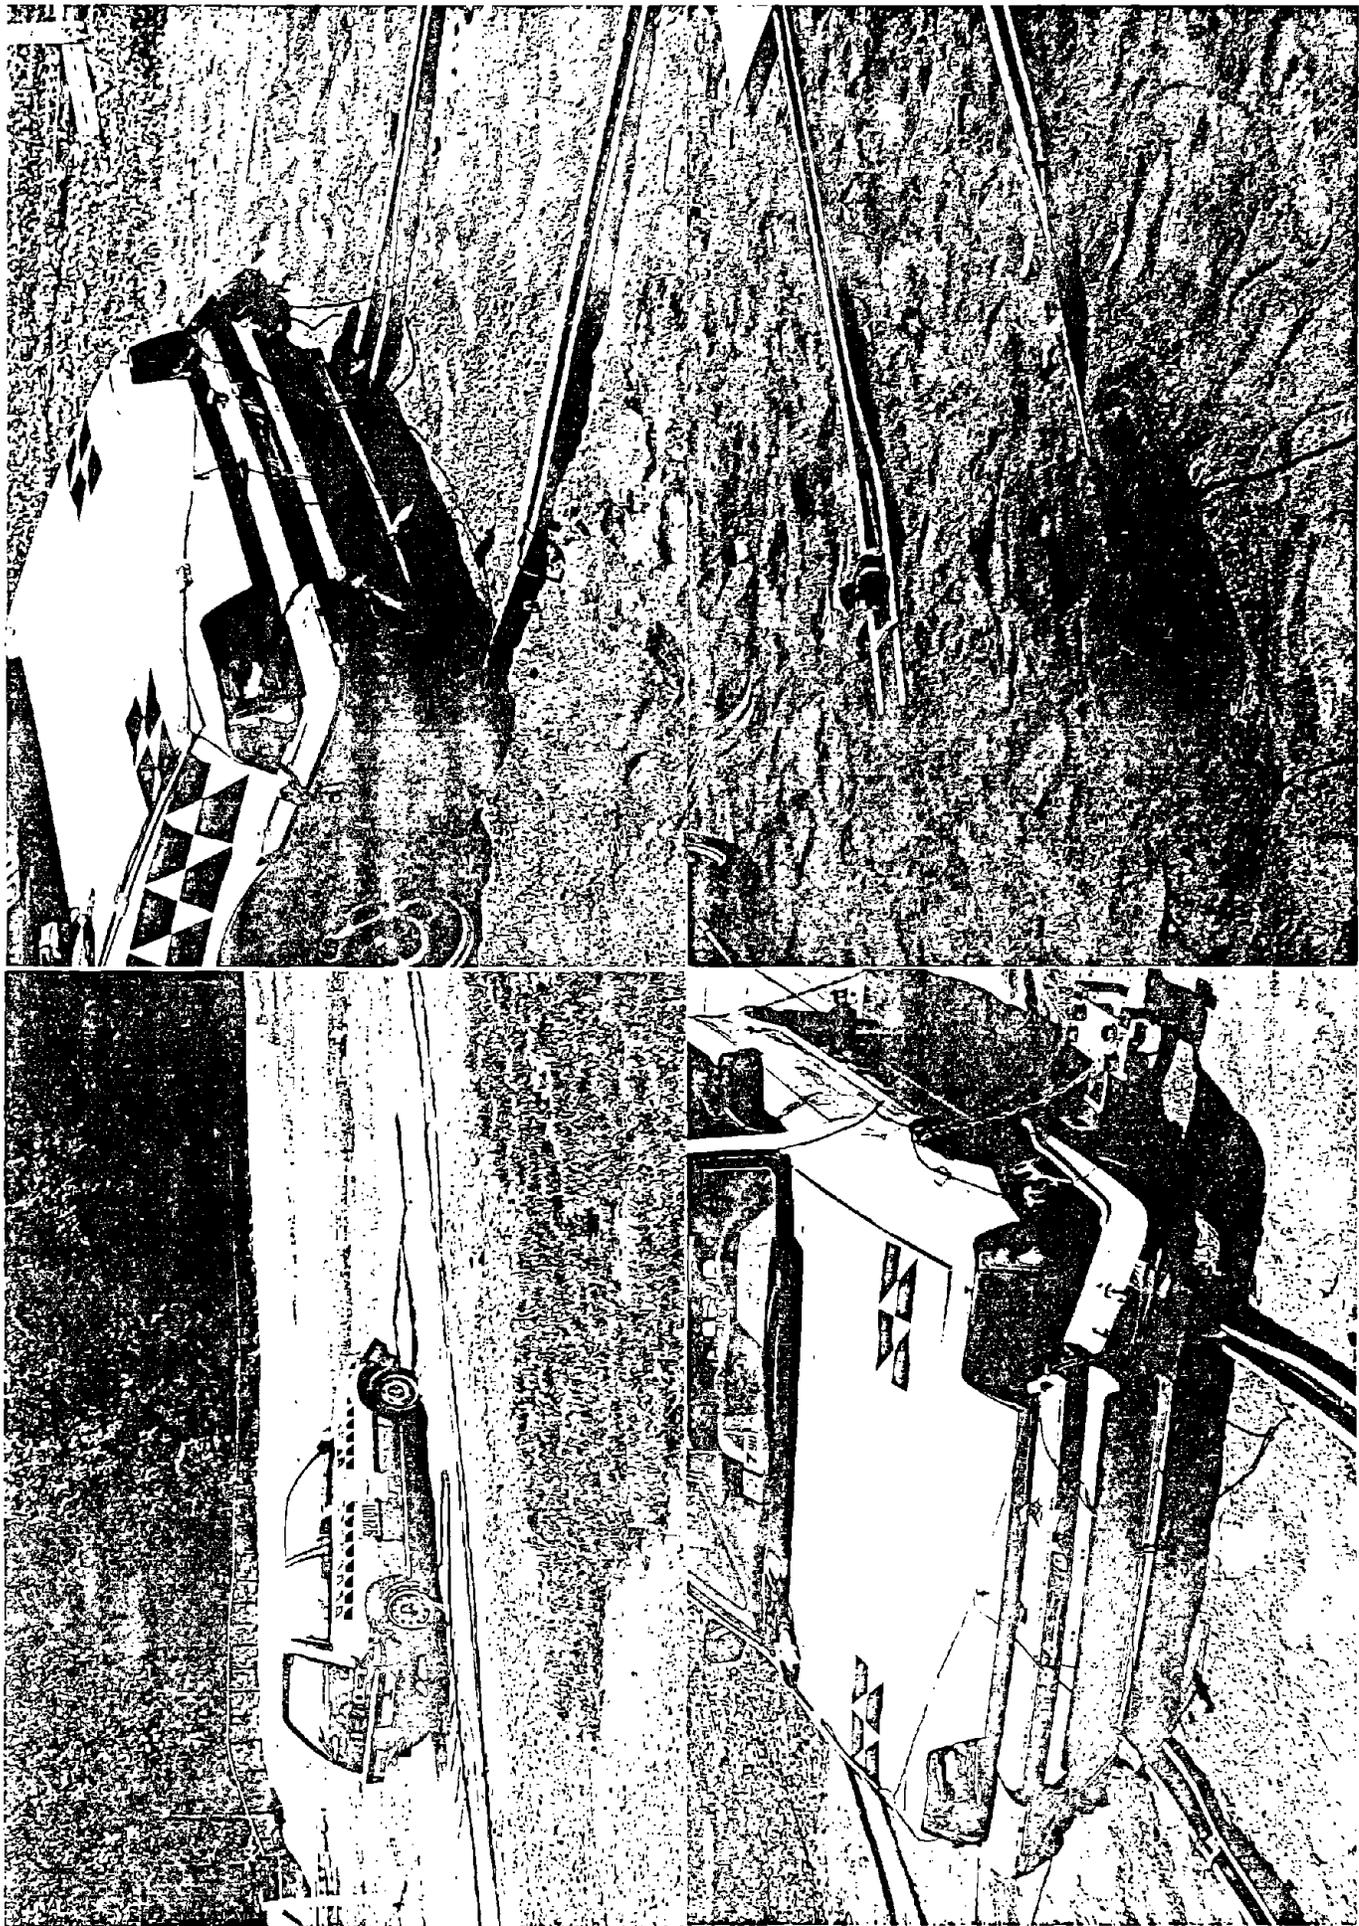
Figure 11. Post-test photographs of test 92F011.

The brunt of the impact occurred to outside edges of each bumper support. The bumper was much softer than the bumper supports therefore damage to the vehicle consisted of damage to the bumper and other plastic elements but no structural damage. Both head light sockets were damaged. The maximum deflection of 9.5 in (0.241 m) was recorded at the left head light cavity. None of the sign components impaled the occupant compartment.

The sign damage consisted of bent and twisted u-channel and four broken grade 9 bolts. The upper and lower sections of the spliced leg were bent and not reusable. The lower sections bent approximately 1 ft (0.3 m) below the groundline. The aluminum sheet panel was in good condition after the test.

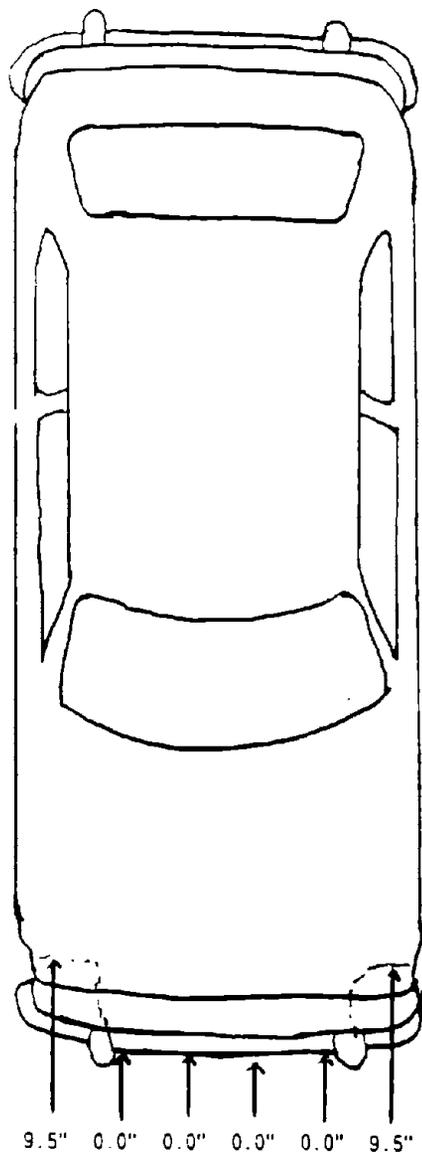
Figure 13. Sketch of vehicle crush, test 92F011.

Max = 9.5"
