PB94-186301

Publication No. FHWA-RD-93-099

Testing of Small and Large Sign Support Systems FOIL Test Number: 92F012

| 16. Abstract <p>This test report contains the results of a crash test performed at the Federal Outdoor Impact Laboratory (FOIL) in McLean, Virginia. The test was performed on a small sign support system at 20 mi/h (8.9 m/s), test 92F012. The vehicle used for these test was a 1985 Honda Civic. The purpose of this test was to evaluate the low-speed safety performance of a dual 3-lb/ft (4.5-kg/m) u-channel sign support in weak soil. The posts were spaced 2 ft 4 in (0.7 m) apart. The performance evaluation was based on the latest requirements for breakaway supports as specified in Volume 54, Number 3 of the Federal Register dated January 5, 1989. These criteria specify, in part, that the occupant change in velocity must be 16 ft/s (4.9 m/s) or less, that the significant test article stub height remaining after impact be no more than 4 in (102 mm), and that there can be no occupant compartment intrusion. The test results indicate that the dual 3-lb/ft (4.5-kg/m) u-channel sign support with 2-ft 4-in (0.7-m) spacing does not meet all of the applicable performance crite

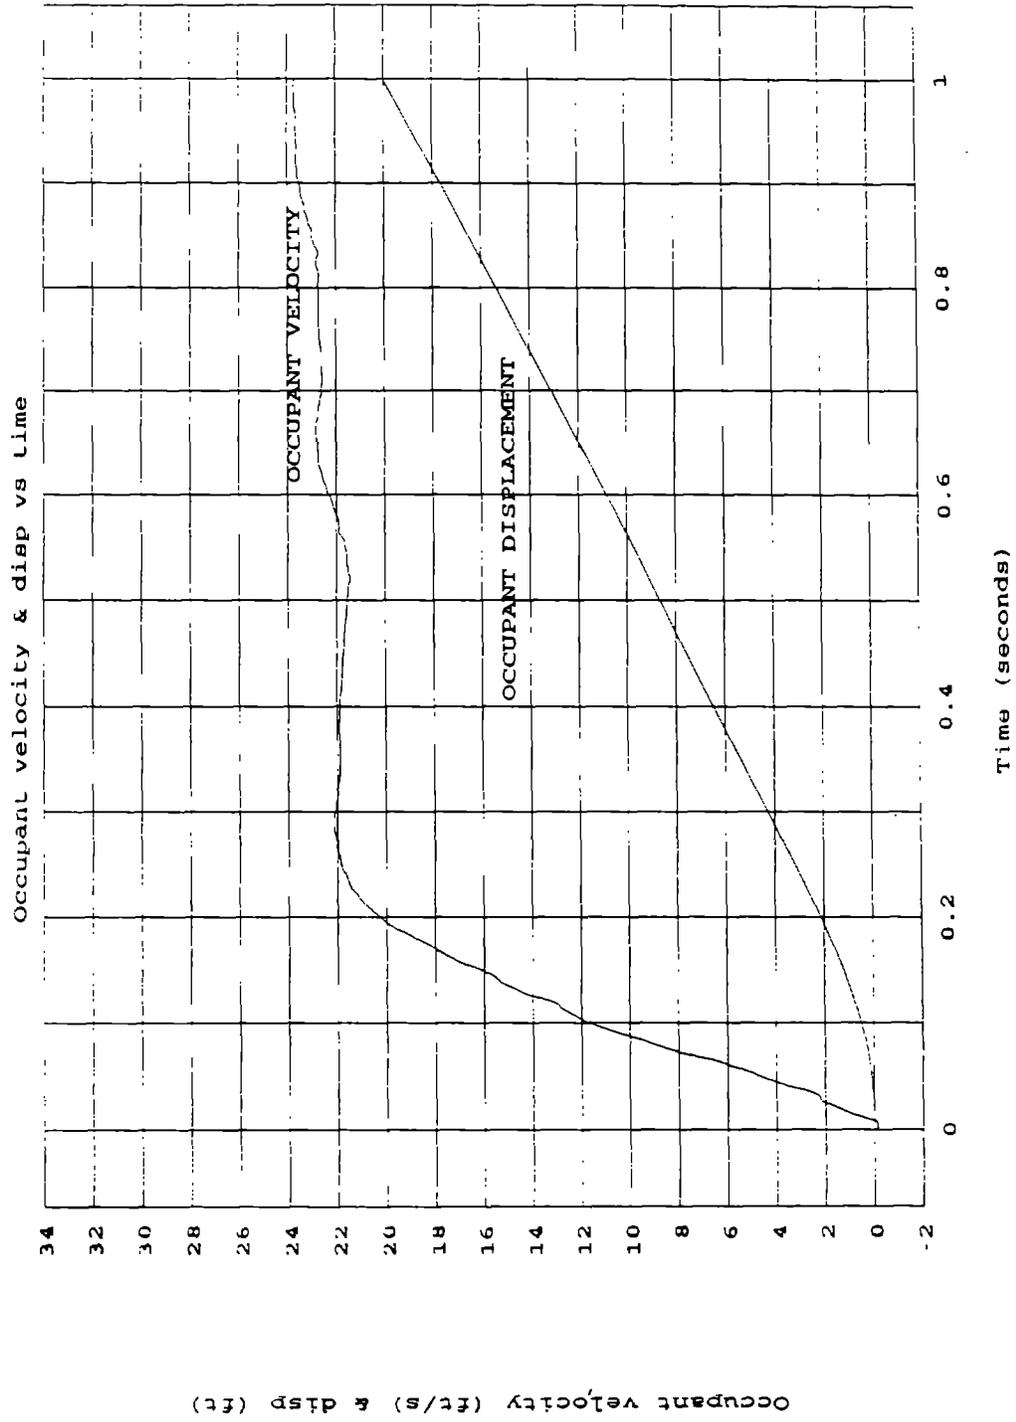
Figure 7. Occupant velocity and relative displacement versus time, X-axis, test 92F012.

The occupant impact velocity using the 2-ft (0.6-m) flail space model outlined in NCHRP Report Number 230, was determined to be 20.3 ft/s (6.2 m/s). The occupant impact velocity was reached 0.194 s into the crash event. The ridedown acceleration was 1.9 g's. The peak force (300 Hz data) for the impact event was 6.9 g's (12.7 kips (56.4 kN)). Because the sign system stopped the vehicle, the vehicle change in velocity is equal to the impact velocity. The actual vehicle velocity change calculated by integration of the on-board accelerometers was 26.4 ft/s (8.1 m/s).

The test results indicate that the small sign support system does not meet all of the applicable criteria for the low-speed test in weak soil. There was no occupant compartment intrusion and no significant stub remaining after the test, however the occupant impact velocity was 20.3 ft/s (6.2 m/s) which is not less than or equal to the 16 ft/s (4.9 m/s) limit specified by the FHWA.

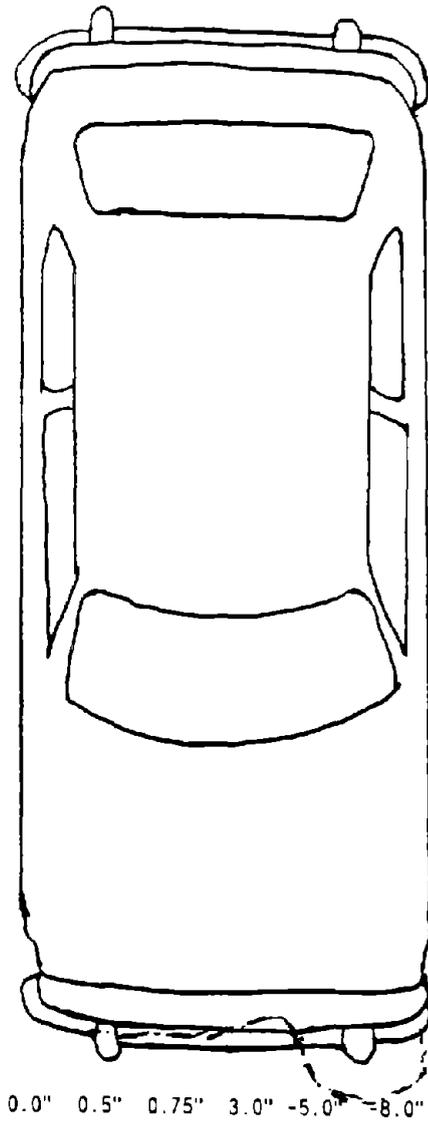
Figure 12. Sketch of vehicle crush, test 92F012.

Damage to the vehicle consisted of minor damage to the bumper and grill. The majority of the damage occurred on the left side of the vehicle where the sign made contact with the inside of the bumper support rather than on the bumper support. None of the sign components impaled the occupant compartment.

Max = 3.0"
