Publication No. FHWA-RD-93-102

# Testing of Small and Large Sign Support Systems FOIL Test Number: 92F014

6. Performing Organization Code	
7. Author(s) Christopher M. Brown		8. Performing Organization Report No.	
9. Performing Organization Name and Address Advanced Technology & Research Corp. 15210 Dino Drive Burtonsville, MD 20866		10. Work Unit No. (TRAIS) 3A5f3142

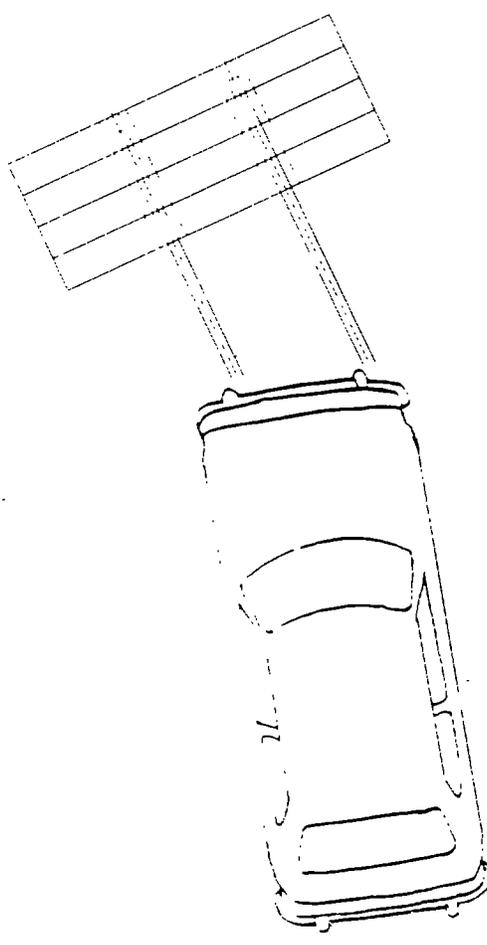
Figure 4. Summary of test 92F014.

The occupant impact velocity using the 2-ft (0.6-m) flail space model outlined in NCHRP Report Number 230, was determined to be 19.8 ft/s (6.0 m/s). The occupant impact velocity was reached 0.153 s into the crash event. The 10 ms ridedown acceleration was determined to be 1.5 g's. The peak force (300 Hz data) for the impact event was 14.8 g's (27.5 kips (122 kN)). Because the sign stopped the vehicle, the vehicle change in velocity was equal to the impact velocity. The actual vehicle change in velocity was calculated to be 29.5 ft/s (9.0 m/s).

The test results indicate that the small sign support system does not meet all of the applicable criteria for the low-speed test in weak soil. There was no occupant compartment intrusion and no significant stub remaining after the test, however the occupant impact velocity was 19.8 ft/s (6.0 m/s) which is not less than or equal to the 16 ft/s (4.9 m/s) limit specified by the FHWA.

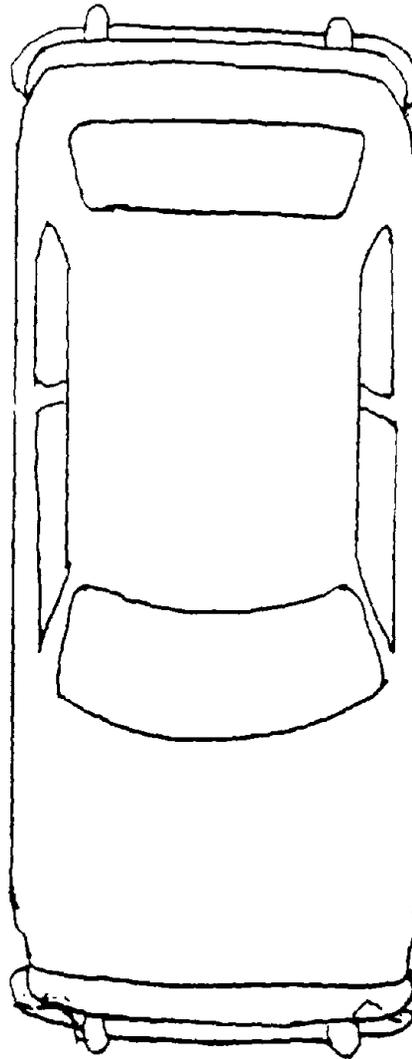
Figure 13. Sketch of vehicle crush, test 92F014.

Damage to the vehicle consisted of minor damage to the bumper. The damage was to plastic bumper parts and not to any structural members. The maximum crush measured after the test was recorded to be 4 in (0.102 m). None of the sign components impaled the occupant compartment.

Max = 4.0"
