Publication No. FHWA-RD-93-105

July 1994

Testing of Small and Large Sign Support Systems FOIL Test Number: 92F017

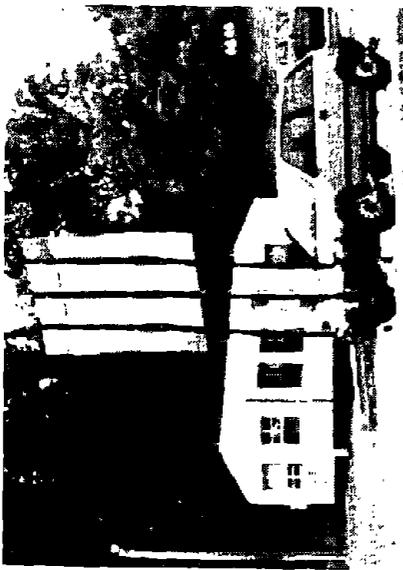
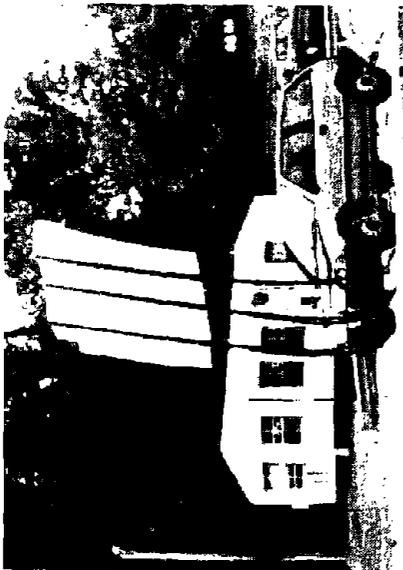
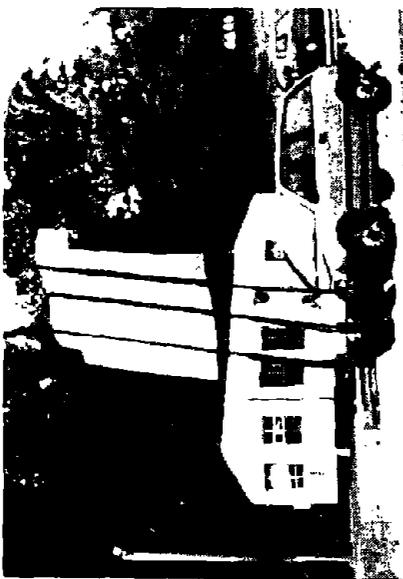
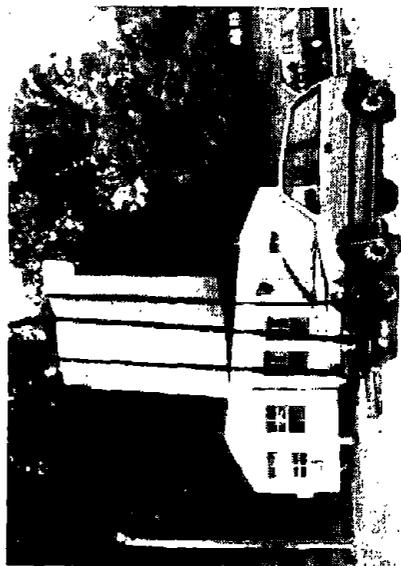
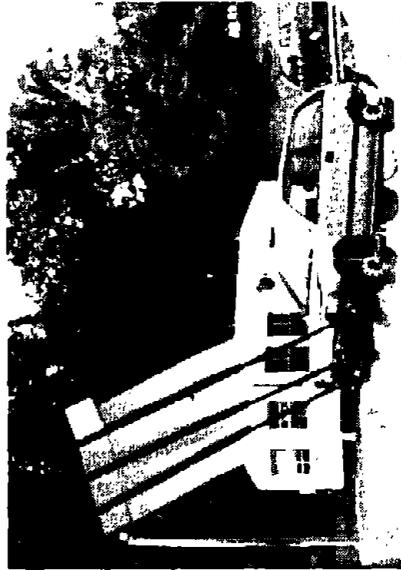
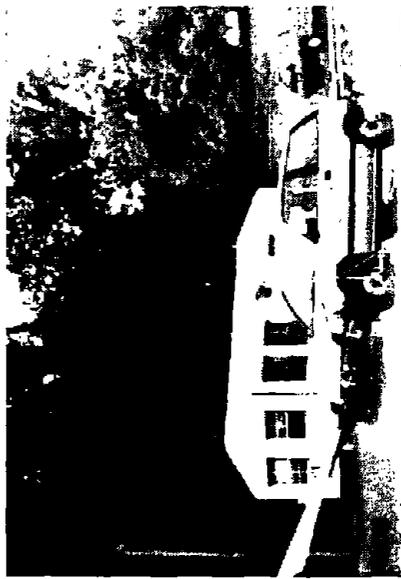
Figure 2. Test photographs during impact, test 92F017.

The bumper made contact with all three sign legs and began to collapse. The bumper collapsed to the outside edge of each bumper support and at the bumper center. The u-channel legs began to bow away from the vehicle and wrap around the front end of the vehicle. The vehicle bumper collapsed as far as the headlight sockets at each end and as far as the hood in the center. The vehicle continued forward, pushing the u-channel legs through the weak soil. The required force to break or flatten the u-channel was higher than the resisting force of the weak soil therefore the weak soil gave way before the u-channel and the vehicle forced the u-channel to plow through the sand. Once the u-channel had pushed through the sand as far as possible the flattening or breakaway force required still could not be obtained because too much energy was consumed plowing through the weak soil. The u-channel bent backwards but never flattened. The u-channel legs pushed through the sand approximately 2 ft (0.6 m). The u-channel began pushing through the weak soil upon impact and continued to push through the weak until the vehicle had come to a stop. The rib-back u-channel center leg split vertically during the test. The sign system remained in the weak soil leaning back 60 degrees. The u-channel was later pulled from the ground and a bend was recorded 12 in (0.305 m) below the ground line.

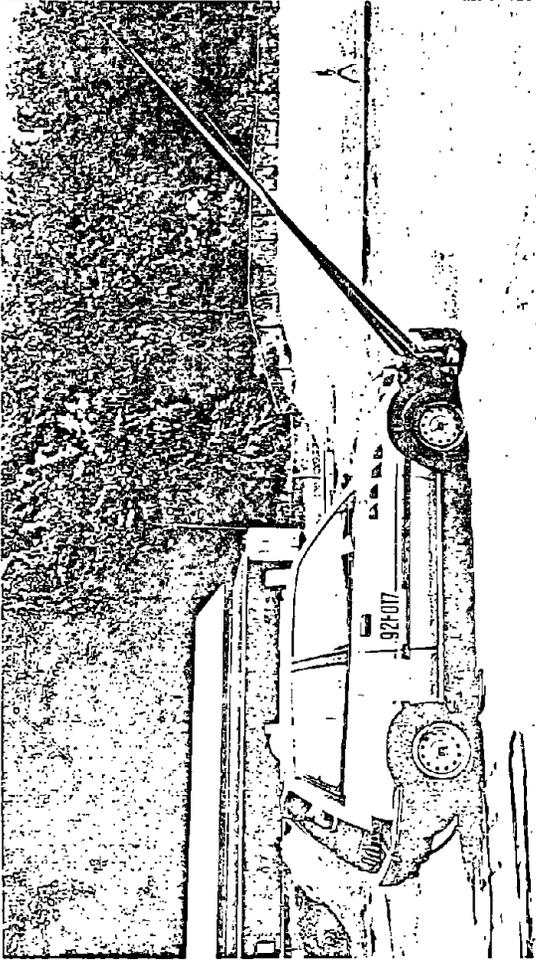
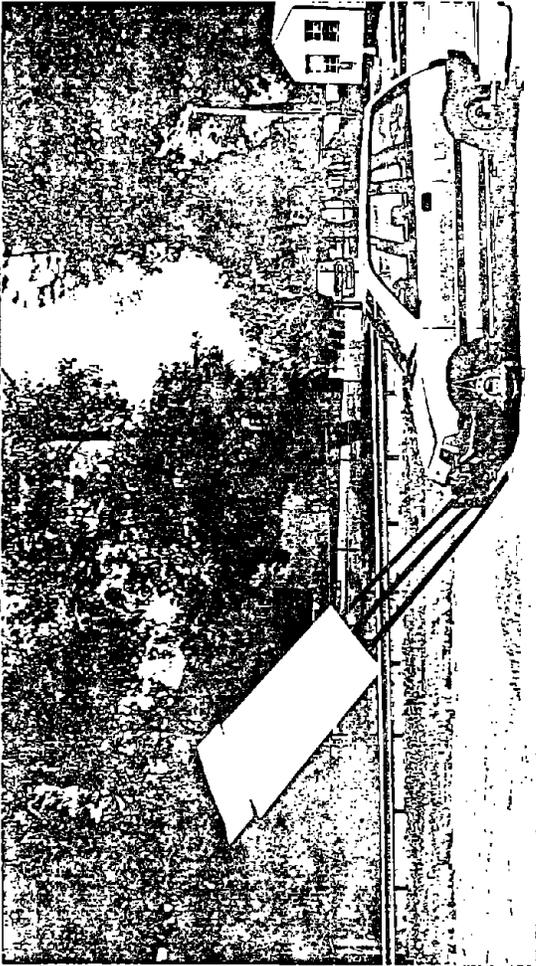
Figure 10. Post-test photographs of test 92F017.

Damage to the vehicle consisted of minor damage to the bumper and grill. The majority of the damage occurred to the outside edge of each bumper support where there was not much structural support. The occupant compartment was intact after the test.

Damage to the sign system consisted of three bent and twisted u-channel legs with one u-channel split vertically. The panel was in good condition after the test.
