Publication No. FHWA-RD-93-106

July 1994

Testing of Small and Large Sign Support Systems FOIL Test Number: 92F018

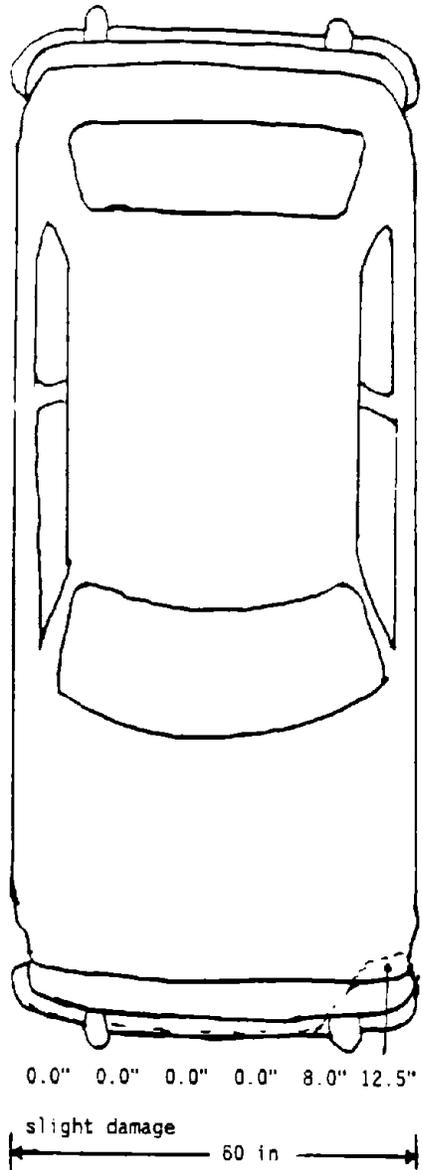
Figure 12. Sketch of vehicle crush, test 92F018.

Max Crush = 12.5 in
