PERFORMANCE OF PROTECTIVE COATINGS ON
STRUCTURAL PLATE PIPE AND PIPE ARCHES

Wallace T. McKeel, Jr.
Research Engineer

Virginia Highway & Transportation Research Council
(A Cooperative Organization Sponsored Jointly by the Virginia
Department of Highways & Transportation and
the University of Virginia)

March 1978
VHTRC 78-R44

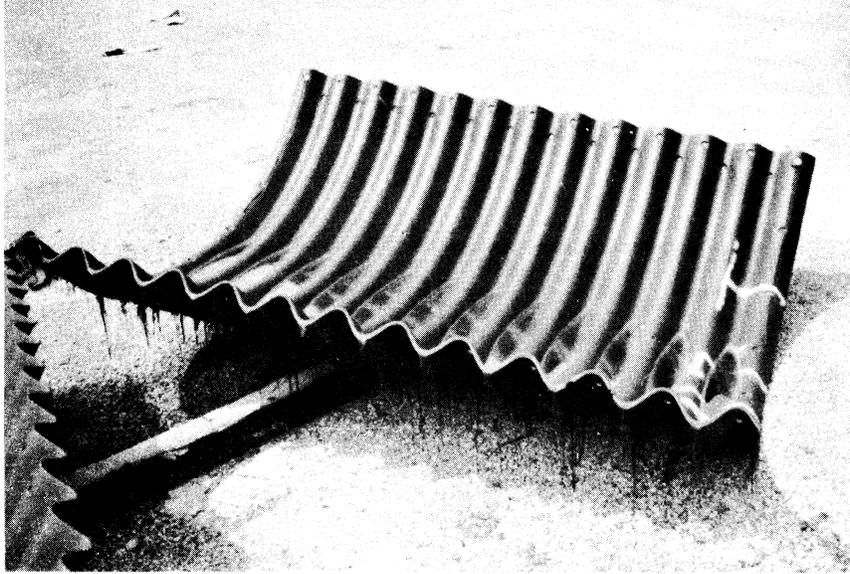
A significant, and apparently unavoidable, problem associated with the immersion process is the flow of the asphalt toward the downward edge of the plate. As may be seen in Figure 1, the coating at the downward edge is thicker than elsewhere on the plate, a condition that was seen during field inspections to have produced difficulties in aligning the plates and developing the proper torque in the bolts.

Figure 1. Asphalt coated structural plates. Heavy coating at edge of plate on right was due to flow during application.

A more serious problem in the case of the asphalt coating may be the difficulties in assembling the precoated plates and obtaining the required torque on the bolts due to the presence of a heavy coating caused by flow of the asphalt during dipping. This may be an unavoidable problem with serious ramifications. Joining of the plates is, of course, not a problem when the structure is coated after erection.

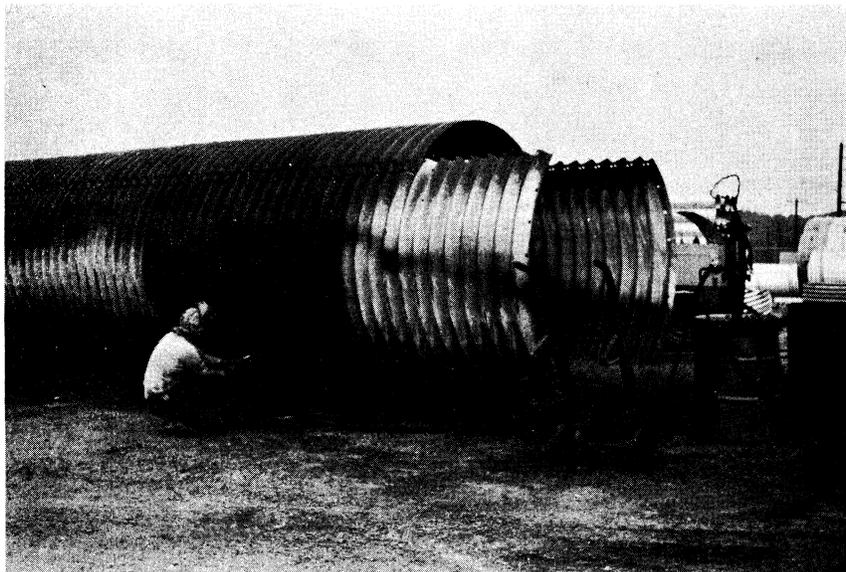
Figure 2. Application of asphalt mastic to structural plate pipe assembled at fabricator's plant.

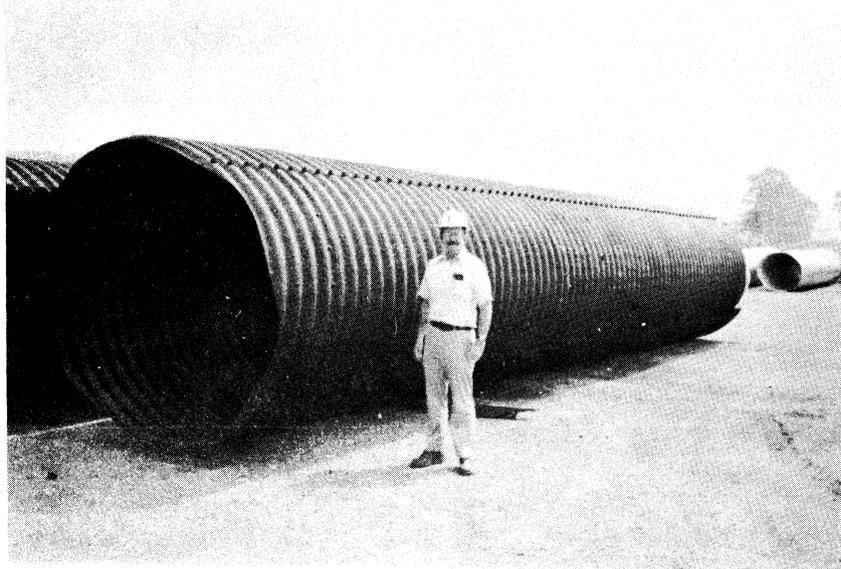
Figure 3. Structural plate pipe assembled and coated at plant in lengths suitable for trucking to site.

3. The application of the asphalt mastic at the plant to large sections of assembled pipe, which are subsequently shipped to the construction site, should be fully explored, as the practice appears to minimize field operations and environmental damage.

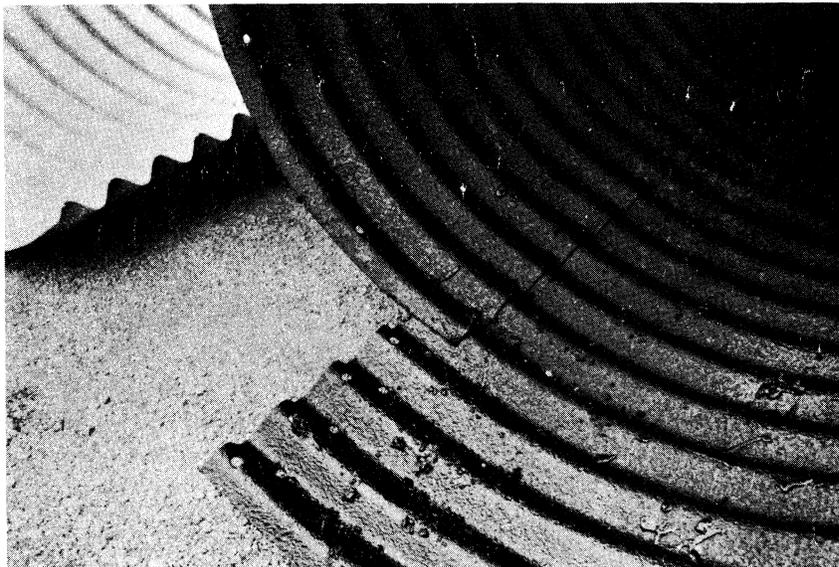
Figure 4. Joint in pipe coated with sprayed asphalt mastic.

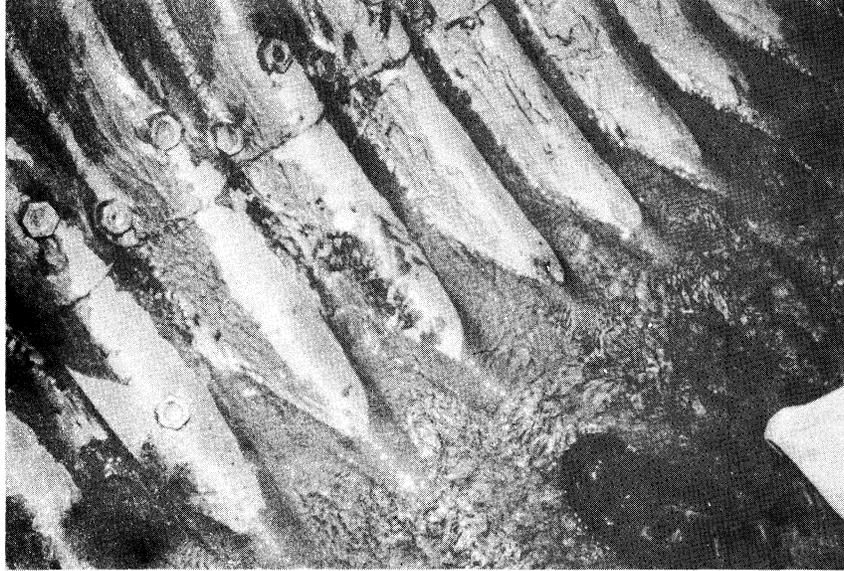
1. Route 460, West of Richlands
Coating Type: Asphalt mastic, sprayed at site.
Service Exposure: 8 years

As was found to be typical of sprayed mastic applications, this coating was thinner than those deposited by immersion. The coating has been removed to the depth of the waterline. Fairly heavy rusting is evident in the invert, which remains sound, and the rusting ceases at a height of 6 to 8 inches above the invert, as indicated in Figure 5. Above the waterline, the coating remains intact and tightly bonded to the steel.

Figure 5. Culvert on Route 460. Close view of typical area where protective coating has been lost.

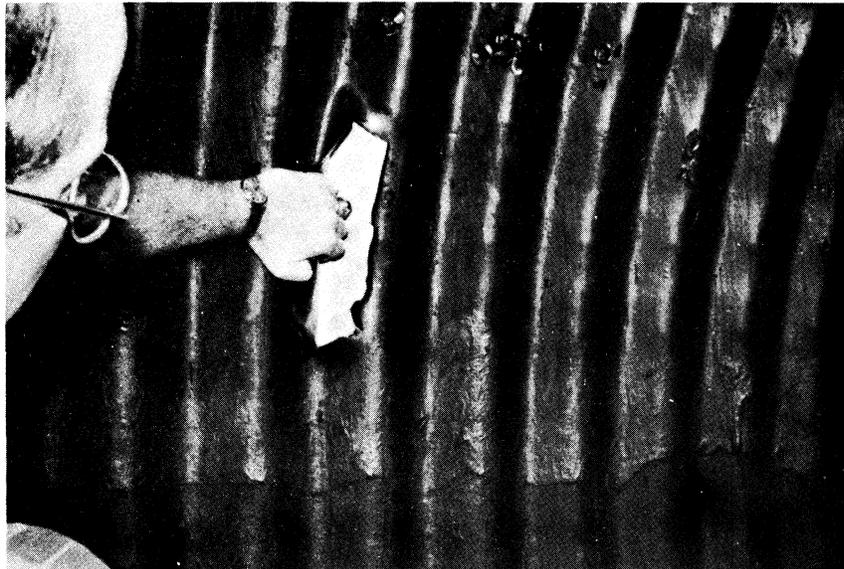
The original coating of asphalt applied out-of-state could be easily peeled from the metal surface, as in Figure 6, once a cut was initiated. There was no foreign matter apparent at the interface of the asphalt and the pipe, but all of the coating seemed loosely bonded.

Figure 6. Peeling of asphalt coating from pipe surface.

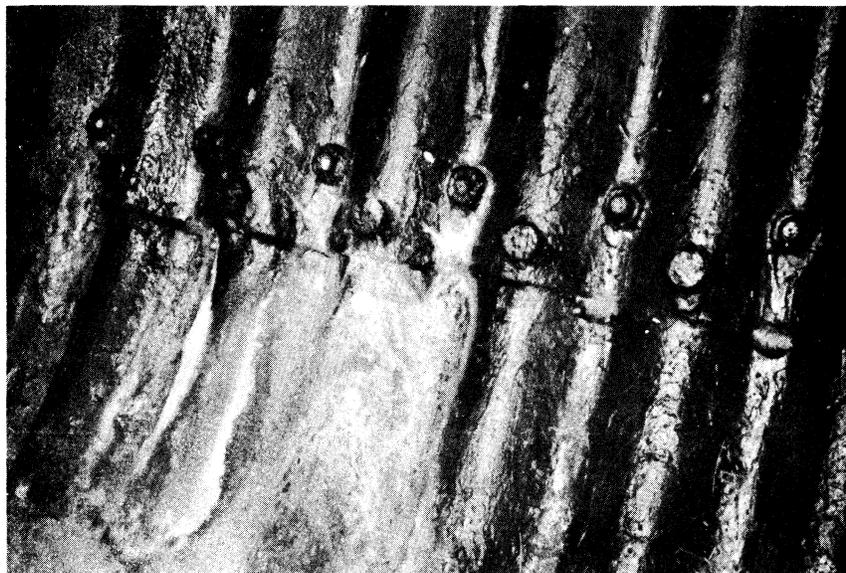
A more serious problem arose due to the varying thickness of the dipped coating. Excess asphalt had been extruded from many of the joints, but several were open more than half an inch. As shown in Figure 7, there was intrusion of soil into the culvert at several points, and water was flowing in an opening in one of the joints. Difficulties in aligning the plate sections caused the omission of several bolts over the length of the culvert. It was also impossible, in some of the bolts, to develop the torque required by the AASHTO Specifications. (2)

Figure 7. Intrusion of soil through partially open joint between plates coated with asphalt before assembly.

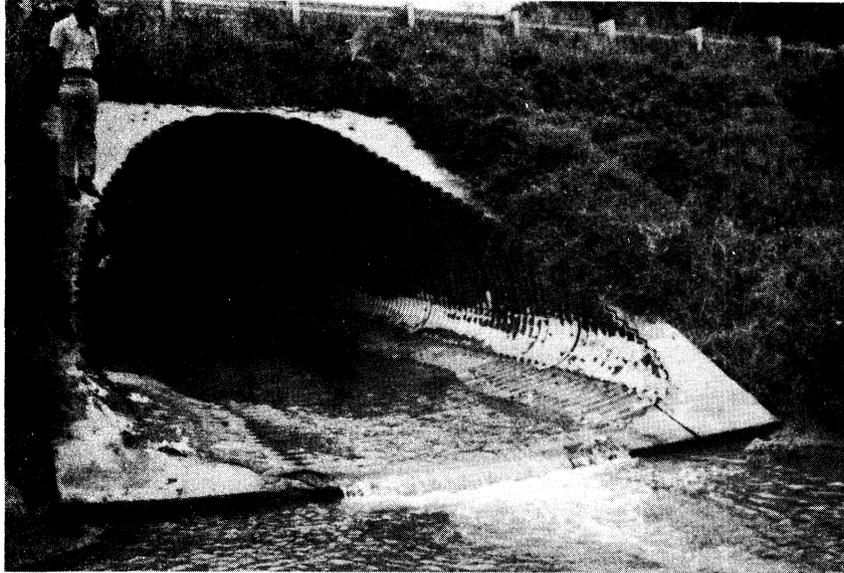
1. Rte I-77 at interchange with Rte 775, Carroll County
 Coating Type: Asphalt, applied by immersion, on-site assembly
 Service Exposure: 2 years

The asphalt coating on this pipe lacks adhesion, as do others applied out-of-state.

The material has been removed from the invert, as shown in Figure 8, and the remaining material can be peeled off easily. There is some staining, but little or no rusting of the bare metal.

Figure 8. Loss of asphalt coating, Route I-77, Carroll County.

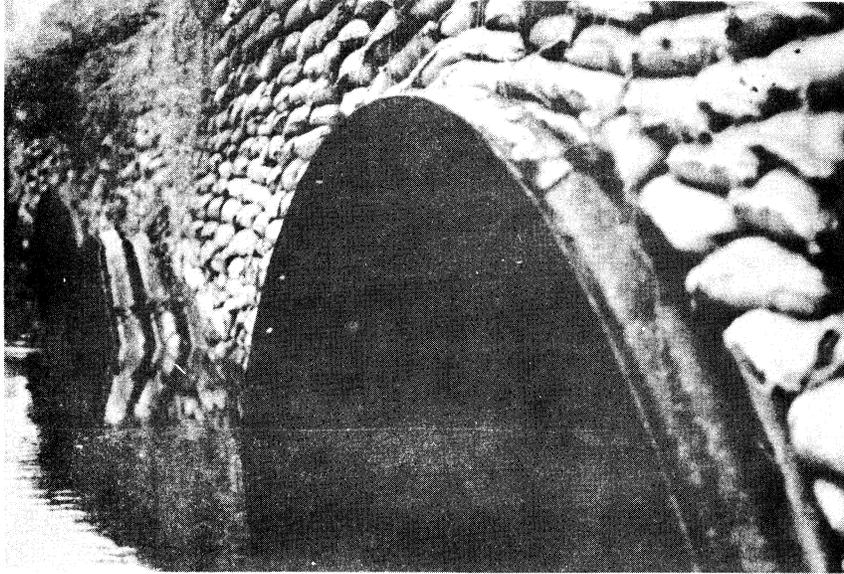
2. Rte 642 (Wilroy Road) over Brewers Creek, city of Suffolk
Coating Type: Asphalt mastic, sprayed at site.
Service Exposure: 4 years

The visible coating on this partially submerged triple line of large structural plate arches is tightly bonded with no evidence of loss. While the lower portion of the pipe cannot be inspected, it appears unlikely that the coating would be subject to impact under high velocity flow at this location, Figure 9.

Figure 9. Pipe arches, Route 642 over Brewers Creek, city of Suffolk.

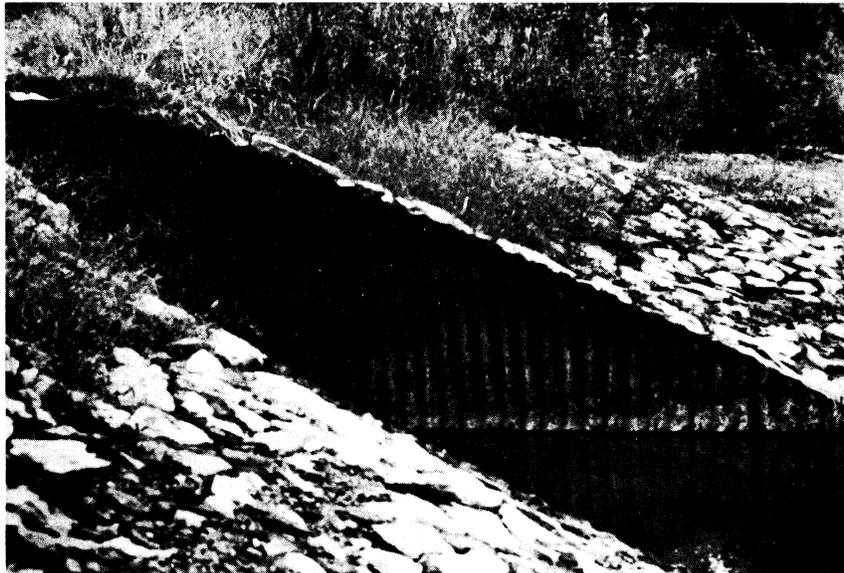
3. Rte 645 over Speights Run (City Reservoir), city of Suffolk
Coating Type: Asphalt, applied by immersion, on-site assembly.
Service Exposure: 20 years

As shown in Figure 10, the bituminous coating has been almost completely lost from this large diameter pipe which has rusted severely. Bituminous material remaining in the joints of this culvert, the oldest installation

Figure 10. Structural plate pipe, Route 645 over Speights Run, city of Suffolk. Entire pipe has rusted.

inspected, indicates that the plates were coated by immersion. The water level was low at the time of inspection due to severe drought conditions, and it is likely that the flow is placid but much deeper.
