EVALUATION OF THE PERFORMANCE OF A PRESS-LAM TIMBER BRIDGE

Bridge Performance and Load Test After Five Years

June 1982  
VHTRC 82-R56

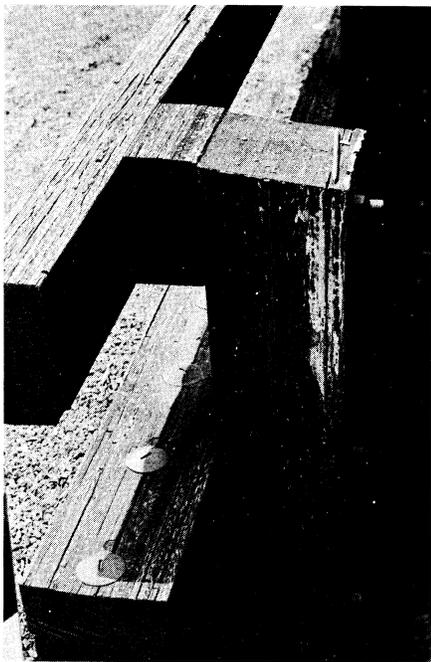
Based on the data collected during the five-year study it appears that the largest dimensional changes are positive (expansion) and in the directions perpendicular to the glue planes. The data indicate that the rails have increased in thickness about 6.0%, the wheel guards about 3.5%, the posts about 2.5%, and the stringers about 2.0%. A 2.0% increase in the thickness of a stringer is only 1/16 in. (1.6 mm) and may be within the precision that can be expected for data collected by different operators. The 6.0%, 3.5%, and 2.5% increases in the thickness of the rails, wheel guards and posts, respectively, are easily understandable considering the amount of delamination that has occurred in these members. Also, part of the 3.5% increase in the depth of the rails and wheel guards may be explained by the fact that because of the delamination, these members have warped slightly and the upper and lower surfaces have become irregular. Some of the areas of delamination are exhibited in the photos in Figures 4 and 5, taken after two years of service life.

Figure 4. Areas of delamination were obvious in post, rail, and wheel guard on southeast corner of bridge after two years of service life.

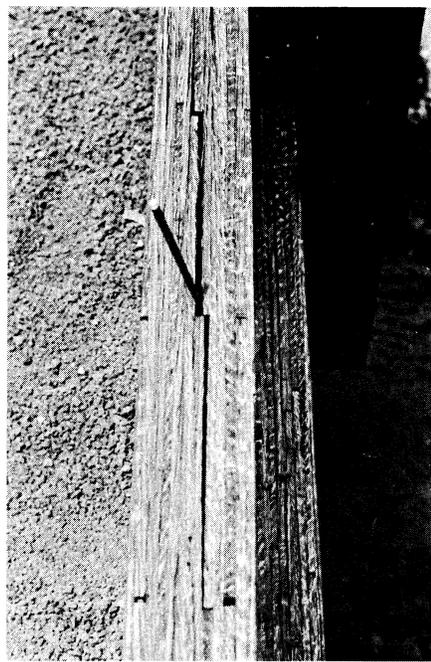
Figure 5. Delamination in east rail after two years of service life.

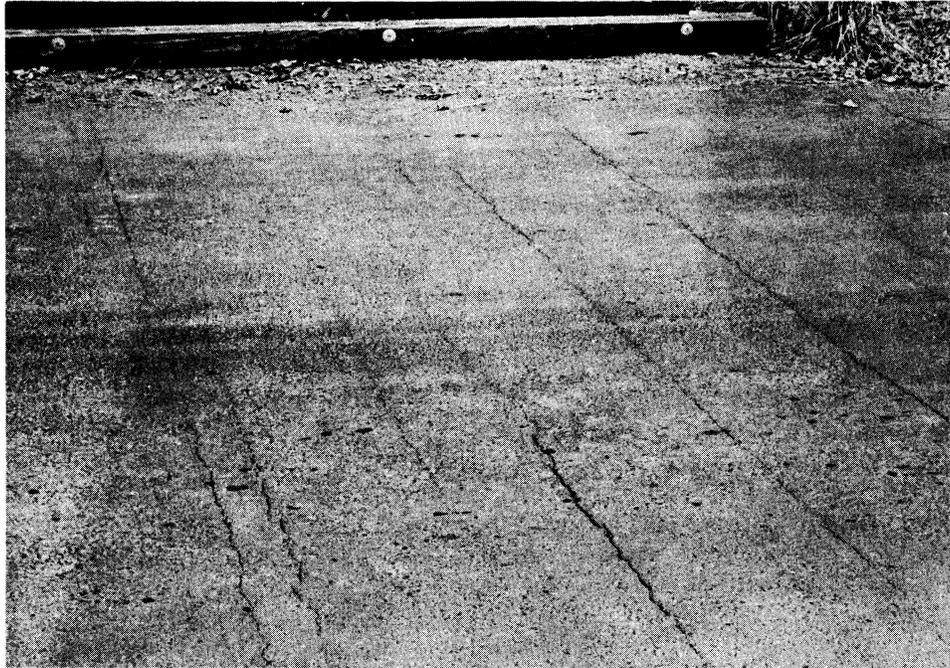
Hairline cracks, most of them directly above the joints between the deck panels, were noted in the wearing surface during the inspection of the bridge after two years of service life. Subsequent inspections revealed that the cracks had become wider and more numerous. However, even after five years of service life, the overlay had not spalled away and could be considered to be in good condition, with the exception that water was able to reach the deck panels directly through the cracks. The condition of the overlay after three years of service life is shown in Figure 7.

Figure 7. Wearing surface after three years of service life.
