INVESTIGATION OF DELAYED CRACKING IN PIVOT STEEL BOX GIRDERS

Report No. VTRC 97-R18	Report Date June 1997	No. Pages 110	Type Report: Final Period Covered: April 96- June 97	Project No.: 9133-010
Title and Subtitle: Investigation of Delayed Cracking in Pivot Steel Girders				Key Words: high-strength steel, box girder, delayed cracks, nondestructive evaluation, metallurgical and failure analyses, crack growth, brittle and fatigue failure assessment
Authors: M. G. Lozev, G. A. Washer, and W. J. Wright				
Performing Organization Name and Address: Virginia Transportation Research Council 530 Edgemont Road Charlottesville, VA 22903				
Sponsoring Agencies' Name and Address Virginia Department of Transportation 1401 E. Broad Street Richmond, VA 23219				
Supplementary Notes				
<p>Abstract:</p> <p>This report describes the results of an investigation to find the cause of the delayed cracking in the welds of the fracture-critical steel pivot box girders fabricated for the George P. Coleman Bridge. Through the use of different nondestructive methods, more than 200 transverse and longitudinal cracks were found.</p> <p>The possibility of unique, rare, and very long-term delayed cracking (co

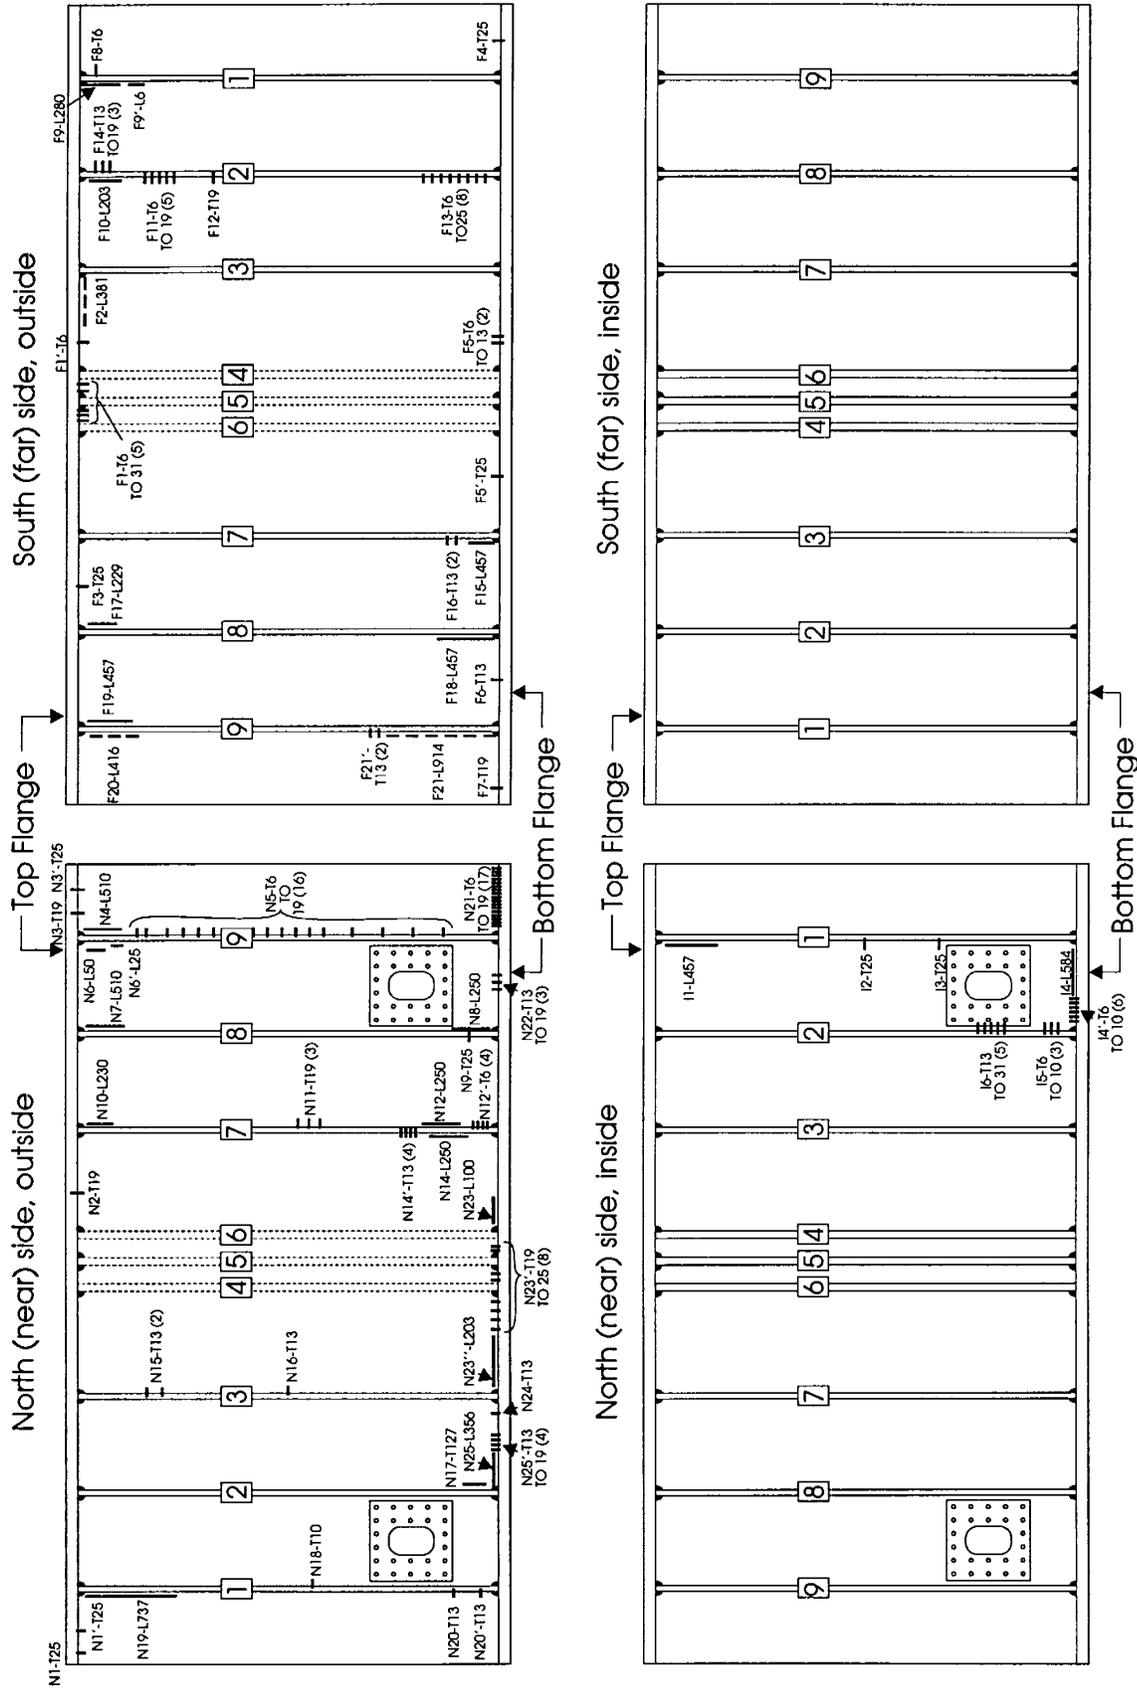
Figure 5. North Girder, MT Inspection, March 1995.

Typical MT indications for the detected cracks are shown in Figure 4. **The locations of the crack indications in the box girder are shown in Figures 5 through 7. The most severe cracks were five transverse cracks detected at the web-to-top flange groove weld in the midspan, outside the south (far) side (see Figure 5, location F1). The potential of top flange fracture initiating from the existing transverse cracks in the midspan should be the subject of a great deal of concern. MT showed the crack length indications to be from 6 to 31 mm (¼ to 1¼ in) long. The actual crack length observed during the repair work was 6 to 12 mm (¼ to ½ in) longer. To excavate the cracks, the weld metal was completely removed in the crack areas.⁶ This was an indication that some of these cracks were very deep and probably through-weld cracks.**

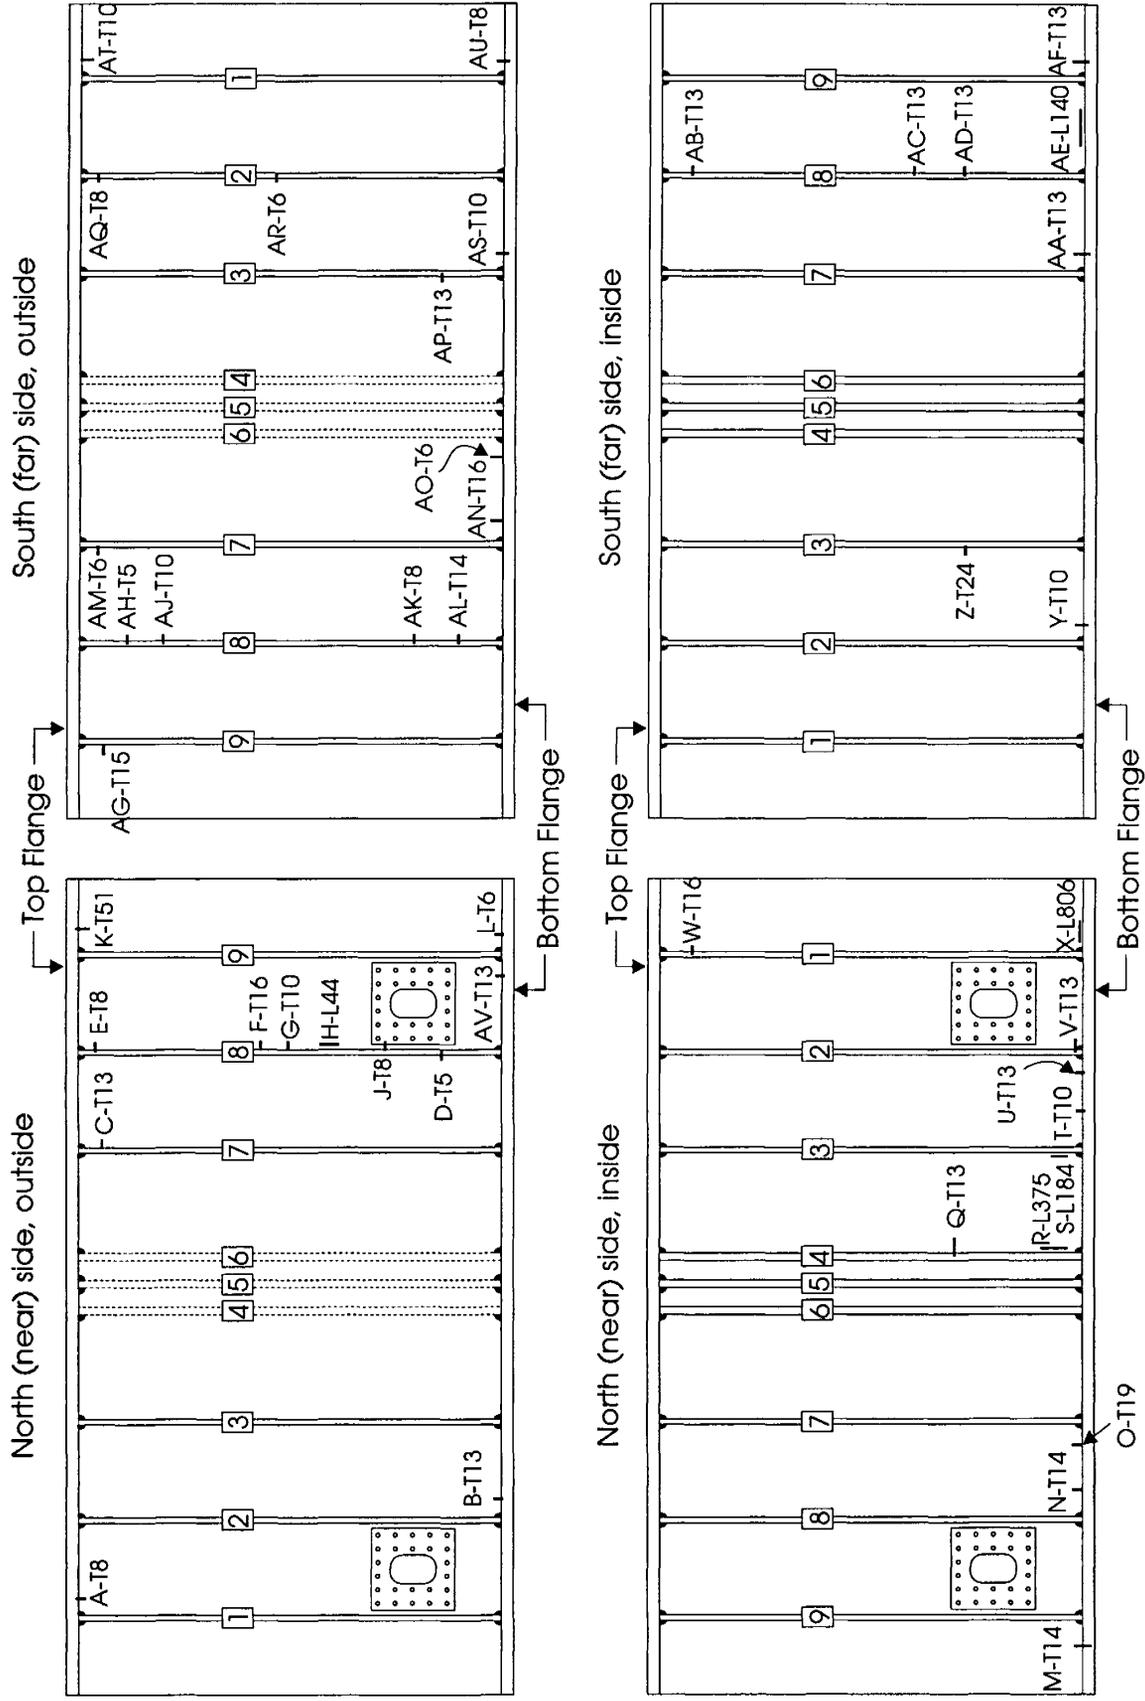
Figure 6. North Girder, MT Inspection, June 1996.

The distribution of the number and length of cracks in the north girder vs. time after fabrication is shown in Figures 8 and 9. Increased delayed cracking was observed in the web-to-top flange groove weld in June 1996 and in the web-to-bottom flange weld in April 1997. A steady decline of cold cracking was noticed in the web and flange-to-stiffener and diaphragm welds. The distribution of the number of cracks vs. length of crack for these three MTs is shown in Figures 10 through 12. Most of the transverse cracks were less than 50 mm (2 in) long. The longest longitudinal crack was more than 0.5 m (20 in) long and was detected in the web-to-stiffener and flange-to-diaphragm welds. Two longitudinal cracks longer than 375 mm (15 in) were detected in the web-to-top flange welds. MT reinspection after field repairs detected five transverse cracks 13 mm (½ in) long 13 to 25 mm (½ to 1 in) outside the repair areas and only one transverse crack 13 mm (½ in) long in the repair areas.

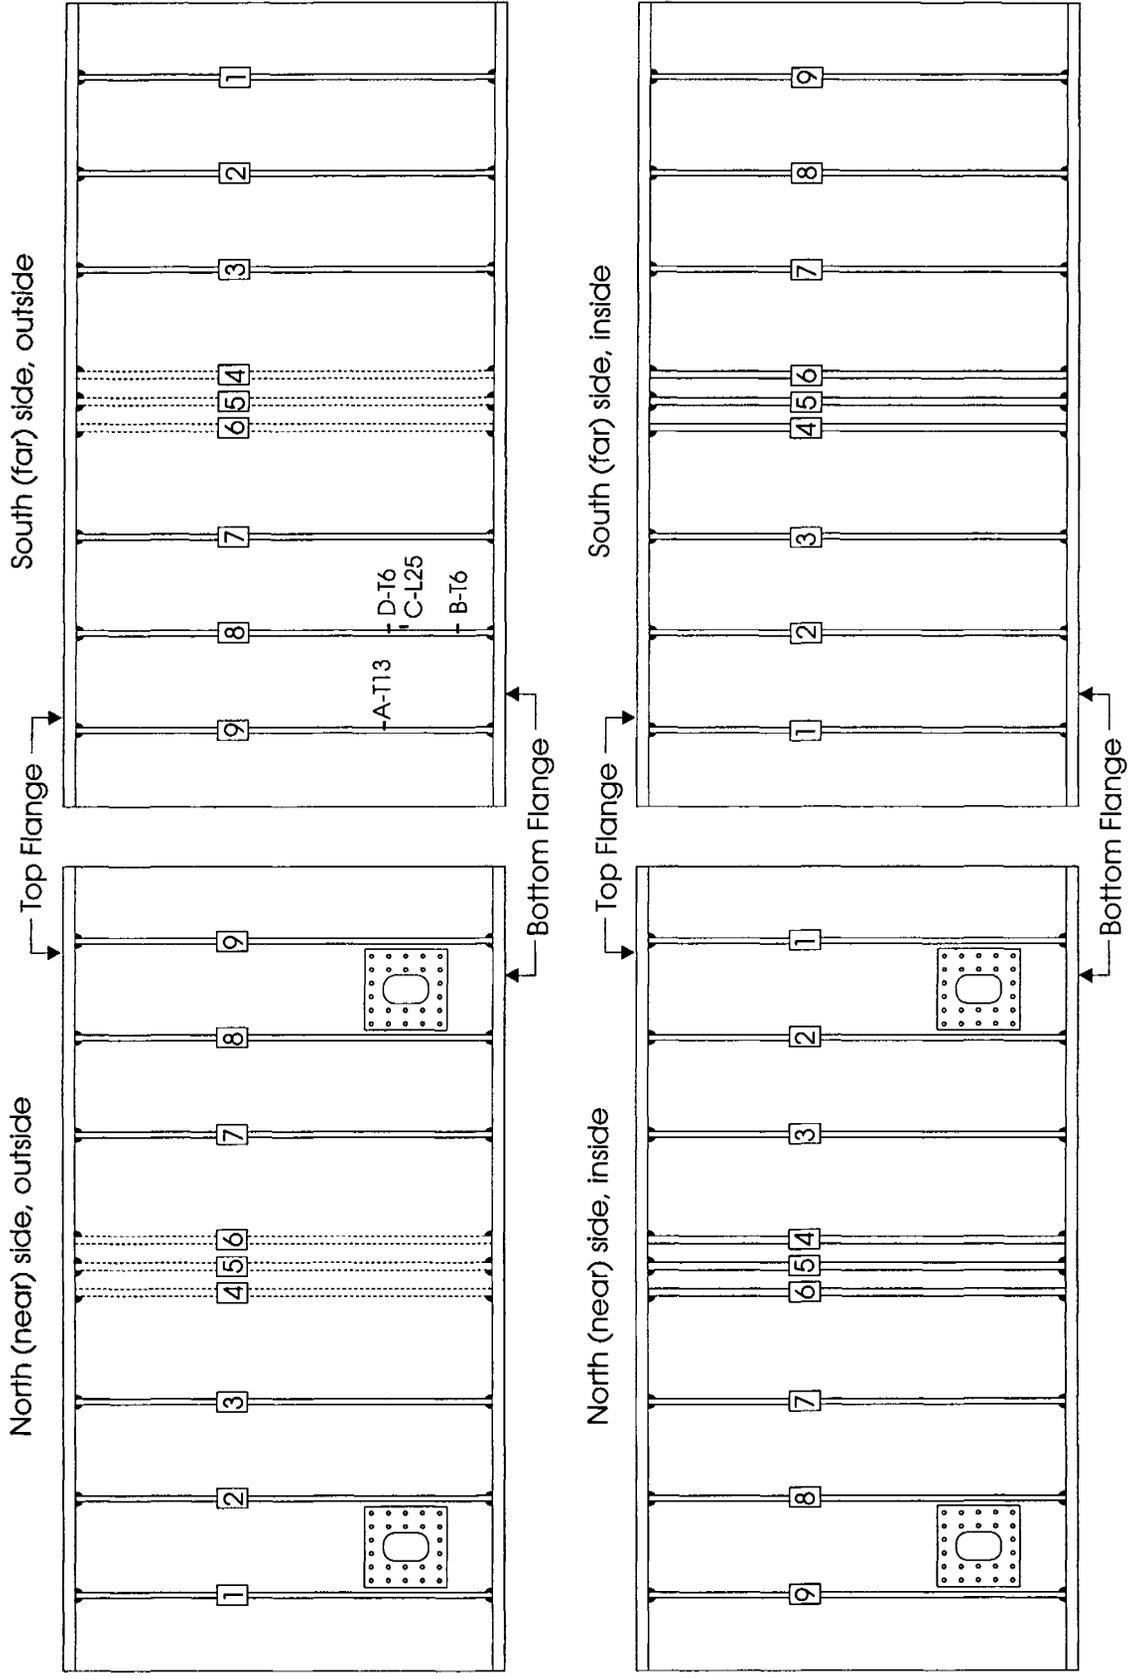
Figure 13. South Girder, MT Inspection, June-October 1995.

MT inspection of the south girder was performed at NIT in June through October 1995. Only four crack indications were observed. The locations and length of these cracks are shown in Figure 13.

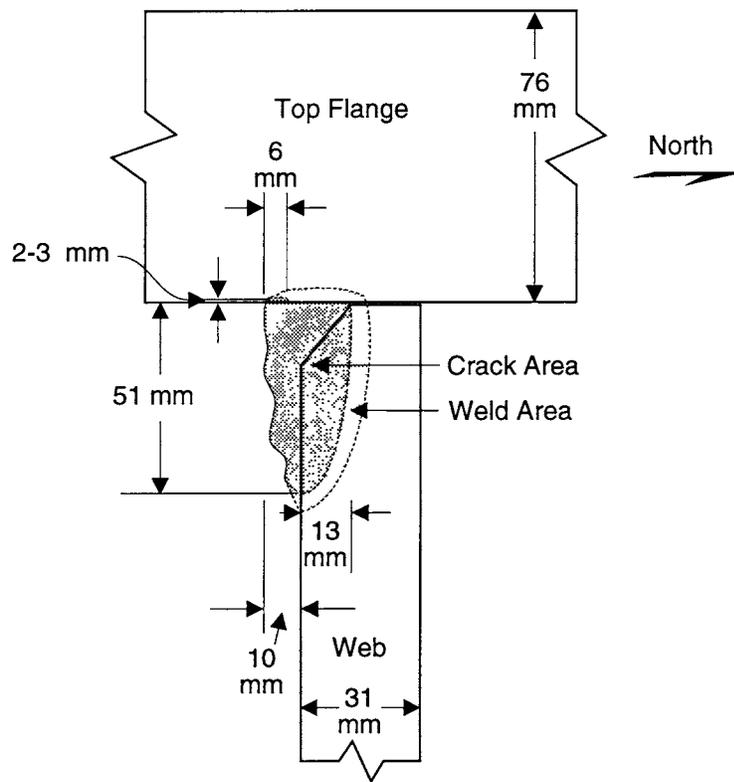
Figure 14. Projected Crack Geometry.

DPT, or the four-point probe technique, has been around for years, and its possible use for evaluating crack depth is still being investigated. If four electrodes are placed in contact with an electrically conducting object and current is passed between two outer electrodes, a potential will be produced between the other two inside electrodes (usually placed above surface-breaking cracks). For a fixed electrode arrangement and one material, an observed change in the current/potential ratio will represent a change in the depth of a crack. The CC-800B instrument, owned by VTRC, with an SP1-B probe was used to measure crack depth in different locations during this investigation. The crack depth varied from microns to 25 mm (1 in). The accuracy was ± 10 percent. The measurements were performed at the weld face only on surface-breaking cracks. The depth of the cracks in locations A, H, and K (June 1996 MT results) were confirmed later during the metallographic and fractographic examinations. An additional comprehensive DPT in April 1997 revealed that the transverse crack in the web-to-top flange single-bevel groove weld at location T (April 1997 MT results) was 50 mm (2 in) long and 13 mm ($\frac{1}{2}$ in) deep in the weld. The depth was measured after 10 mm ($\frac{3}{8}$ in) of weld metal was removed from the face (crown) of the weld. **The same crack is propagating in the top flange. Its visible length there was 6 mm ($\frac{1}{4}$ in), and its depth was 2 to 3 mm (0.1 to 0.12 in). The projected crack geometry is shown in Figure 14.**

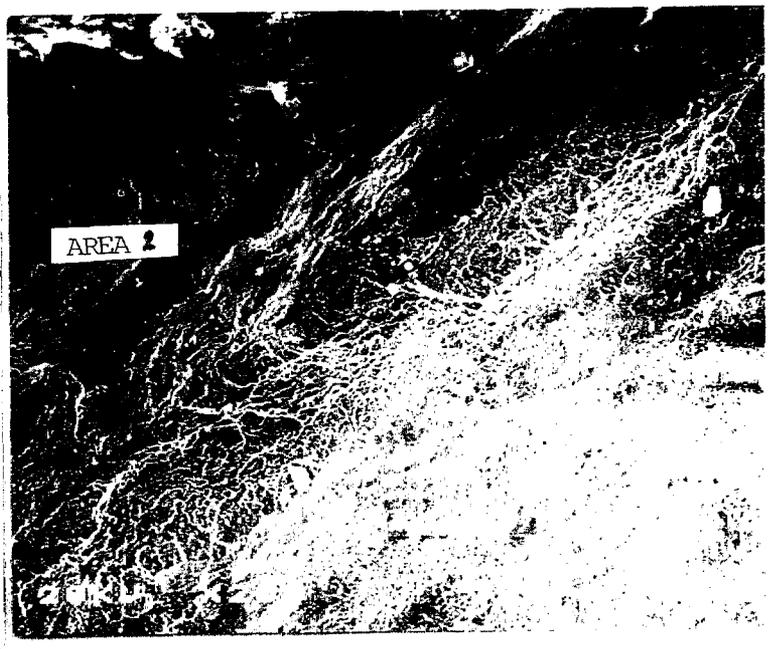
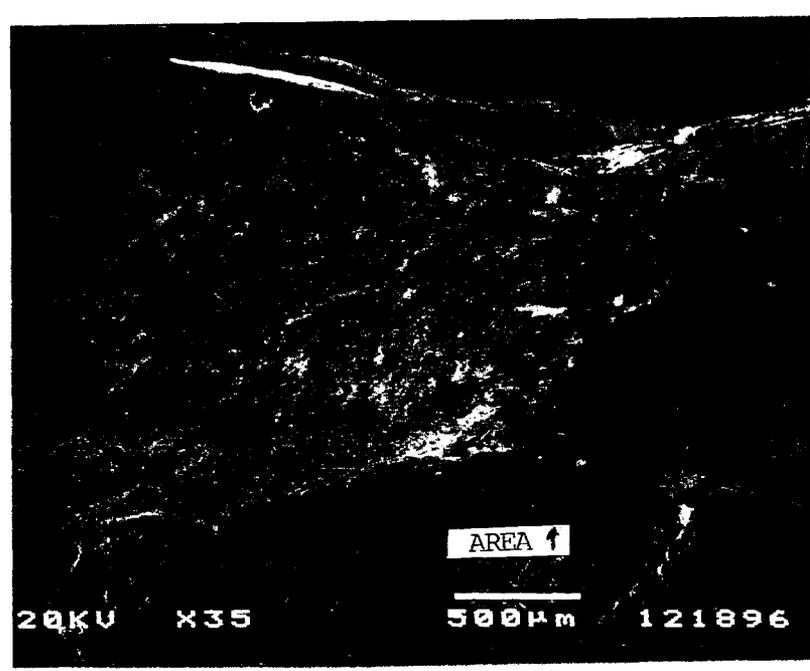
Figure 33 (a, b, c, d)

Figure 33. Macro-Micro Examination of Weld-Through Transverse Crack Detected in Core A.

- (a) fractography of exposed fracture surface (1.6x)
- (b) fractography of features characteristic of ductile tensile overload
- (c) fractography of intergranular appearance (35x)
- (d) fractography of intergranular facets (2000x).

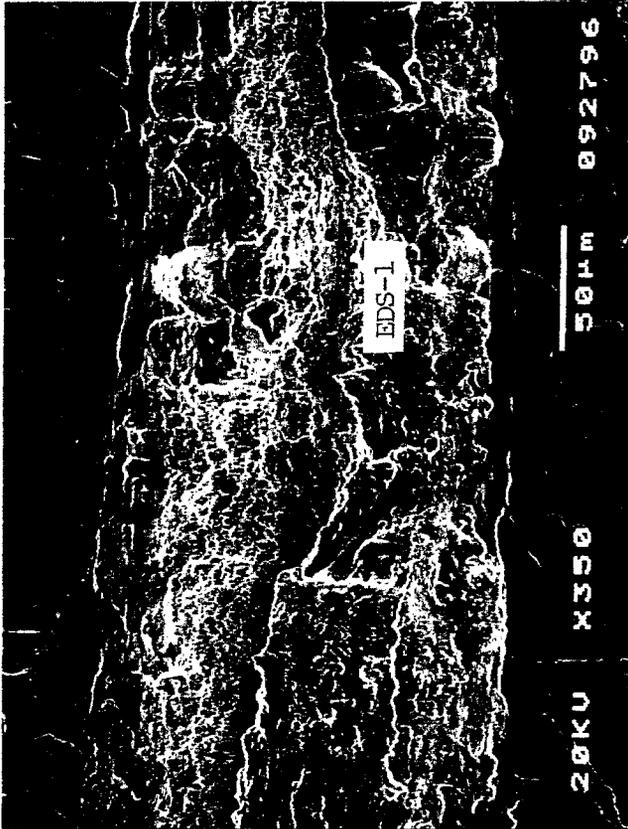
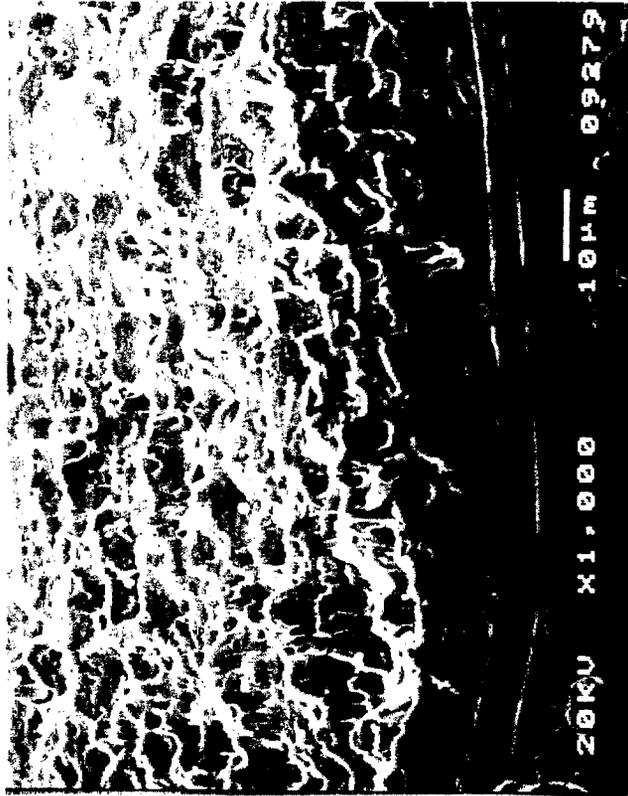
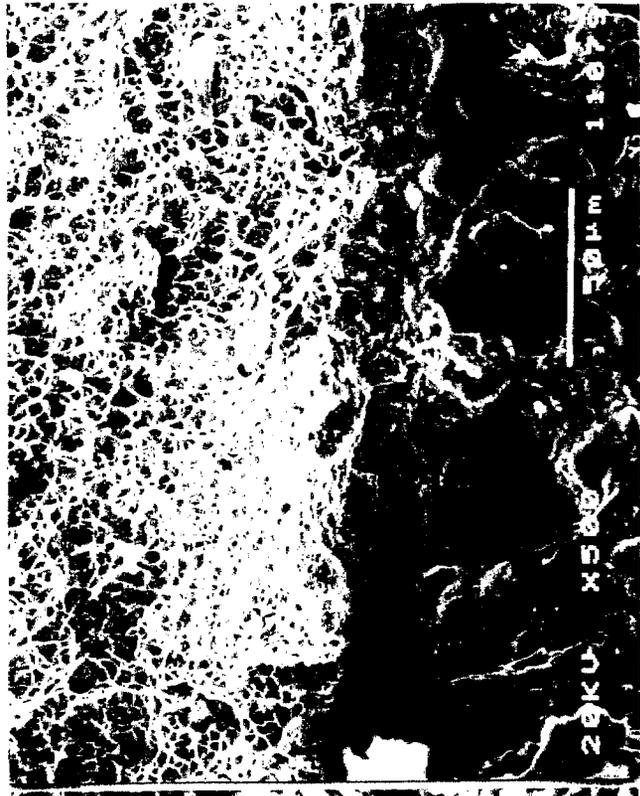
Figure 34 (a, b, c, d)

Figure 34. Fractography of Ductile Tearing and Quench Cracking Features in Exposed Fracture Surface of Cores H and A.

- (a) crack 1 in core H (350x)
- (b) crack 2 in core H (1000x)
- (c) near root of crack A1 in core A (500x)
- (d) near tip of crack A1 in core A (500x).
