**JRC2011-56074**

## **POTENTIAL SCENARIOS OF CONCERN FOR HIGH SPEED RAIL OPERATIONS**

**Michael Carolan  
Laura Sullivan**

Volpe National Transportation Systems Center  
US Department of Transportation  
Cambridge, MA 02142

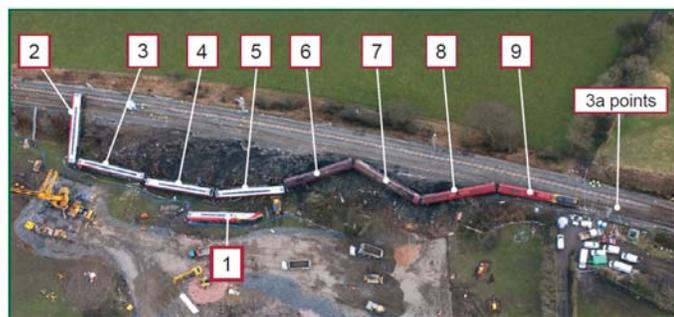
This accident occurred on February 23, 2007 near Grayrigg in Cumbria, England. A Virgin Pendolino train was travelling at approximately 95 mph when it passed over a switch. The switch was not in a proper state of repair, and the switch rail was able to move as the train passed over. All of the cars making up the train derailed, with several moving down an embankment and coming to rest on their sidewall structures. A photograph of the accident equipment is shown in Figure 1 with annotations indicating each car's position in the consist. As a result of this accident, one passenger was fatally injured and twenty eight passengers and two crew members were seriously injured [2].

**Figure 1. Grayrigg Derailment [2]**

While some of the train cars involved in this derailment came to rest on their sides, the occupied volumes of the cars were substantially intact. The majority of the injuries in this accident were the result of secondary impacts, and not loss of occupied volume. The accident mitigation measures designed into the equipment, in particular the sidewall strength and interior configuration, were successful in mitigating the negative consequences of this particular collision. As a result of this accident, inspections of 1473 switches were conducted to

determine if any other switches of the same design were in a similar state as the accident switch. This inspection effort did not find any switches in the same state of repair, but did find some components that had precursors to failure [2]. This increased scrutiny of the maintenance of track components is an example of accident prevention through maintenance-of-way.

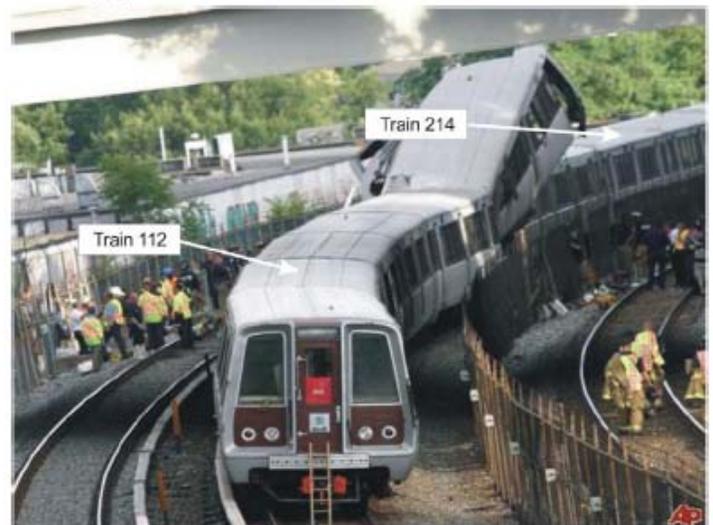
**Figure 2. Post-accident Photograph of Washington, D.C. Metro Accident [3]**

In this particular accident, the leading car of the trailing train experienced a significant loss of occupied volume. In its report

With regard to the survivability of the accident, the investigation found that the structural design of the 1000-series railcars offers little occupant protection against a catastrophic loss of survival space in a collision and this contributed to the severity of the occupant injuries and fatalities [3].

While the operating environment was equipped with a sophisticated train-control system that was designed to prevent two trains from striking one another, the system failed in such a way as to allow an accident to happen. In its report, the NTSB stated that a similar signal system malfunction occurred in 2005, resulting in two near-misses between trains. In the 2005 incidents, collisions were prevented by employee intervention. The report also states that while enhanced testing procedures were developed to ensure the control system components were functioning properly these procedures were unfamiliar to the technicians that were to be implementing them.

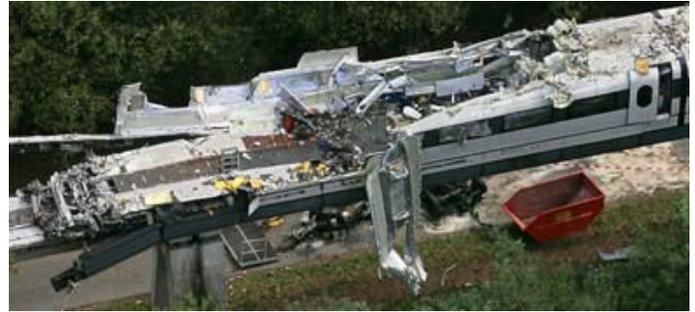
This accident occurred on a magnetic levitation (maglev) demonstration track in Lathen, Germany, on September 22, 2006. A maintenance-of-way vehicle was operating over the tracks to ensure the right-of-way was clear of debris. A maglev train carrying employees of the company operating the demonstration site struck the maintenance vehicle at approximately 120 mph [4]. Twenty-three passengers were killed, and another ten received serious injuries. While this track did have a safety system that was capable of preventing this type of accident from occurring, the system was not turned on at the time of the accident [5]. Figure 3 is a photograph of the damaged lead car of the maglev train after the accident [6].

**Figure 3. Post-accident Photograph of Lead Car, Transrapid Maglev Train [6]**

It is unclear from the publicly-available information what crashworthiness features were included in the design of the maglev vehicles. Accident-prevention features designed into the system did include an automatic braking system that could prevent two trains from striking one another if they appeared to be in danger of striking one another. However, the control system allowed operations to occur without the safety system engaged.

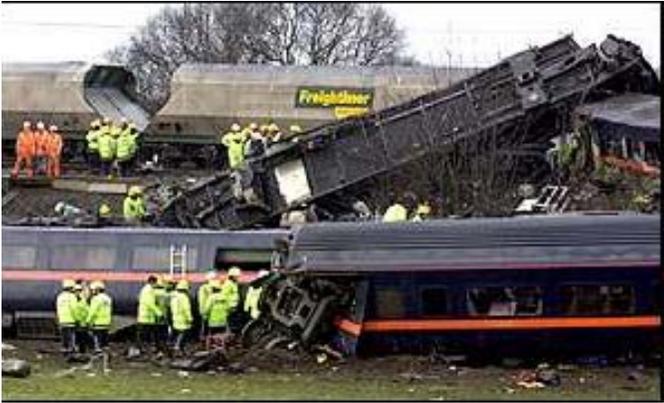
The fourth example of potential accidents occurring within Operating Environment 1 occurred in Selby, U.K., on February 28, 2001. In this particular accident, a motorist was driving an SUV with an automobile in tow. The SUV drifted from the highway, through a fence, across a field, and through a second fence before coming to rest across a set of train tracks that passed beneath the highway. The driver of the SUV contacted police to notify the railroad of his vehicles obstructing the track. Before the railroad could be contacted, a passenger train traveling at approximately 125 MPH struck the road vehicles and derailed, fouling a second set of tracks in the right-of-way. This train then travelled further down the right-of-way, where it impacted an oncoming freight train on the adjacent track it was fouling [7]. As a result of this accident, ten people on board the passenger train were killed, including the engineer. While operations in Environment 1 do not include freight trains, a second passenger train could be involved in this type of incident with equally serious consequences.

**Figure 4. Post-collision Photograph of Passenger and Freight Trains, Selby, UK [8]**

In this accident, there was not sufficient time for the SUV driver to contact the police, the police to contact the railroad, the railroad to contact the engineer of the train, and the engineer to bring the train to a stop before striking the highway vehicles on the track. While technology exists that may alert a train engineer of an obstruction fouling the right-of-way, there are practical limitations to the usefulness of such alerts. Even if a train engineer can be instantly notified of an obstruction ahead, the train will take time (and, consequentially, distance) to be brought to a stop. During their investigation of the Selby accident, the Health and Safety Commission (HSC) examined a wide range of railroad accidents involving highway vehicles. Their conclusion was that preventing highway vehicles from entering the railroad right-of-way, rather than preventing trains from hitting them, was the best approach toward reducing risk [7].

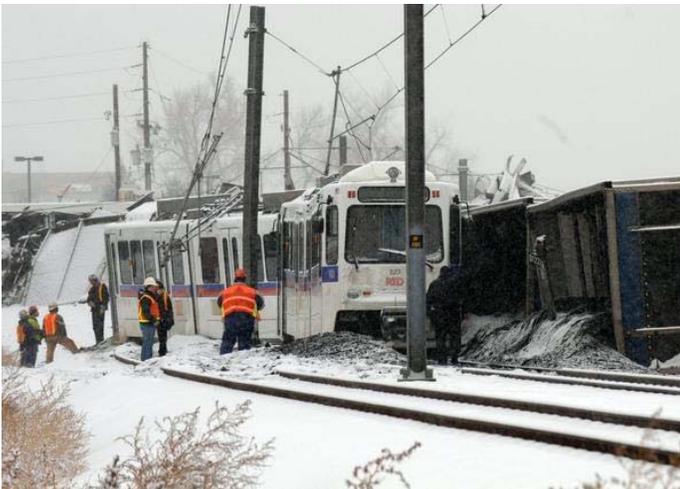
This particular example demonstrates one of the potential hazards associated with different types of equipment operating over dedicated tracks in a shared (or separated, but adjacent) right-of-way. In metropolitan Denver, Colorado, light rail service is operated in close proximity to freight rail tracks. On December 11, 2007, a coal train experienced a derailment on a section of freight tracks adjacent to the light rail tracks, derailing approximately 20 cars and spilling coal into the light rail right of way [9]. At the time of the derailment, a light rail train was traveling on the track closest to the freight right-of-way. The light rail train could not stop in time and struck the coal that was obstructing its tracks. There were no fatalities when the light rail train derailed.

**Figure 6 - Photograph Showing Light Rail Train and Derailed Coal Cars [10]**

This accident emphasizes a potential hazard that results from the presence of dissimilar railroad equipment operating on adjacent rights-of-way. While placing dissimilar pieces of equipment on separate rights of way will prevent train-to-train collisions as a result of operating two trains over the same section of track, this case illustrates that more effective measures for separation of rights-of-way may be necessary to truly prevent the possibility of impacts between operating equipment and derailed equipment. Where the possibility of such a collision remains it is important to consider the design of the passenger vehicle and select appropriate crashworthiness features to mitigate any such collision.

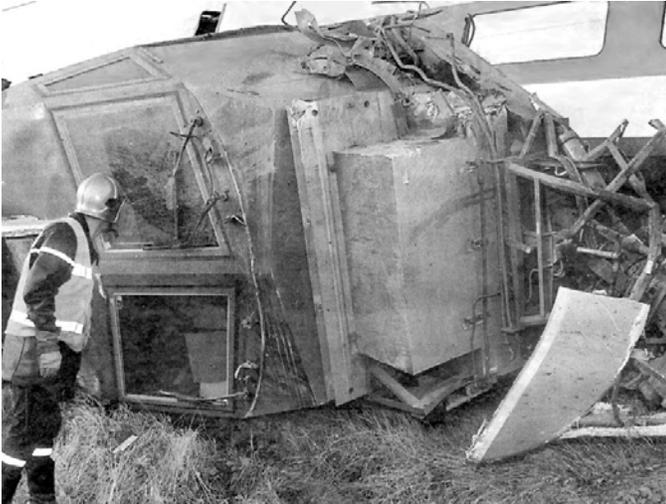
On September 25, 1997, a TGV trainset was operating over conventional lines when it struck an asphalt paving machine that had gotten stuck at a grade crossing near Bierne [11]. The speed of the train at impact was approximately 81 MPH. Figure 7 shows the leading power car after the accident, lying on its side.

**Figure 7. Leading TGV Power Car from Bierne, France Collision [11]**

There were no fatalities in this accident. This can partially be attributed to the crashworthy design of the TGV consist that was involved in the collision. In 1988, a similar accident occurred at Voiron, France, with a TGV travelling at 68 MPH striking a heavy truck at a grade crossing. Two fatalities occurred in this collision, which served as a catalyst for a research program into the crashworthiness of the future TGV equipment [12]. In both of these accidents heavy equipment became stranded on a grade crossing.

Several accident prevention strategies can be employed to increase the safety of grade crossings. Employing improved roadway designs that reduce the likelihood of vehicles becoming stuck at the grade-crossing and improved barriers to prevent drivers from entering a crossing shortly before a train decreases the likelihood of a vehicle being on the tracks when a train comes through. Restricting the speed at which a train may pass through a grade-crossing provides a greater likelihood of stopping if an obstruction is seen, and may reduce the consequences of striking an object that cannot be avoided. Removing the grade crossing further reduces the possibility of a highway vehicle being struck by a rail vehicle.

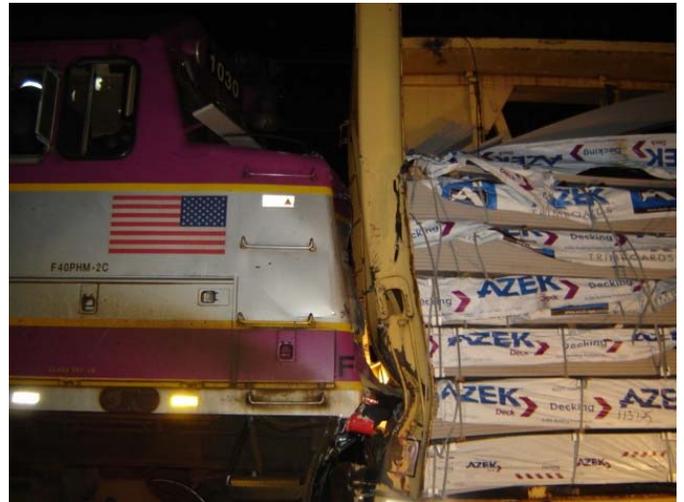
At the same time, a commuter train was traveling on the Northeast Corridor in the direction from which the freight car originated. The commuter train engineer realized the signals indicated something occupying the track ahead and brought his train to a stop. The freight car struck the passenger train before it could be backed up. The damaged freight car and passenger locomotive following the collision are shown in Figure 8.

**Figure 8. Post-accident Photo from Canton, MA (2008)**

While the speed of the freight car is estimated at being between 25-40 MPH, the force of the impact was sufficient to drive the standing passenger train back by approximately 47 feet [13]. There were no fatalities in this accident, but there were 150 people with reported injuries.

This accident demonstrates the need for crashworthy vehicles even in an environment with a train control system. While there were precautions in place to prevent a freight car from leaving the siding, the precautions failed to keep this car on its siding. The signal system worked as intended, and alerted the commuter train engineer that something was on the track ahead. The commuter engineer acted properly and brought his train to a stop. However, at this point the locomotive engineer was unable to take any further action to prevent his train from being struck. In this accident, the locomotive and passenger cars were sufficiently crashworthy to protect the crew and passengers from fatal injury.
