JRC2011-56103

PRELIMINARY RECONSTRUCTION OF THE NOVEMBER 30, 2007 CHICAGO, IL RAIL COLLISION

Volpe National Transportation Systems Center
US Department of Transportation
Cambridge, MA 02142

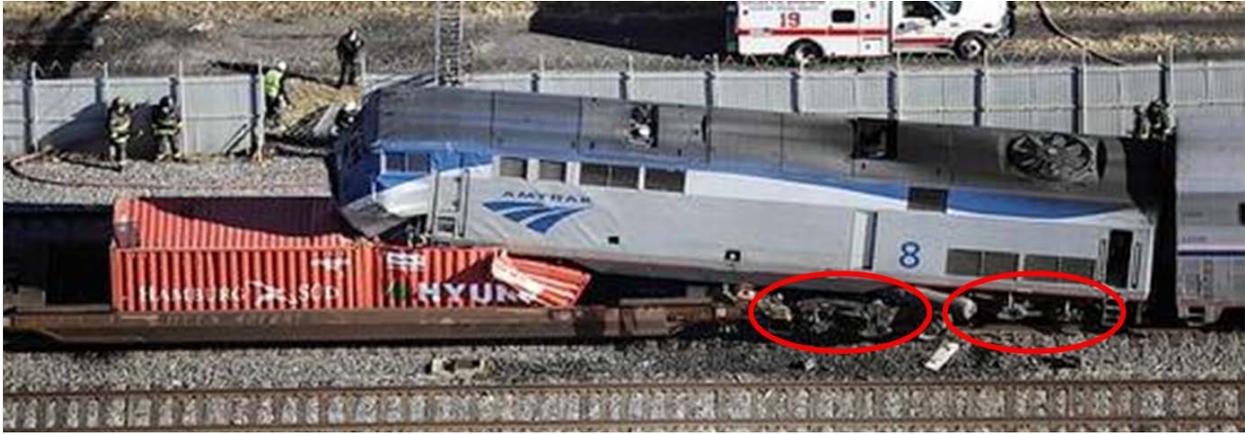
The final position of the equipment (shown in Figure 4), the structural damage of the equipment, the wayside evidence, and the event recorder were interpreted in order to synthesize the impact sequence of events, broken down into a series of phases shown in Figure 5.

Figure 4. Final position of the locomotive and freight car. The locomotive came to a stop on top of the freight car [6].

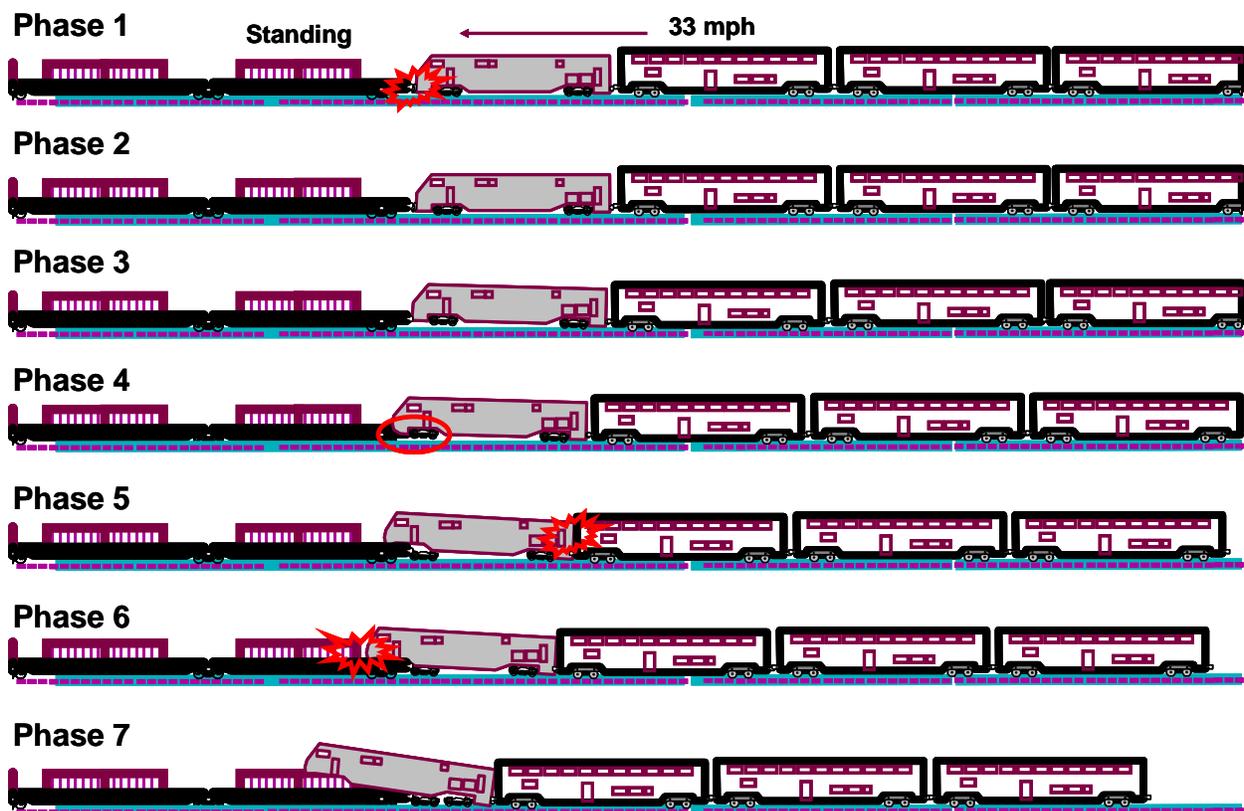
Figure 5. The impact sequence was broken down into phases.

- Phase 1: Contact of the couplers;
- Phase 2: Both draft gears bottomed out;
- Phase 3: Locomotive began to climb rear of freight car;
- Phase 4: Locomotive lead truck engaged freight car;
- Phase 5: Locomotive roof engaged lead passenger car;
- Phase 6: Locomotive striker engaged freight container;
- Phase 7: Locomotive crushed two containers and passenger train came to a stop.

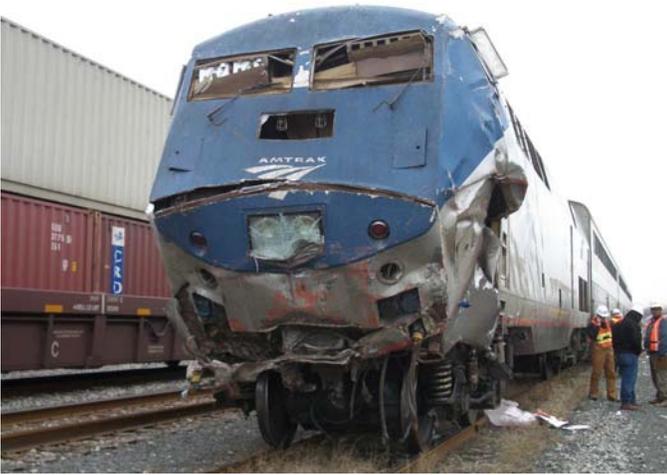
Detailed descriptions and photographs of each phase are provided below. In the last phase of the impact, the passenger train came to a stop with the locomotive resting on top of the last freight car, as shown in Figure 4. A photograph of the impacted end of the locomotive is shown in Figure 6.

Figure 6. Impacted end of locomotive.

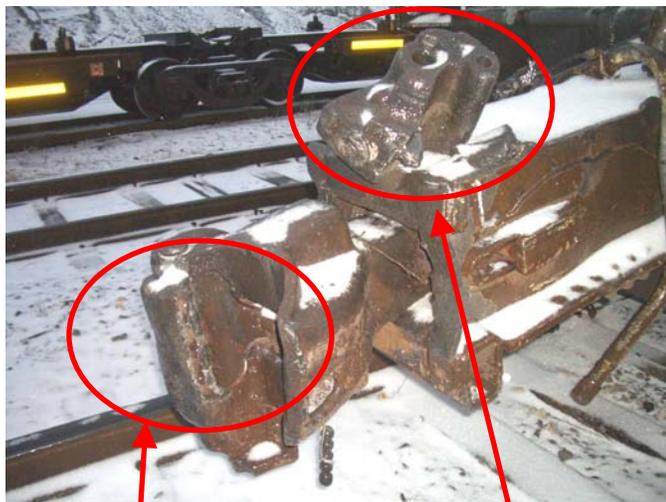
In Phase 1, there was knuckle-to-knuckle contact of both couplers, as shown in Figure 5. The knuckle of the locomotive coupler broke off and a piece of the knuckle of the freight car

also broke off. Figure 7 shows what remained of both couplers after the accident.

Broken knuckle of freight car

Piece of broken knuckle of locomotive

Figure 7. Locomotive and freight car couplers.

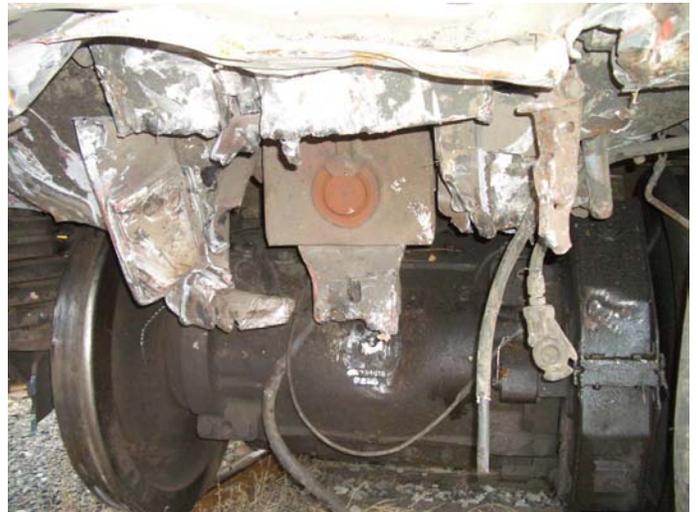
In Phase 2, the locomotive and the freight car couplers moved straight back and both draft gears bottomed out, as shown in Figure 5. Both couplers remained in line and did not swing out laterally. There was little damage to either bellmouth. This was instrumental in keeping both trains mostly in line during the collision sequence. Had either of the couplers swung out, it is very likely that the passenger train would have derailed laterally. This lateral motion would have caused the passenger train to collide with the trains passing by on the adjacent tracks, resulting in a much more severe accident. Figure 8 shows the broken coupler shank of the locomotive.

Figure 8. Deformed locomotive draft gear housing and coupler.

8 shows the broken coupler shank of the locomotive and the fractured sides of the draft gear pocket. Figure 8 also shows the indentation that the coupler shank left on the front truck of the locomotive. The coupler shank was most likely pinned between the lead truck of the locomotive and the rear of the freight car. The deformation of the locomotive draft gear housing caused the nose of the locomotive to roll under and push up towards the operator’s cab compartment, as shown in Figure 10. Figure 10 also illustrates the resulting deformation of the underframe, which caused a loss of occupant volume in the cab compartment. The nose rolling under also caused the desktop components of the cab to roll forward and push through the front windows of the cab compartment, as shown in Figure 11. Again, the majority of the motion and deformation was in the longitudinal direction, with very little motion or deformation laterally. Had there been more of a lateral component, a much more severe accident would have resulted.

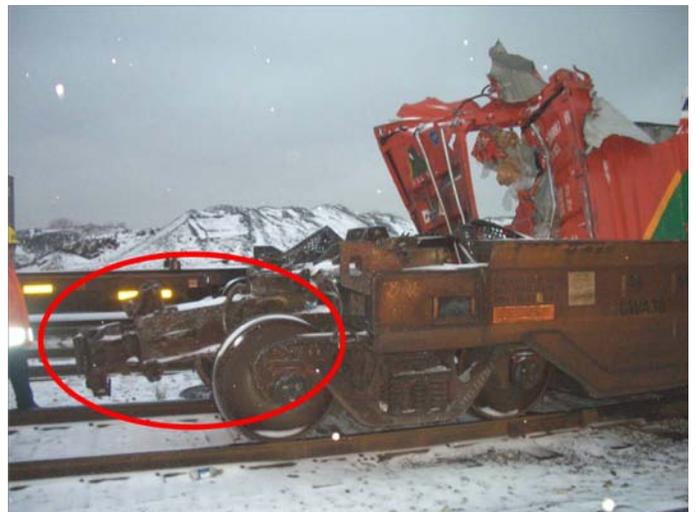
In Phase 3, the locomotive coupler carrier failed and the draft sill of the freight car deformed downward. The deformed draft sill effectively acted as a ramp to enable the locomotive to begin to climb the freight car, as shown in Figure 5. Figure 9 shows the freight car draft sill deformed downward at an angle. The locomotive climbed the freight car, which allowed the trains to remain in line. Again, had the cars sawtoothed or zigzagged with respect to each other and derailed, there is a very high likelihood that the train would have collided with the trains running on both adjacent tracks, resulting in more severe injuries and possibly fatalities in all of the trains involved.

Figure 9. Deformed draft sill of freight car.

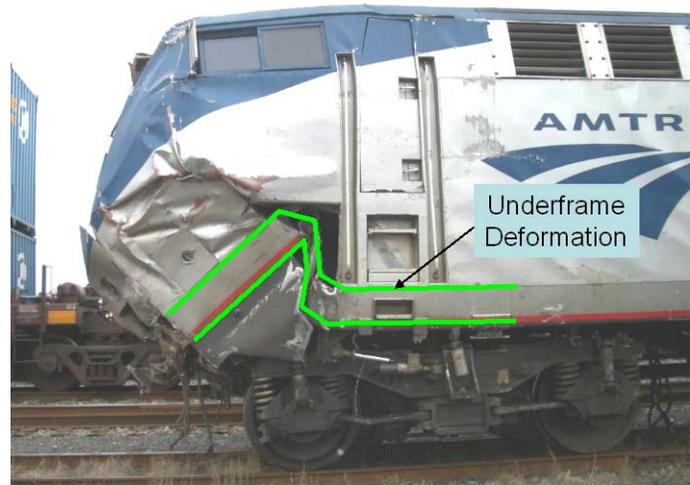
Figure 10. Locomotive nose damage.

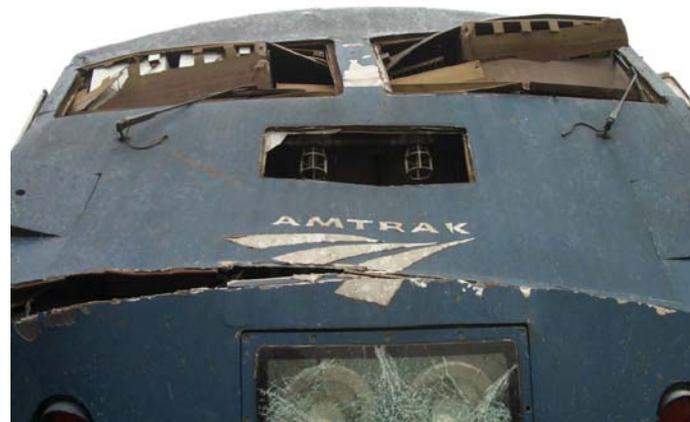
Figure 11. Locomotive desktop components in windows.

The impact between the locomotive and the freight car caused the nose of the locomotive to roll under and push upward, resulting in the underframe deforming upward towards the operator’s cab. This deformation caused the desktop components of the cab to roll forward and push through the front windows of the cab compartment, as shown in Figure 11. The deformation of the underframe also caused catastrophic failure of the floor of the cab, resulting in the floor and the seats in the cab to be pushed upward. Figure 15 is a photo of the cab interior that shows the window components pushed through the windows, the raised floor, and the relief engineer’s seat displaced upward and pushed into the ceiling of the cab. Figure 16 shows the distance the floor of the cab was raised, approximately 1.5 ft. (0.45 m.).

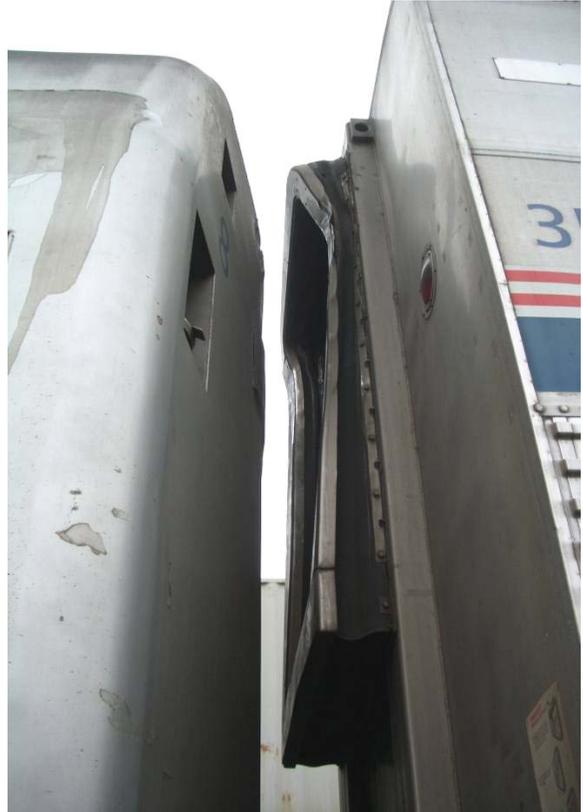
the rear of the roof of the locomotive engaged the lead passenger car collision posts as the locomotive tilted in its climb. The damage to the diaphragm of the first passenger car is shown in Figure 12. This was the extent of the exterior damage incurred by the coach cars; there was no other exterior damage. The coach cars and their couplers stayed in line for the duration of the accident with no damage occurring at the coach car interfaces.

Figure 12. Damage to diaphragm of first passenger car.

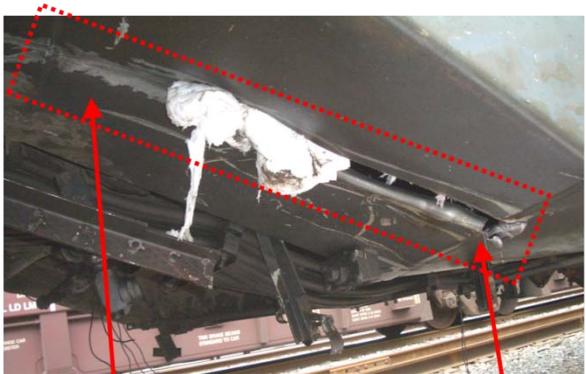
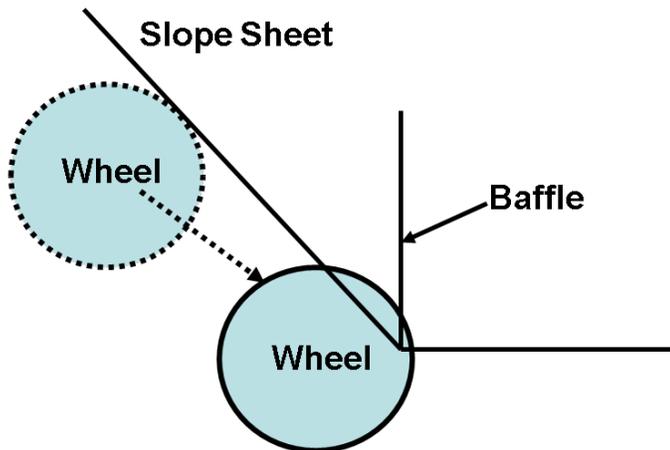
In this phase, the locomotive fuel tank was damaged by the rear wheel of the front truck as the locomotive climbed the freight car. The damage to the fuel tank, as well as a diagram depicting how the damage occurred, is shown in Figure 13. The rear wheel of the locomotive front truck was still spinning when it contacted the slope sheet of the fuel tank. As the

locomotive climbed the freight car, the spinning wheel fractured the slope sheet then penetrated the corner of the fuel tank baffle. Approximately 300 gallons of diesel fuel spilled from the tank.

Truck wheel rubbed, then fractured slope sheet of fuel tank

Truck wheel penetrated bottom corner of baffle

Figure 13. Fuel tank damage.

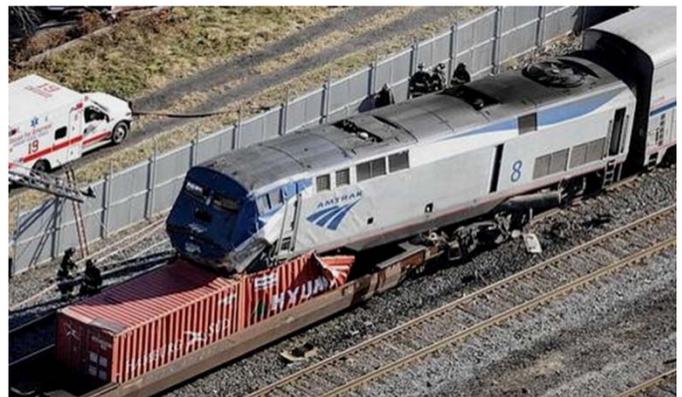
In Phase 7, the locomotive crushed the rear container and part of the front container of the freight car. A photograph of the locomotive at rest on top of the freight car is shown in Figure 14. The crushing of both containers absorbed the last of the locomotive kinetic energy and the passenger train finally came to a stop with the locomotive resting on top of the freight containers at an angle. The three trailing coach cars remained upright and the couplers remained coupled. Only the locomotive derailed; the three coach cars remained on the track. Almost all of the exterior damage to the passenger train was sustained by the locomotive. The locomotive experienced severe damage to its nose and underframe, with approximately 5 ft. (1.5 m.) of total crush, as well as wrinkling of both side

walls, damage to the rear roof due to contact with the first coach car, and the shearing off of its lead truck. The wrinkles on the side of the locomotive body can be seen near the Amtrak symbol in Figure 14. The exterior damage to the coach cars was limited to the diaphragm of the first coach car, as shown in Figure 12.

Figure 14 shows the adjacent tracks on both sides of the trains involved in the collision. At the time of the collision, there were trains running on both adjacent tracks. Again, had the passenger train not climbed the freight car, the couplers would have caused the cars to sawtooth laterally. This lateral buckling is typical and if it had occurred in this accident, the passenger train could have impacted the trains running on both adjacent tracks, resulting in a more severe accident.

Figure 14. The locomotive came to a stop on top of the rear freight car [6].

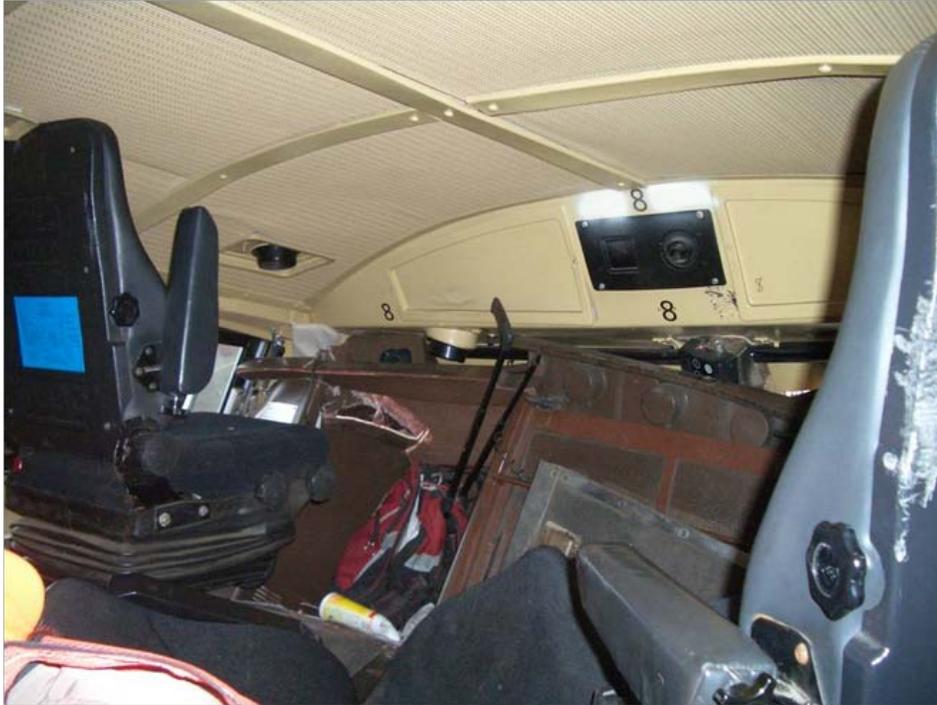
Figure 15. Locomotive interior cab damage.

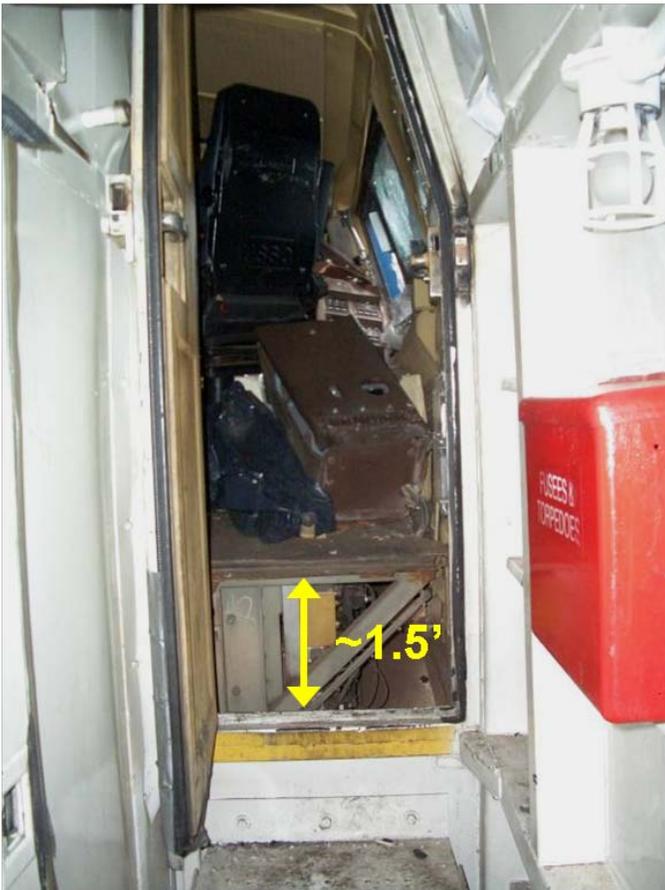
Figure 16. Raised floor of locomotive from impact

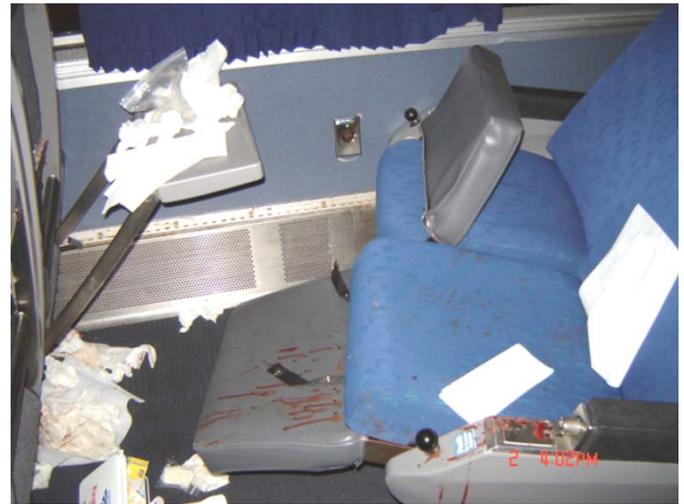
The structural damage to the interiors of the coach cars was minor in comparison to the locomotive interior. All of the coaches were equipped with seat pairs that can be rotated 180° to face either forward or backward. After the accident, two seat pairs in the first coach car, four seat pairs in the middle coach car, and three seat pairs in the last coach car were all rotated with respect to their original positions. Their seat latches had failed to secure the seat pairs in the locked position. Figure 17 shows one of the rotated seat pairs in the third coach car.

Figure 17. Rotated seat pair.

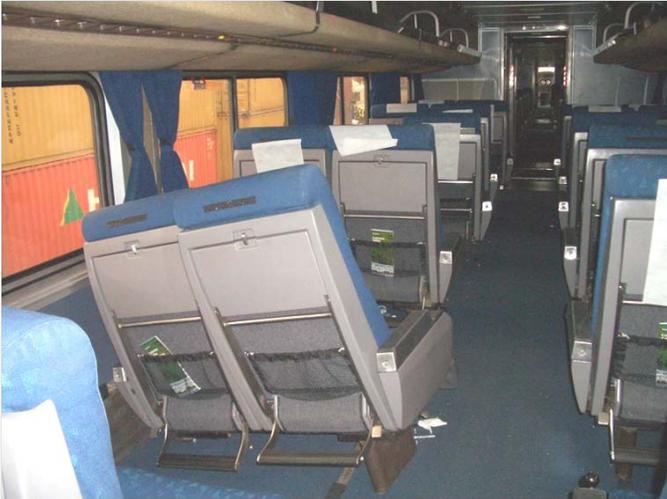
In addition to the four rotated seat pairs, the middle coach car also had a seat pair that had separated from the wall and floor due to fastener failure, shown in Figure 18. The failed seat pair is believed to have been caused by impact from a standing occupant. The rotated seat pairs in all of the coach cars may also have been caused by impact from standing occupants.

Figure 18. Failed seat pair.

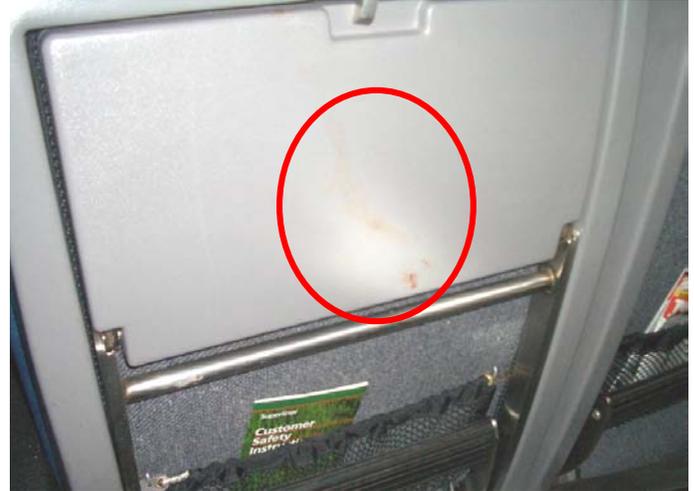
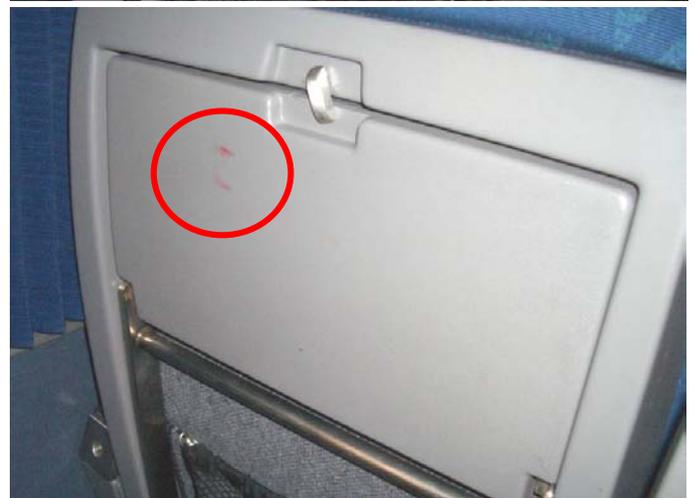
Figure 19. Evidence of passenger injuries from impact with seat backs.

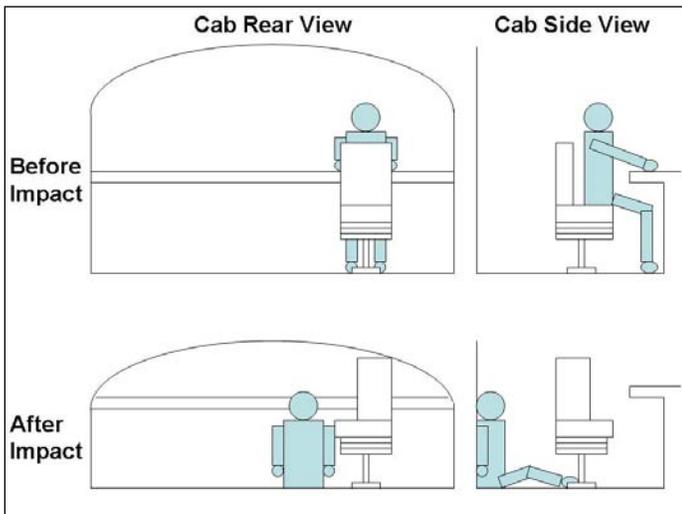
Figure 20 shows the operating engineer's location before and after impact. Prior to impact, the operating engineer indicated that their seat was in the back position and their weight was shifted forward. The operating engineer had both arms extended to the control desktop as they were trying to apply the brakes on the train. The impact caused the operating engineer's body to travel forward and then upward, at which point the operating engineer remembers hitting their head. The operating engineer was then thrown backwards, hitting the rear panel of the cab compartment. The operating engineer came to rest behind and to the left of their seat. Figure 15 shows the damage to the interior of the cab from the impact. Figure 16 shows the cramped space behind the operating engineer's seat where the operating engineer came to rest. The operating engineer sustained a torn meniscus in their left knee, a torn left rotator cuff, a severe concussion, multiple head lacerations, bruises on the left elbow and left ribs, and a sore neck and back. After the accident, the operating engineer was carried out through the rear door of the locomotive.

Figure 20. Operating engineer location within the cab before and after impact.

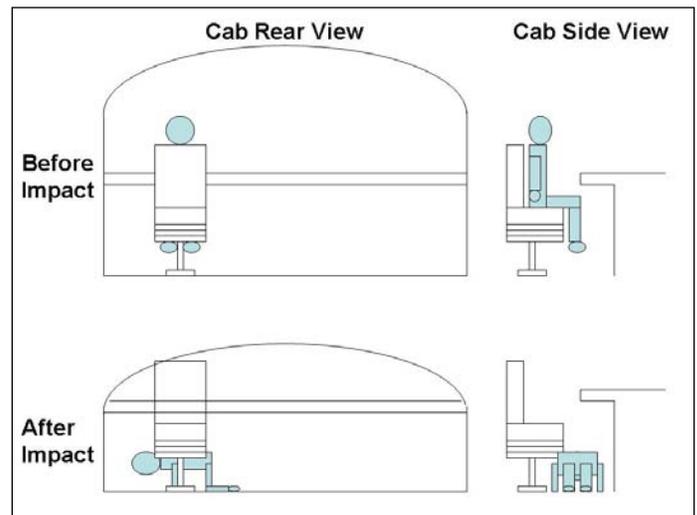
Figure 21 shows the relief engineer’s location before and after impact. Prior to impact, the relief engineer indicated that their seat was in the midway position. The relief engineer was fully seated and either looking forward or looking to the right at the operating engineer. The relief engineer does not remember whether or not they extended their arms out to brace against the impact. The relief engineer thinks that the impact caused them to slide off of their seat and underneath the desk, which can be seen in Figure 15. The relief engineer came to rest on their hands and knees facing to the left. The relief engineer sustained a severely broken nose, a head concussion, bruises on their left side, and multiple head lacerations on the left side of their head. The relief engineer thinks that the head lacerations were caused by the heavy metal structure of the seat pedestal, shown in Figure 15. Note that the relief engineer’s seat has been pushed into the ceiling of the cab. Had the relief engineer remained in their seat, they might have sustained severe head, neck, and spinal injuries from being pushed into the ceiling by the seat. After the accident, the relief engineer climbed out through a side window and walked away under their own power.

Figure 21. Relief engineer location within the cab before and after impact.
