ASSESSMENT OF BURROWING MAMMAL  
IMPACTS ON PAVED HIGHWAYS  
IN MONTANA

FHWA/MT-10-010/8117-39

*Final Report*

*prepared for*  
THE STATE OF MONTANA  
DEPARTMENT OF TRANSPORTATION

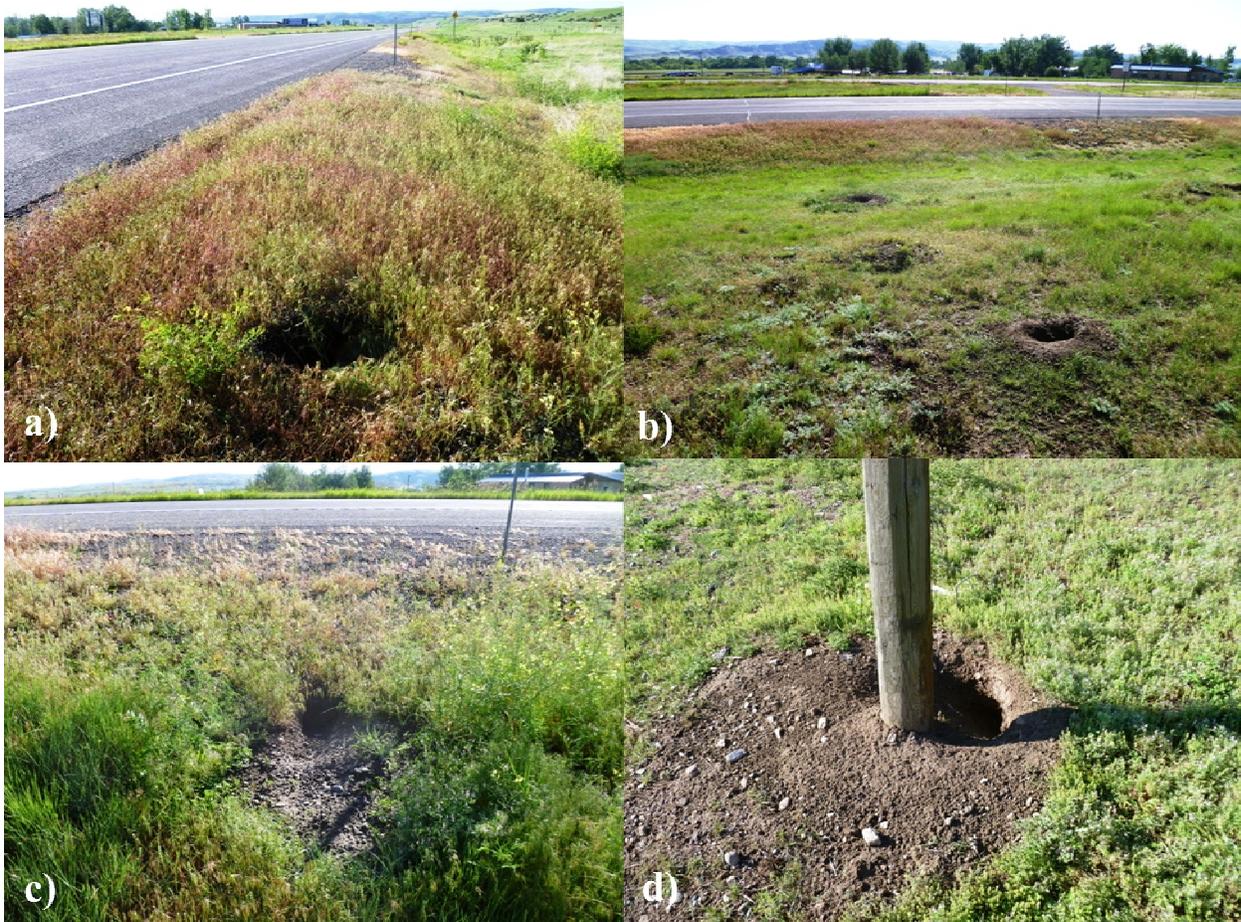
This site was on a four-lane divided interstate highway surrounded by grassland and ranchland with plentiful organic soils (Figure 14). Prairie dog holes were present in the right-of-way and unpaved shoulder along approximately a half mile of roadway, although holes near the road shoulder were shallow. No direct structural damage to the pavement surface or support structure was observed to be due to the activities of burrowing mammals. Many of the individual mounds were raised above the graded surface, which may cause a nuisance to mowers, although much of the vegetation in the area was short from feeding activities. Disturbed earthen mounds and feeding activities seem to have promoted weed growth in the area.

Figure 14. Photos of Site 1: a) burrows near shoulder, b) burrows in right-of-way, c) burrow at base of shoulder, and d) burrow near sign post.

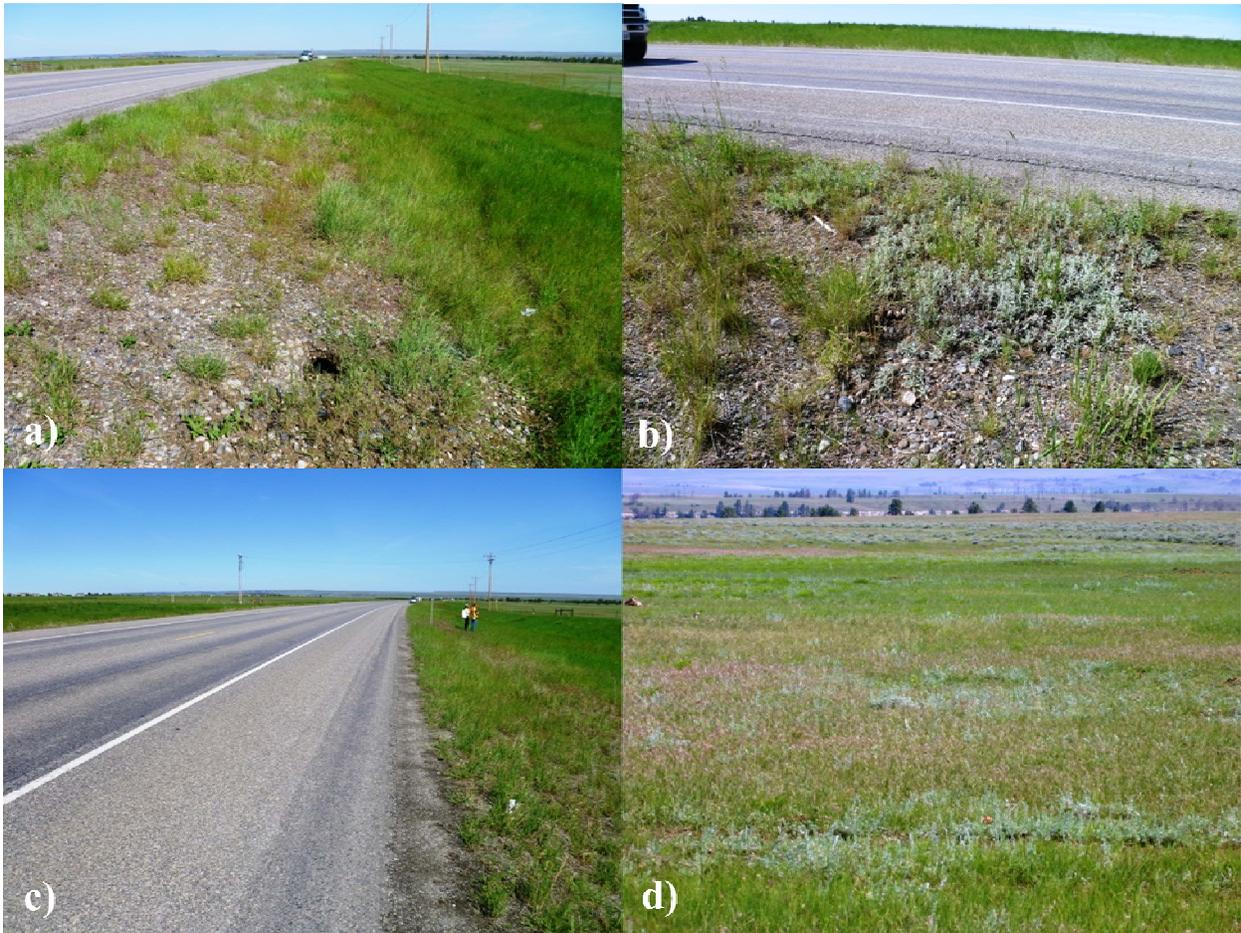
This site was located on a rural two-lane highway surrounded by grasslands and ranchland with sandy organic soils (Figure 15). Prairie dog holes were present in the right-of-way and the unpaved shoulder on both sides of the road. Activity within about 10 feet of the paved edge in the graveled shoulder was less developed and was likely the result of the dispersal of young. Most of these mounds were abandoned. MDT personnel indicated concern for water infiltration through burrows under the road, although no pavement or structural damage was apparent.

**Figure 15. Photos of Site 2: a) abandoned burrow in shoulder, b) abandoned burrow covered with vegetation near shoulder, c) general layout and condition of roadway, and d) adjacent landscape.**

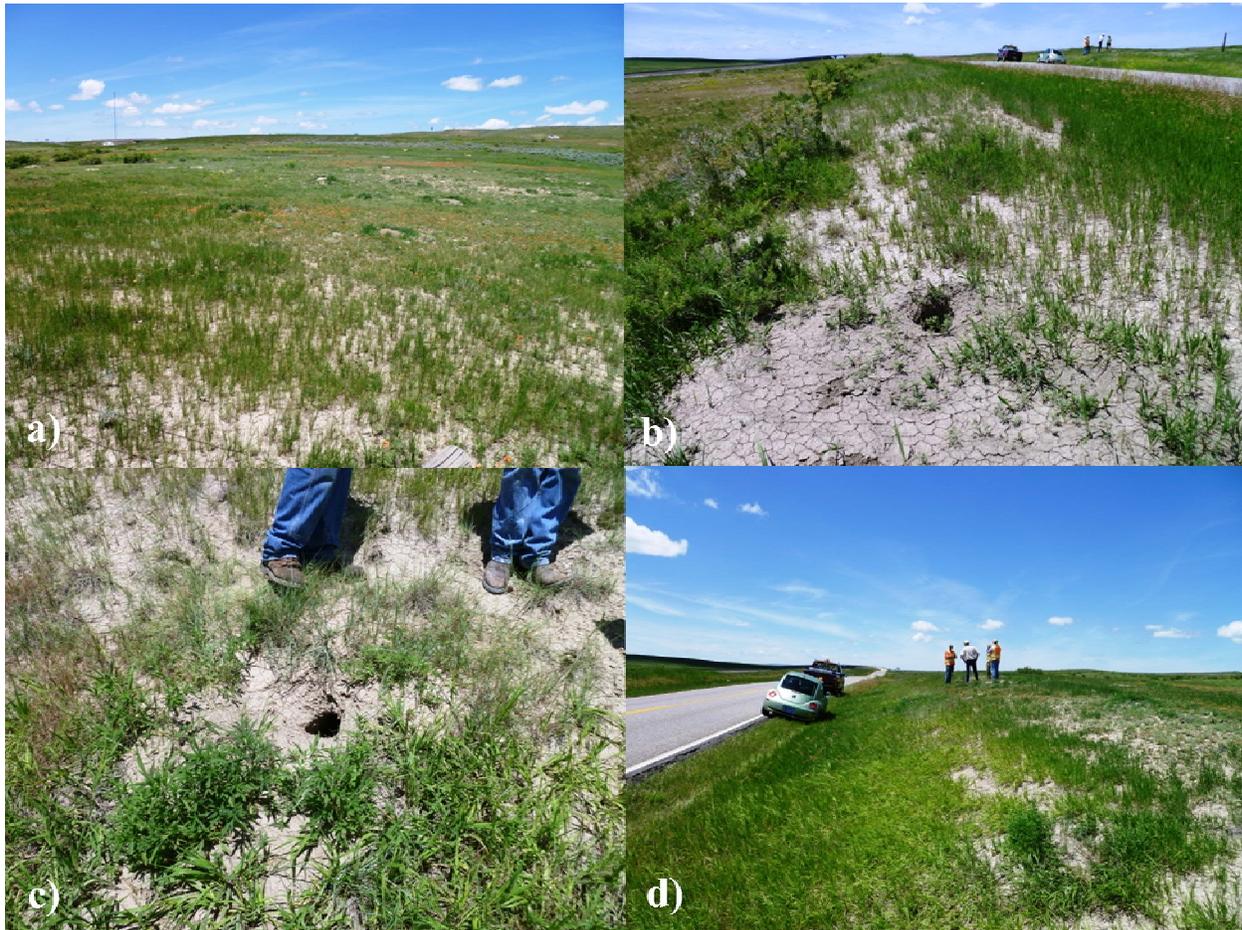
This site was on a two-lane rural frontage road between active railroad tracks and an interstate highway and surrounded by grasslands and ranchlands having silty/clayey soil (Figure 16). Extensive prairie dog holes were present in the right-of-way and in adjacent lands, but no live animals were spotted during the site visit because of recent poisoning. MDT personnel expressed concern about the possibility of erosion on the cut slopes adjacent to the road due to burrowing activity and about vegetation loss from feeding animals. Vegetation around mounds and abandoned holes was reestablishing itself. Direct damage to the pavement structure and surface was not observed.

**Figure 16. Photos of Site 3: a) adjacent prairie dog town, b) abandoned burrow in right-of-way, c) reestablishment of vegetation near abandoned burrow, and d) exposed earth in right-of-way from burrowing activity.**

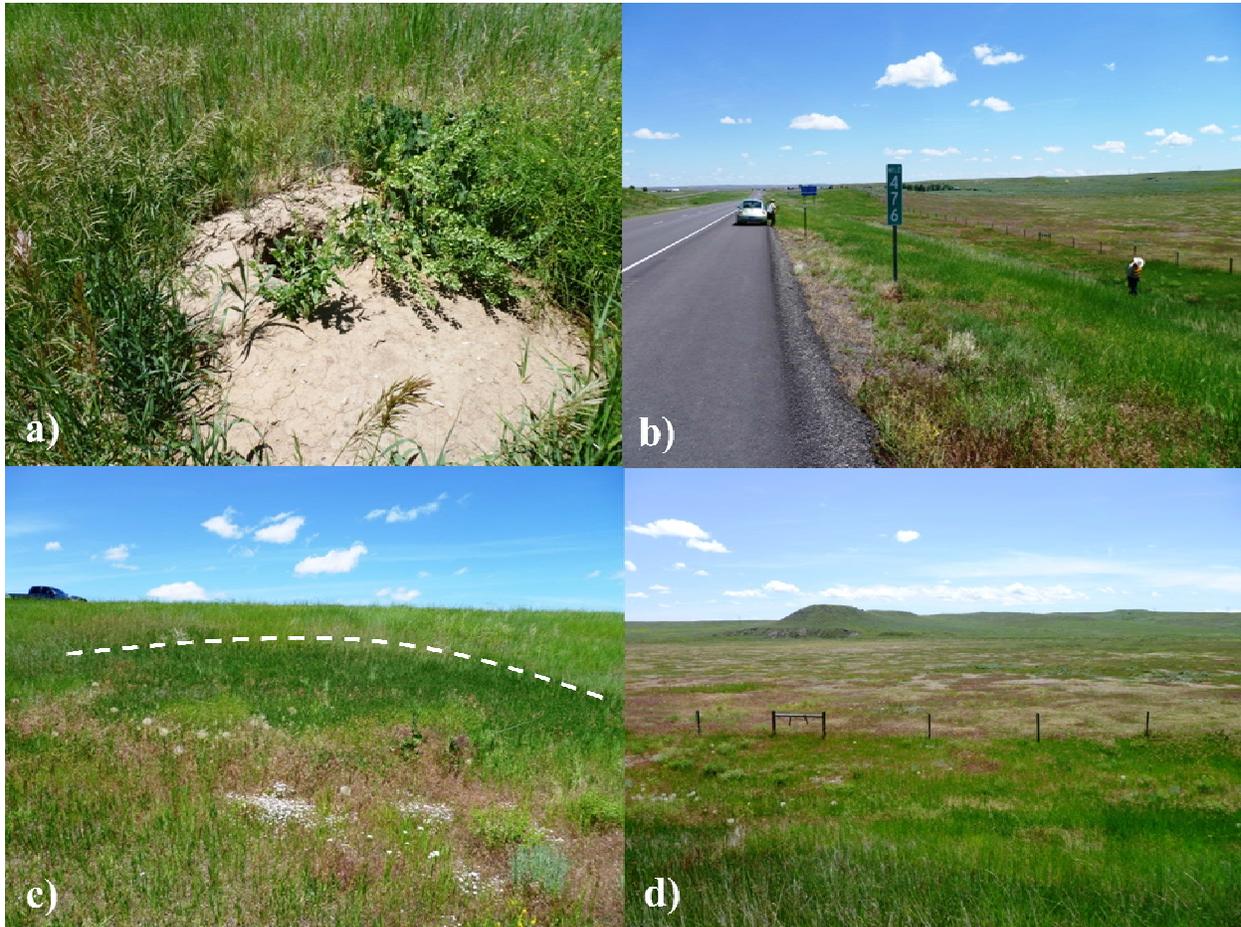
The fourth site visit was on a divided interstate highway surrounded by grasslands and ranchland with silty/clayey organic soils (Figure 17). Prior prairie dog activity was noted in the right of way, but there was no current activity at the site. Concerns over erosion due to mound activities were noted by MDT personnel. Vegetation near inactive mounds had become reestablished. Adjacent land showed signs of vegetation disturbance due to burrowing mammal activity. Mounds were of a significant distance from the paved road edge such that damage to the pavement surface or structural fill was not present or likely.

**Figure 17. Photos of Site 4: a) prairie dog mound, b) longitudinal view of roadway, c) reestablishment of vegetation near abandoned burrow showing outline of new growth area, and d) mottled landscape from burrowing mammal activity.**

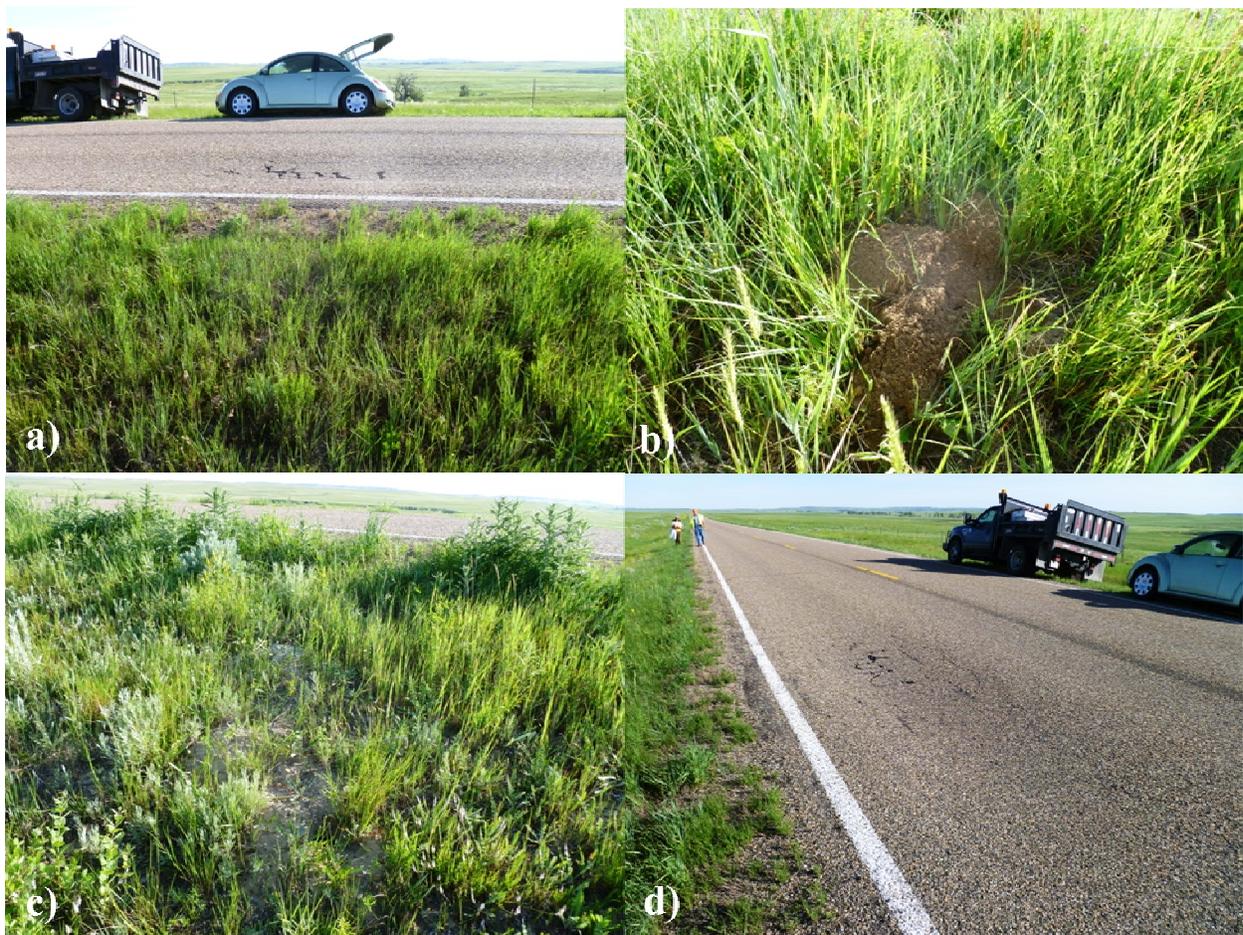
This site was situated on a two-lane rural road surrounded by grassland/ranchland with plentiful organic soils (Figure 18). A few pocket gopher holes were present in the shoulder and right-of-way and mounds were present in areas with and without pavement damage. Ground squirrels and voles were also spotted in this region. Pavement damage was observed in a wet area that showed no sign of recent animal activity. MDT personnel voiced concerns over pavement damage as it relates to the burrowing mammal activity in the area, but also stated that increased truck traffic and wetter conditions likely play a significant role in pavement-related distresses. Nonetheless, burrowing mammal activity could increase the porosity of the soil, which could increase water-related distresses in the pavement structure. Further investigation is necessary to substantiate a direct link between burrowing mammal activity and pavement-related distresses at this site.

**Figure 18. Photos of Site 5: a) low area in pavement, b) pocket gopher activity near shoulder, c) pocket gopher activity in right-of-way, and d) longitudinal view of roadway.**

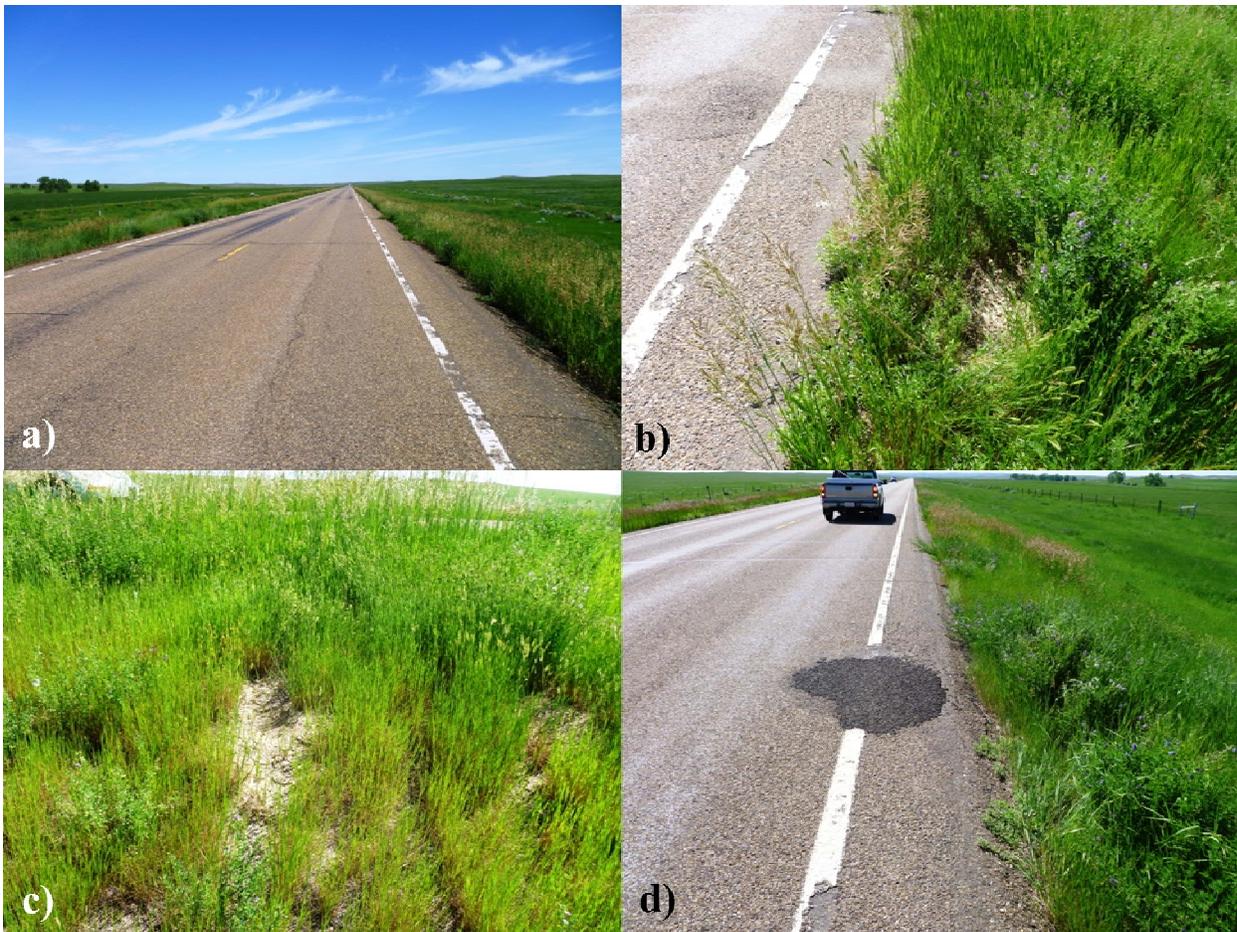
This site was located on a two-lane rural road completely surrounded by grasslands and ranchland with plentiful organic and soft soils (Figure 19). Pocket gopher and badger activity was observed in the area; however, no animals were spotted during the site visit. Burrows were in the immediate vicinity of the pavement edge and extended into the right-of-way. Pavement distresses such as an occasional pothole and transverse cracking of the pavement were present on this stretch of roadway. MDT personnel voiced concerns about possible water infiltration into the pavement system due to burrowing mammal activity, which may lead to loss of structural integrity of the pavement. Tall grass and the lack of recent burrowing activity at the time of the visit made it difficult to determine whether visible pavement distresses were caused by burrowing mammals. This would need to be substantiated by further investigation, such as digging into and under the roadway with a backhoe.

**Figure 19. Photos of Site 6: a) longitudinal view of roadway, b) pocket gopher activity near road edge, c) pocket gopher activity near shoulder, and d) pavement distresses on shoulder.**

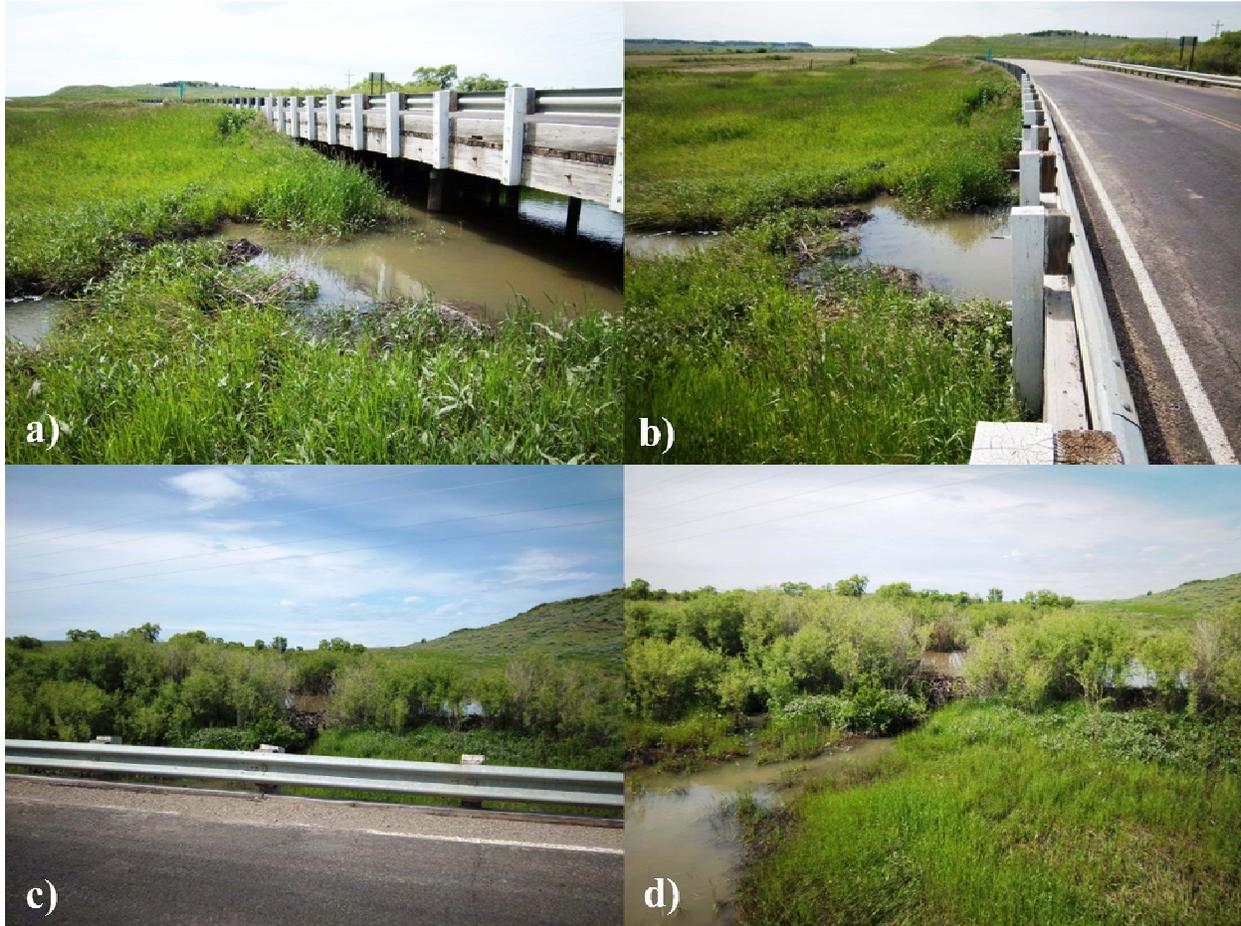
This site centered on a rural two-lane bridge over an active creek surrounded by grasslands and ranchlands (Figure 20). Active beaver dams were observed upstream from the bridge, in riparian habitat. Creek flows were obviously affected from beaver activity, but were not posing any immediate stress or damage to the road or bridge structure. During higher flows, water, and/or debris may cause issues to the structure and/or roadway.

**Figure 20. Photos of Site 7: a) beaver dam below bridge, b) longitudinal view of roadway with beaver dam, c) view of beaver dam above bridge, and d) closer view of beaver dam above bridge.**

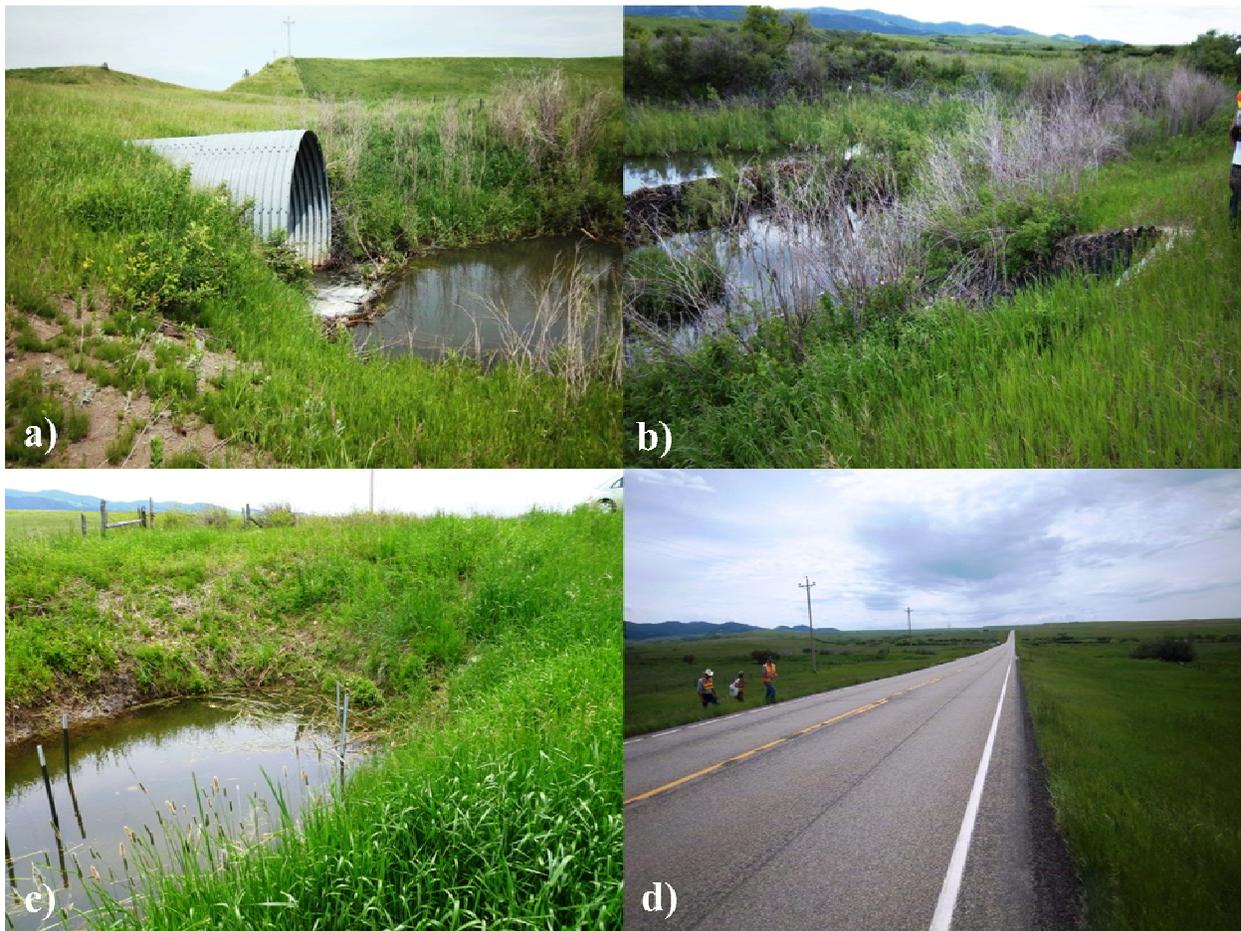
This site was situated on a two-lane rural road surrounded by grassland and ranchland near an active riparian habitat (Figure 21). Issues in this area centered on beaver activity near several culverts, all of which contained active flows. Beaver activity has been documented in this area for 19 years. MDT personnel stated concerns of flooding because of frequently blocked culverts and the constant attention required by staff to clean out debris and prevent future damming. This has, at times, put maintenance crews at risk. Additionally, MDT personnel indicated that deposition of limbs and soil disturbance from beavers has affected mowing operations in the area. Large culverts in the vicinity have prevented the water from topping the road, so there was no apparent damage to the road substructure or pavement surface.

**Figure 21. Photos of Site 8: a) beaver dam above large culvert, b) beaver dam below culvert, c) culvert blocked from beaver activity, and d) longitudinal view of roadway near active beaver areas.**

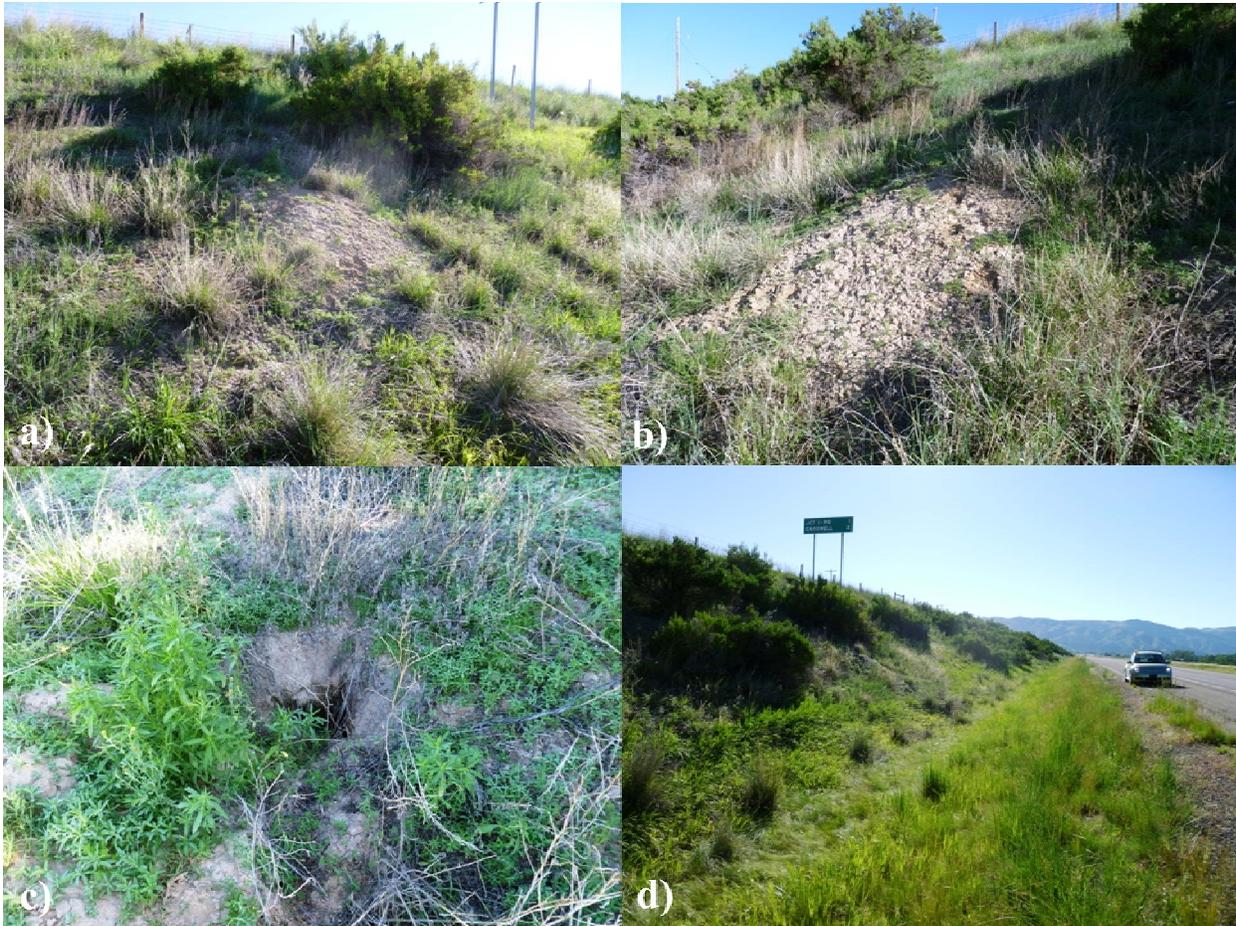
This site was located on a four-lane divided interstate highway surrounded by grassland and ranchlands spotted with small juniper bushes in silty soils (Figure 22). Several abandoned badger holes were located within the right-of-way along a quarter mile section of the highway. Badgers were not observed in the area and vegetation near the mounds was reestablishing. Mounds were prominent in an embankment adjacent to the drainage ditch on the north side of the westbound traffic lane. Burrowing activity may cause localized erosion issues but no indication of damage to the pavement or structural support was apparent or imminent.

**Figure 22. Photos of Site 9: a) badger mound on embankment, b) badger mound on embankment, c) reestablishment of vegetation near badger hole, and d) longitudinal view of roadway.**

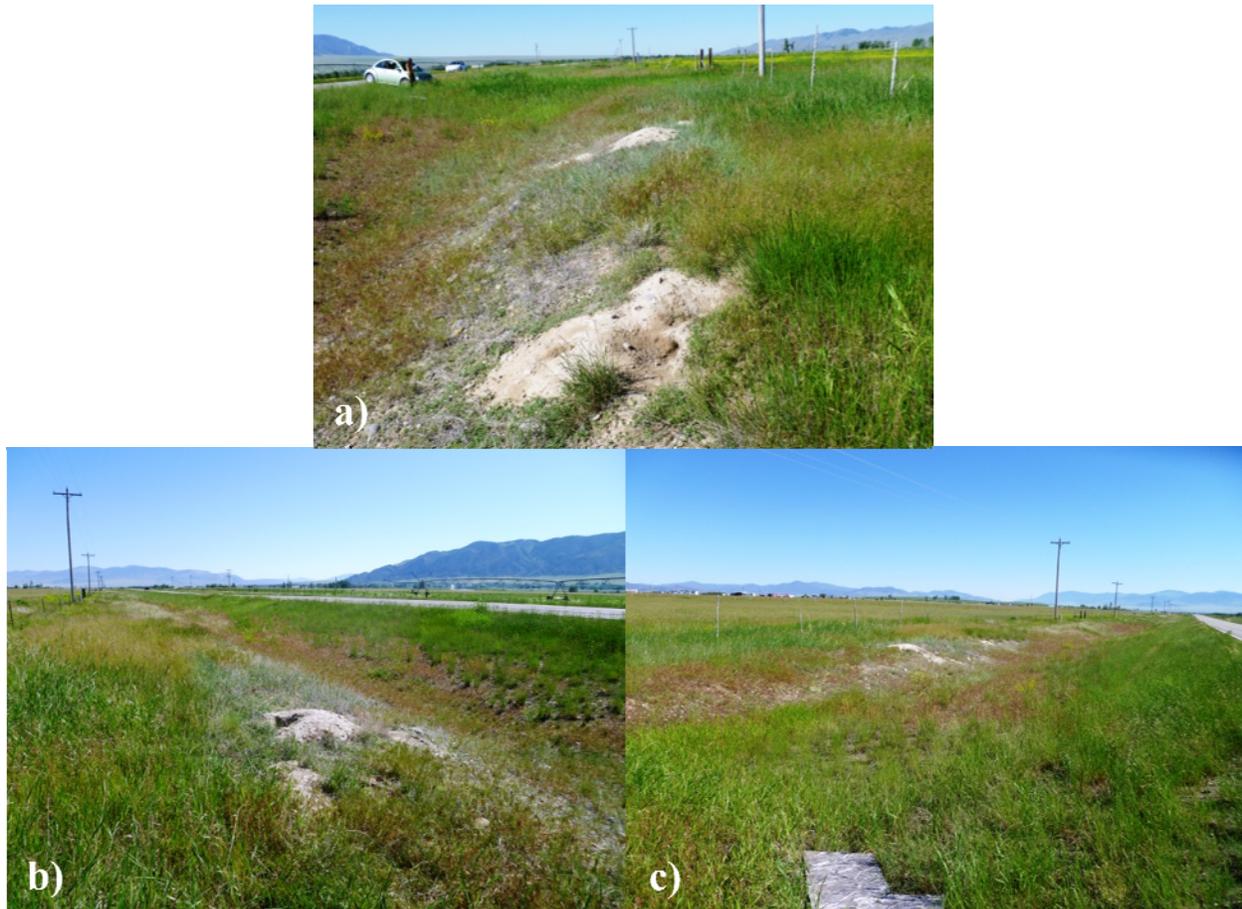
This site was located on a two-lane rural highway near grass and ranchland with silty soils (Figure 23). Ground squirrels were observed in active burrows in the right-of-way beyond the toe of the shoulder. Disturbance to the landscape was minor and there was no indication of damage to the road and support structure.

**Figure 23. Photos of Site 10: a) ground squirrel mounds in right-of-way, b) longitudinal view of roadway, and c) longitudinal view of right-of-way.**

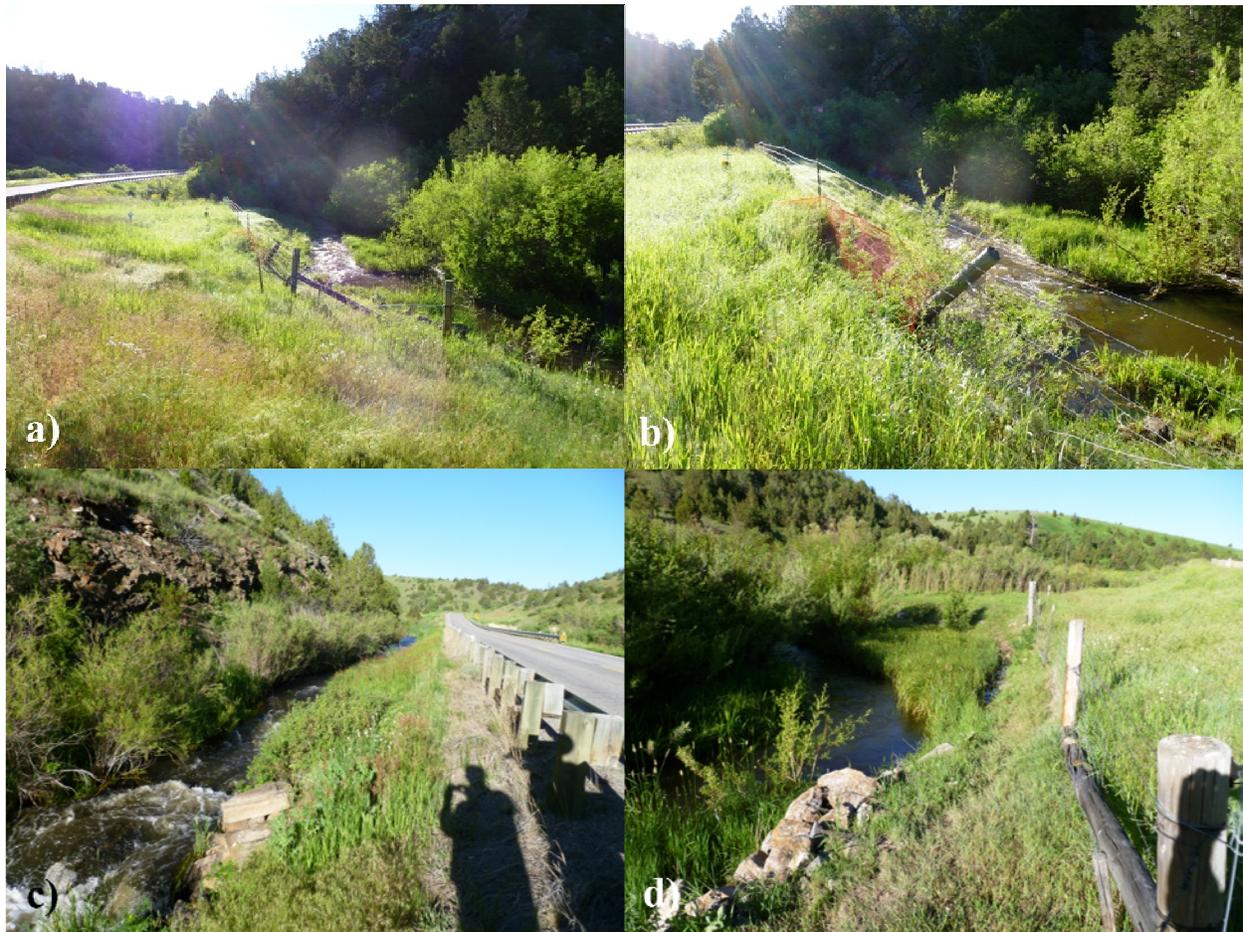
This site was located on a two-lane rural road in a forested area near an active stream abundant with willows (Figure 24). The main issue in this area was beavers, but minimal pocket gopher presence was also noted. Past damming of the stream diverted the water from its natural channel, subsequently eroding the road embankment at the edge of the right-of-way. The structural integrity of the roadway and pavement surface showed no obvious signs of distress from this activity.

**Figure 24. Photos of Site 11: a) stream migration toward roadway, b) close-up of embankment erosion, c) longitudinal view of right-of-way adjacent to stream, and d) channel migration.**

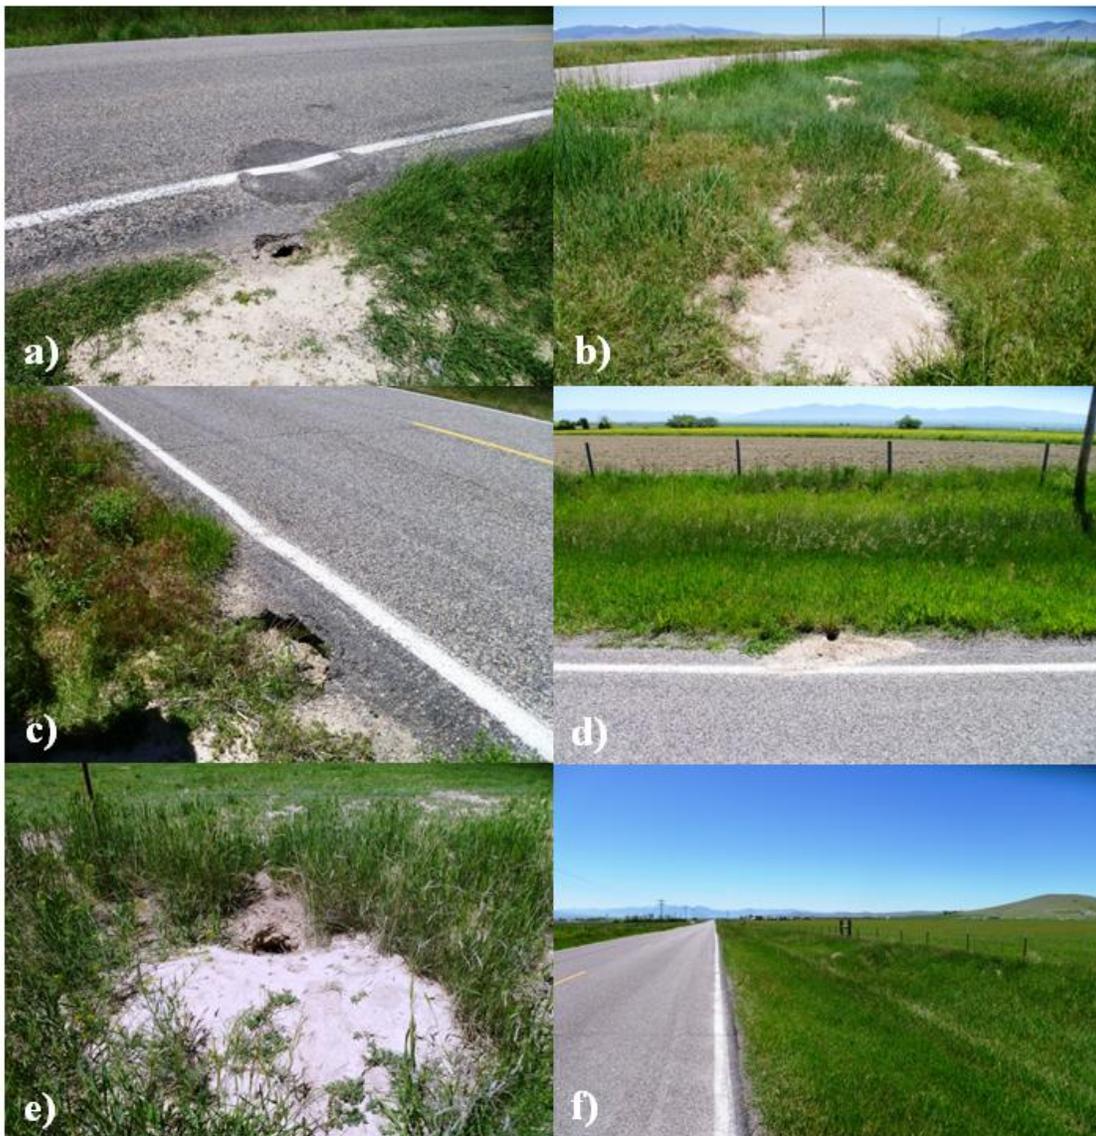
This site was located on a rural two-lane road adjacent to irrigated and non-irrigated farm and ranchlands with silty organic soils (Figure 25). Extensive ground squirrel activity was observed along a three-mile stretch of the highway. Most activity in the right-of-way was near the irrigated farm ground even though overall ground squirrel density was greatest away from the right-of-way near the non-irrigated grassland areas. Burrowing activity from ground squirrels along the shoulder of the road apparently caused the pavement to collapse and/or deteriorate in several places. MDT staff had patched several of these areas to maintain roadway integrity. Several burrows close to the pavement edge appeared to extend under the pavement. Badger activity was also apparent in the right-of-way.

**Figure 25. Photos of Site 12: a) pavement damage adjacent to ground squirrel activity, b) mounds in right-of-way, c) deterioration of pavement edge, d) mounds on shoulder, e) badger mound, and f) longitudinal view of roadway.**

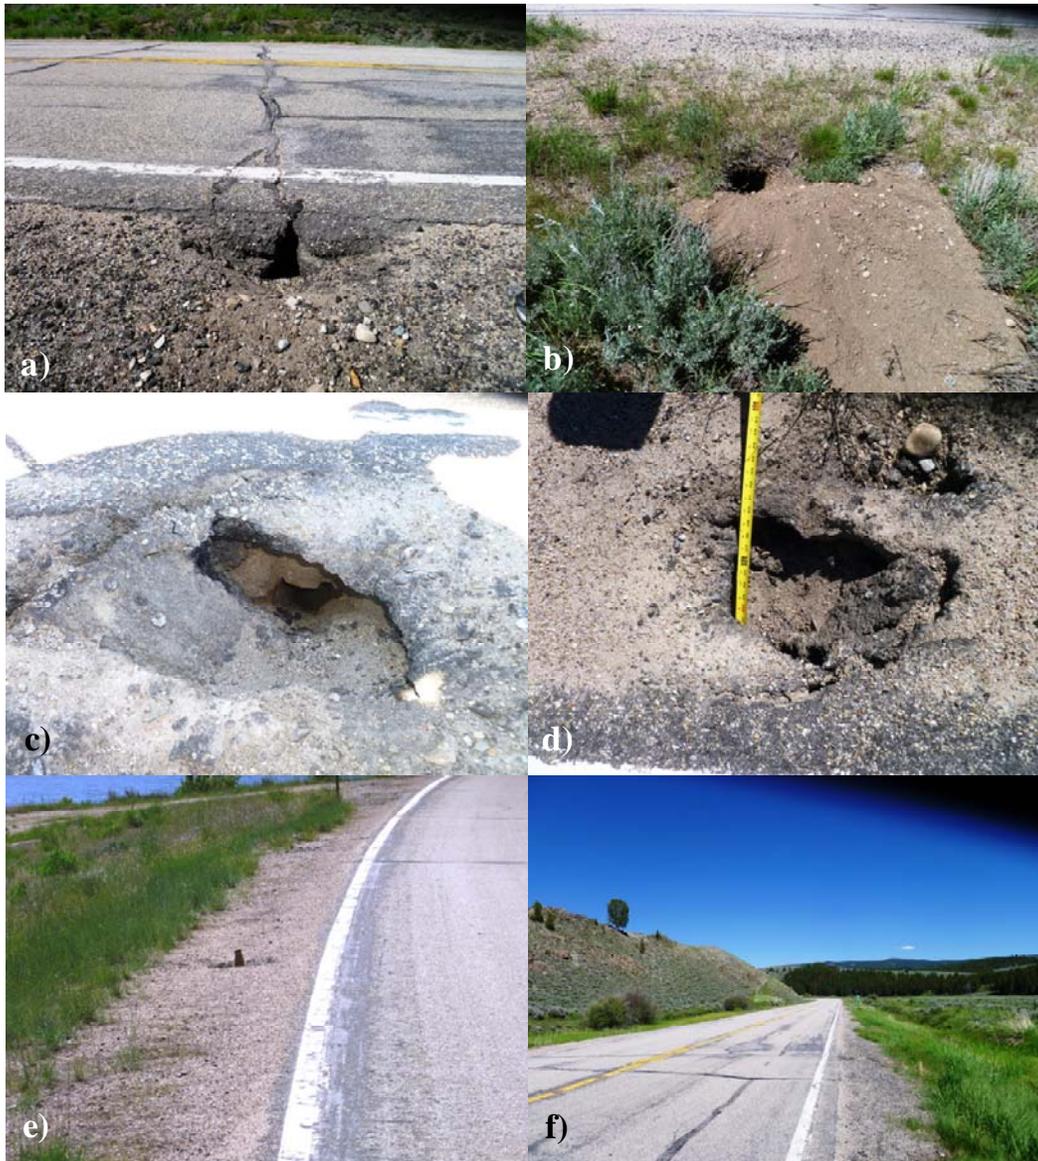
This site was located on a rural two-lane highway near grass and ranchlands with sandy organic soils (Figure 26). Ground squirrel activity was observed in the right-of-way up to the pavement edge. In several cases, burrows extended under the roadway causing subsidence of the pavement and allowing infiltration of runoff water. One such burrow extended about three feet under the pavement. Subsided areas were also observed in conjunction with transverse cracking of the pavement but, in some cases, burrows may be accelerating the scour effect. MDT personnel noted that burrows under the road were found when sections of the road were excavated to conduct patching repair.

**Figure 26. Photos of Site 13: a) transverse cracking in pavement coincident with ground squirrel activity, b) burrow in right-of-way, c) burrow under pavement, d) depth of burrow under pavement, e) ground squirrel near road edge, and f) longitudinal view of roadway.**

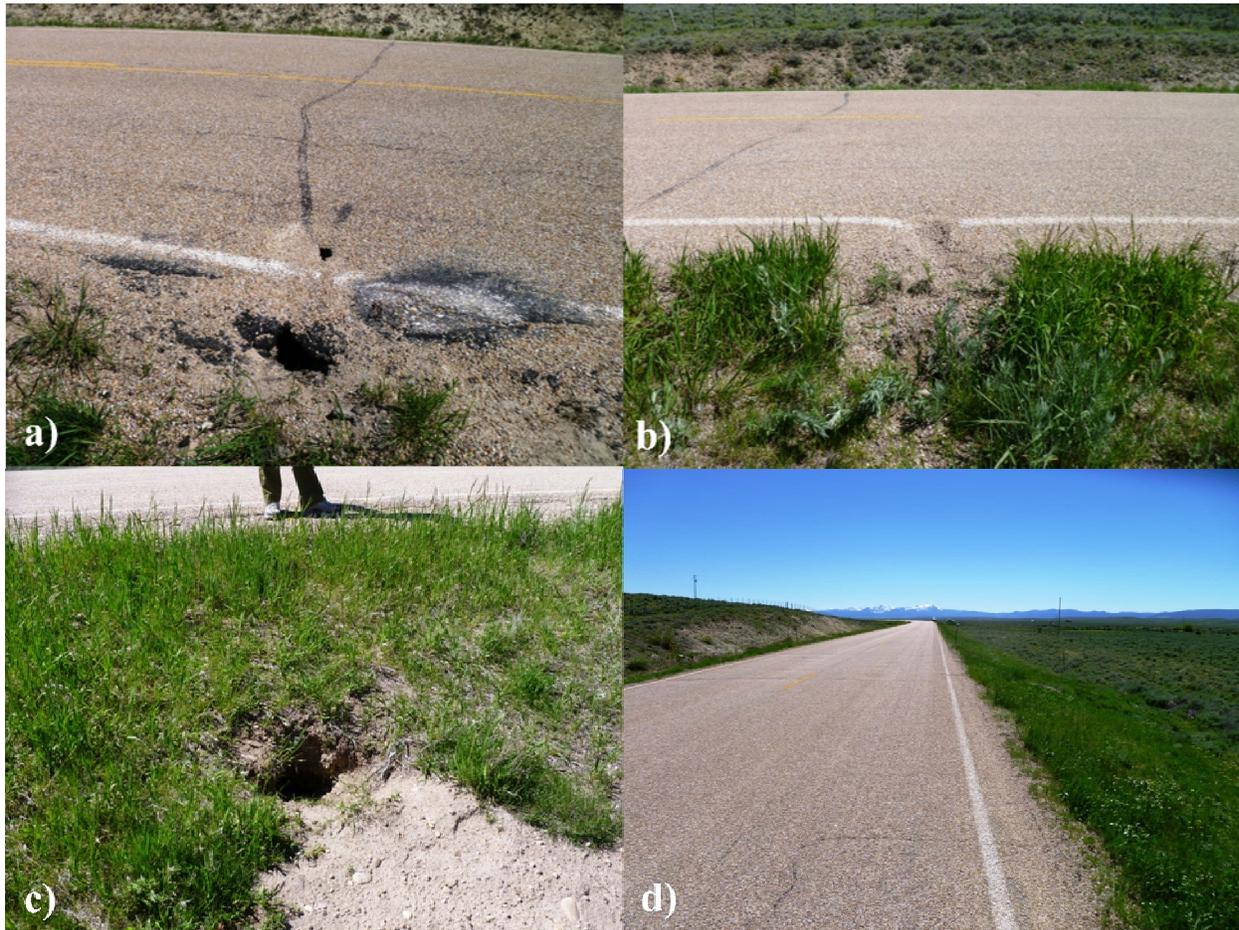
This site was approximately 10 miles from Site 13 on the same two-lane, rural highway (Figure 27). Ground squirrel and badger burrows were observed within the right-of-way up to the pavement edge for several miles. Similar to Site 13, some ground squirrel burrows extended under the pavement causing subsidence and further deterioration of existing cracks.

**Figure 27. Photos of Site 14: a) transverse cracking in pavement coincident with ground squirrel activity, b) subsidence of paved shoulder near old burrow, c) badger burrow in right-of-way, and d) longitudinal view of roadway.**

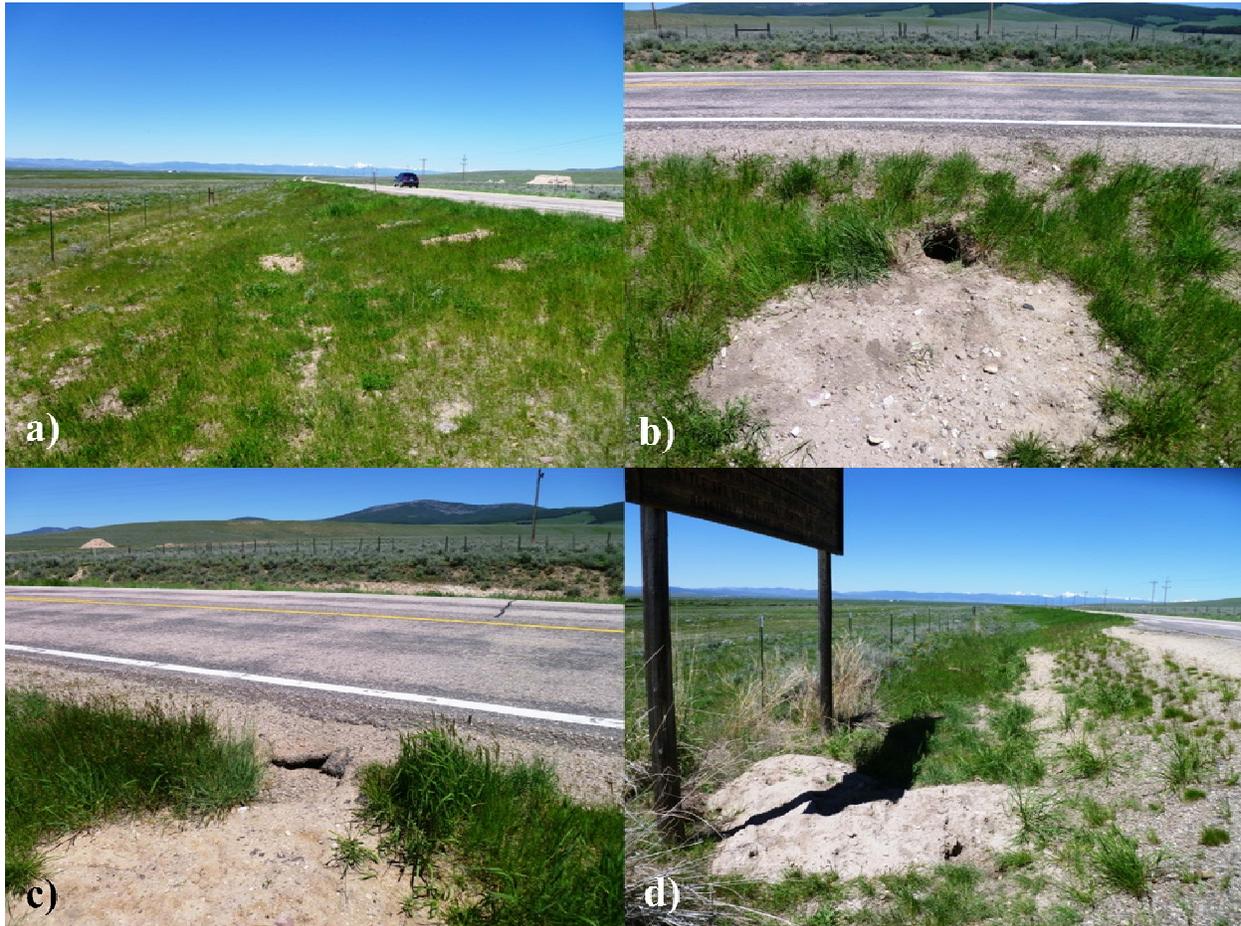
This site was on a rural two-lane highway adjacent to sub-irrigated grasslands and ranchlands (Figure 28). Sporadic ground squirrel and badger activity was observed over a one-mile stretch. Some of the burrows are at the edge of the paved surface and may be linked to nearby pavement distresses and/or subsidence. A recently applied chip seal obscured many areas where patches were used to repair areas associated with burrowing mammal activity.

**Figure 28. Photos of Site 15: a) burrow activity in right-of-way, b) ground squirrel burrow near shoulder, c) badger burrow near edge of road, and d) burrows near road sign.**

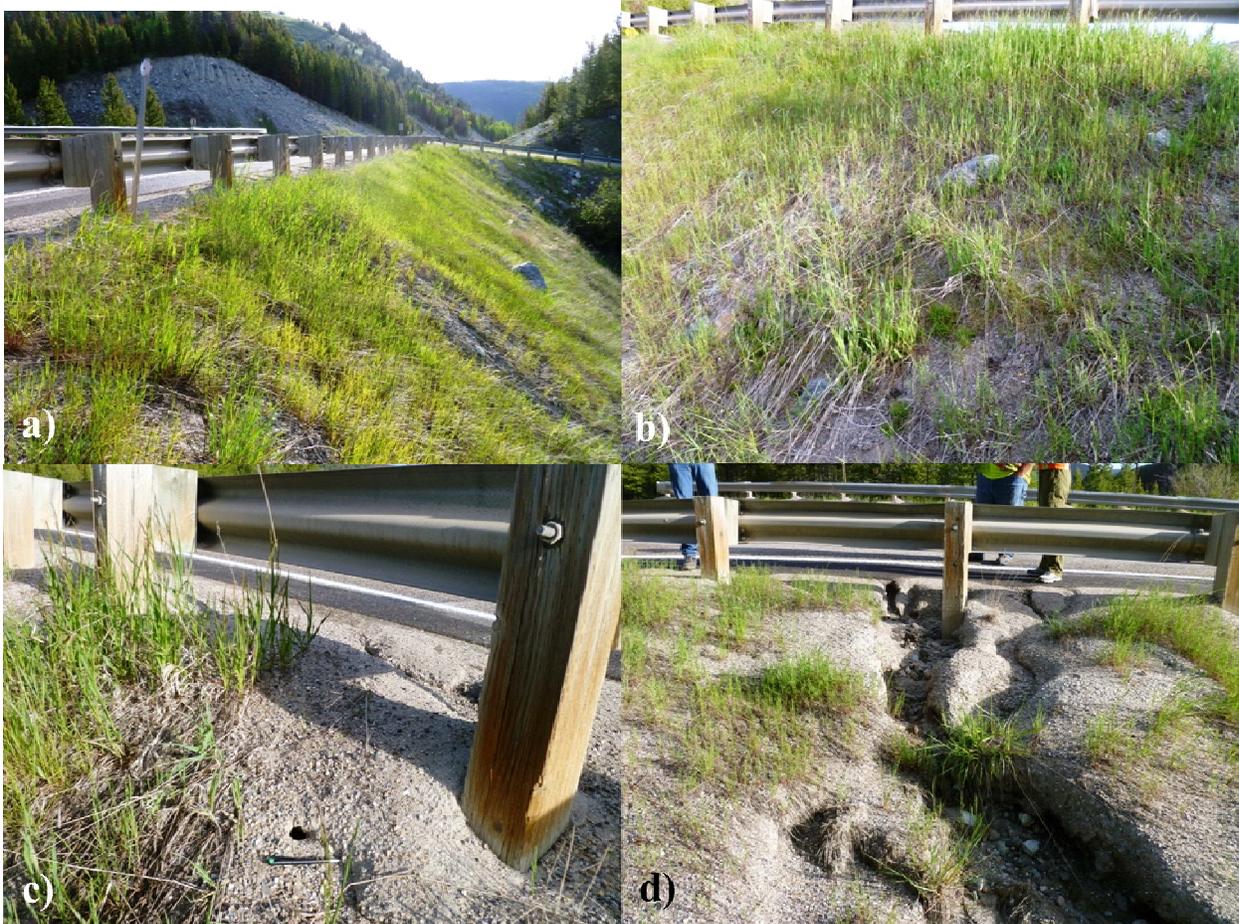
This site was situated on a rural two-lane highway with a passing lane that traversed a large fill area in a high-elevation, forested region (Figure 29). Soils in the area were mostly sandy and/or granular with shallow organic materials. Drainage of water from the road during rain and snow events has eroded shoulder material adjacent to the paved surface and around the guardrail over a tenth of a mile section of road. MDT personnel indicated that burrows exacerbated erosion issues; however, substantial burrowing mammal activity was not observed during the site visit. Small burrows from mice or voles were found near the guardrail.

Figure 29. Photos of Site 16: a) longitudinal view of embankment and roadway, b) small burrows on embankment, c) burrow near guardrail, and d) erosion of embankment from runoff water.
