ASSESSMENT OF BURROWING MAMMAL  
IMPACTS ON PAVED HIGHWAYS  
IN MONTANA

FHWA/MT-10-010/8117-39

*Final Report*

*prepared for*  
THE STATE OF MONTANA  
DEPARTMENT OF TRANSPORTATION

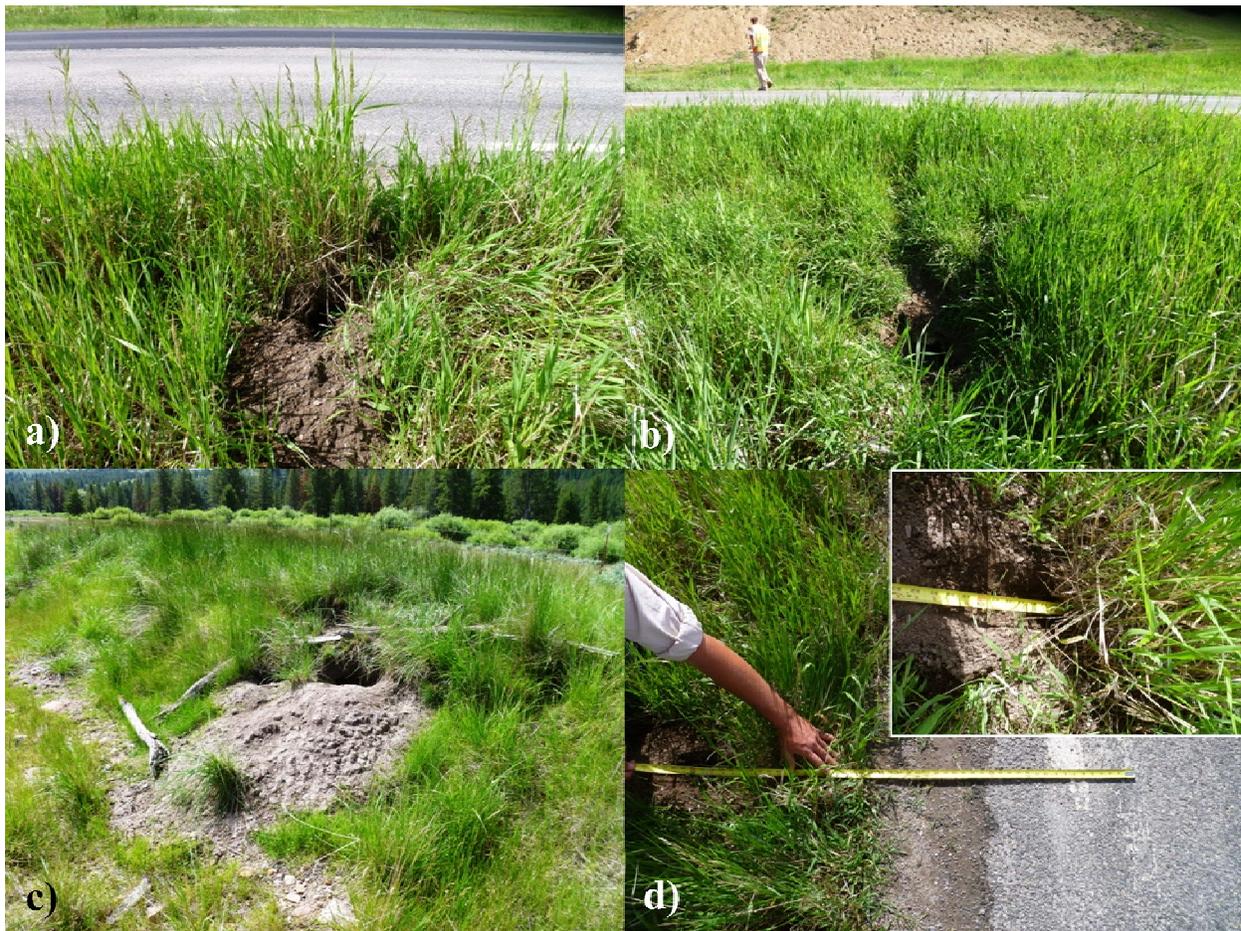
This site was situated on a rural two-lane road adjacent to sub-irrigated grass and ranchlands and partially forested areas with sandy, gravelly organic soils (Figure 30). Ground squirrel, pocket gopher, vole, and badger activity were observed. Pavement distresses on one section of road in the area were all repaired during a recent paving operation. Multiple transverse and longitudinal cracks were present in the pavement. The majority of the pavement distresses were due to the age of the pavement, poor base support, and significant log truck traffic. However, some ground squirrel burrows near the pavement edge extended under the road, which may initiate damage or exacerbate existing distresses. The shallow taper of the shoulder may also lend to further burrowing mammal activity.

**Figure 30. Photos of Site 17: a) active ground squirrel burrow near roadway, b) burrow in right-of-way, c) badger burrow in right-of-way, and d) ground squirrel burrow under roadway.**

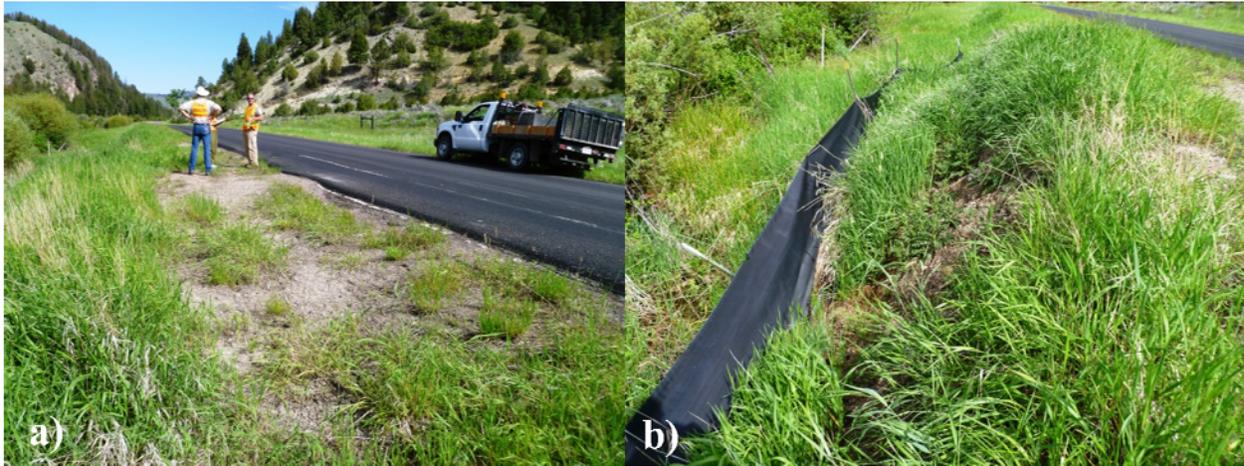
This site was approximately one mile from Site 17 on the same two-lane road (Figure 31). Recent repairs were made to the road in this area due to damage from an adjacent creek when it overflowed due to beaver activity. MDT personnel indicated this area has recurrent beaver activity that affects the roadway and right-of-way.

**Figure 31. Photos of Site 18: a) longitudinal view of roadway showing new pavement, and b) erosion of right-of-way from creek overflow.**
