CORRELATION OF ROCK QUALITY DESIGNATION AND ROCK SCOUR AROUND BRIDGE PIERS AND ABUTMENTS FOUNDED ON ROCK

**Research Report KTC-99-57
KYSPR-94-157**

**Correlation of Rock Quality Designation and Rock Scour Around
Bridge Piers and Abutments Founded on Rock**

September 1999

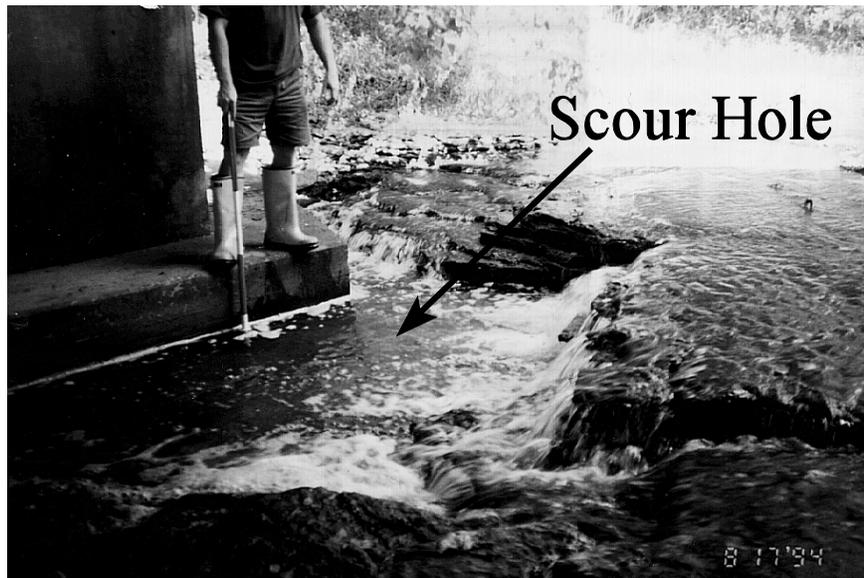
Figure 1. A scour hole at a bridge abutment founded on rock, KY Route 1659 bridge over Glenn's Creek in Woodford County, Kentucky.

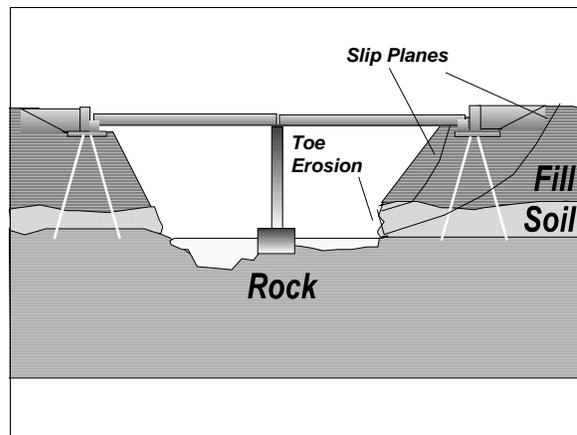
Figure 9. Unstable bridge approach embankment created by toe erosion, or scour.

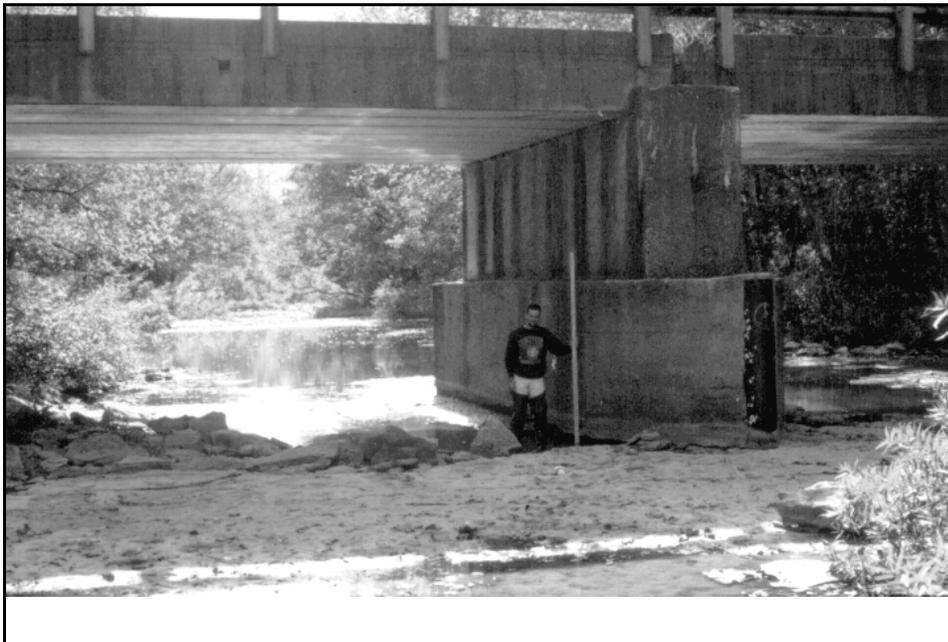
Figure 23. General view of local scour hole adjacent to concrete bridge footer.

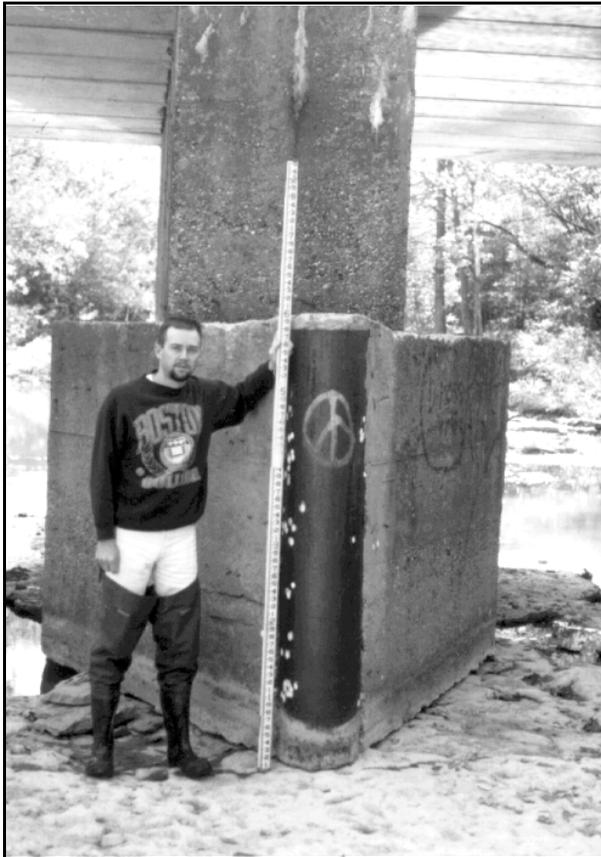
Figure 24. Close-up view of local scour showing

these Figures, the proximity of the apparent rock scour is adjacent to the footing. Consequently, the proximity condition is assigned a value of 100 points. Close examination of the scour hole depth, d_c , Figure 24, reveals that the bottom of the footing is exposed. This condition is given 100 points. The scour hole depth, d_s , extends several centimeters below the bottom of the footing. A value of 100 points is assigned to this condition. As shown in Figures 25 and 26, the erosion has penetrated beneath the footing more than 6 inches at several points along the length of the footing. This condition is given a value of 100 points. Finally, the average annual daily traffic is 210 vehicles per day. Because this value is below 400, Table 1, this condition is given a value of above 2 points. The total score for this site is 402 points. As shown in Table 4, a score of 402 corresponds to a code of 2 or 3 of the FHWA Guide -- that is the scour is below the spread footing and countermeasures should be considered.

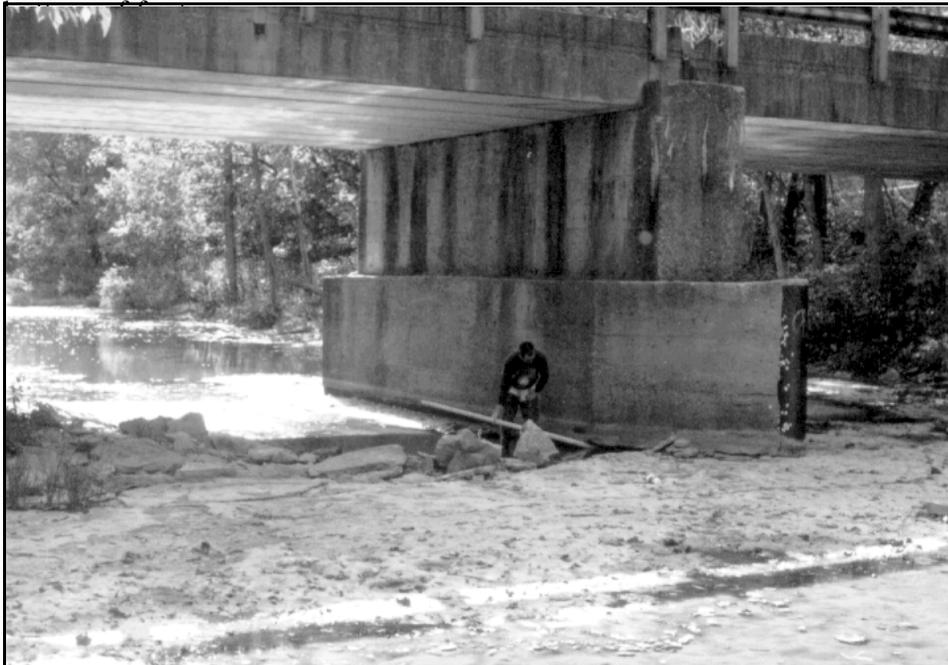
Figure 25. Overview of range pole penetrating below the bottom of the footing.

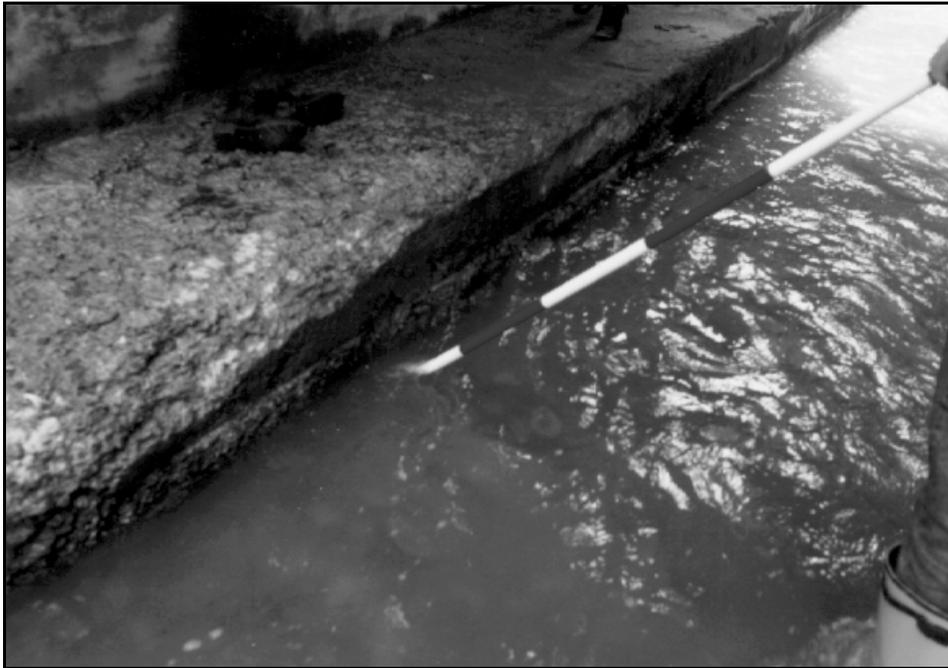
Figure 26. Close-up view of range pole penetrating below bottom of footer.

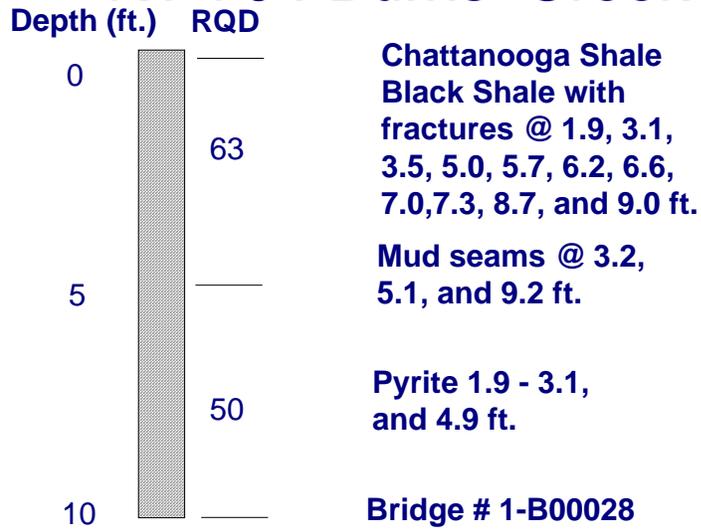
Adair County KY 704 Burns Creek

Constructed 1952
Scour Rating = 106
Small (1 in.) Penetration Scour at
Corner of Pier Footer
2 in. Scour Below Footer

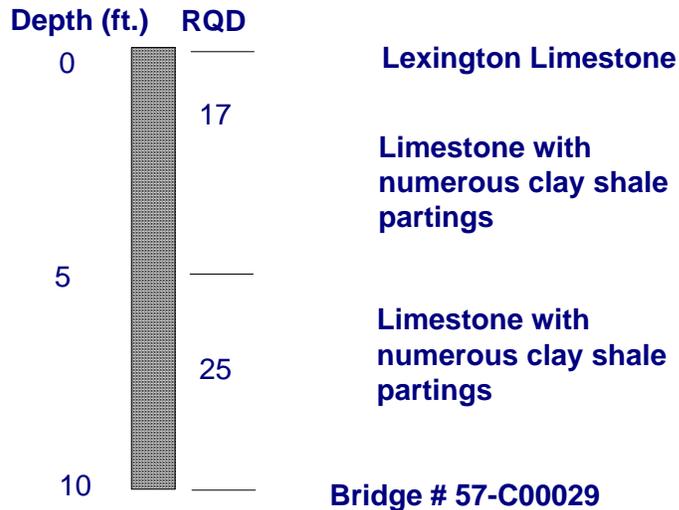
Jessamine County Elm Fork Road Hickman Creek

Built 1987?
Deck Only 1987?
Scour Rating = 377

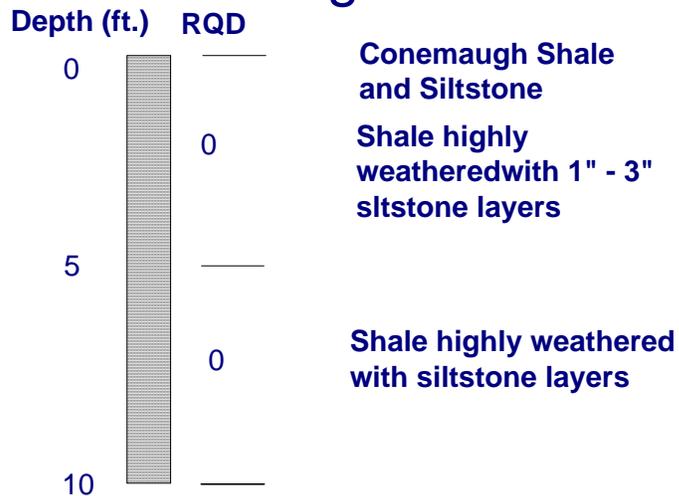
Lawrence County KY 707 Long Branch Creek

Bridge # 64-B00035
Constructed 1930 - 1933?
Scour Rating = 401
5 Ft. Penetration Scour
3 Ft. Scour Below Footer
