Final Report

Non-Destructive Bridge Testing With Advanced Micro-II Digital AE system

Hampton University

BRIDGE ON COAST GUARD BOULEVARD

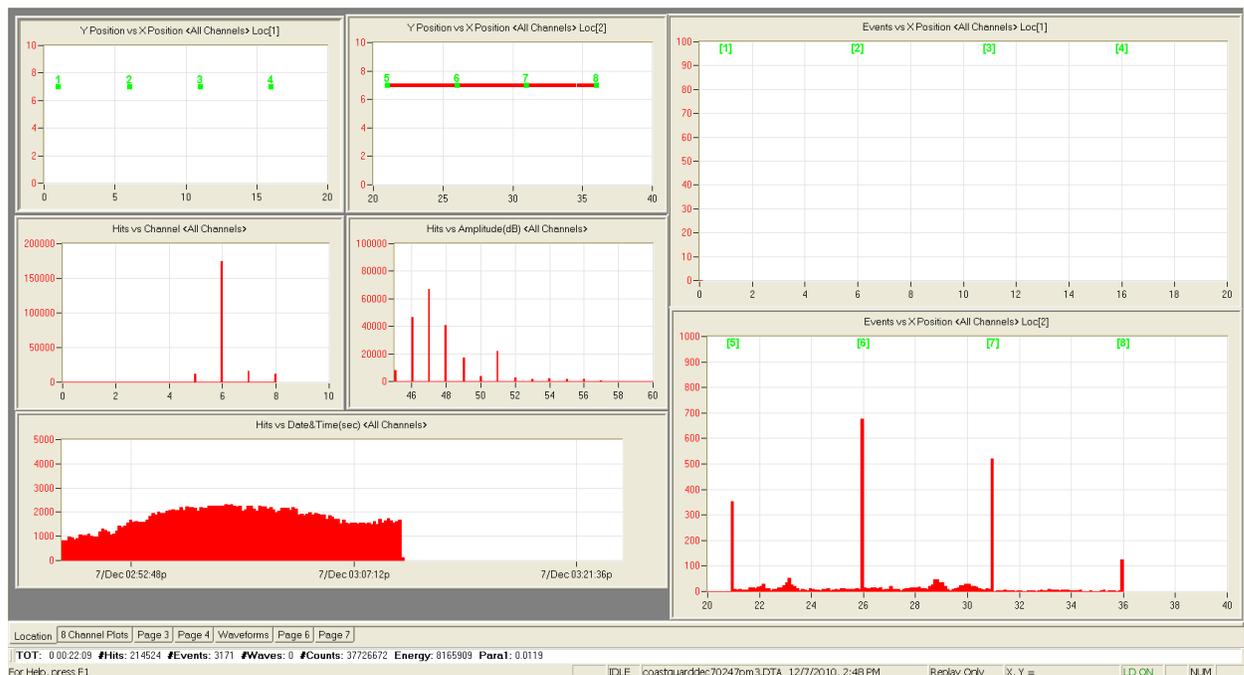
1. AE signals related to a break in metal (rebar) are supposed to be dramatic. These will have high energy, high amplitude and very short duration. The AE amplitudes from sensors 5 - 8 installed on the test location in Table 1 are relatively feeble indicating their origin to be initiation and/or expansion of cracks in the concrete
2. The concrete wall is AE active and requires further investigation covering the entire width of the wall.

Figure 5. Typical response from AE sensors December 7, 2010 for the sensor locations in Table 1. Sensors 1-4 do not show any response being located on the wall area outside of the bridge.

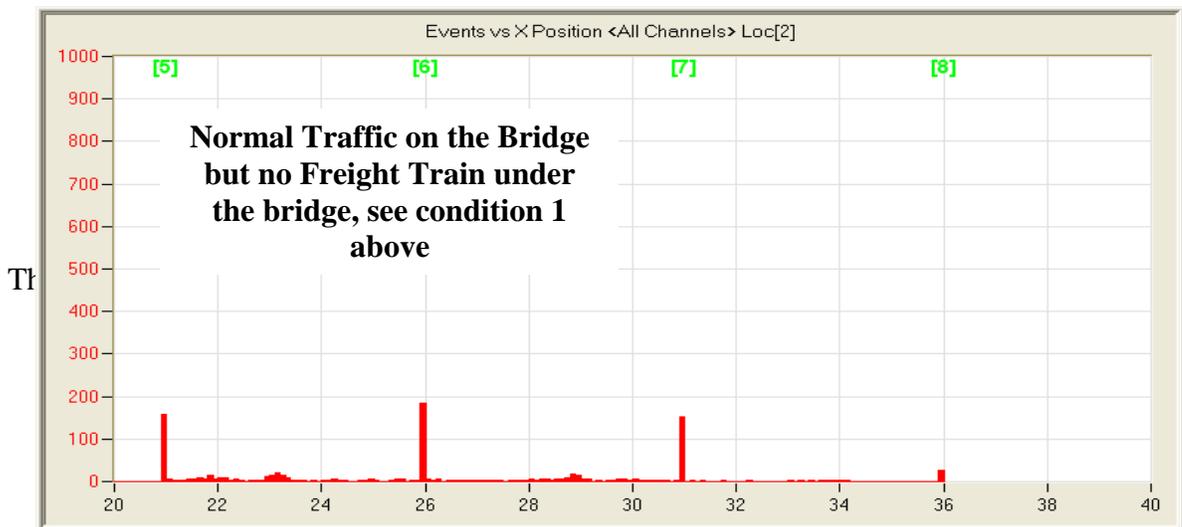
Figure 6 shows responses from sensors 5 – 8 for locations given in Table 1 for the traffic situation in item 1 above where AE events have been plotted against the sensor locations on the back wall. The cluster of events in the wall stretch between sensors 5 - 6 and between 6 -7 are from locations falling under the central steel girders in Figure 2. These AE events are resulted from the existing cracks in these regions.

Figure 6. AE responses from AE sensors 5 – 8 recorded on December 7, 2010 for the sensor locations in Table 1 for a regular traffic on the bridge and no freight train movement under the bridge.

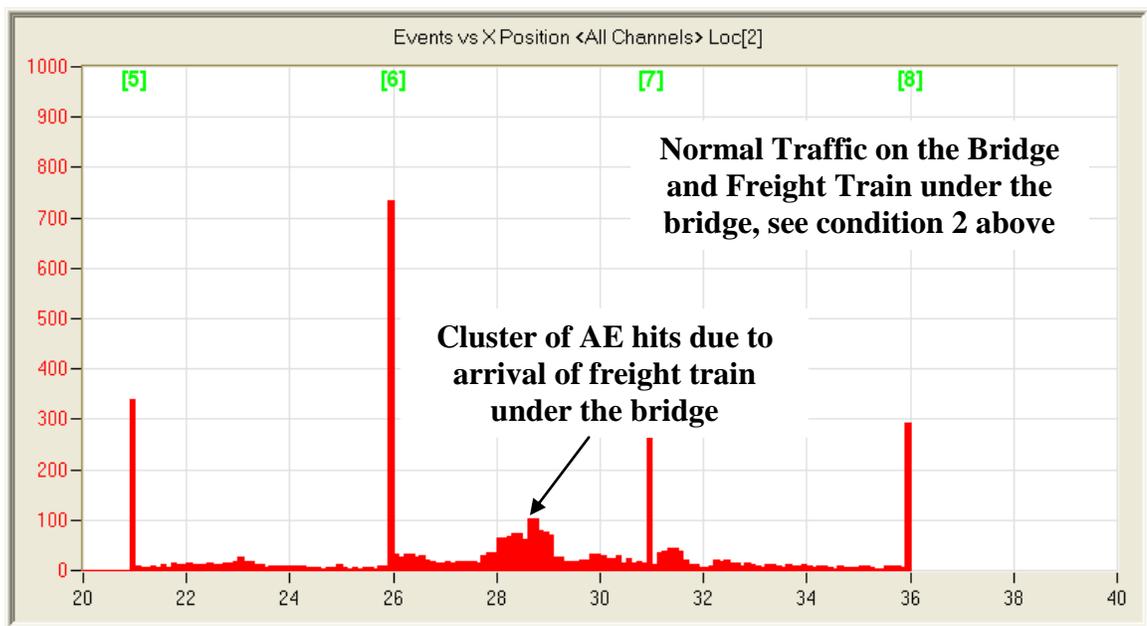
Figure 7 shows responses from sensors 5 – 8 for locations given in Table 1 for the traffic situation in item 2 above where AE events have been plotted against the sensor locations. The cluster of events in the wall stretch between sensors 5 - 6 and between 6 -7 are from locations falling under the central steel girders in Figure 2. These AE events are resulted from the existing cracks in these regions. Comparison of Figures 6 and 7 clearly demonstrates the effect of freight train movement on the AE activity in the wall. The effect is significant indicated by a large number of recorded hits, specifically in the sensor 6 - 7 stretch and in the vicinity of sensor 7 towards sensor 8.

Figure 7. AE responses from AE sensors 5 – 8 recorded on December 14, 2010 for the sensor locations in Table 1 for a regular traffic on the bridge and also freight train movement under the bridge.

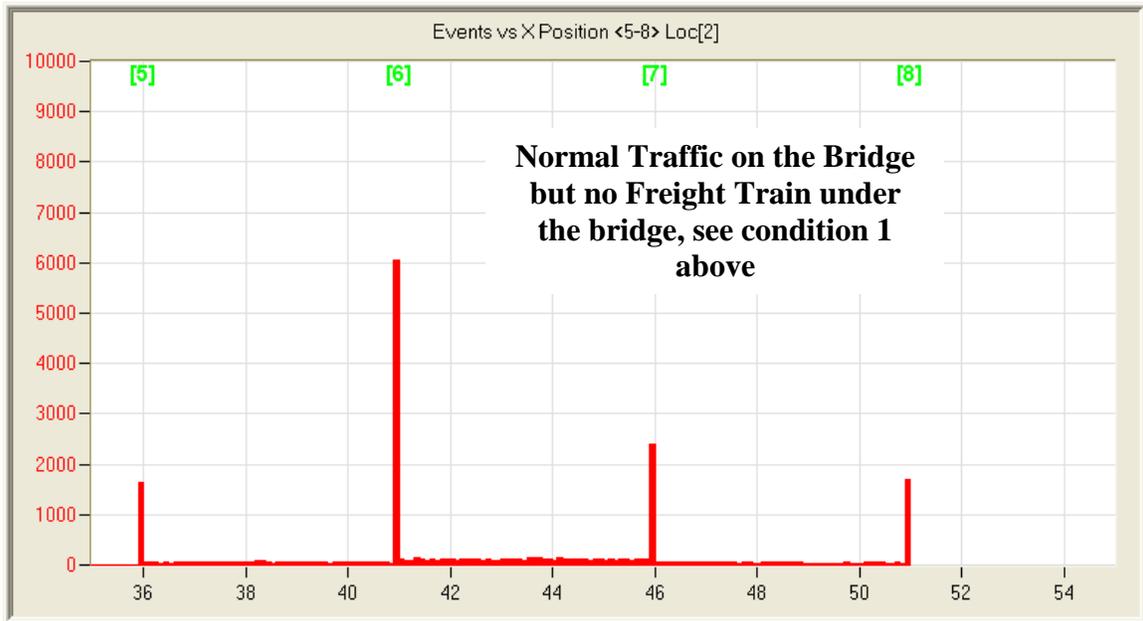
Figure 8 (a) shows installations of the relocated sensors (see Table 2 for locations) to cover the wall area between 16 feet – 51 feet. Considering the width of the back wall of the bridge as 54.5 feet, this relocation covers the entire width of the wall at 7.75 feet from the ground. The responses from sensors 5-8 in this configuration acquired on December 22, 2010 are demonstrated in Figure 9 in the absence of any freight movement under the bridge. However, when the freight train arrived on the same day, the data showed a significant change in AE activity shown in Figure 10. Figure 9 shows responses from sensors 5 – 8 for locations given in Table 2 for the traffic situation in item 1 above where AE events have been plotted against the sensor locations. Figure 10 shows the cluster of events in the wall stretch between sensors 5 - 6 and between 6 -7 are from locations falling around the central steel girders in Figure 2. The situation in Figure 10 corresponds to the condition of item 2 above where there is also the presence of train freight apart from the normal traffic on the bridge. These AE events are resulted from the existing cracks in these regions as well as generation/expansion of new cracks. Comparison of Figures 9 and 10 clearly demonstrates the effect of freight train movement on the AE activity in the wall. The effect is significant as indicated by a large number of recorded hits, specifically in the sensor 6 - 7 stretch and in the vicinity of sensor 7 towards sensor 8.

Figure 9. AE responses from AE sensors 5 – 8 recorded on December 22, 2010 for the sensor locations in Table 2 for a regular traffic on the bridge and no freight train movement under the bridge.

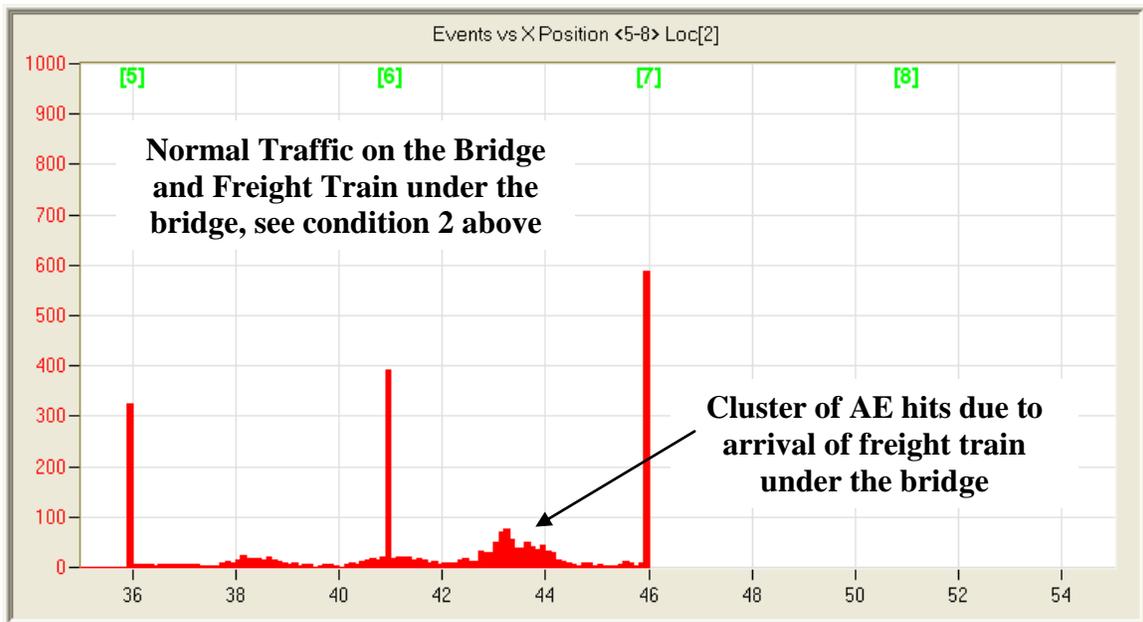
Figure 10. AE responses from AE sensors 5 – 8 recorded on December 22, 2010 for the sensor locations in Table 2 for a regular traffic on the bridge and also freight train movement under the bridge.

As shown in Figure 10, areas of significant AE activity have been found around locations of sensors 5-7. In order to focus on this area, AE sensors were redistributed to include vertical distance variations according to the location scheme of Table 3. In this scheme, sensors 3, 5 and 7 were relocated 32” higher than shown in Figure 8(a). The new scheme of sensor locations is shown in Figure 8(b). This redistribution allowed closer look around sensors 2, 4 and 6. The AE sensor locations and AE response from sensors in scheme of Table 3 is shown in Figure 13. Areas of high and low AE activity are clearly

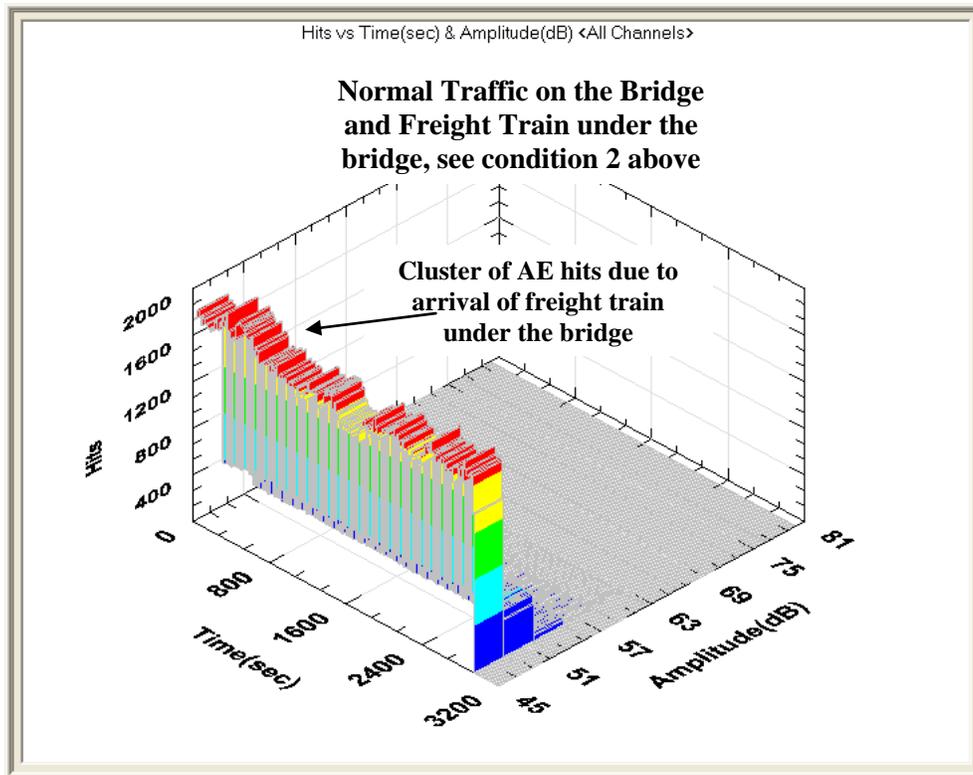
The data of Figures 9 and 10 for the absence and presence of the freight train component has further been analyzed to give a 3 D perspective in Figures 11 and 12, respectively. In 3D diagrams, the AE hits and their amplitudes have been plotted against the time of the hits being recorded at a given sensor. A “hump” of hits related to AE activity due to arrival of freight train in Figure 12 is absent in Figure 11.

Figure 12. 3D representation of responses from AE sensors 5 – 8 recorded on December 22, 2010 for the sensor locations in Table 2 for a regular traffic on the bridge and also freight train movement under the bridge.

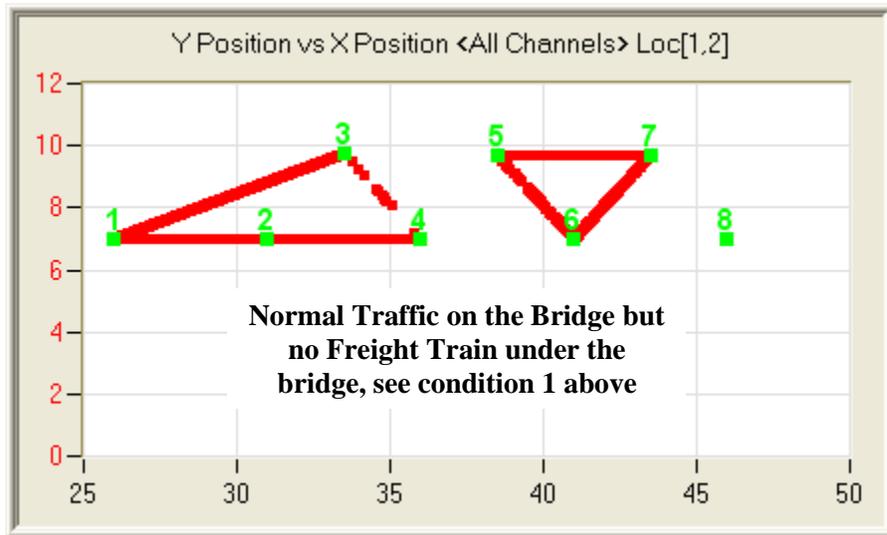
Seen on Figure 13. Whereas, no AE activity was recorded between sensors 4 and 5, 4 and 6; and 7 and 8, there was AE activity between sensors 3 and 4. Further, strong AE activity was recorded between sensors 1 – 3, 5, 6 and 7. These observations clearly show AE activity originating from vertical locations. Further, the amount of AE activity shown in between sensors 3 and 4; and between sensors 5 and 6 is lower in comparison to that between 5 and 7. This demonstrates that the AE activity is not uniform in the entire wall but there are strong AE activity areas along the wall closer to the foot of the wall.

Figure 13. AE responses from AE sensors 1 – 8 recorded on February 02, 2011 for the sensor locations in Table 3 for a regular traffic on the bridge but no freight train movement under the bridge.

- *Measurement and mapping of the cracks (both active and existing) in all the (4) back walls of this bridge should be undertaken. AE is relatively better suited technique for the purpose.*
- *Evaluation of the entire height of the wall, especially the areas falling under the central girders and the anchorage regions of the girders with the walls should be conducted.*
- *VDOT should consider using AE periodically to evaluate the health of this structure and determine which regions are exhibiting the greatest AE activity. Regions with elevated AE activity should take precedence over non-active regions during inspection.*
- *More number of bridges that cross R/R should be evaluated using AE in conjunction with other inspection techniques if necessary. VCTIR and HU/ESITAC should provide guidance for this recommendation on request from VDOT.*

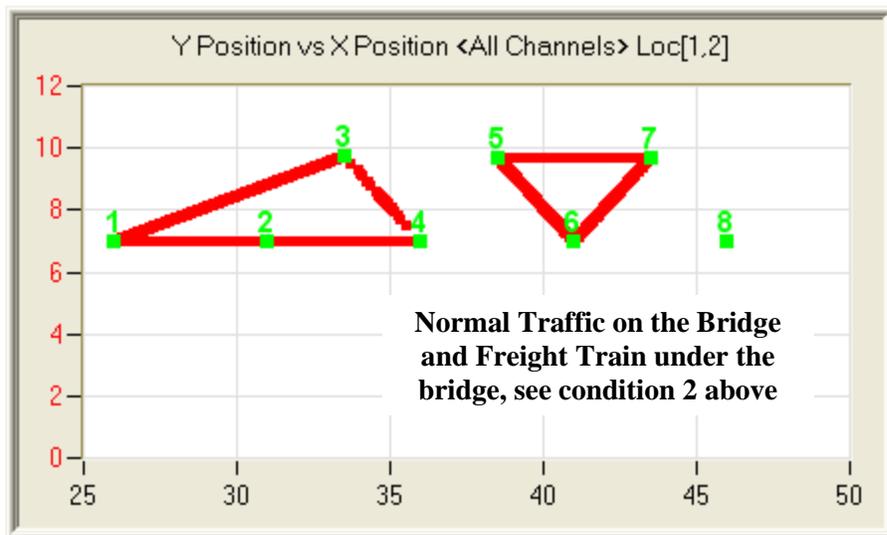
Figure 14 shows spur in AE activity due to arrival of freight train under the bridge in comparison to that in Figure 13 when the freight traffic is absent.

Figure 14. AE responses from AE sensors 1 – 8 recorded on February 07, 2011 for the sensor locations in Table 3 for a regular traffic on the bridge and also freight train movement under the bridge.
