**Ohio Route 50 Joint Sealant Experiment**  
*State Job No.: 14668(0)*  
**FINAL REPORT**

**April 2002**

**Ohio Rout 50 Joint Sealant Experiment**  
*State Job No.: 14668(0)*  
**FINAL REPORT**

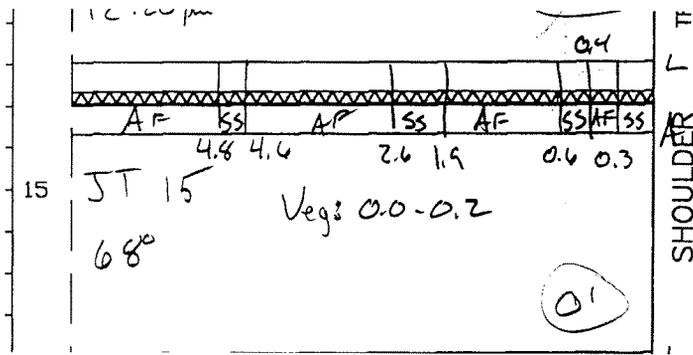
**Figure 5.9** Comparison between field logs from EBOC00 and EBJN01 for Joint 15 in the Crafc0 903-SL (4) section.

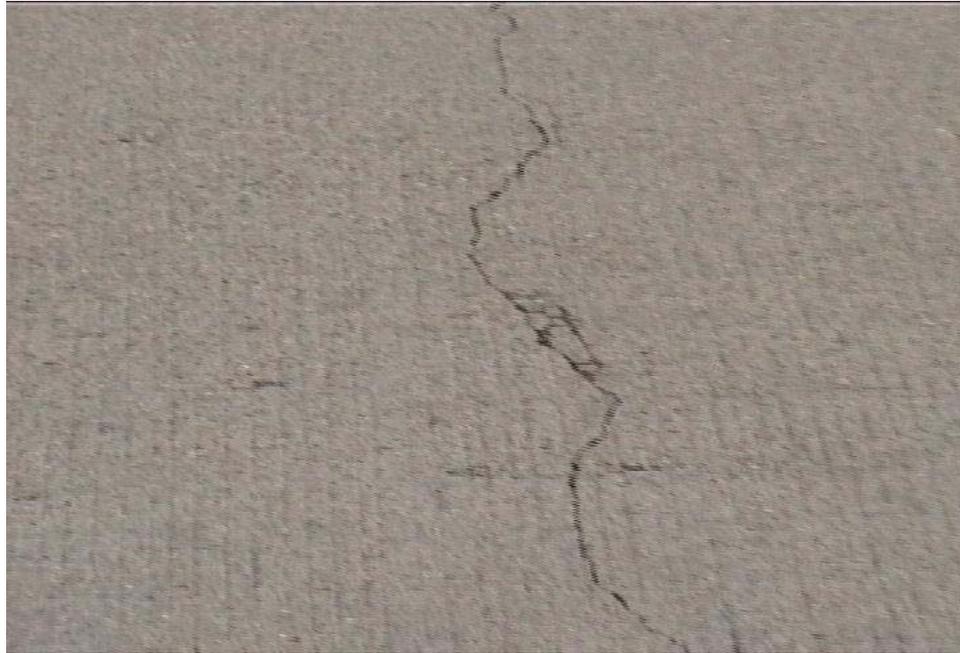
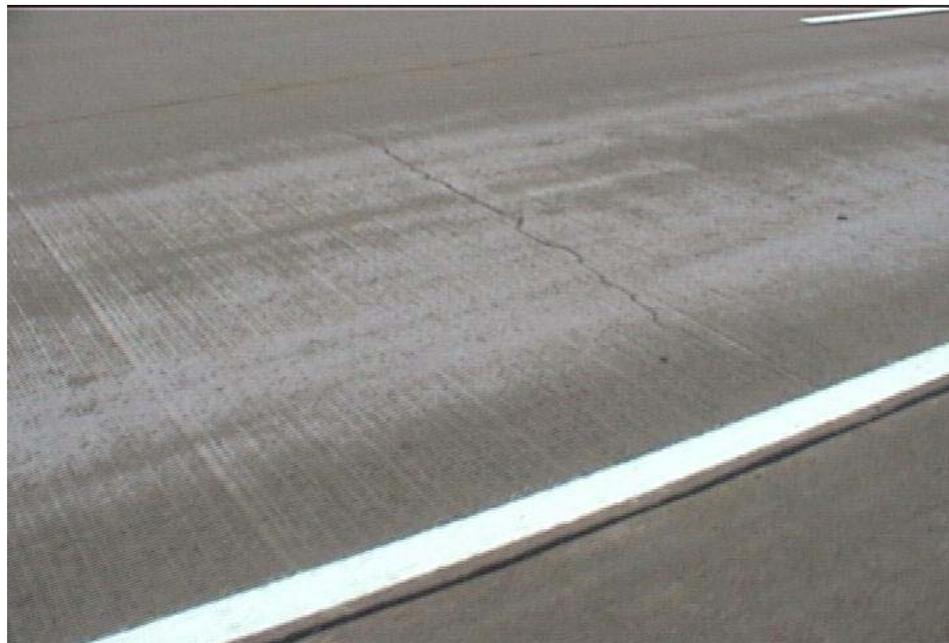
**Figure 5.46** Examples of transverse cracks

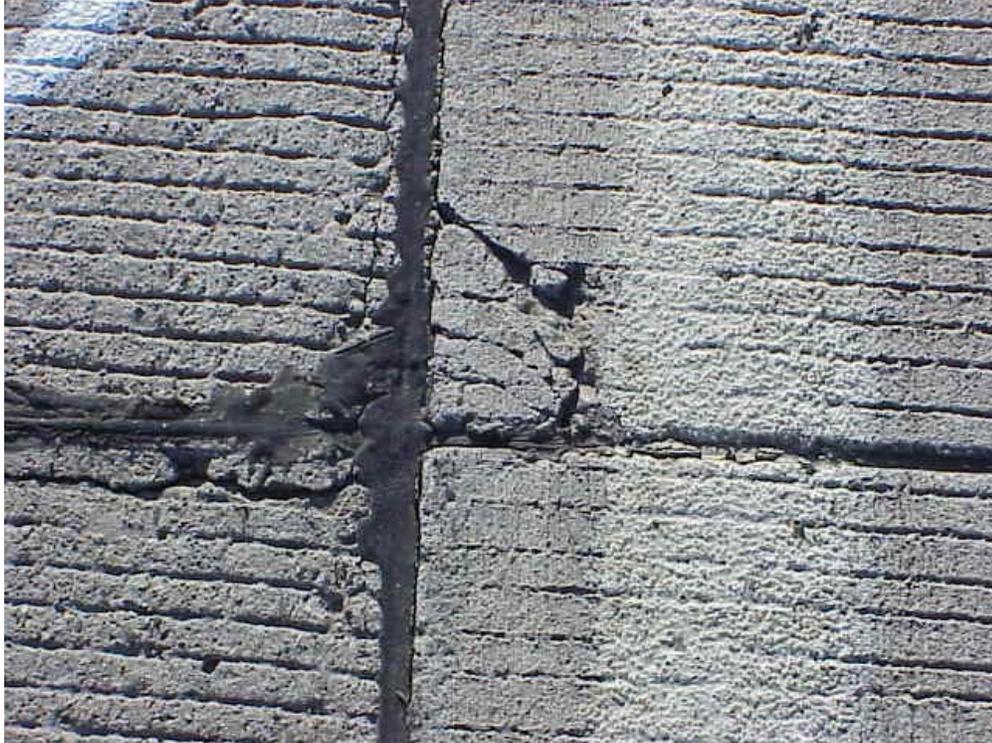
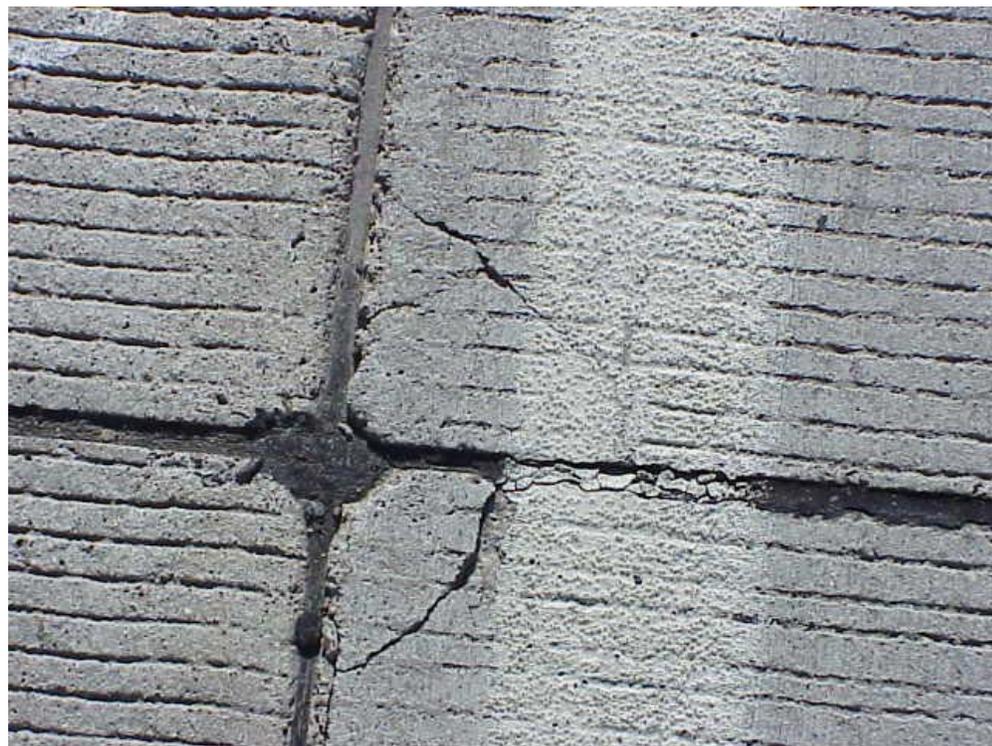
**Figure 5.47** Examples of corner breaks

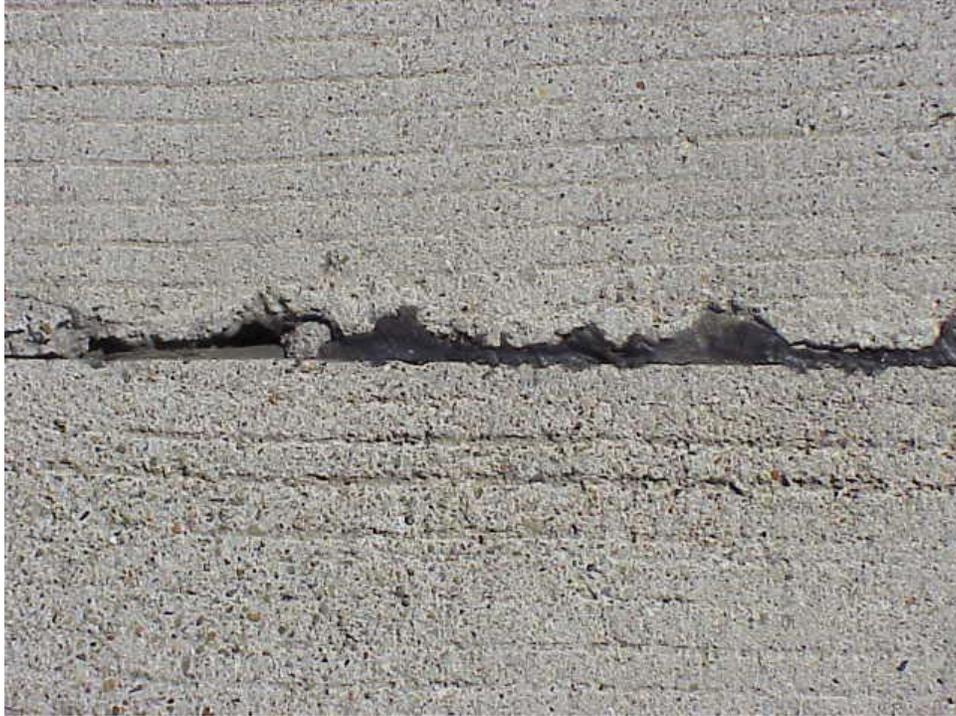
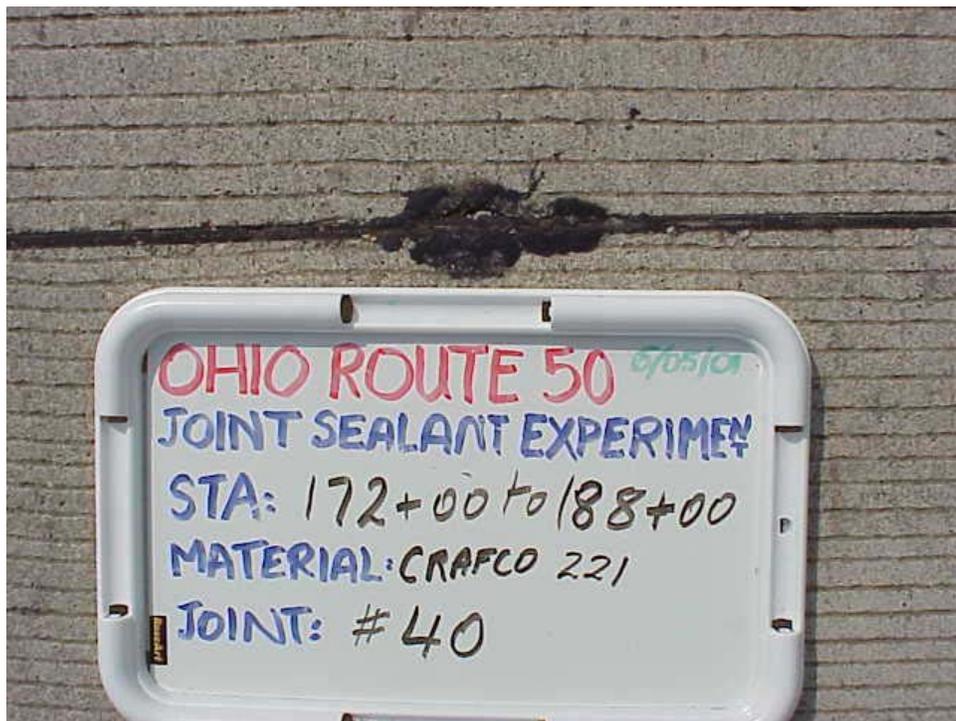
**Figure 5.48** Examples of spalling failures

[Top: Joint 7 of WB Dow 890 (4); Bottom: Joint 40 of WB CrafcO 221 (1); both appear to be created at the time of joint sawing]

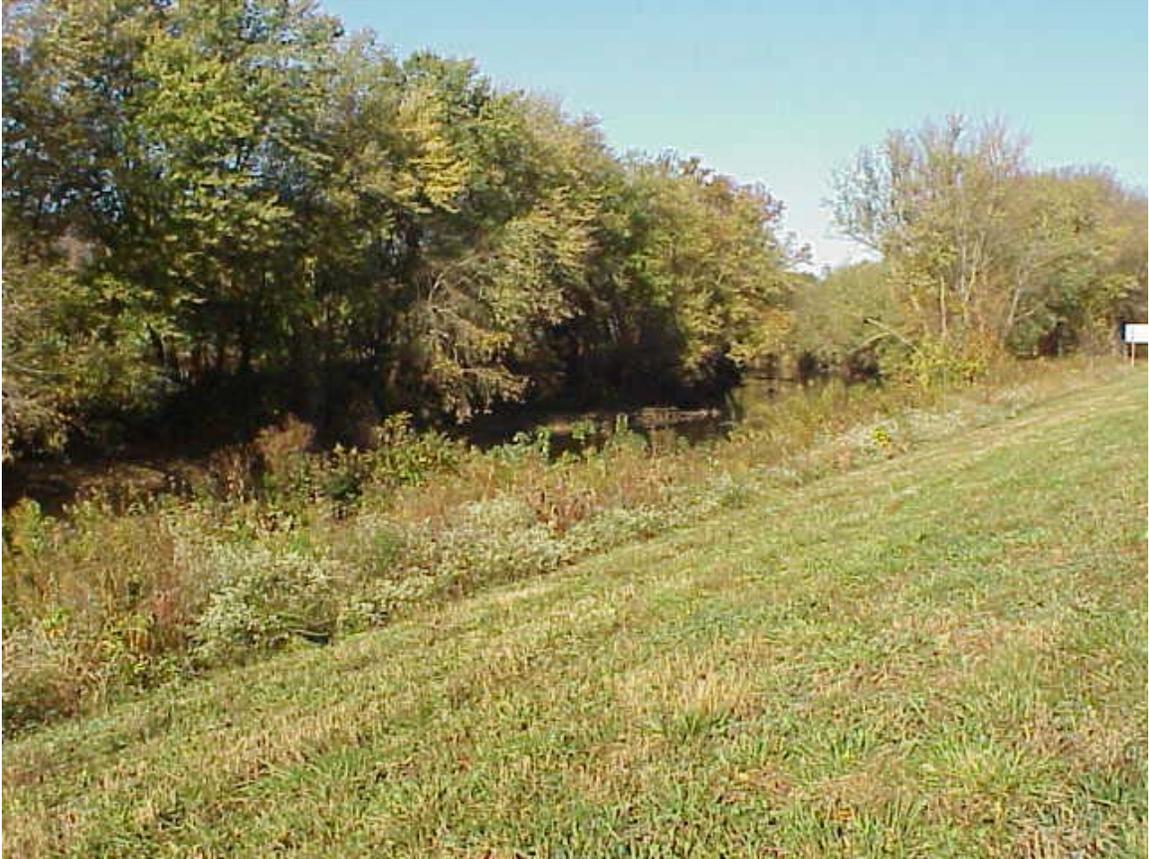
**Figure 6.5** Mowed and unmowed areas

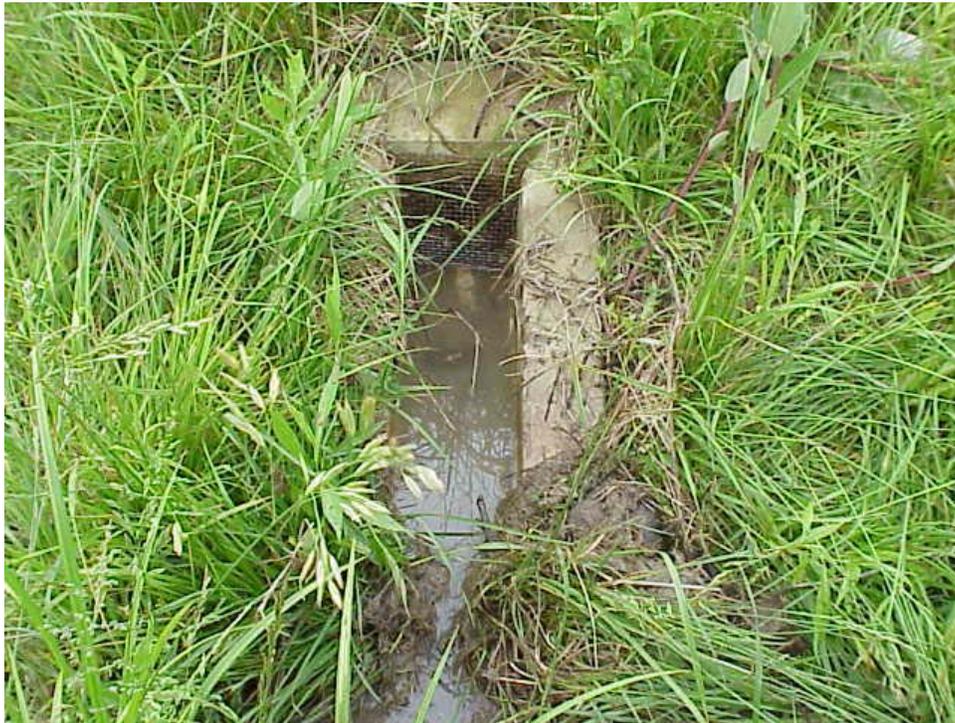
**Figure 6.13** Typical outlet, as found and after sediments were removed

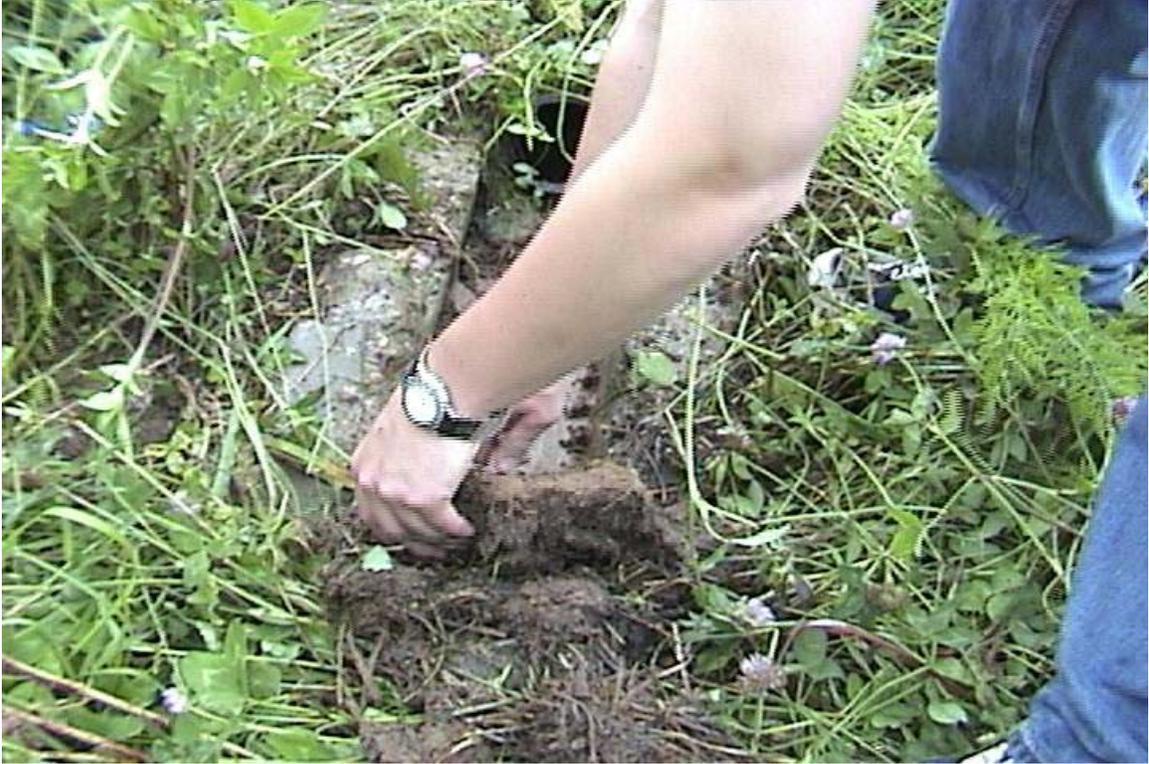
**Figure 6.14** An older concrete outlet, which appears to have been recycled
