REPORT NO. **FAA-75-1**  
FAA-RD-75-16

SURVEY OF VISUAL GROUND AIDS  
AT O'HARE INTERNATIONAL AIRPORT

INTERIM REPORT

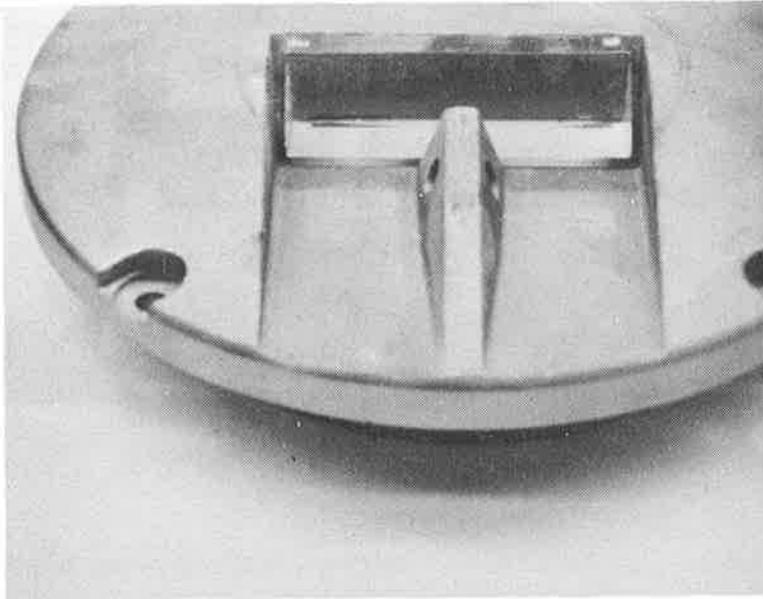
Figure 2-18. Top View of L-843 Fixture

Figures 2-18 and 2-19 provide top and bottom views of the L-843 fixture, respectively. The metallic contacts seen in Figure 2-19 provide a mechanical pressure contact with the terminals housed in the installed base assembly. There have been considerable problems with this arrangement as a result of annealing of the copper/beryllium strips and subsequent arcing and pitting of these contacts. These fixtures are expected to be replaced in the near future with the L-850 fixture.

Another type of problem encountered with the L-843 touchdown zone fixture is with the two copper beryllium spring contacts used to establish the electrical connection between the lamp housed in the fixture and the electric contact posts housed in the shallow base which is epoxy bonded to the runway surface. The spring contacts tend to soften through an annealing process thus eventually causing arcing and subsequent failure.

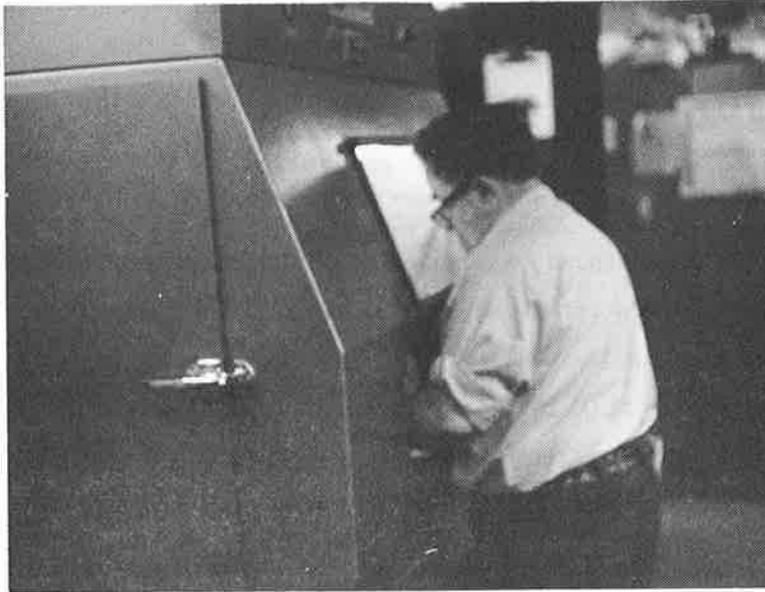
**Figure 2-22. Maintenance Man Using Blasting Machine**

Figure 2-22 shows a maintenance man operating a blasting machine used in removing rubber deposited by aircraft tires on touchdown and rust which has accumulated on various parts of the touchdown or centerline fixtures. Small glass beads are sprayed under pressure against the fixture which has had all glass components removed or covered before the refurbishing process is begun. Failure of the O-ring seals or the previously mentioned breakage of the optical assembly

seals are the most common failures which allow water to enter the housing and quickly erode the various internal parts.

After the fixtures have been cleaned and broken lenses, optical assemblies, and electrical contacts replaced or cleaned, the fixtures are relamped and stored either in the shop or in a trailer. The trailer is towed to the field when lamps or fixtures are to be replaced. Sufficient stock is maintained in the trailer to meet the needs of normal replacement activities which are performed during the midnight shift when airport operations tend to be at minimum levels.

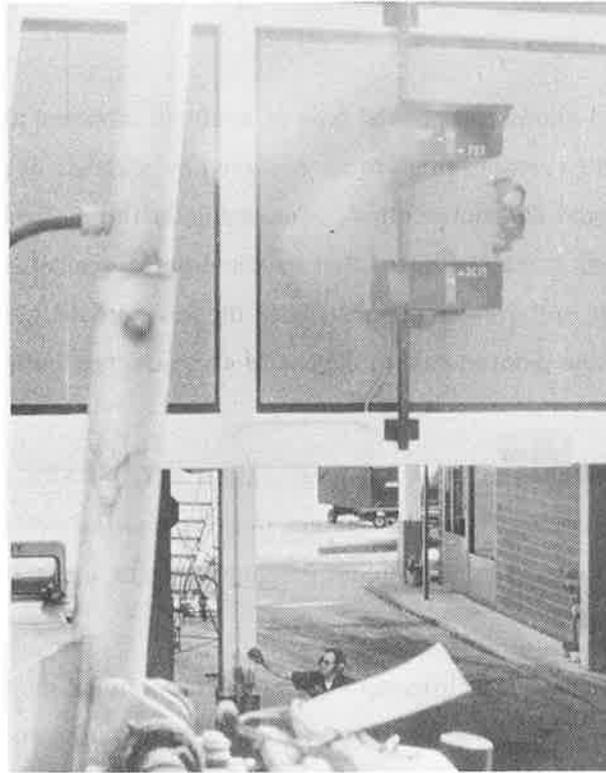
Figure 7-3. Docking Aids at Gate K-J

Figure 7-3 shows the second type of system, mounted at gate K-5. We were advised that this system is due to be replaced as a result of pilot dissatisfaction with its operational characteristics. Consequently the methods of docking were not pursued; however, it may be noted that forward movement of the aircraft will cause a vertical shift in the relative location of the horizontal light bar. Alignment of the light bar with the painted dash adjacent to aircraft type indicates the correct stopping point.
